Construction and Storm Water Inspection

April 3, 2019

Operator: BURLINGTON RESOURCES OIL & GAS LP – 26580

Location ID: 461862

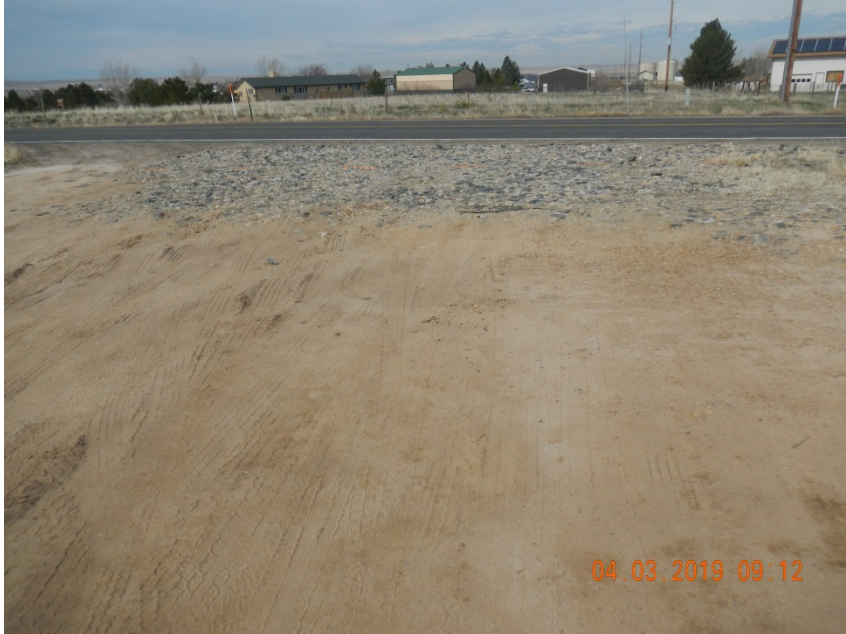
Photo 1. Photo taken from the entrance of the location off Imboden Road , facing West. Appears Operator has installed gravel to potentially limit tracking onto the road.

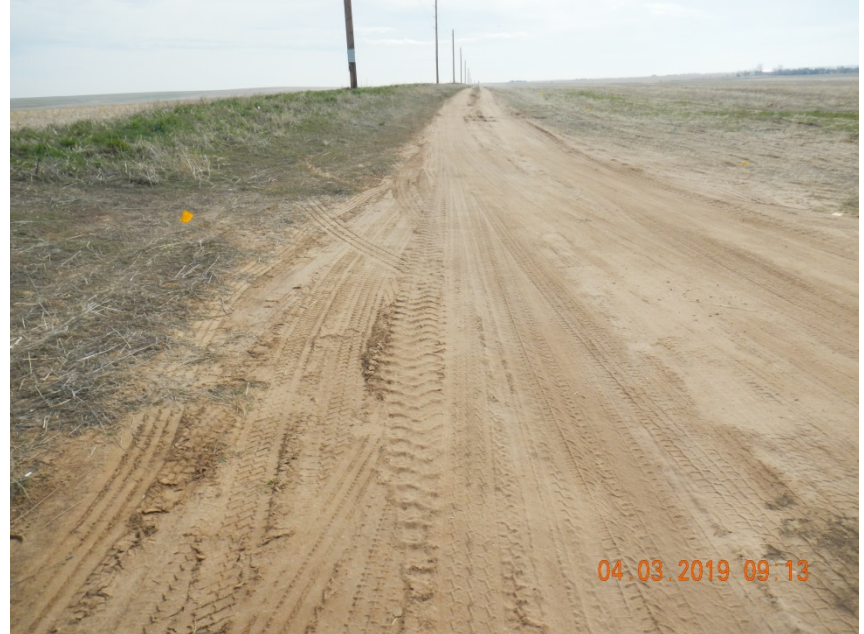
Photo 2. Photo taken from the entrance of the location off Imboden Road looking along the existing access road, facing East.

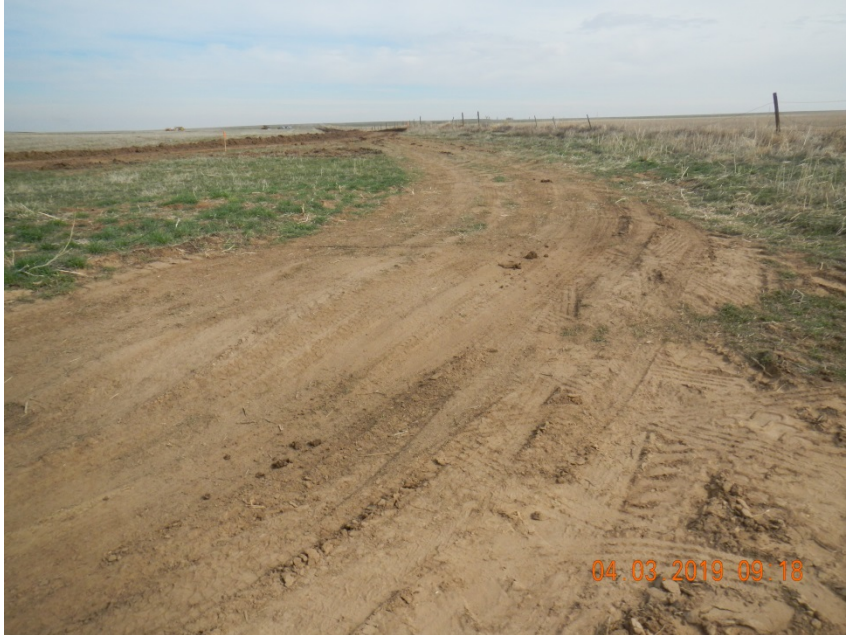
Photo 3. Photo taken from the access road looking into the location, facing North. Photo depicts the access road into the pad is currently under construction.

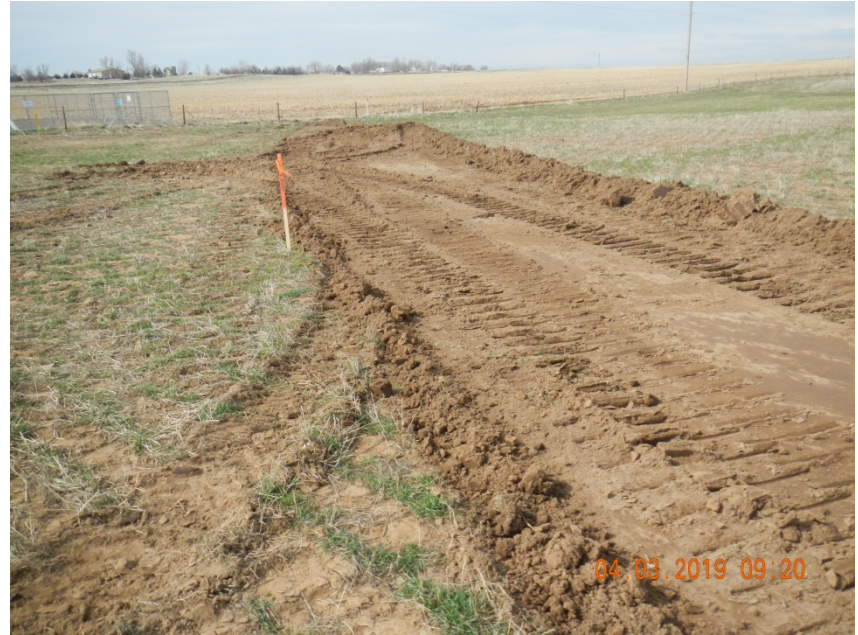
Photo 4. Photo taken from the access road, facing South. See comments from Photo 1.

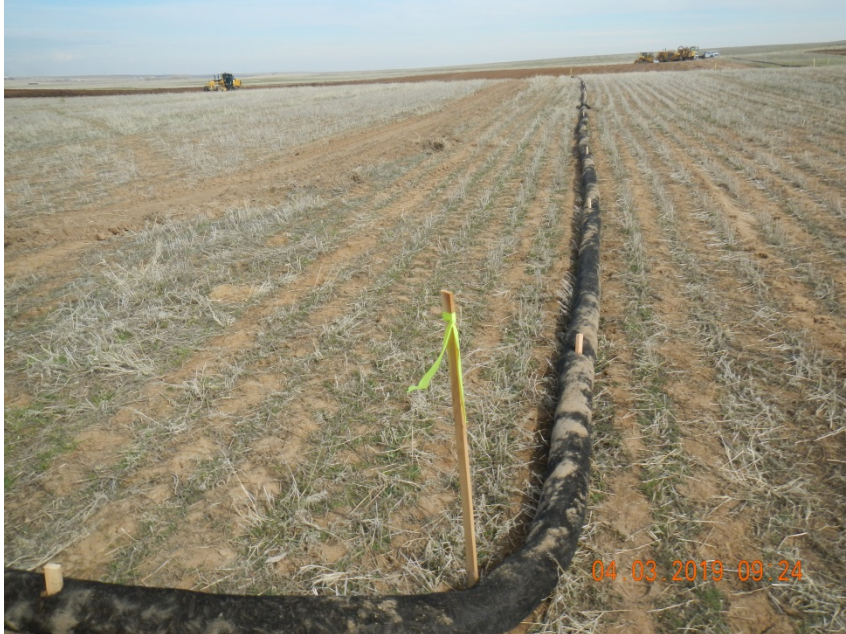
Photo 5. Photo taken from the southeastern perimeter of the location, facing North. Photo illustrates a filtrex BMP that has been installed around the entire perimeter of the location in conjunction with other BMPs.

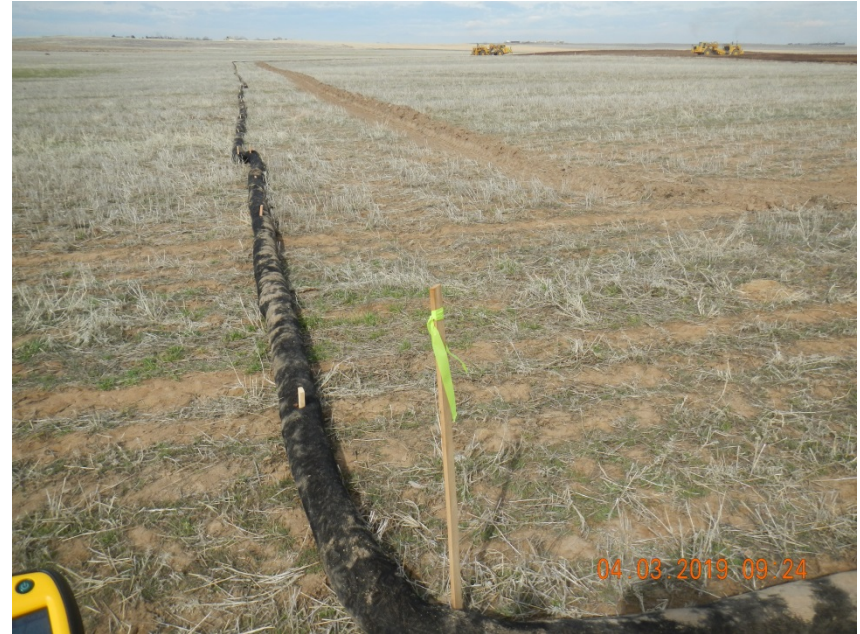
Photo 6. Photo taken from the southeastern perimeter of the location, facing West. See comments from Photo 5.

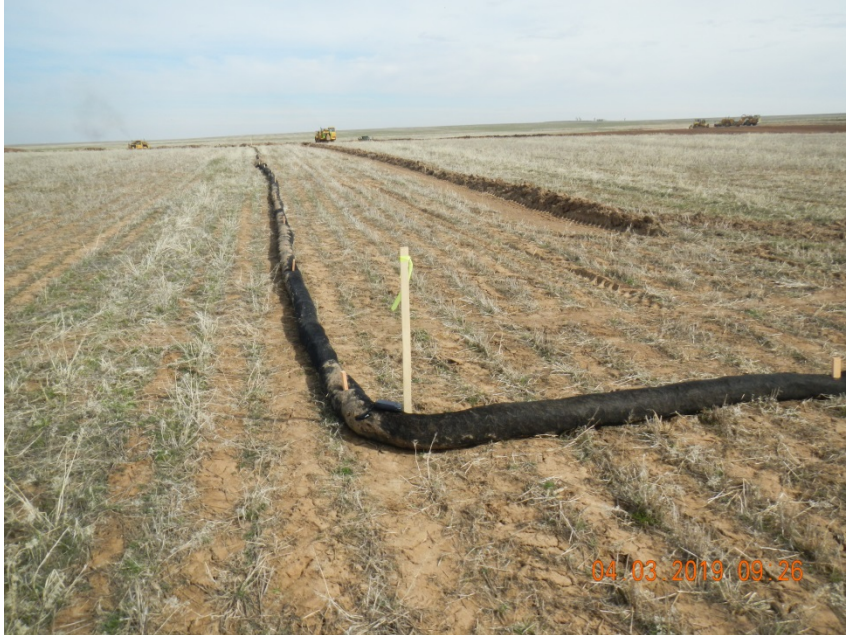
Photo 7. Photo taken from the southwestern perimeter of the location, facing North. See comments from Photo 5.

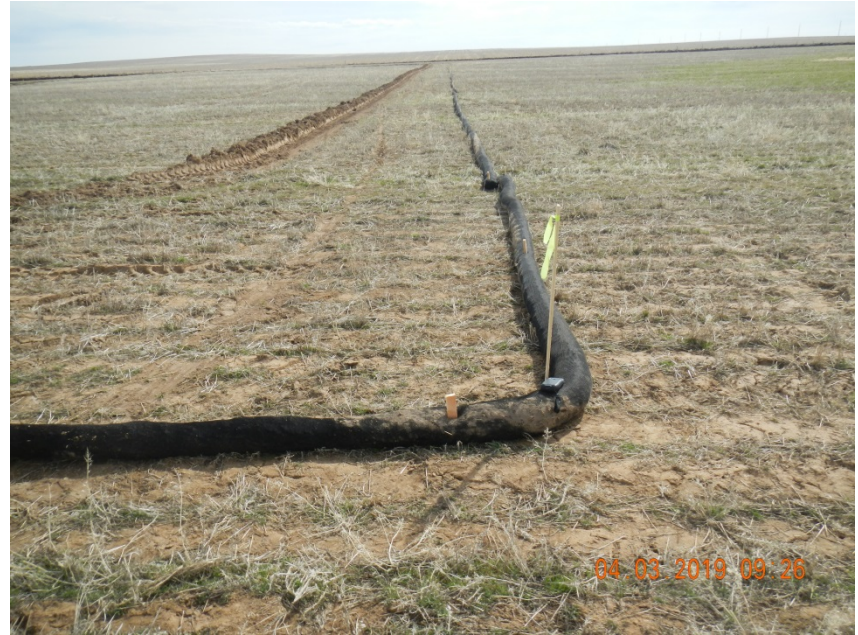
Photo 8. Photo taken from the northeastern perimeter of the location, facing East. See comments from Photo 5.

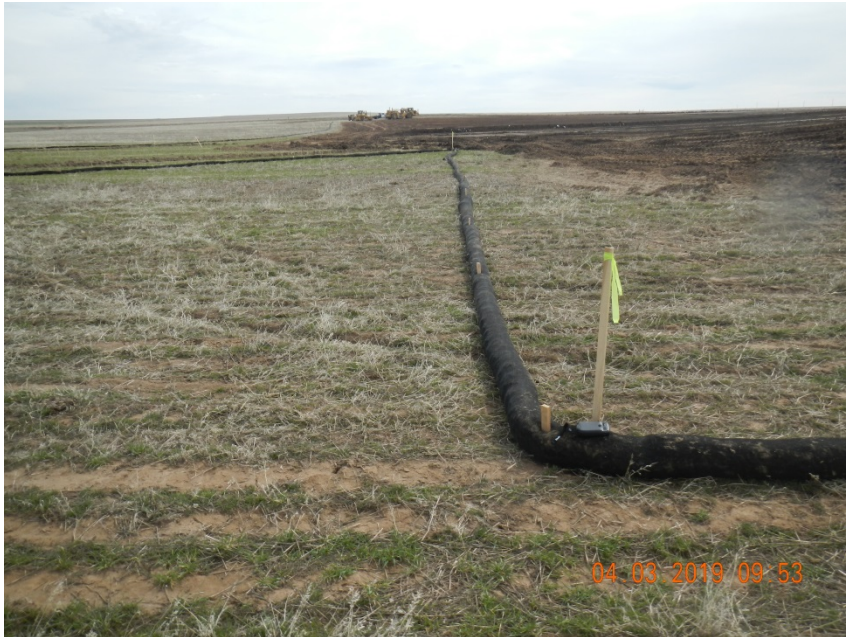
Photo 9. Photo taken from the northwestern perimeter of the location, facing East. See comments from Photo 5.

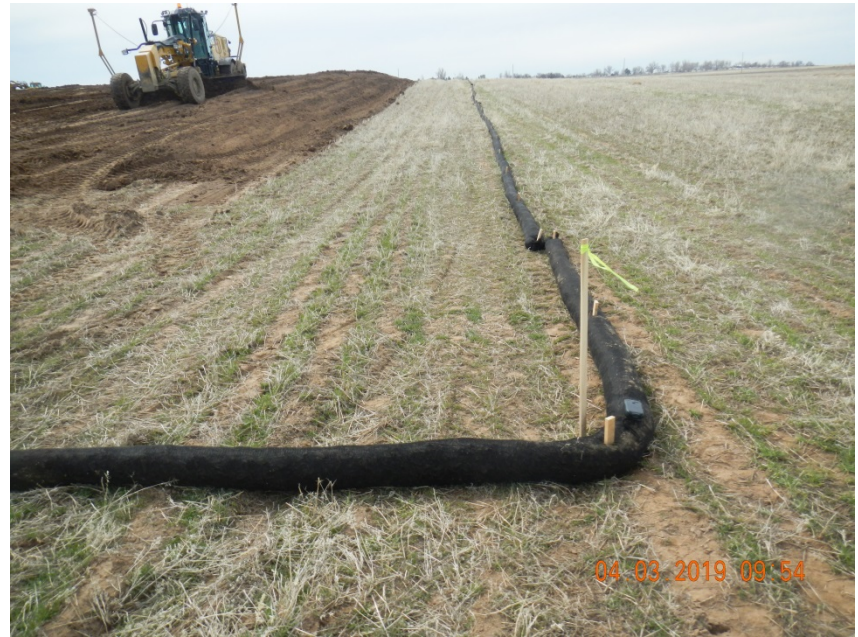
Photo 10. Photo taken from the northwestern perimeter of the location, facing South. Photo depicts the topsoil stock pile that is currently being salvaged.

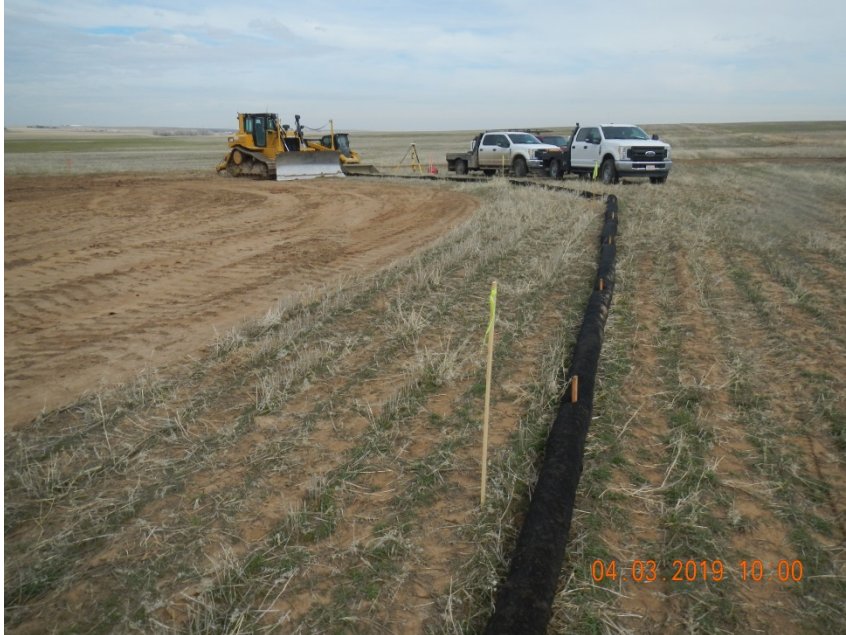
Photo 11. Photo taken from the northeastern perimeter of the location, facing North. See comments from Photo 5.

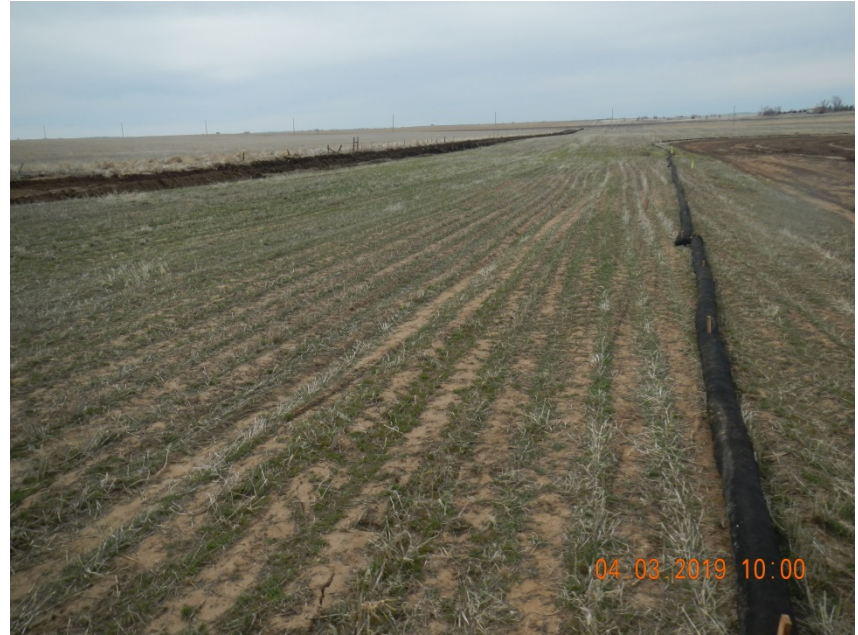
Photo 12. Photo taken from the northeastern perimeter of the location, facing South. See comments from Photo 5.
