Inspection Photos
Operator: BP America
Location/API #: 067-08293
Date: 4-9-2019

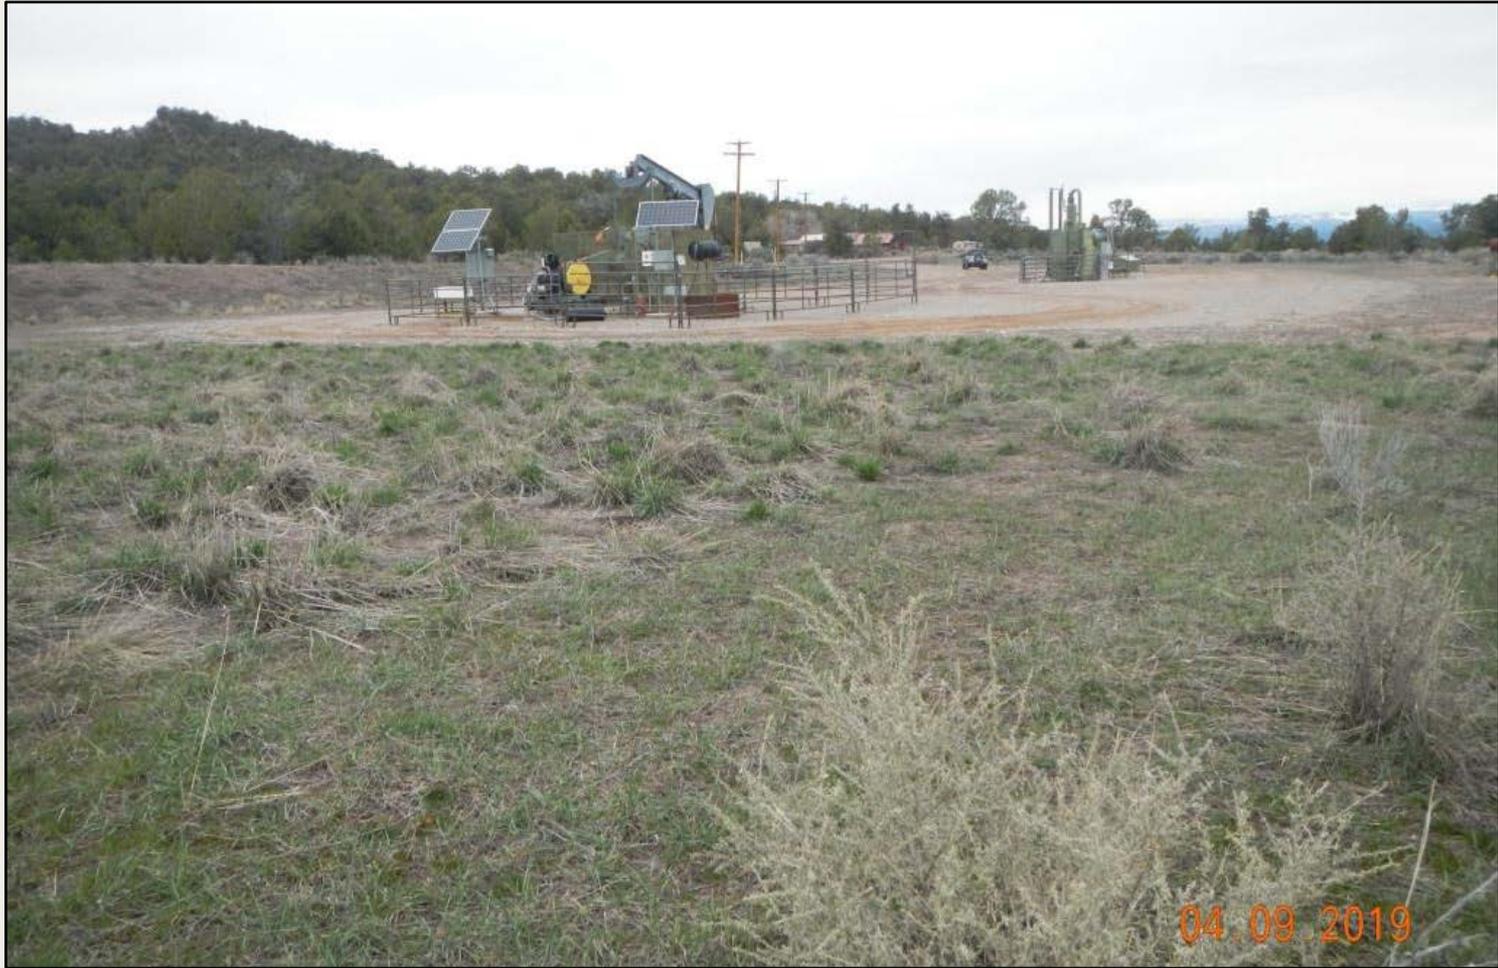
Photo 1. View of the project area from the southeastern corner facing center.

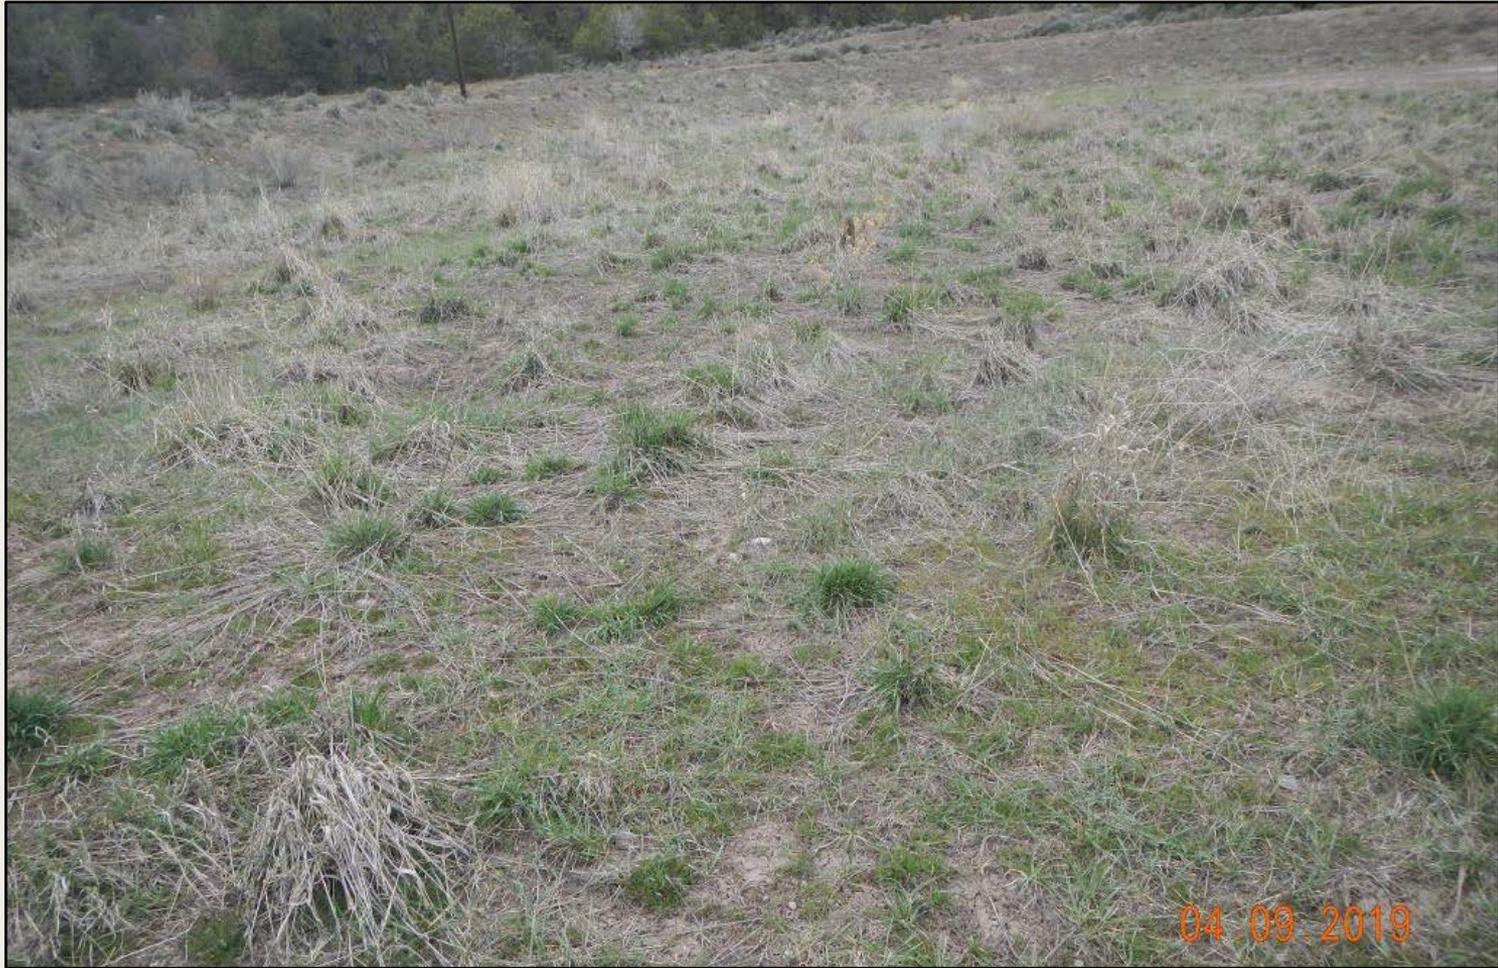
Photo 2. View of the southern project area from the southeastern corner facing westward.

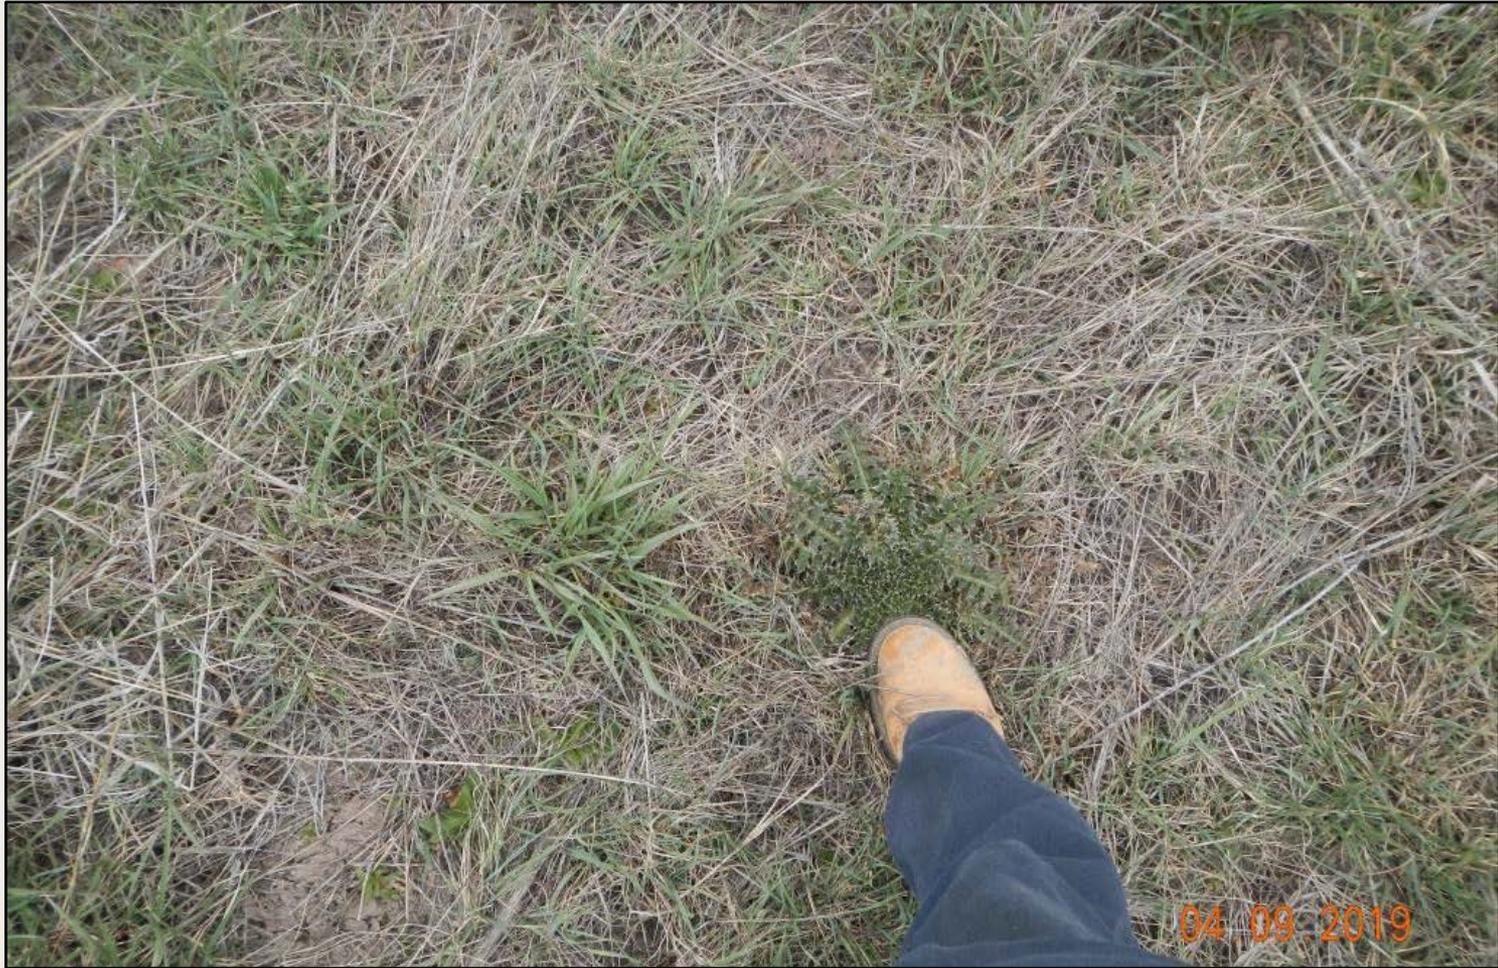
Photo 3. View of musk thistle rosettes within the project area.

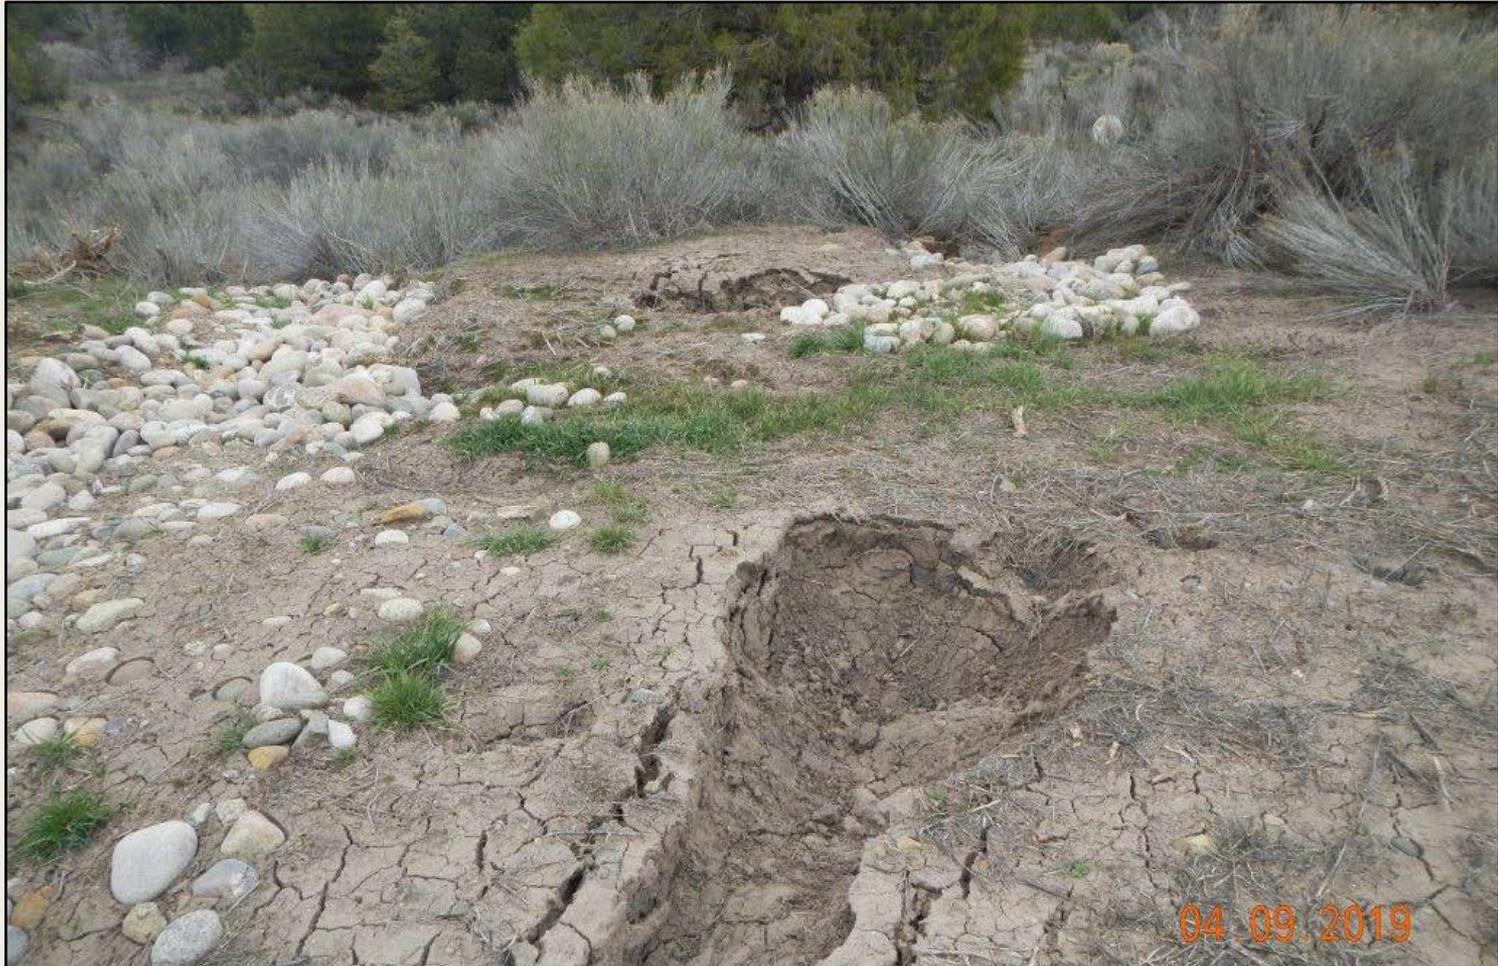
Photo 4. View of erosional tunneling within the eastern project area. Cobble BMP is not and adequate sto

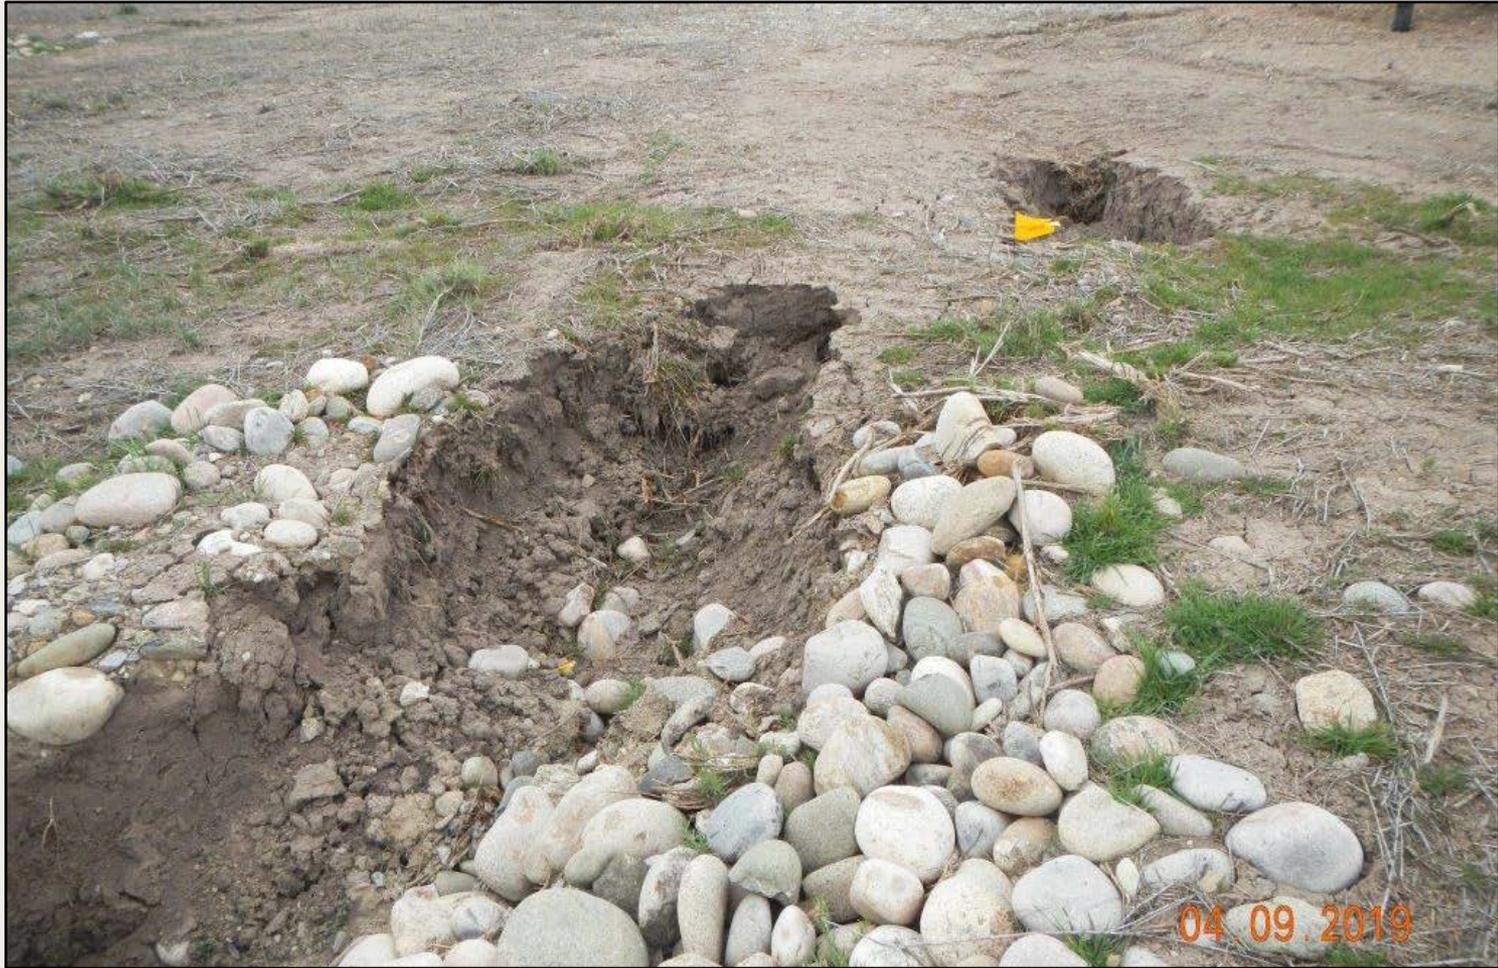
Photo 5. View of more erosional tunneling within the eastern project area.
