*Inspection Photos*  
*Loc#414268*  
*Operator: Laramie*  
*Insp#692400911*  
*Inspection Date: 4/16/2019*

Inspection Photos: Laramie Knox Loc#414268

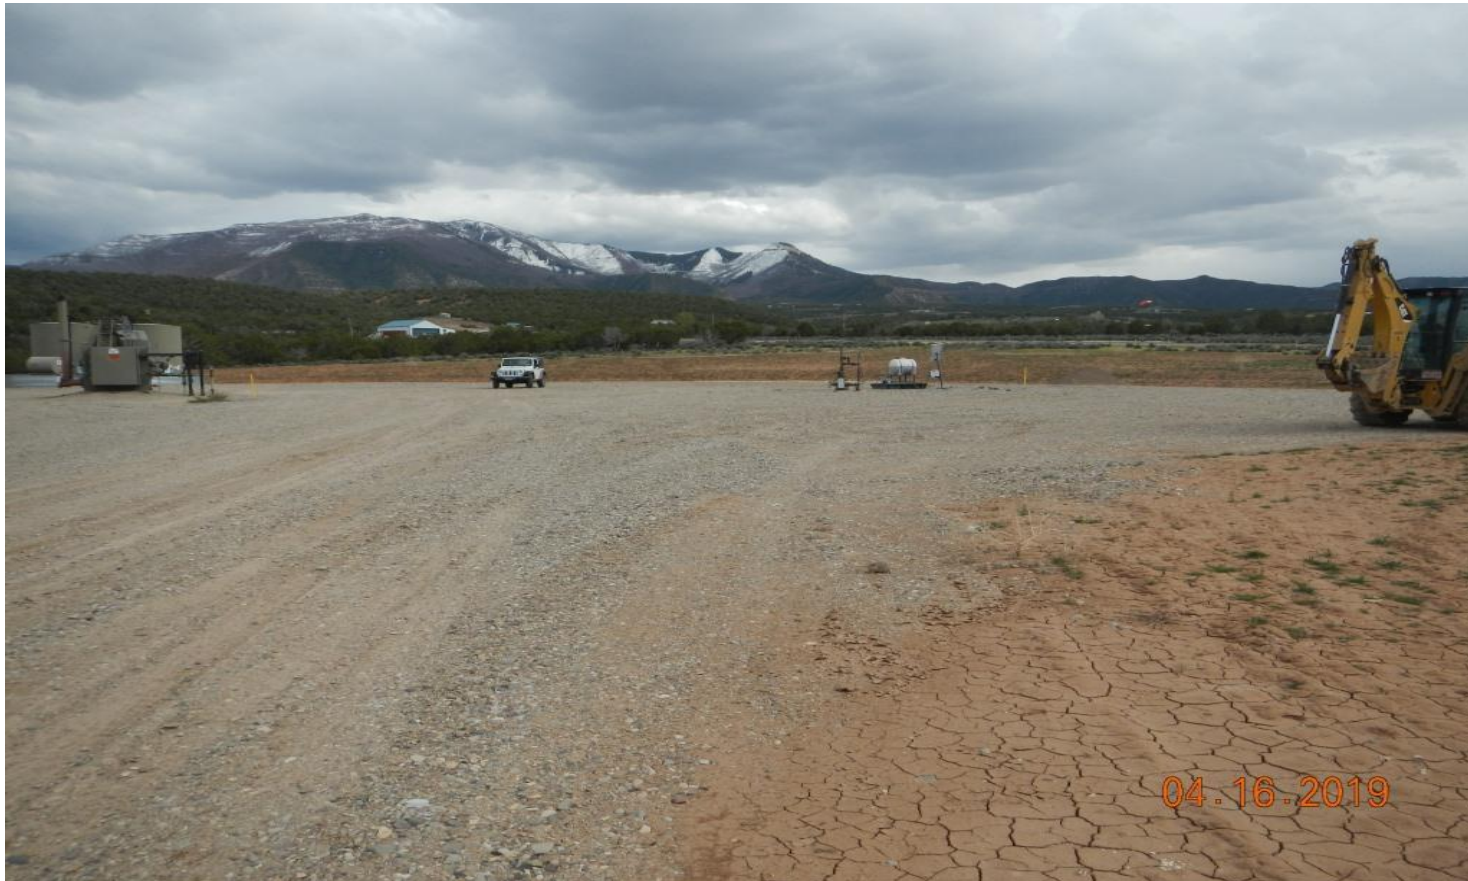
**Photo#1:**  
Overview of Location from entry to Southeast.

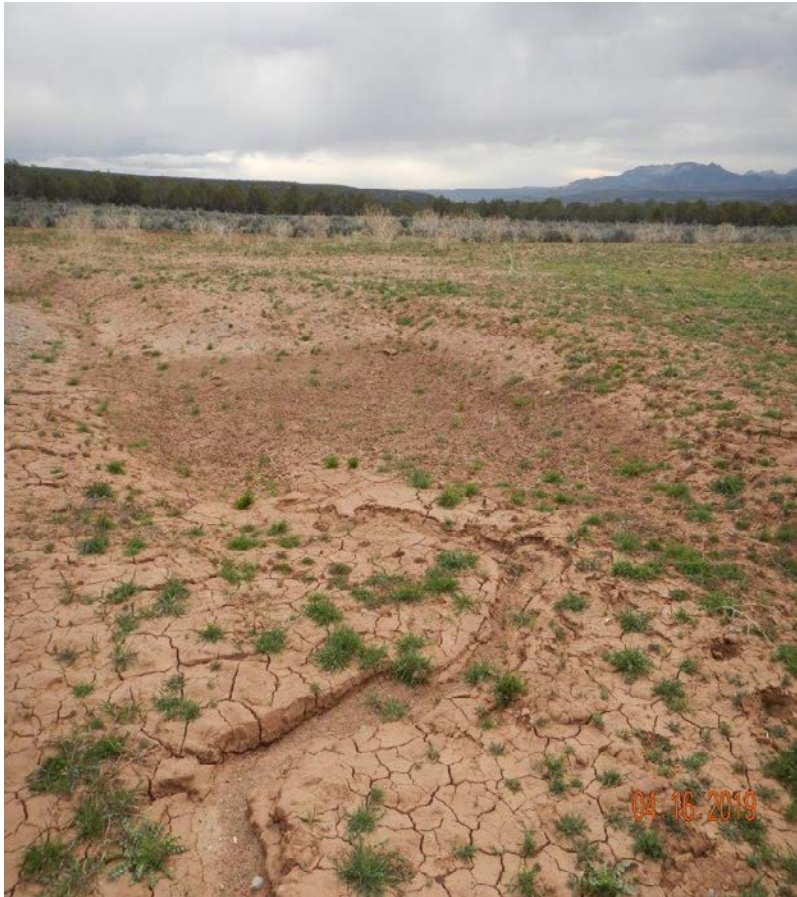
Photo#2:  
Stormwater is collecting at points just off  
Pad.

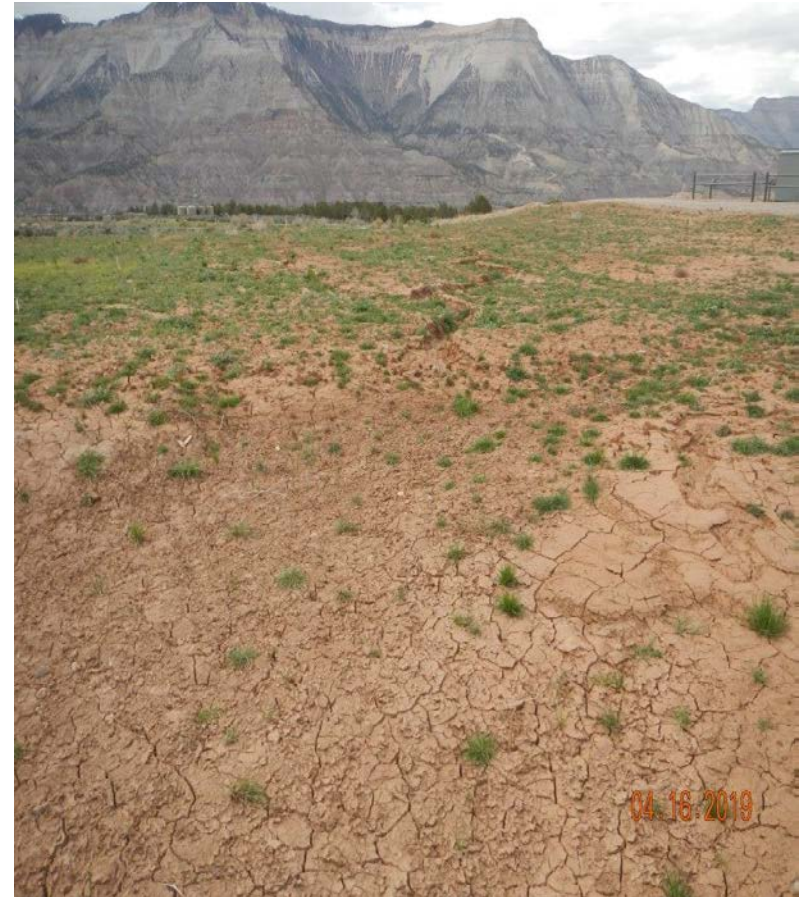
Photo#3:  
Stormwater is collecting at points just off  
pad.

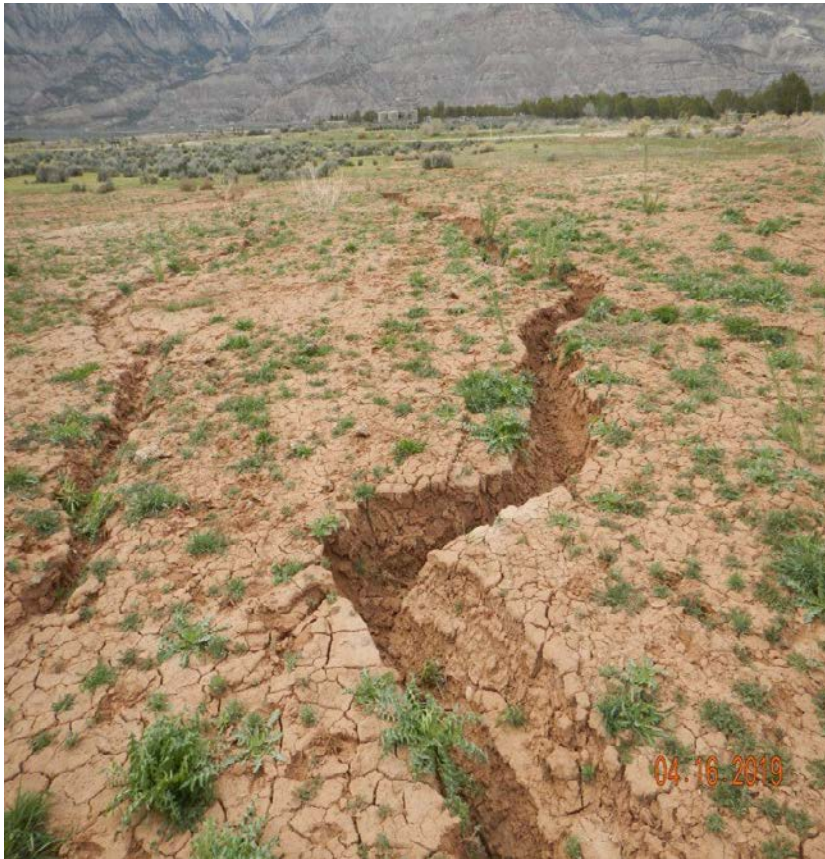
Photo#4:  
Stormwater cutting channels, washing out  
vegetation.

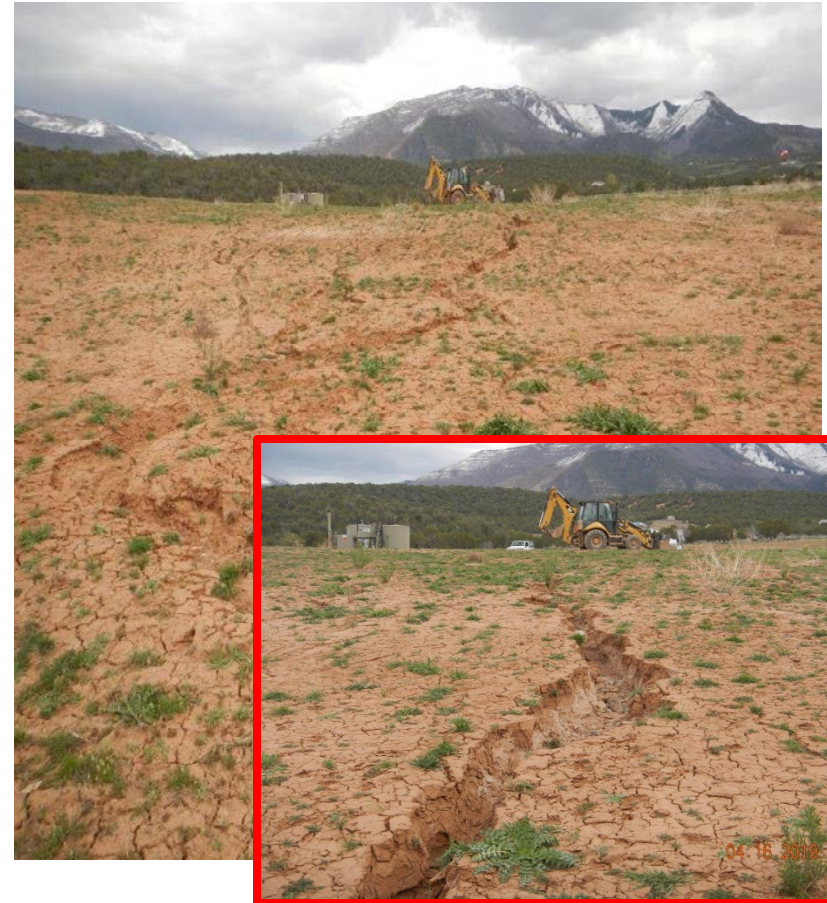
Photo#5:  
Stormwater cutting channels, washing out  
vegetation.

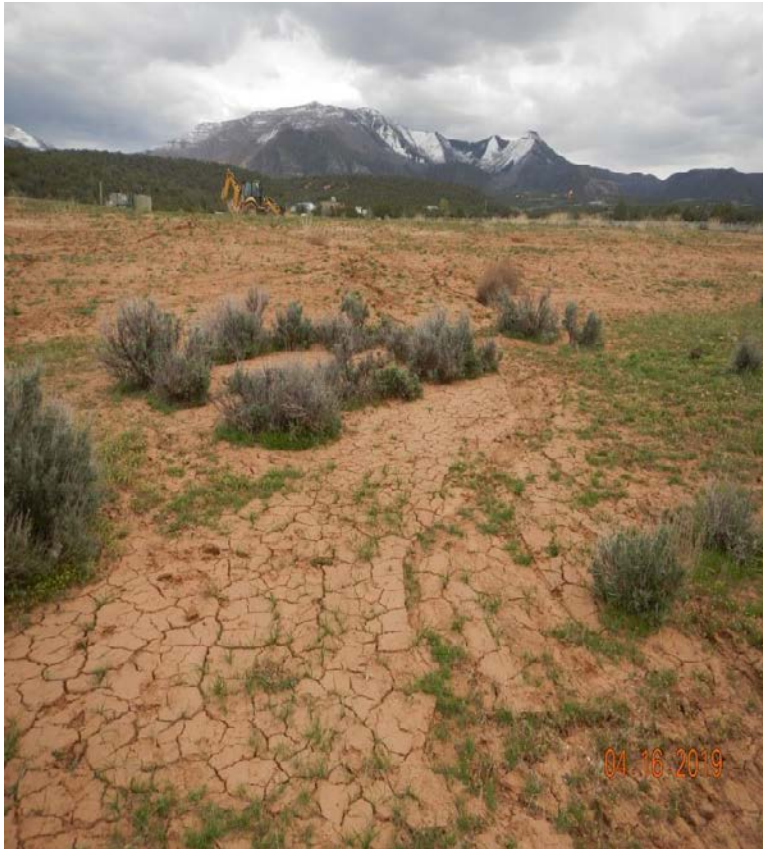
Photo#6:  
Sediment moving off site.

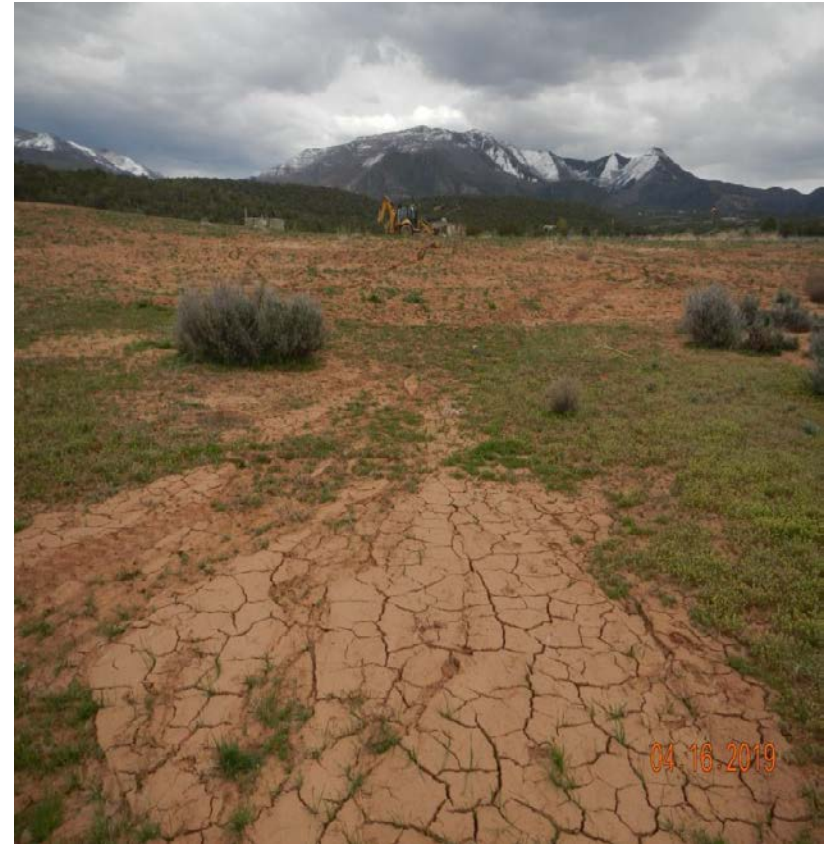
Photo#7:  
Sediment moving off site.

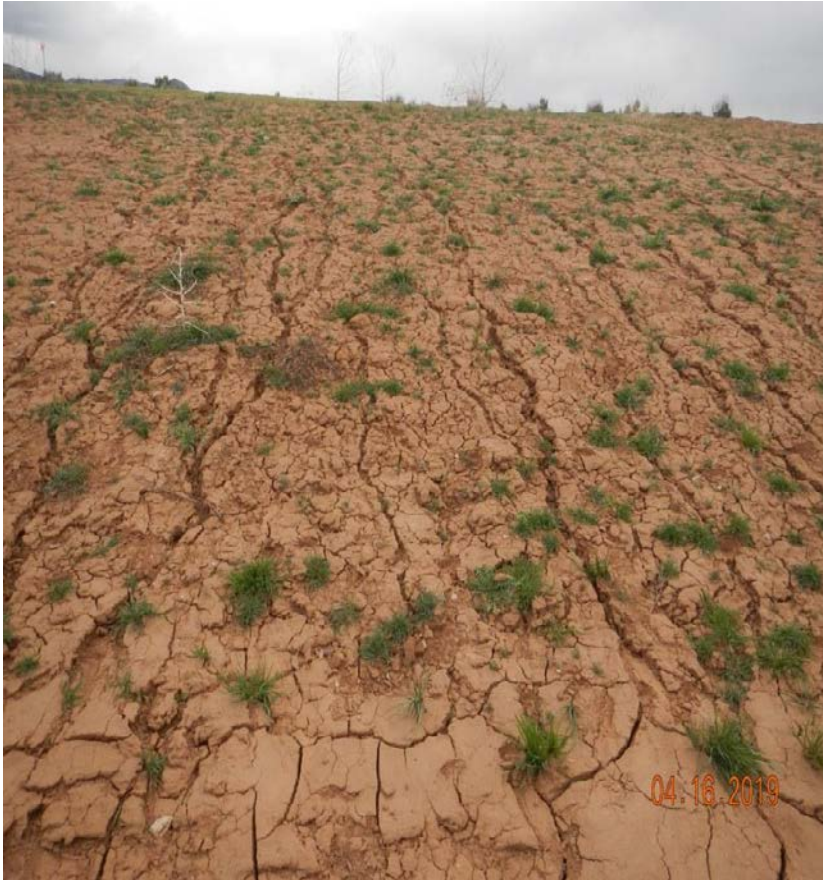
Photo#8:  
Erosion concerns on cut slope.

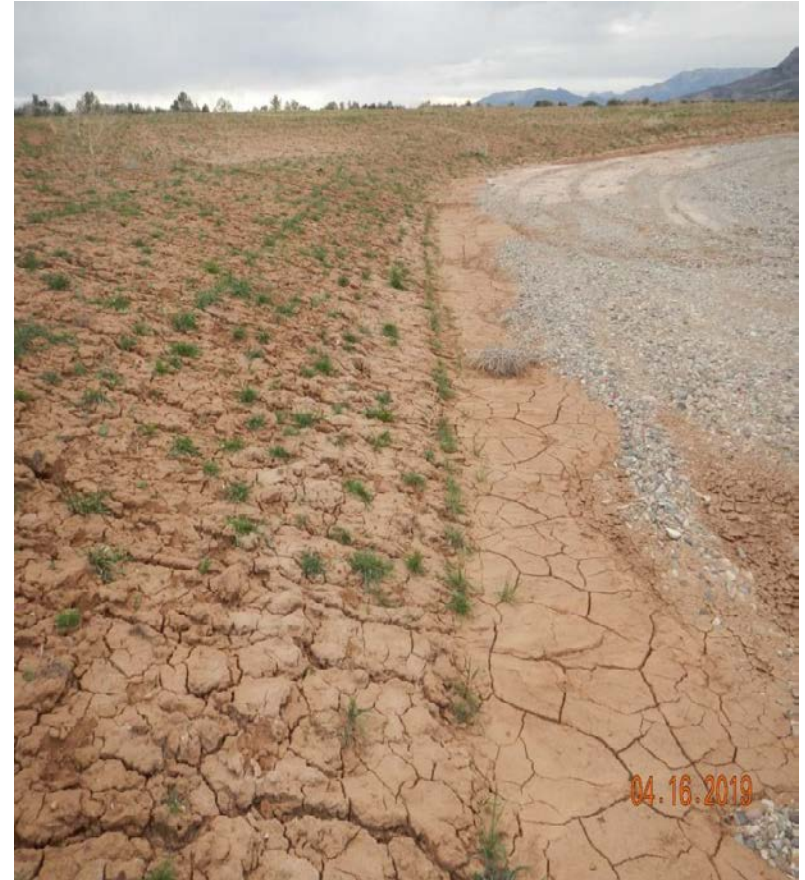
Photo#9:  
Erosion concerns on cut slope.
