Inspection Photos
Loc#457122
Operator: Caerus
Insp#692400904
Inspection Date: 4/15/2019

Inspection Photos: Caerus NPR P17 Loc#457122

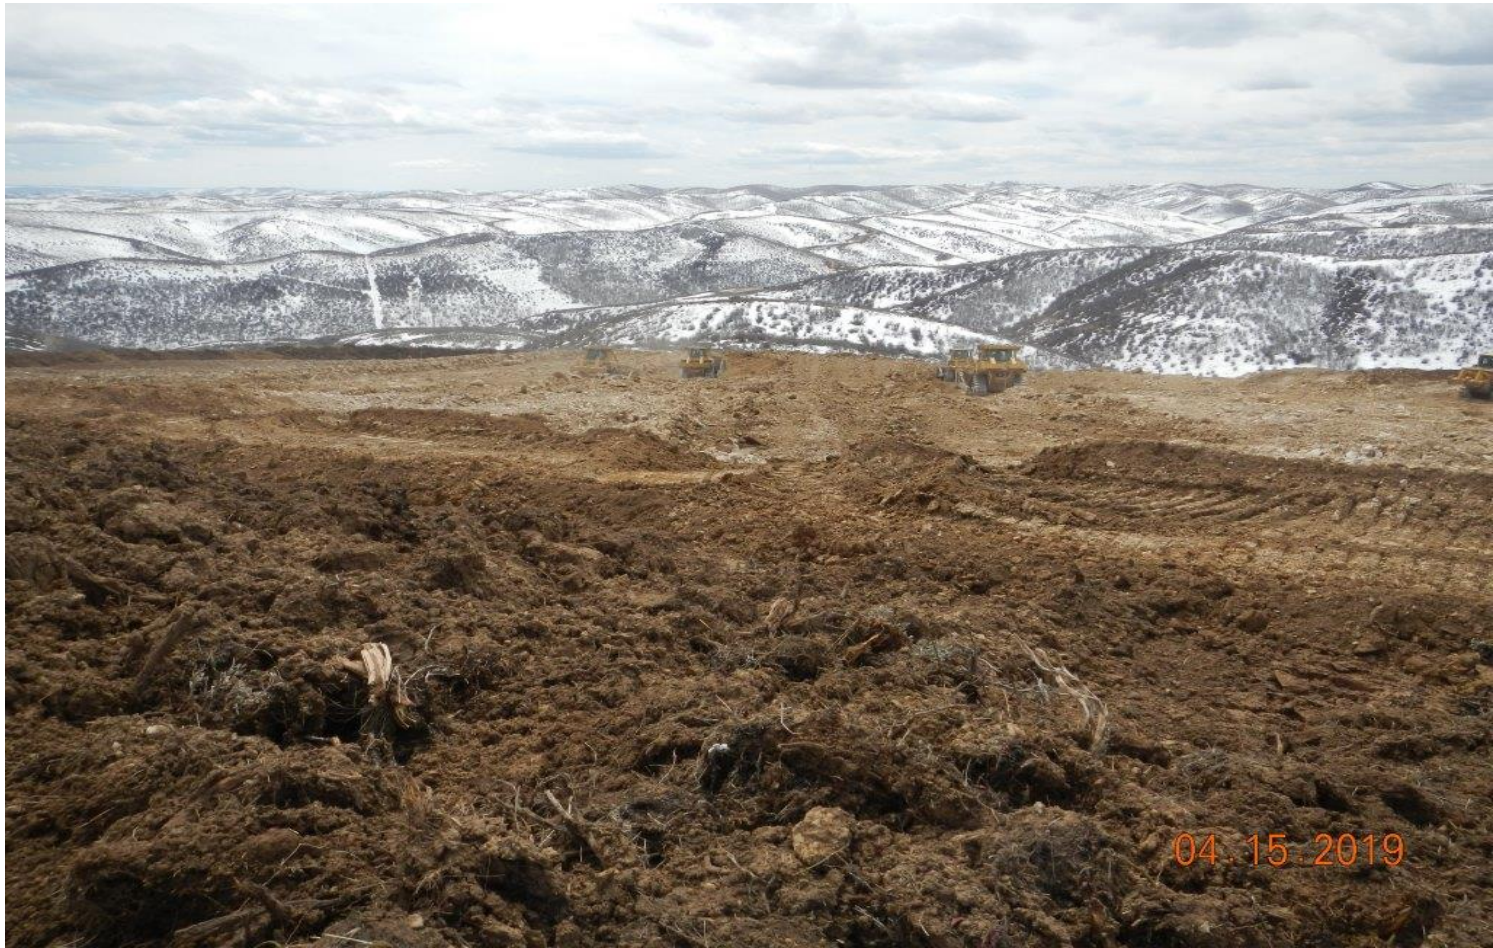
Photo#1:
Overview of Location from top of Cut slope to Southwest.

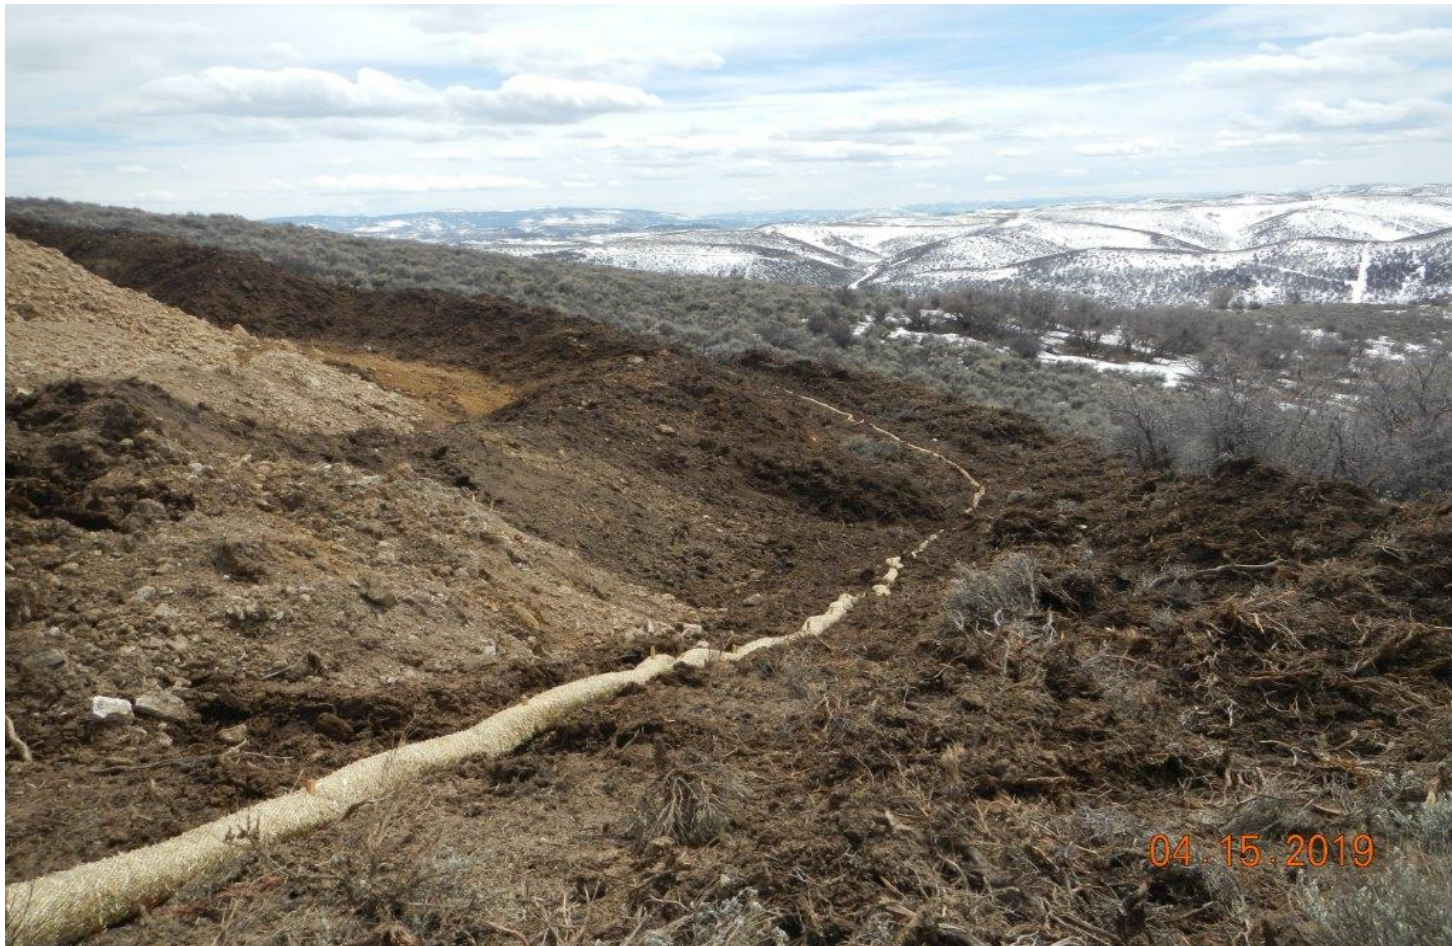
Photo#2:
View along Southern perimeter of Location.

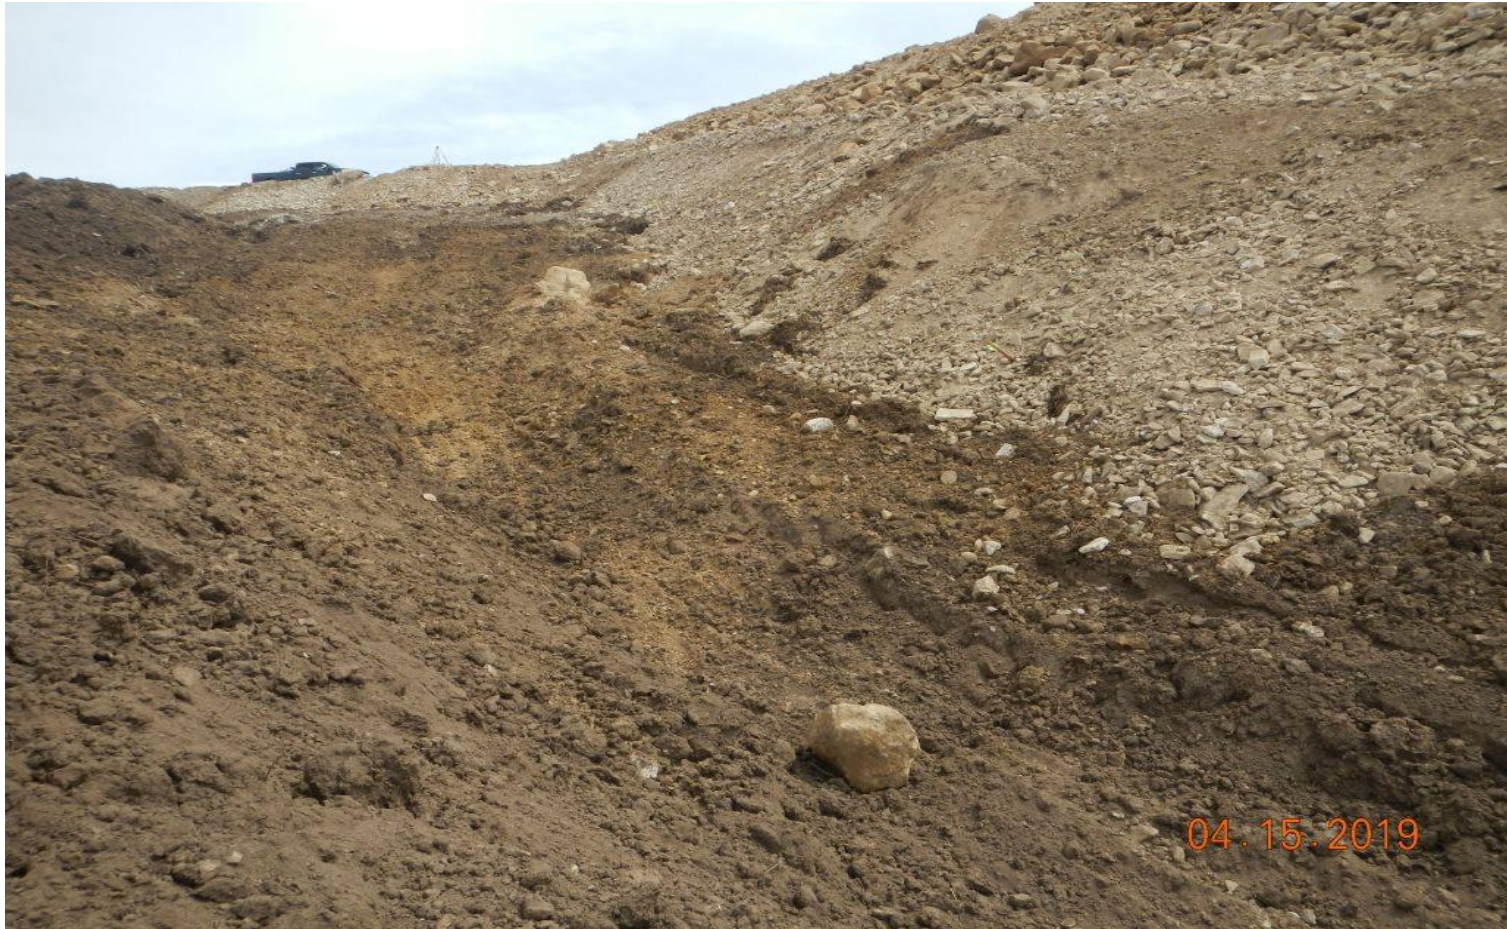
Photo#3:

Southwest of entry showing a more defined compacted definition between fill slope & topsoil than further South along the perimeter.

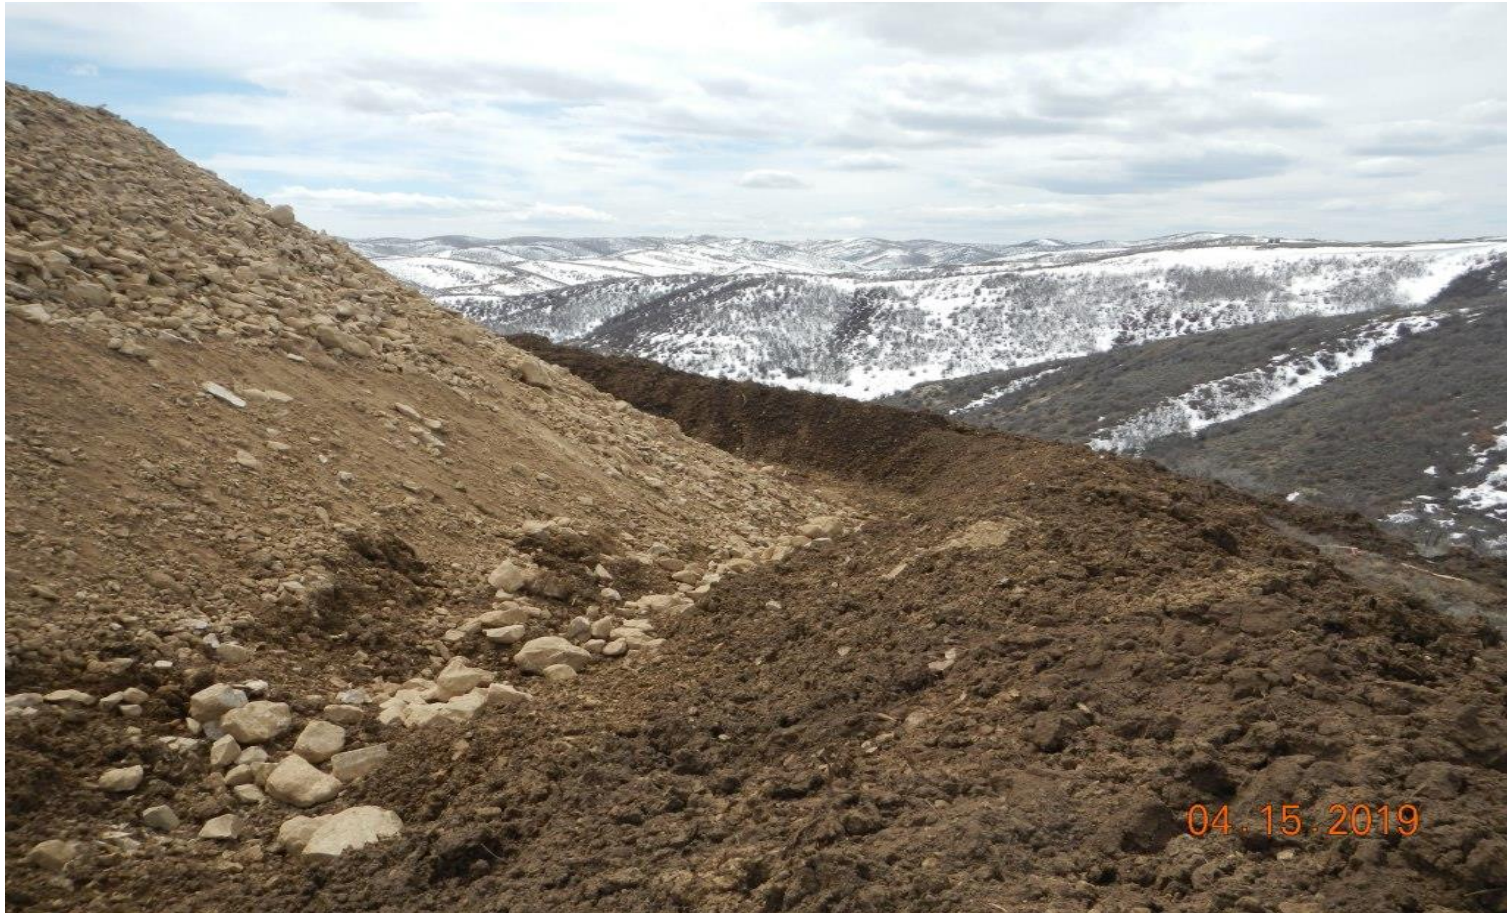
Photo#4:
Topsoil windrowed along toe of Fill slope

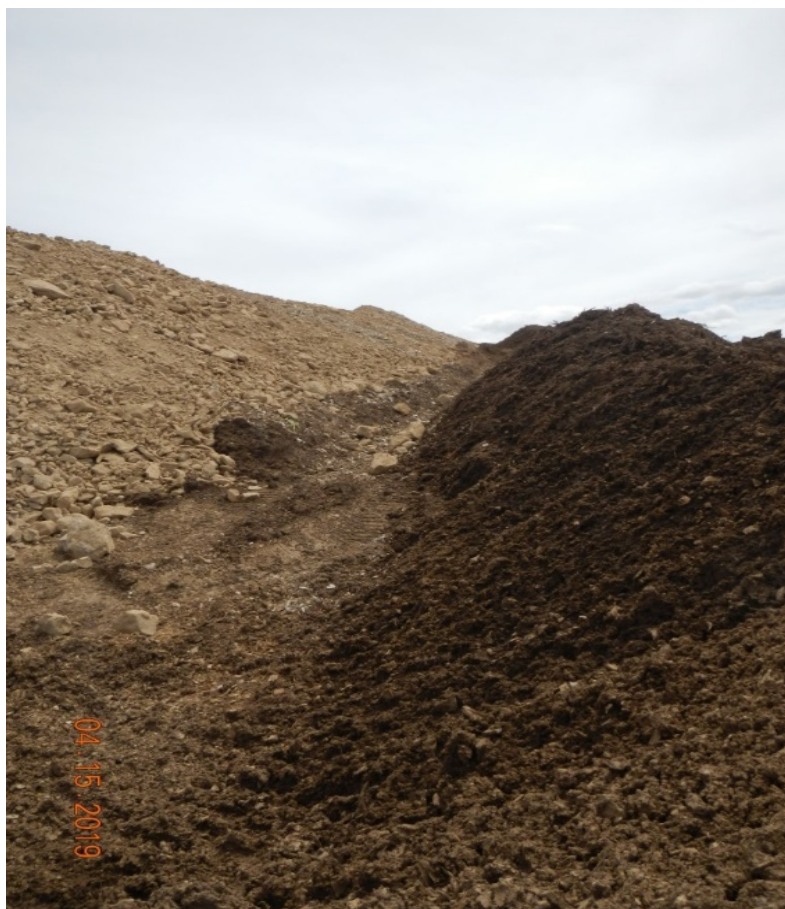
Photo#5:
Topsoil windrowed along toe of Fill slope

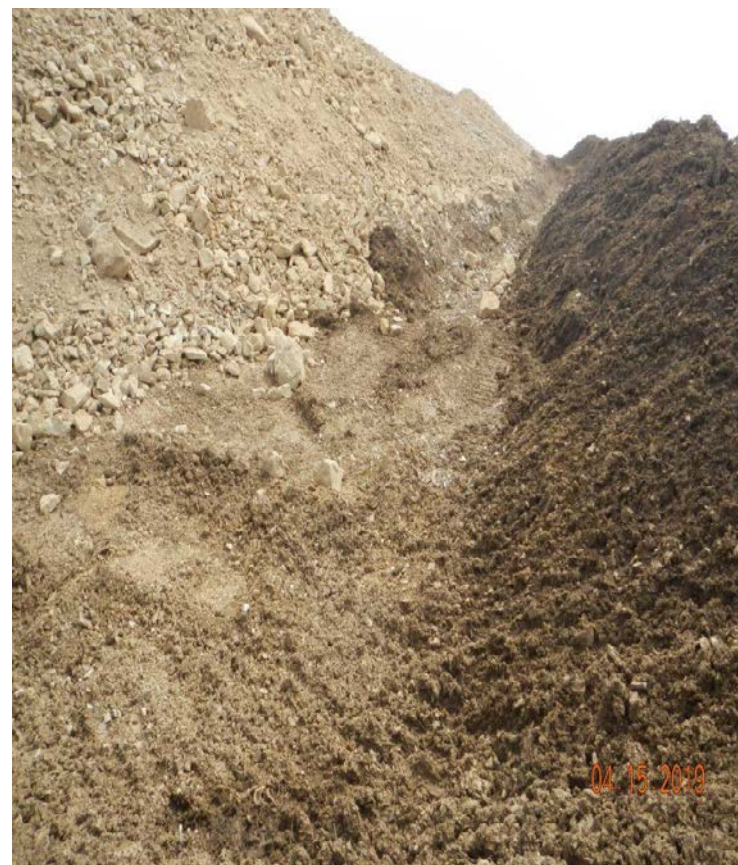
Photo#6:
Topsoil windrowed along toe of Fill slope

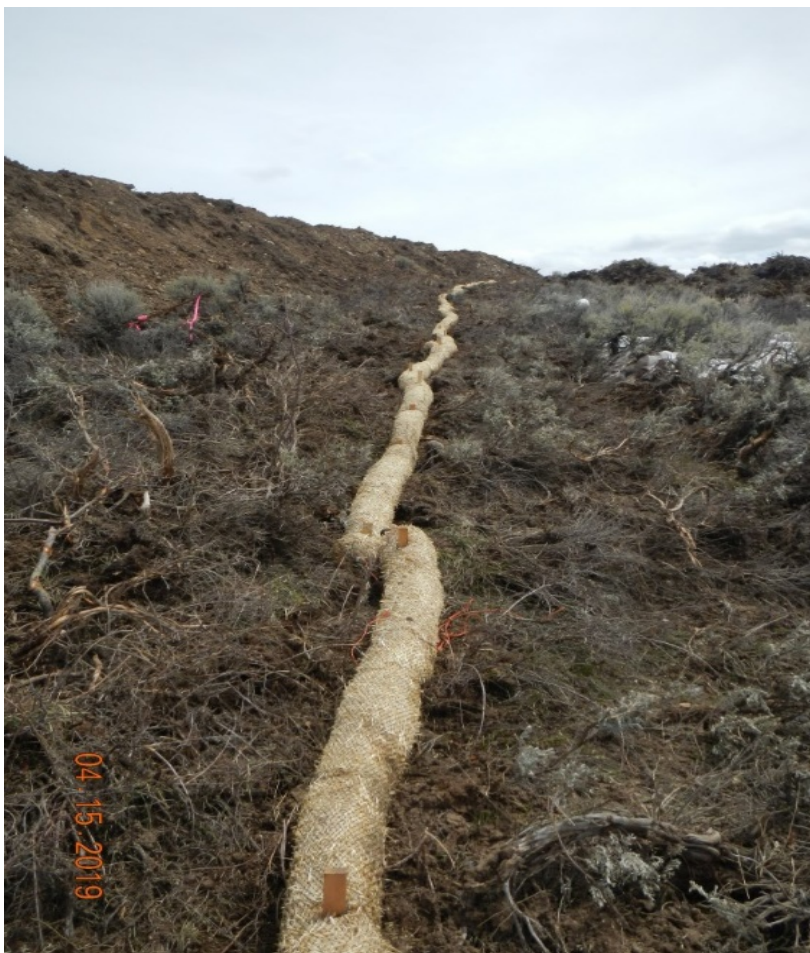
Photo#7:
Wattles have been installed as Perimeter control.

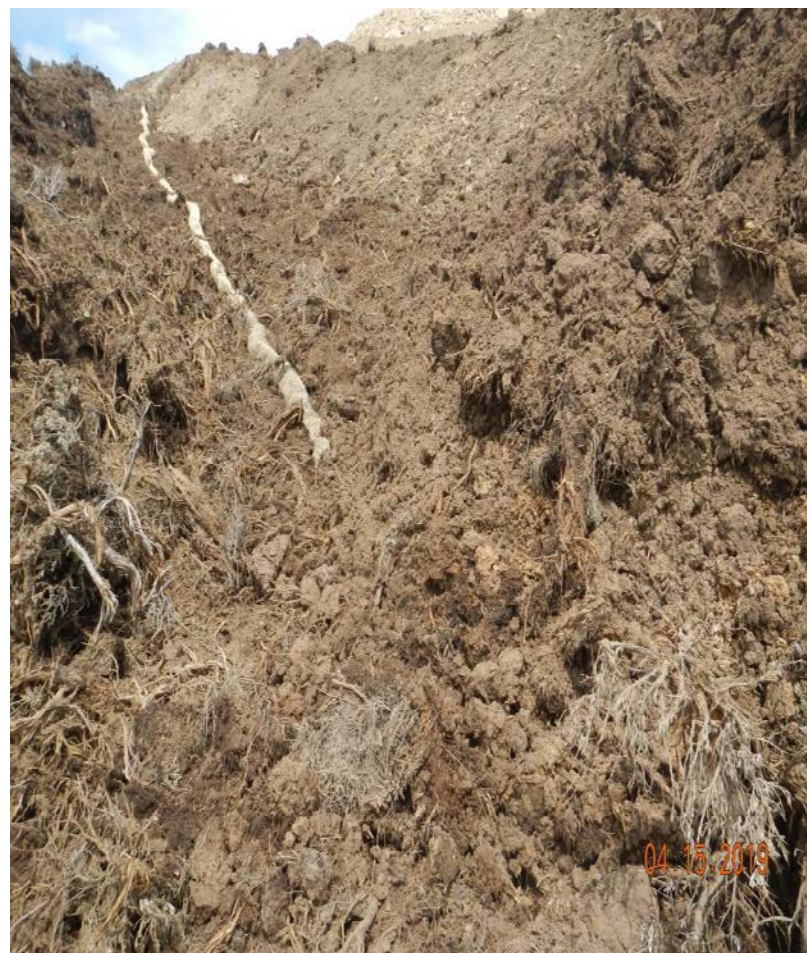
Photo#8:
In a few places wattles have been overwhelmed.
