Penrose #2-8H

Corrective Actions Taken on the Penrose #2-8H for the COGCC
compliance INC.

04/22/19

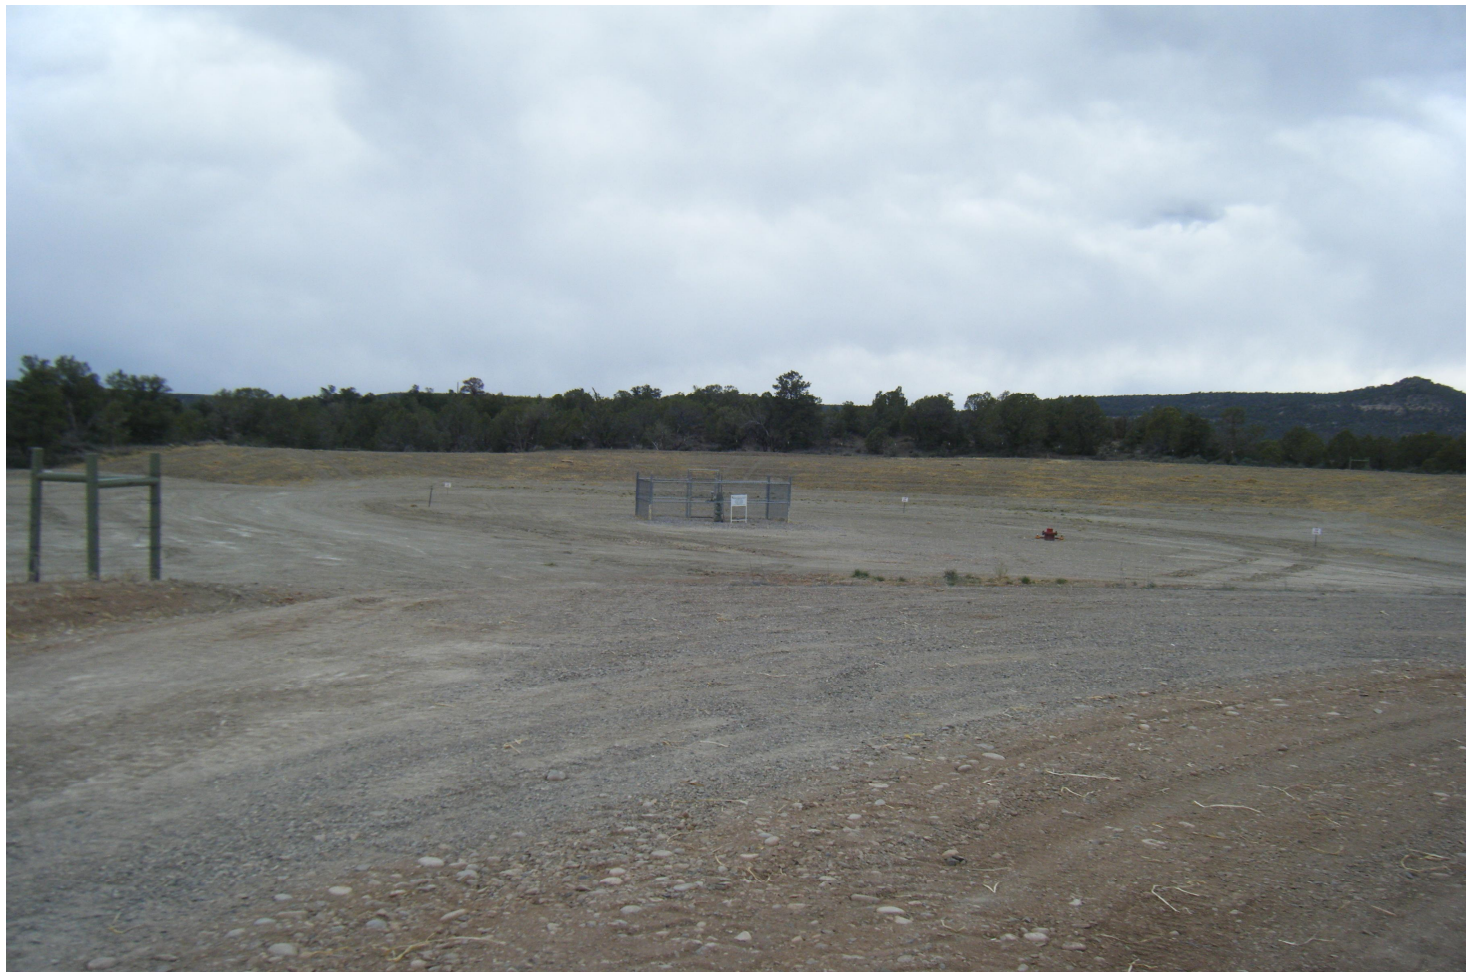
Interim reclamation has been conducted and Storm Water management controls have been established to stabilize erosion. Location tear drop has been established, top soil has been laid out, and all disturbed area's have been seeded with the exception of the tear drop driving surfaces.

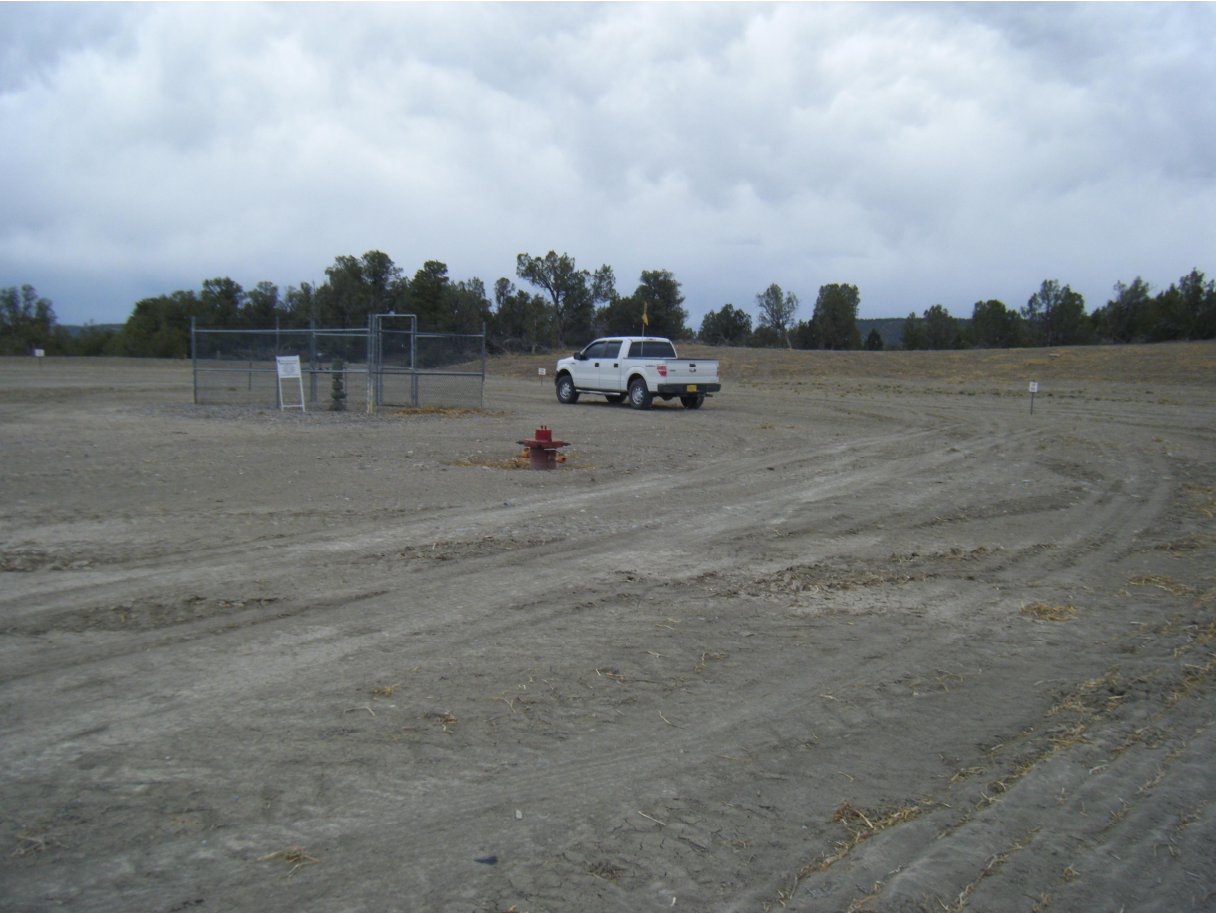
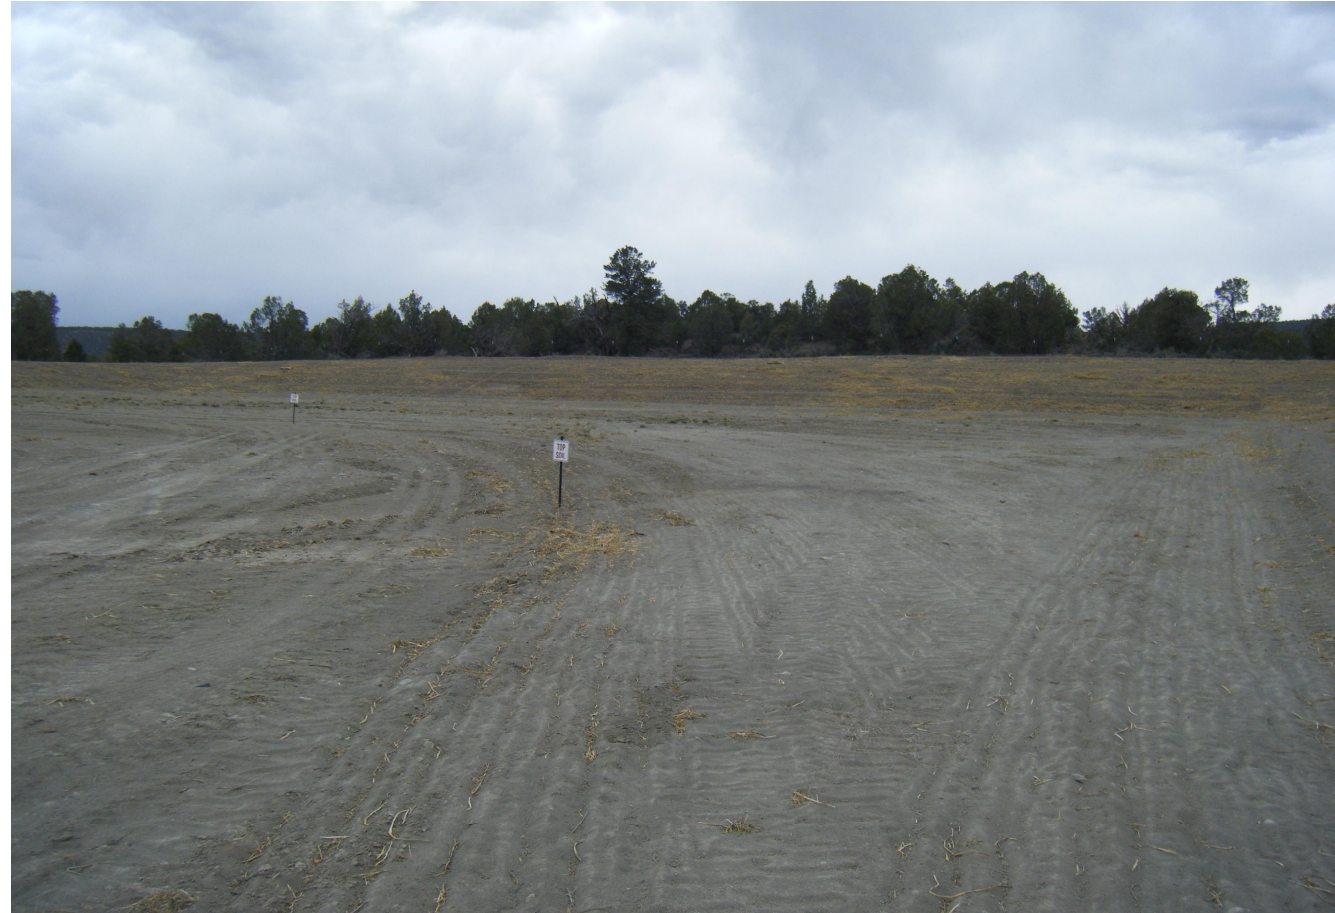
Interim reclamation has been conducted and Storm Water management controls have been established to stabilize erosion.

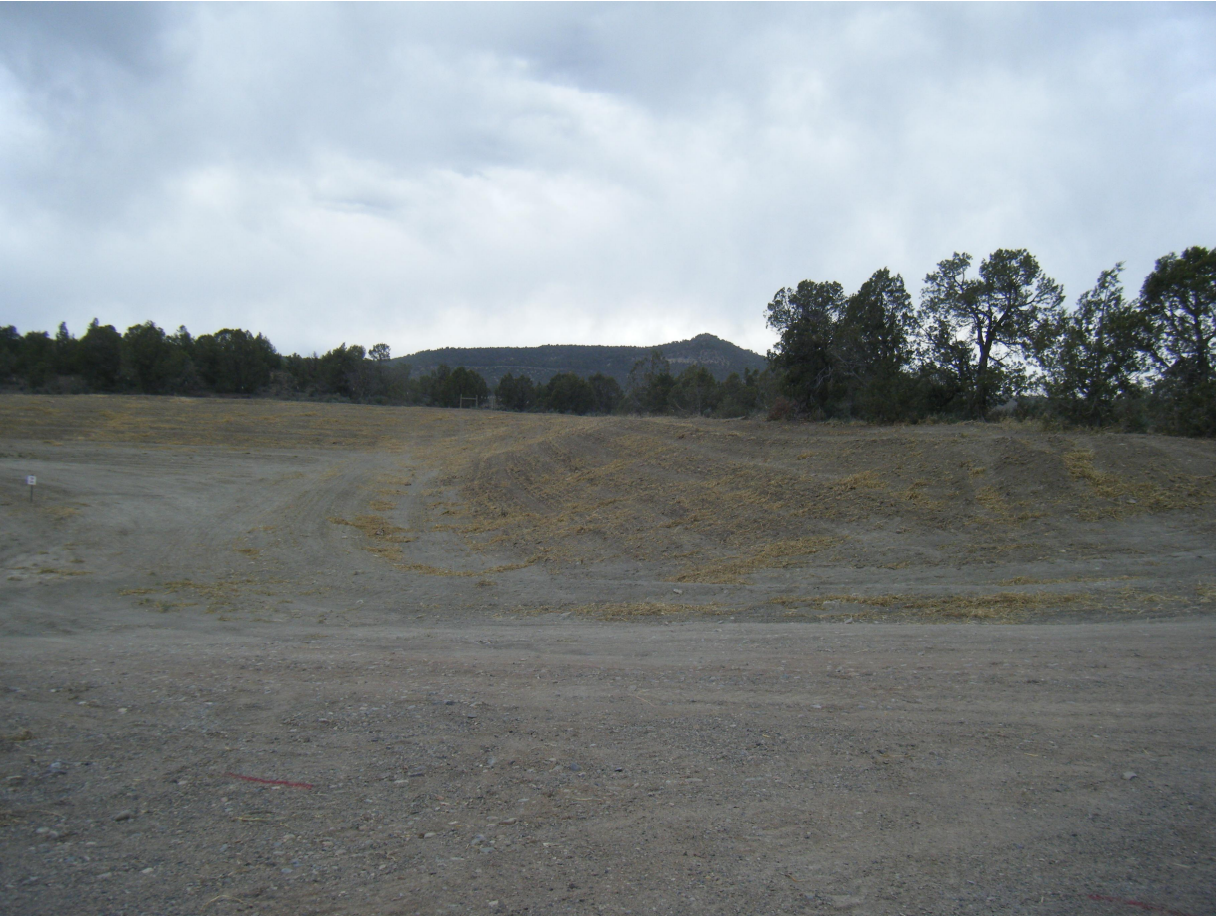
View of storm water controls and reclamation looking south on east side of location.

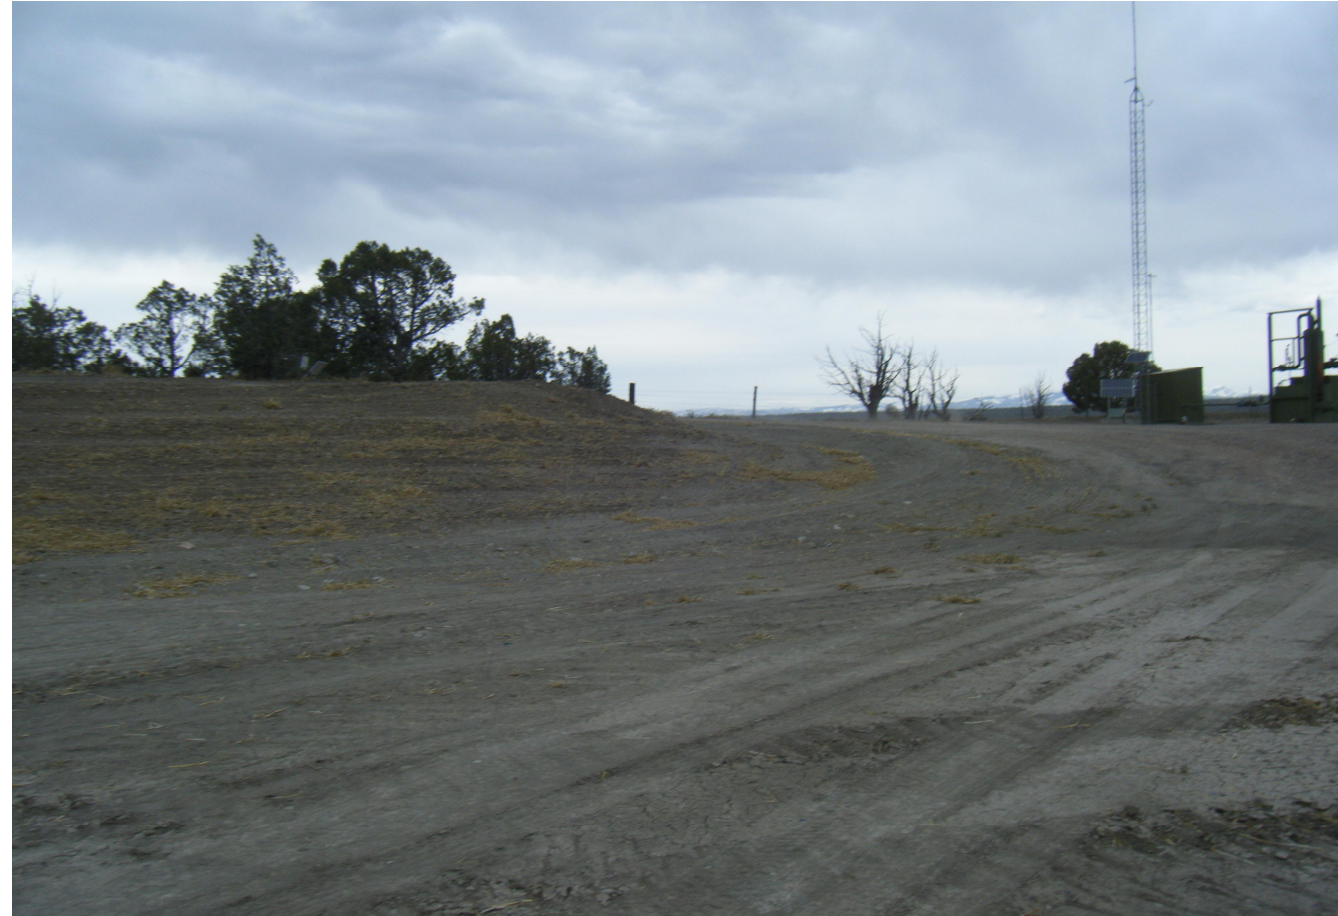
View of storm water controls and reclamation to location entrance looking North on east side of location.

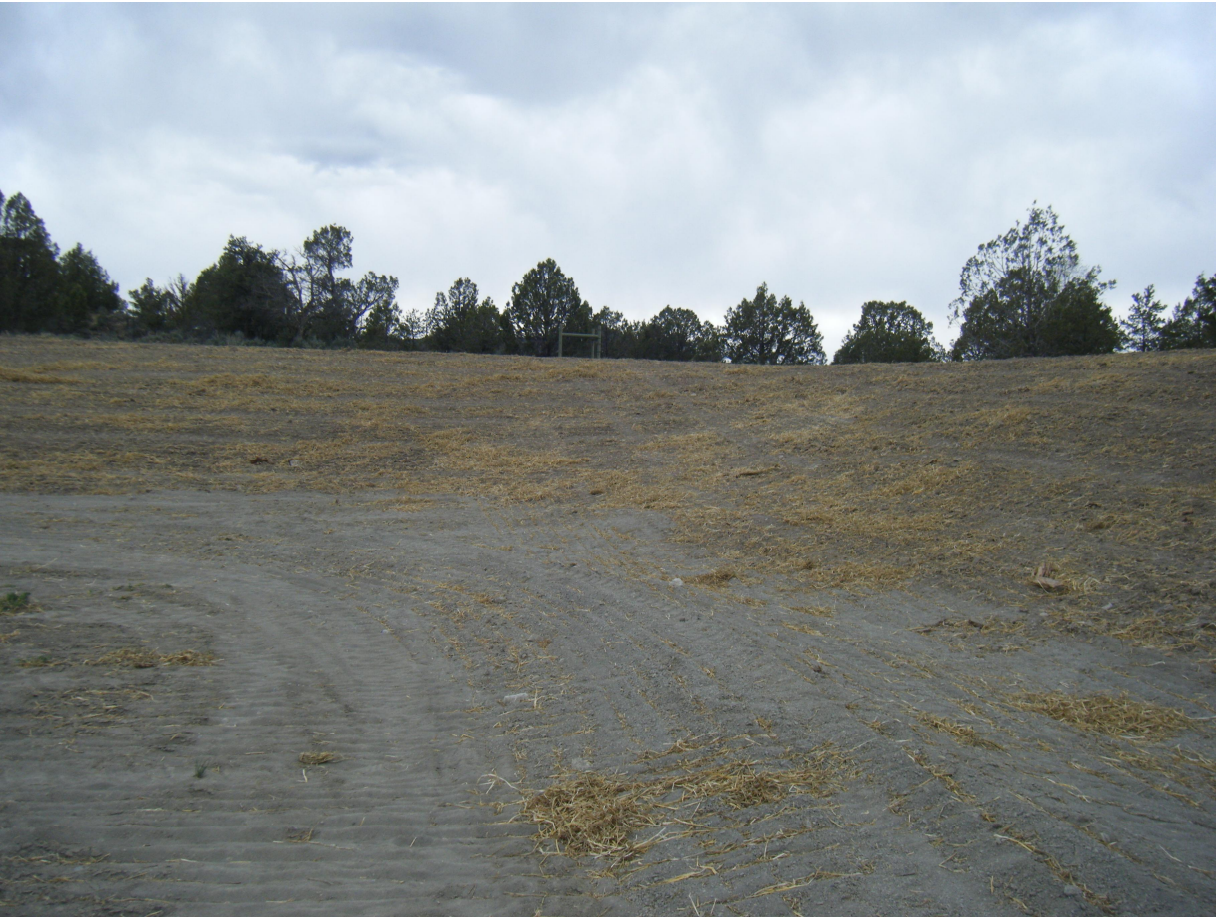
View of storm water controls and reclamation southwest corner of location.

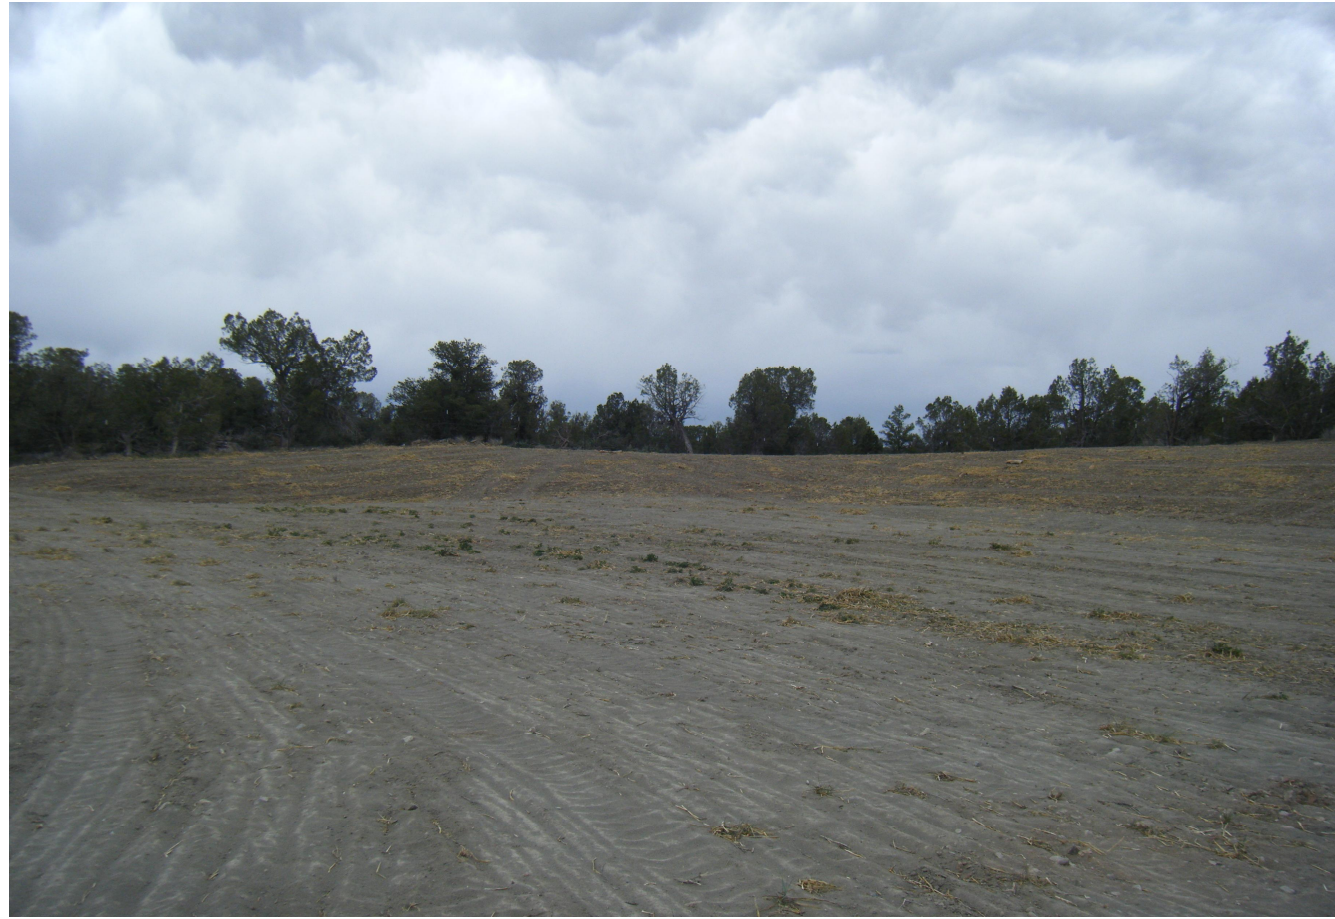
View of storm water controls and reclamation looking southeast.

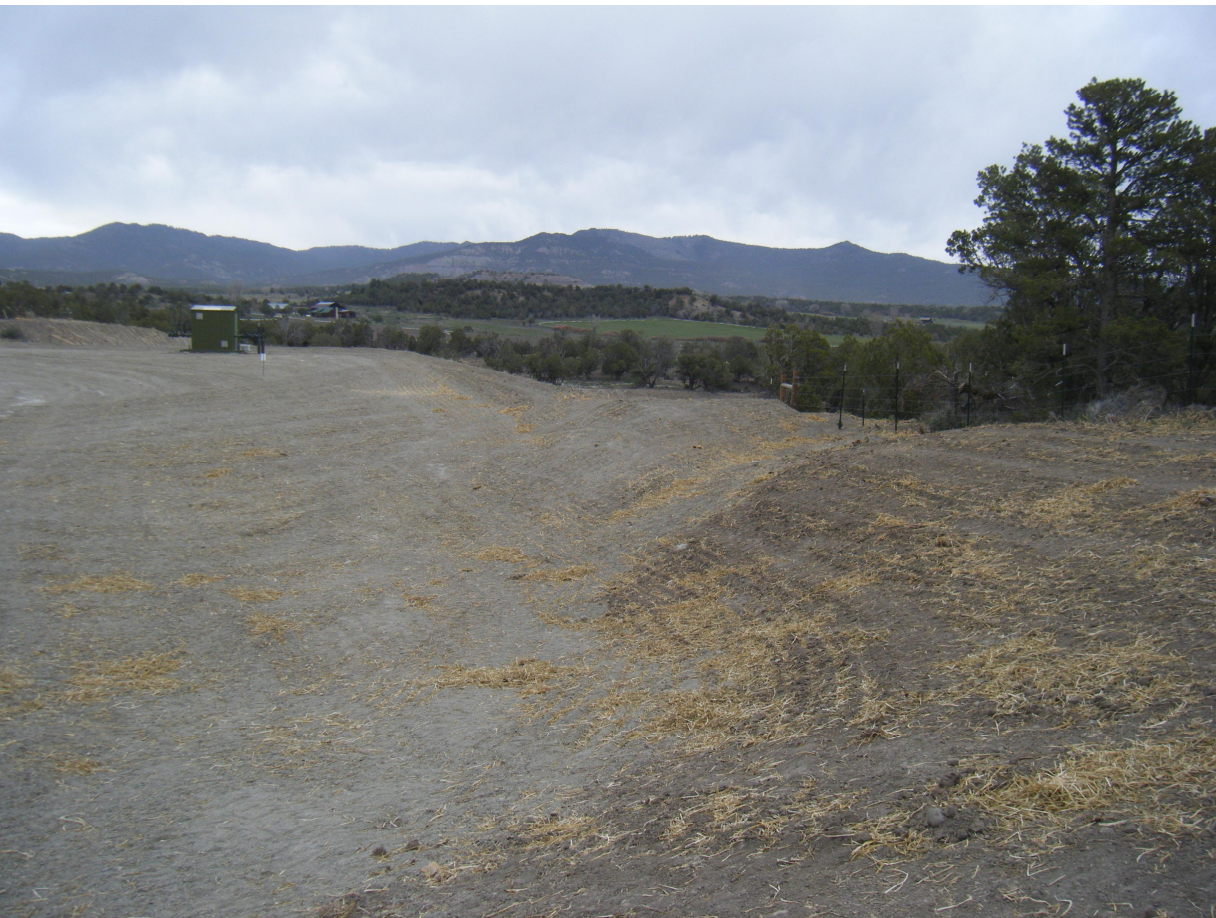
View of storm water controls and reclamation looking north on southeast corner of location.

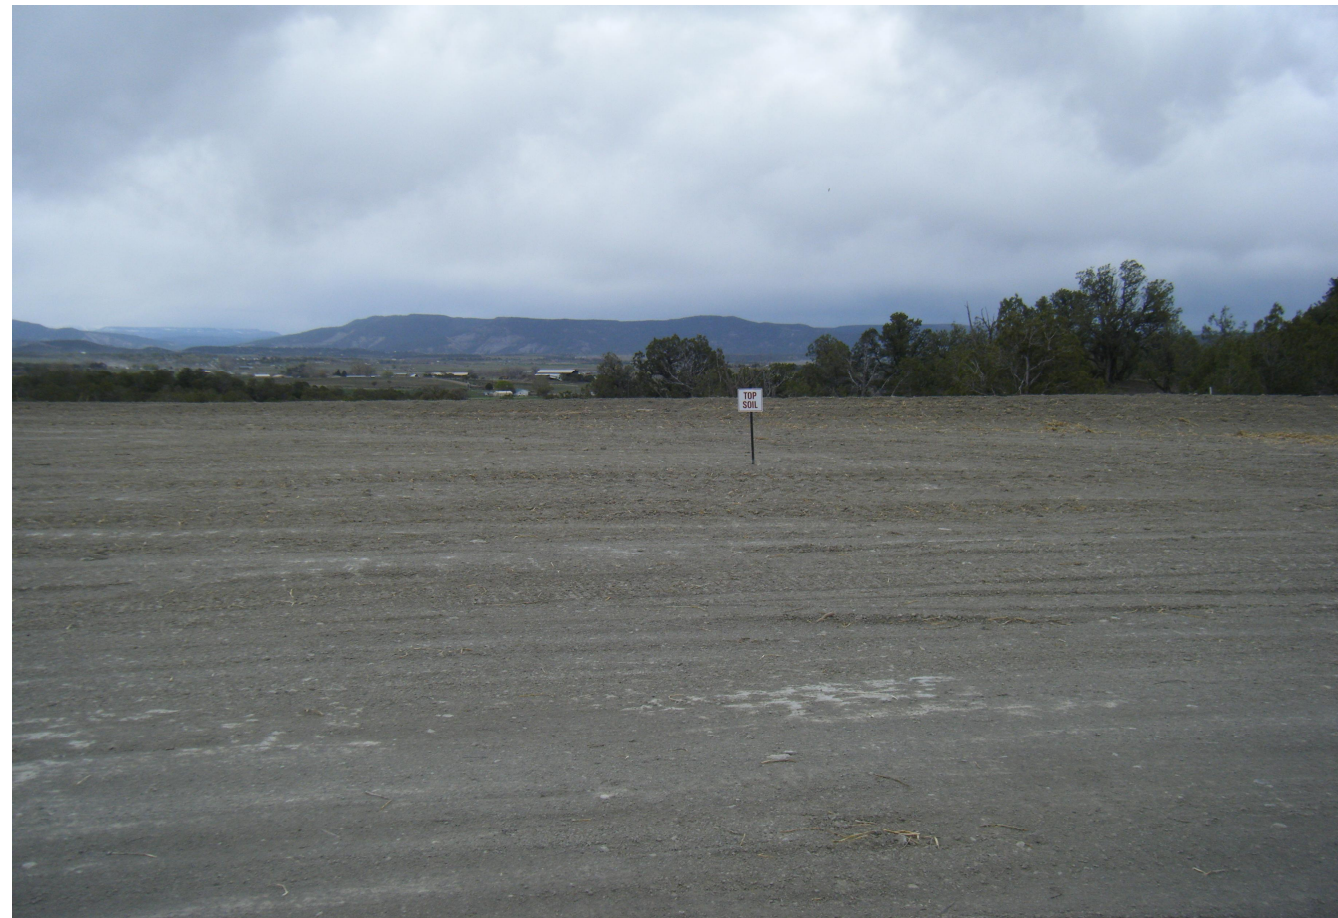
View of storm water controls and reclamation looking east.

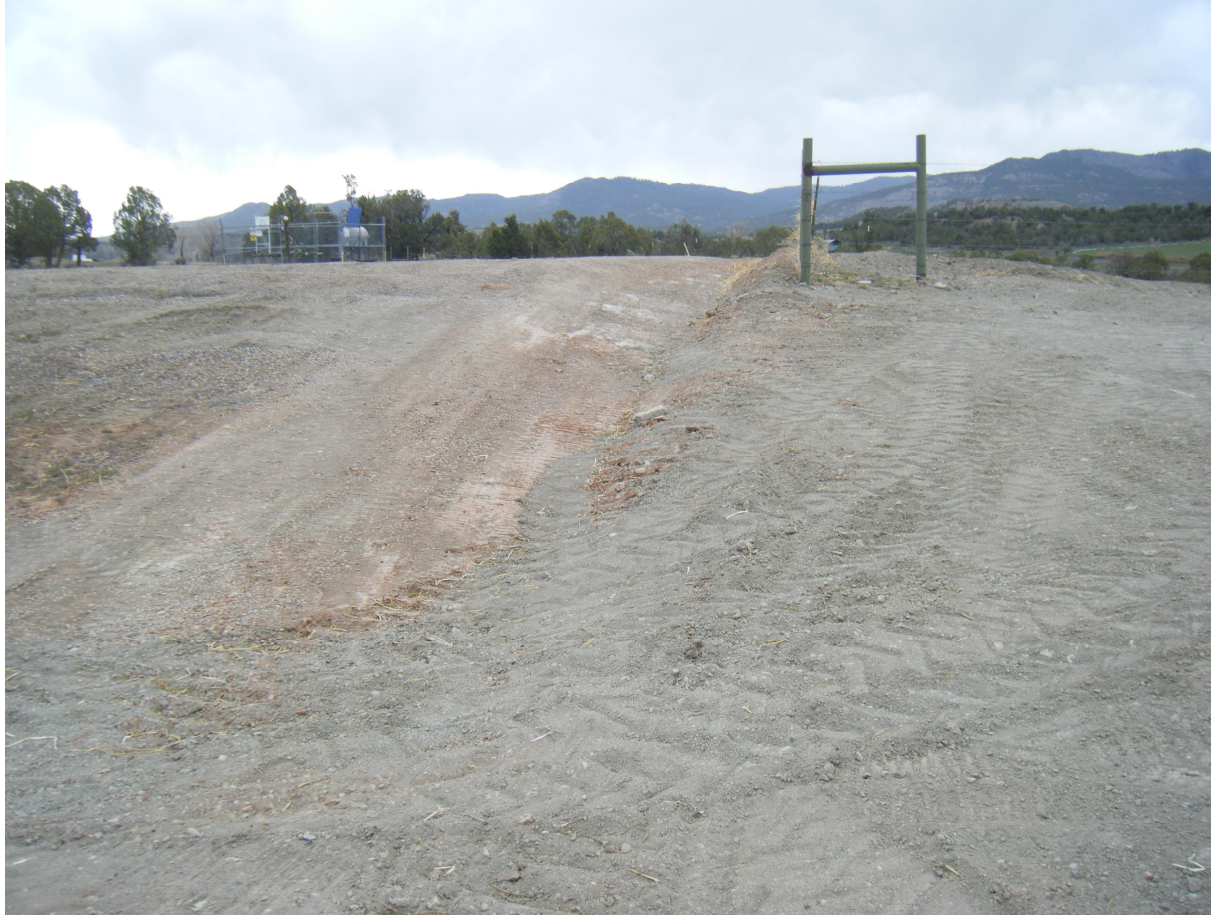
Storm Water management controls have been established to stabilize erosion water run on from adjacent location.

View of storm water controls looking north to adjacent 067-08698 well pad.
