Construction and Stormwater Inspection

April 2, 2019

Operator: ENERPLUS RESOURCES (USA) CORPORATION - #10177

Inspection Photos
Location Name: Colorado Rivers Pad
Location ID: 461838

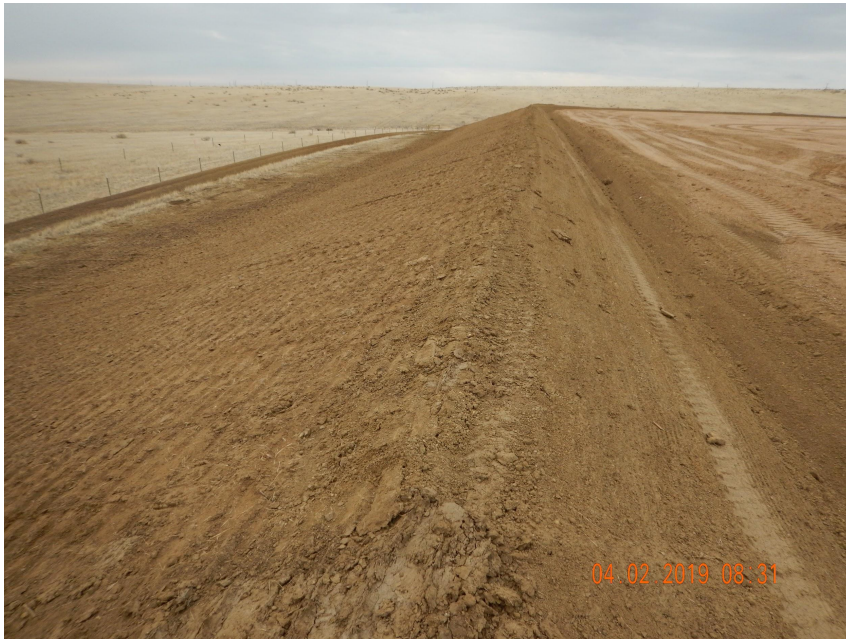
Photo 1. Photo taken from the eastern well location, facing South. Photo illustrates a ditch installed around the perimeter of the well pad which will be directed to a sediment trap. The eastern fill slope has been temporarily stabilized with equipment tracking.

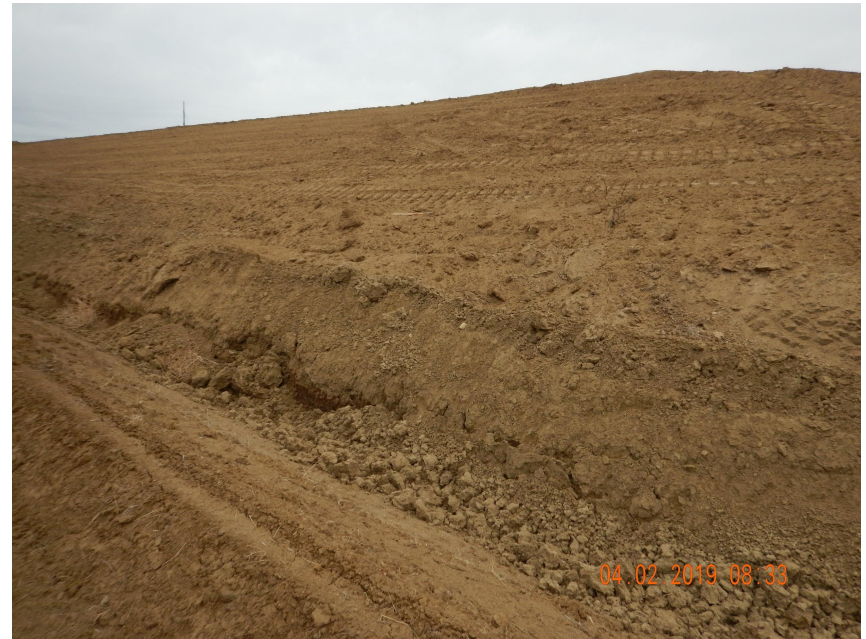
Photo 2. Photo taken from the southeastern location, facing Northwest. Operator is still in process of constructing the location. The southern fill slope needs to be stabilized and will be tracked in like the eastern fill slope.

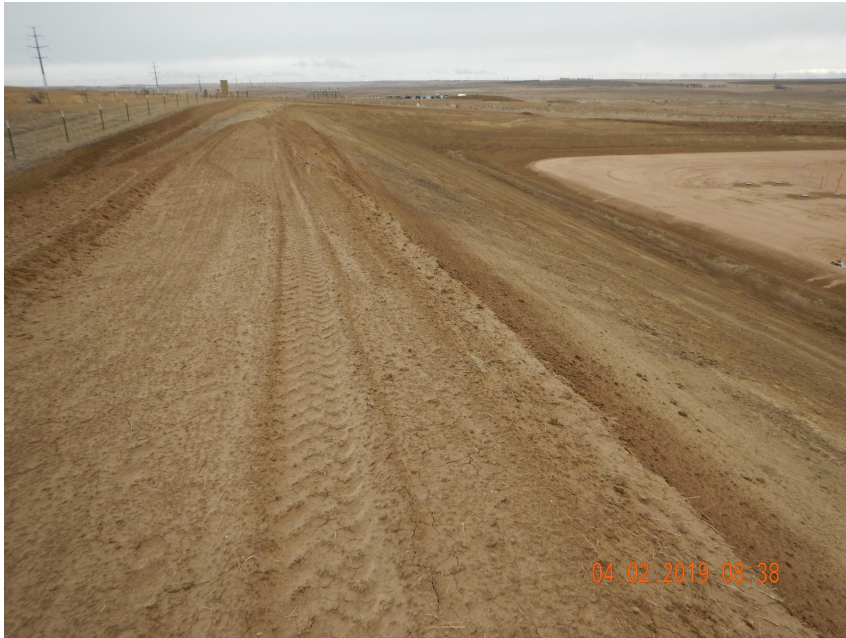
Photo 3. Photo taken from the western location, facing North. Photo illustrates a portion of the topsoil stockpile. Operator shall comply with Rule 1002 to stabilize the topsoil stockpile.

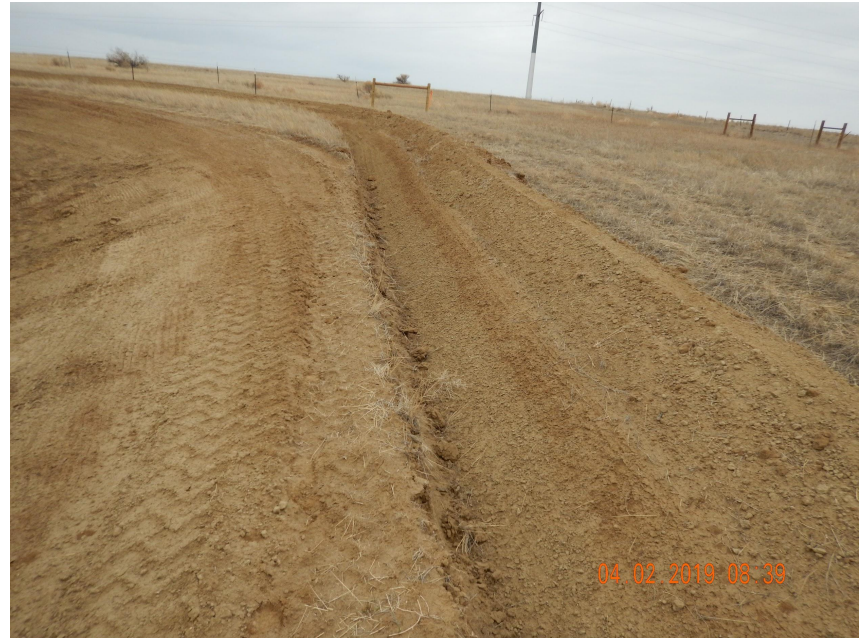
Photo 4. Photo taken from the northwestern location, facing West. Operator shall stabilize the berm BMP, as an unconsolidated berm BMP is not a properly functioning BMP.
