Inspection Photos
Location Name: Federal 43-20
API: 05-081-07197

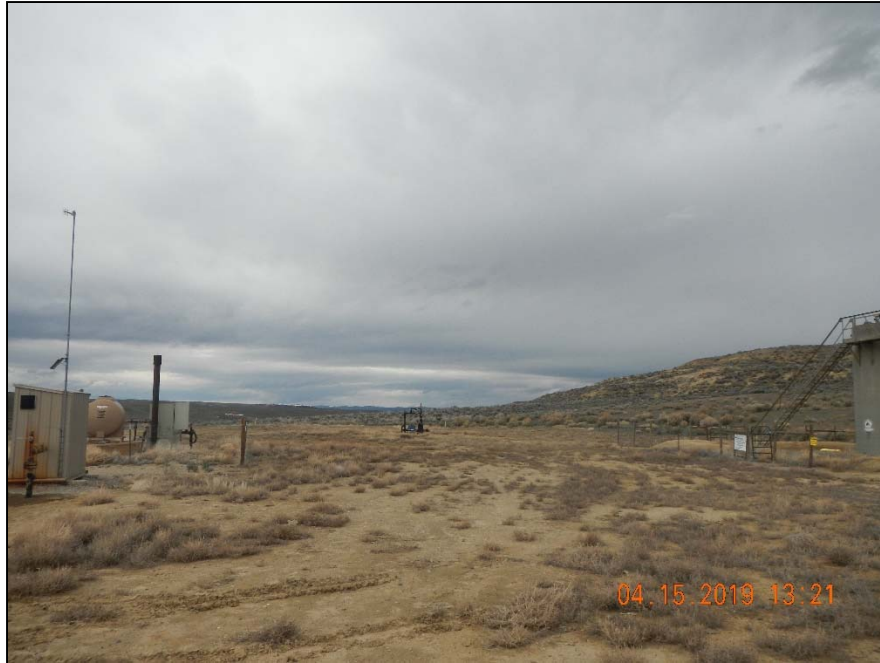
Photo 1. Overview of location taken at entrance facing west.

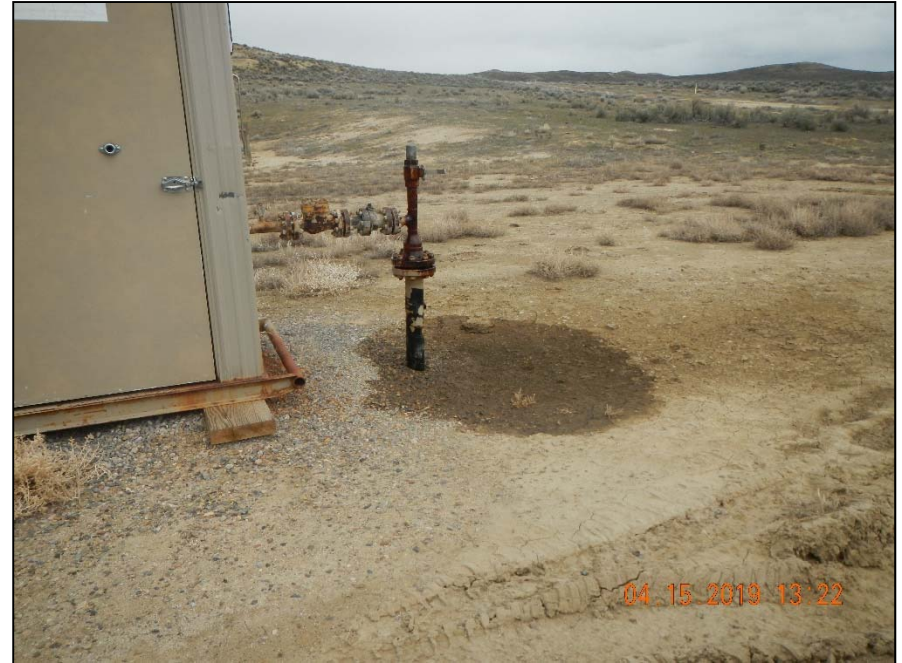
Photo 2. Non reportable spill. Stained soil at meter run flowline.
