# Inspection Photos

Operator: BENCHMARK ENERGY LLC - 10380

Location ID: 390294

Inspection Doc. Number: 682504795

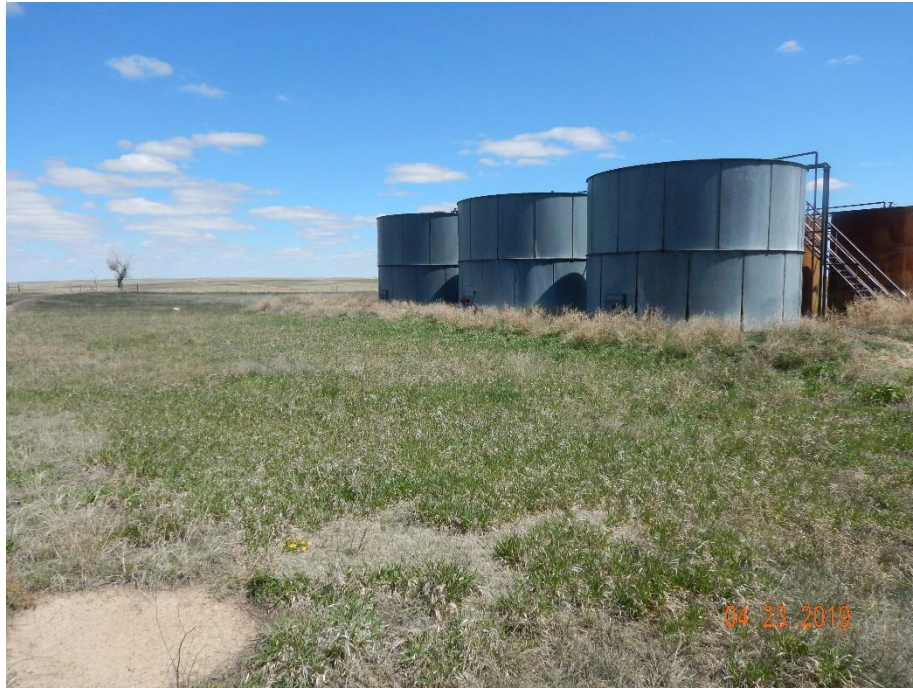
**Photo 1:** Photo taken from the southwest end of the tank battery, facing north. Photo shows weed debris accumulation on the berms and around equipment.

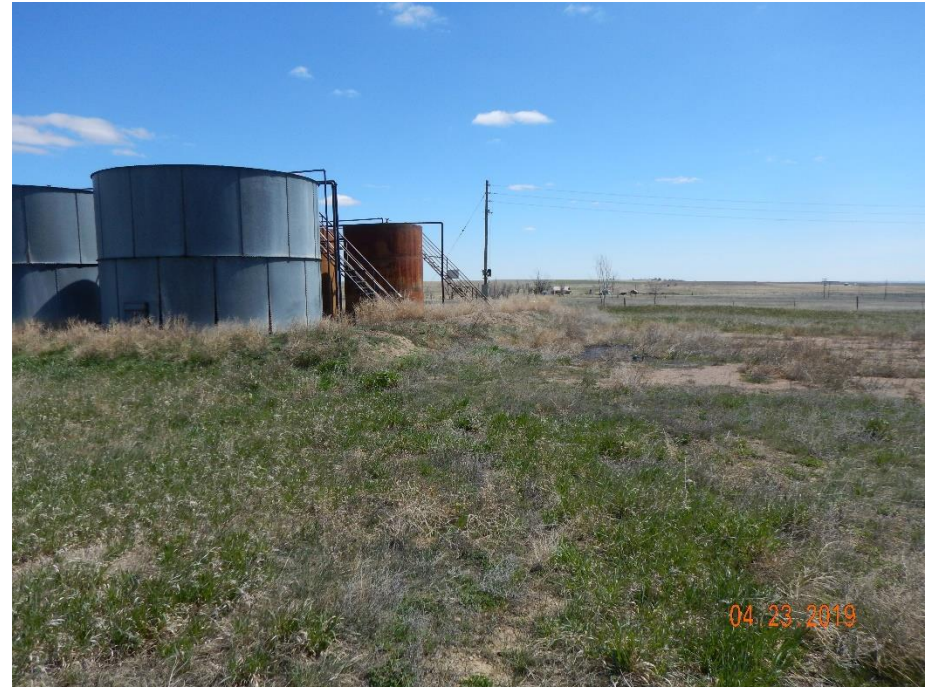
**Photo 2:** Photo taken from the southwest end of the tank battery, facing east. Photo shows weed debris accumulation on the berms and around equipment.

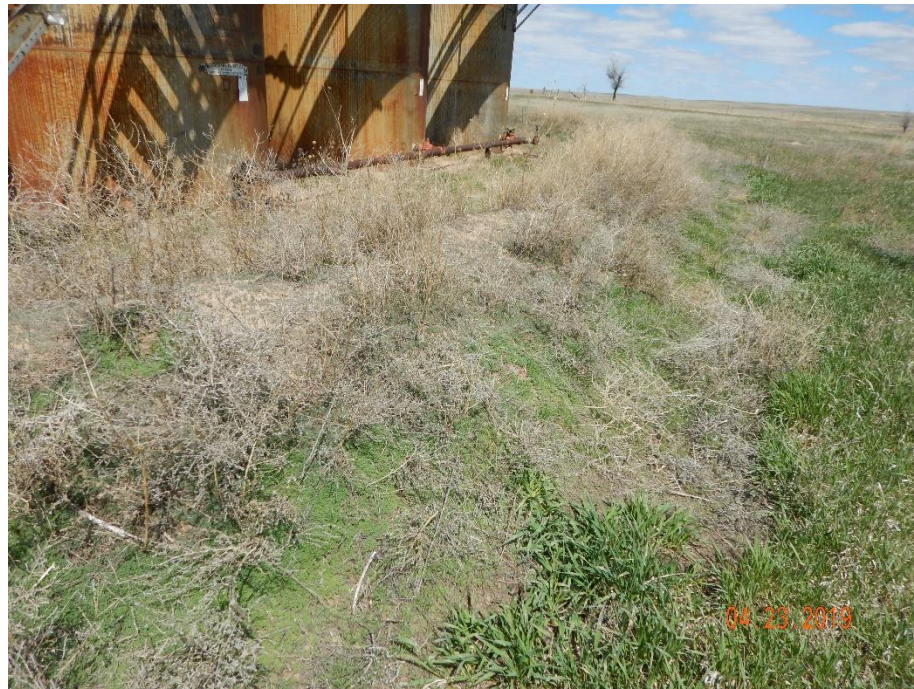
**Photo 3:** Photo taken from berm at the tank battery, facing north. Photo shows weed germination and weed debris accumulation on the berms and around equipment.

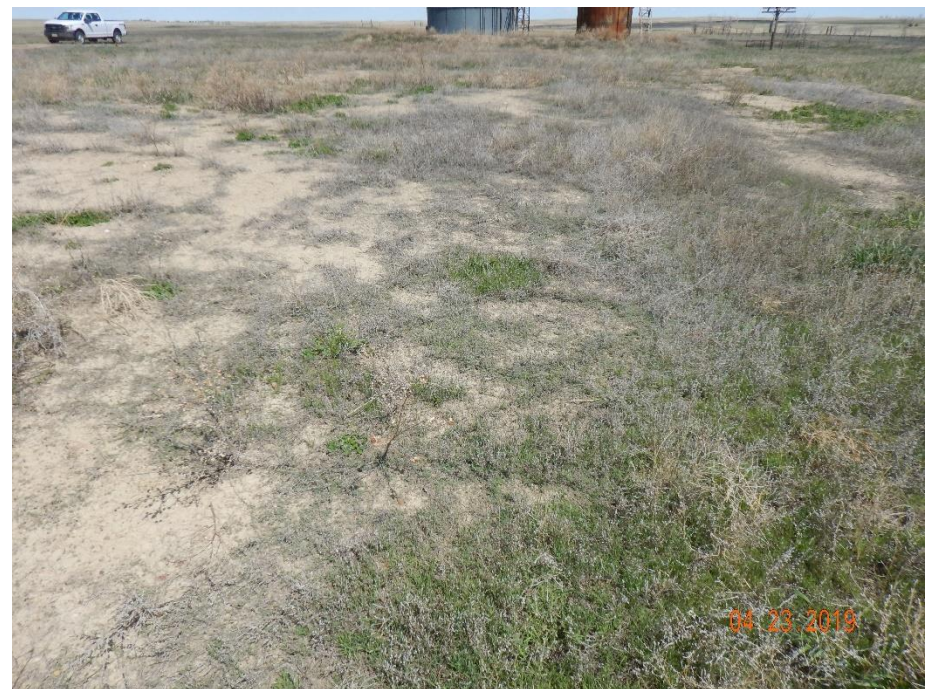
**Photo 4:** Photo taken from the south of the tank battery, facing north. Photo shows large areas of the location where undesirable weedy plant species appear to be the only vegetation establishing.

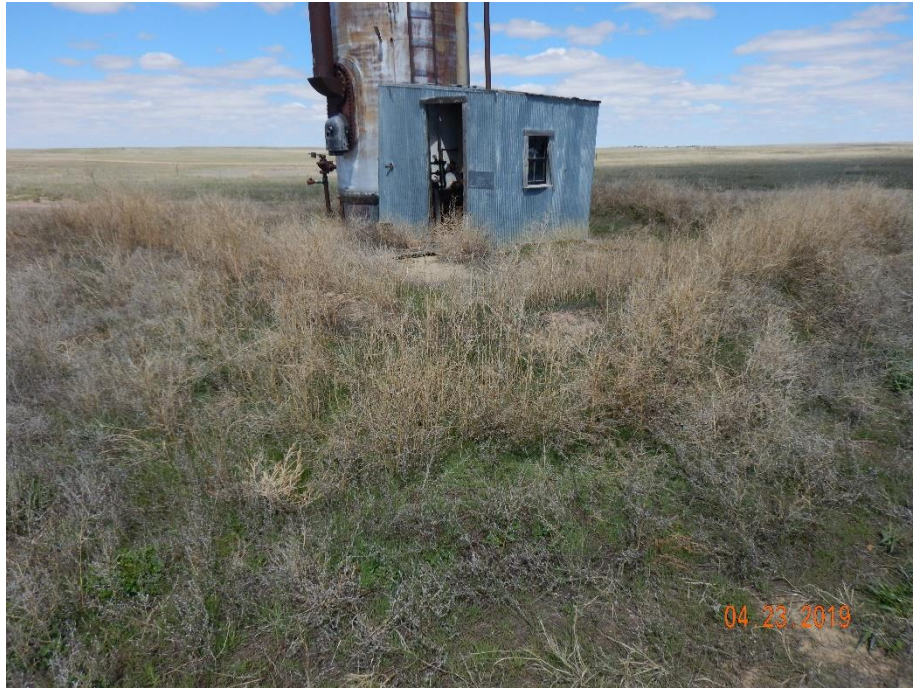
**Photo 5:** Photo shows undesirable weedy plant establishment, and weed debris accumulation on berms and equipment.

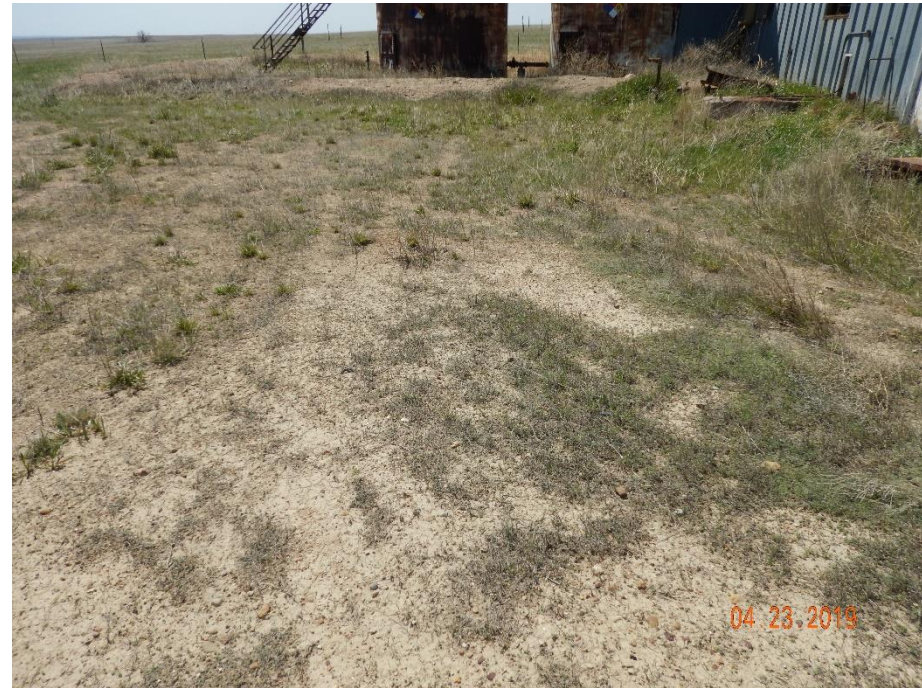
**Photo 6:** Photo shows undesirable weedy plant establishment, and weed debris accumulation on berms and equipment.

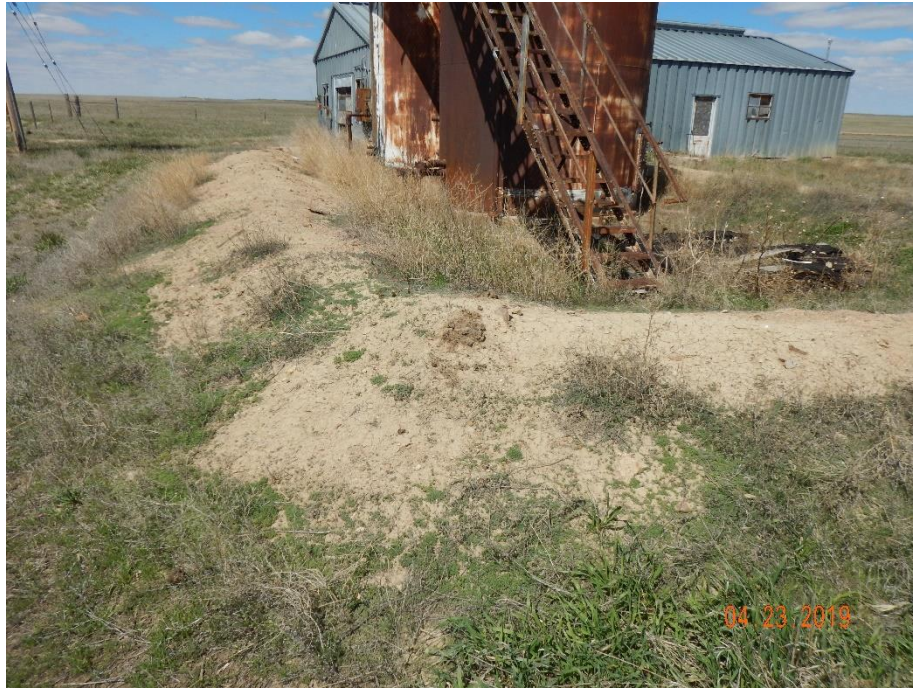
**Photo 7:** Photo shows undesirable weedy plant establishment, and weed debris accumulation on berms and equipment.

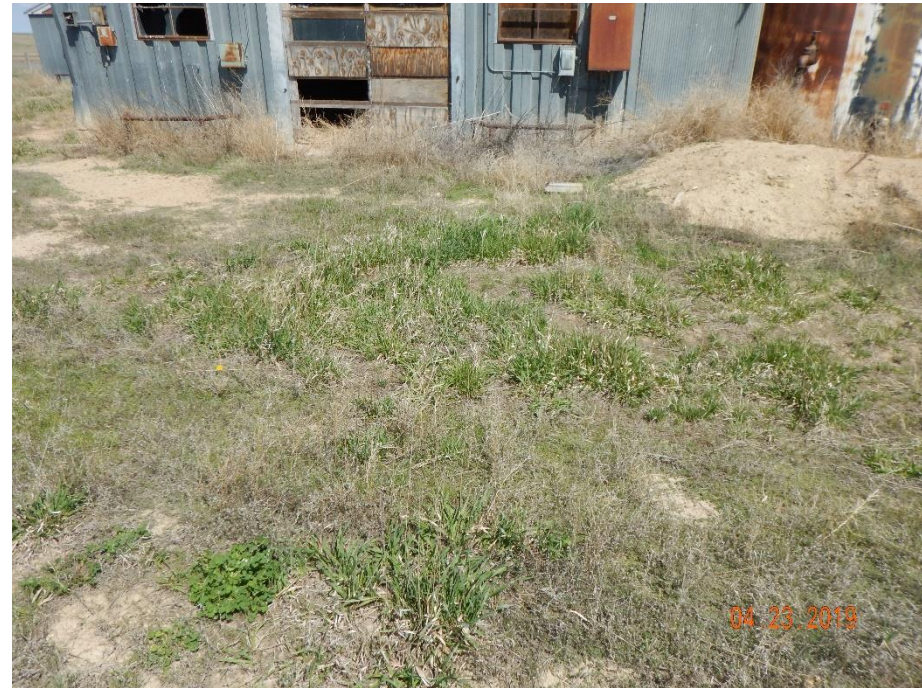
**Photo 8:** Photo shows undesirable weedy plant establishment, and weed debris accumulation on berms and equipment.
