Inspection Photos
Location Name: MURPHY 21-20
API #: 05-071-06356
Insp. Doc. # 695100540

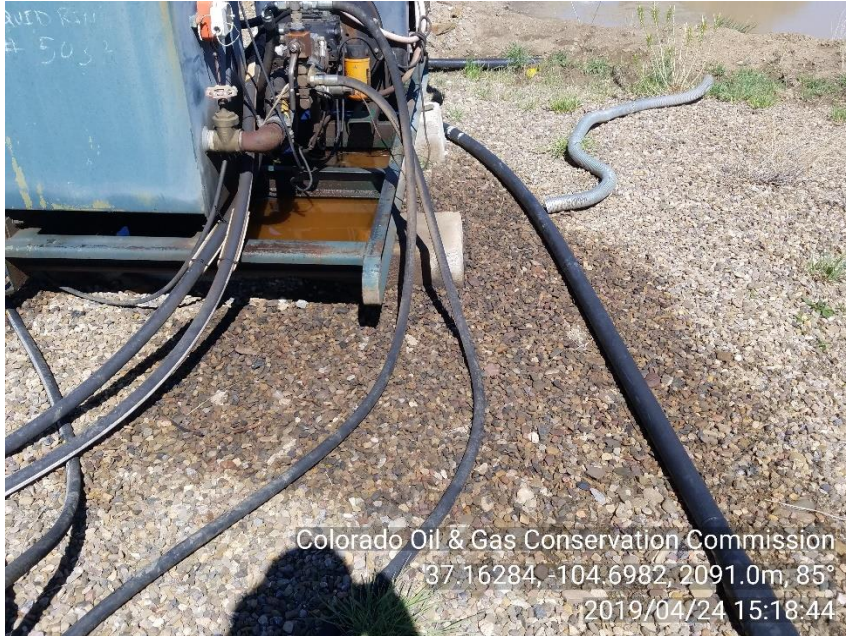
PHOTO 3: THERE IS IMPACTED SOIL ON SOUTH AND SOUTHWEST SIDE OF COMPRESSOR POWER UNIT SKID

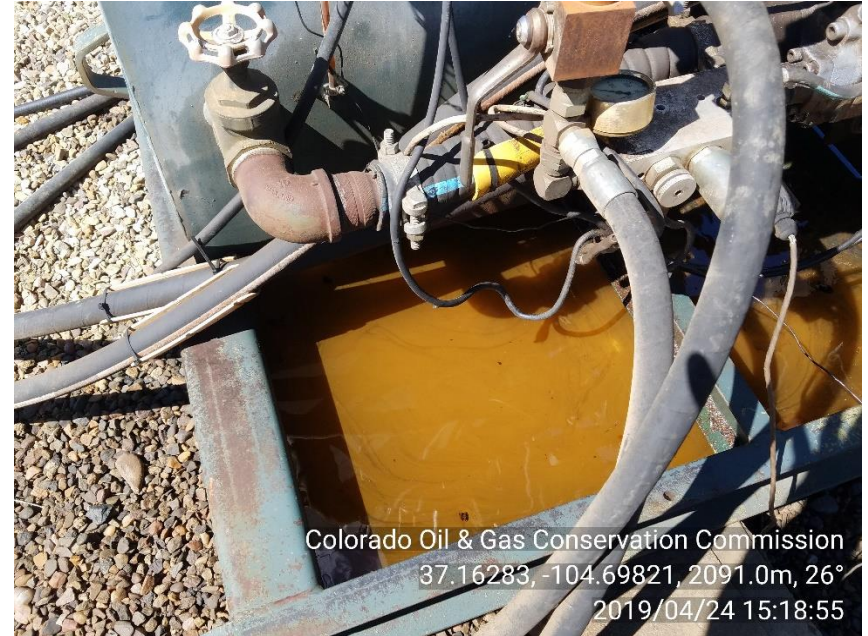
PHOTO 4: THERE IS APPROXIMATELY 2" OF OILY WATER IN COMPRESSOR POWER UNIT SKID.

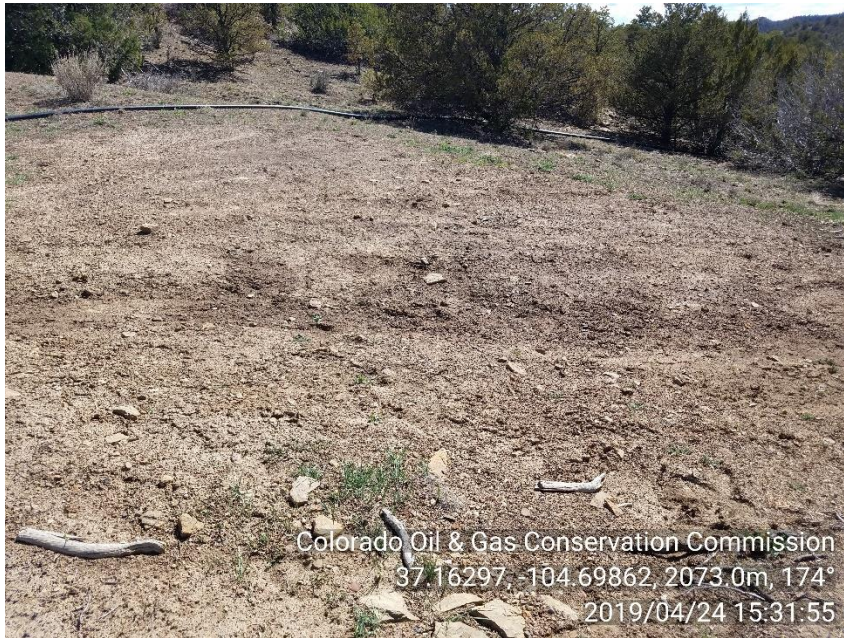
PHOTO 5: INADIQUATE VEGETATION COVER ON WEST SIDE OF LOCATION

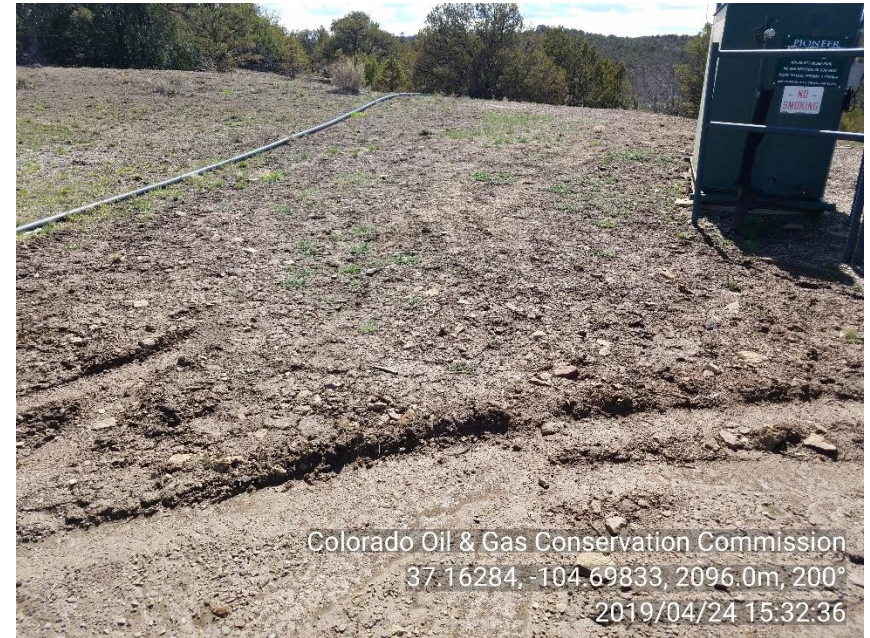
PHOTO 6: INADIQUATE VEGETATION COVER ON DISTERBED AREA ON WEST SIDE OF LOCATION NEAR METER HOUSE

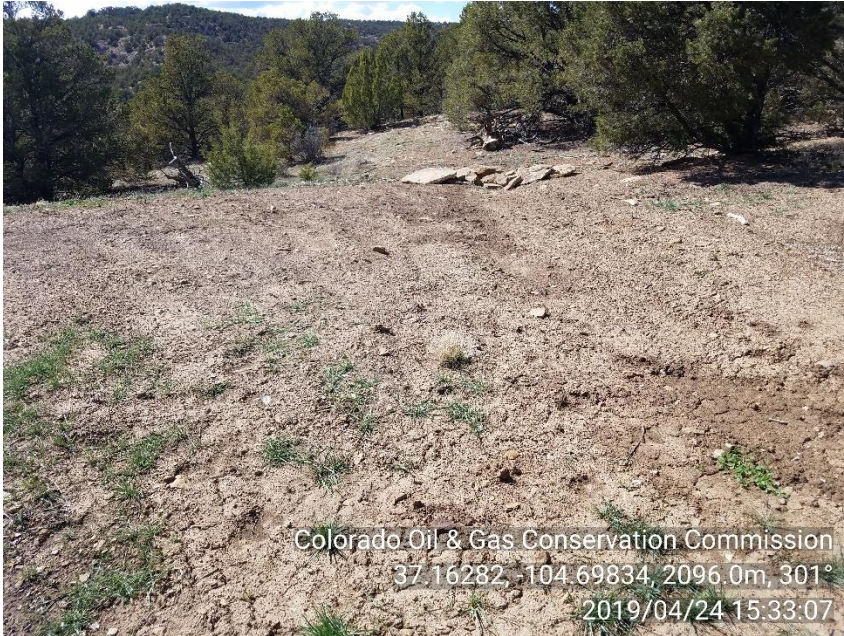
**PHOTO 5: INADIQUATE VEGETATION COVER ON WEST SIDE
OF LOCATION**
