Inspection Photos

Location: Taiga Mt 6-22, API 103-08920

Inspection Date: 4/24/19

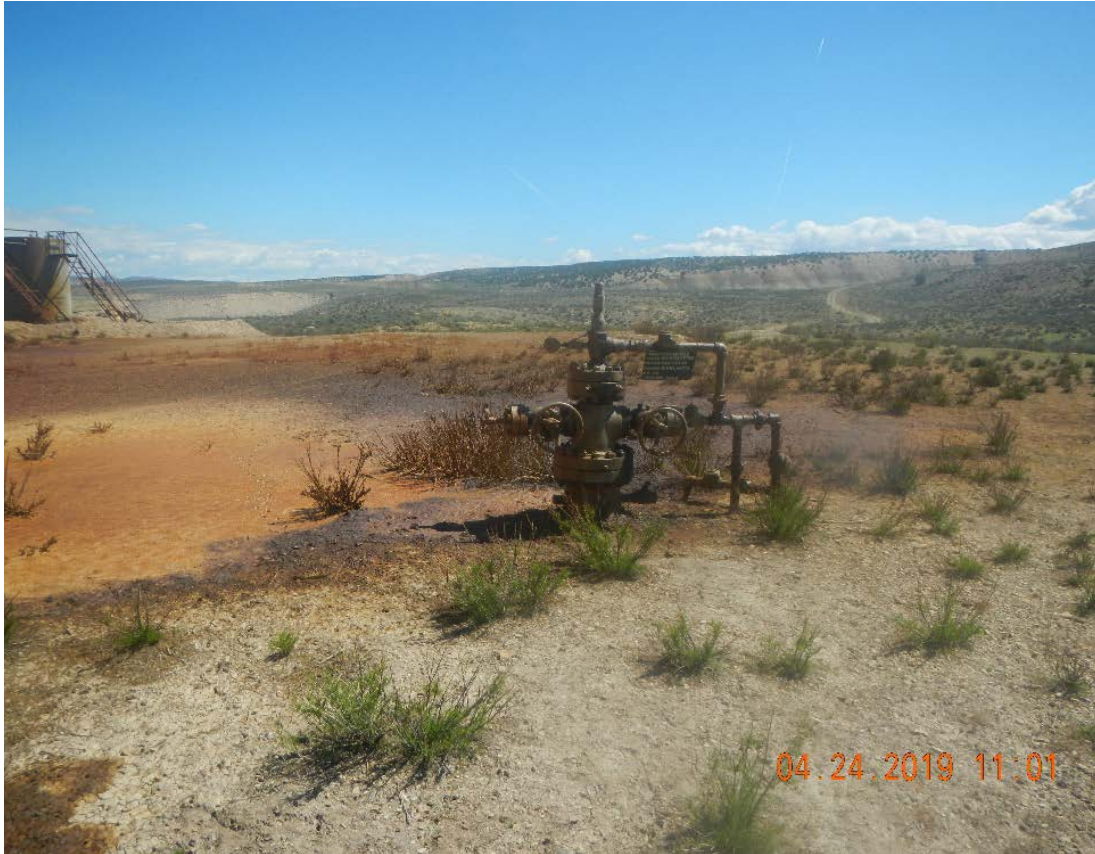
Photo 1-Wellhead,looking northeast. It was observed that the spill blew primarily to the northwest. Note tank in background for reference.

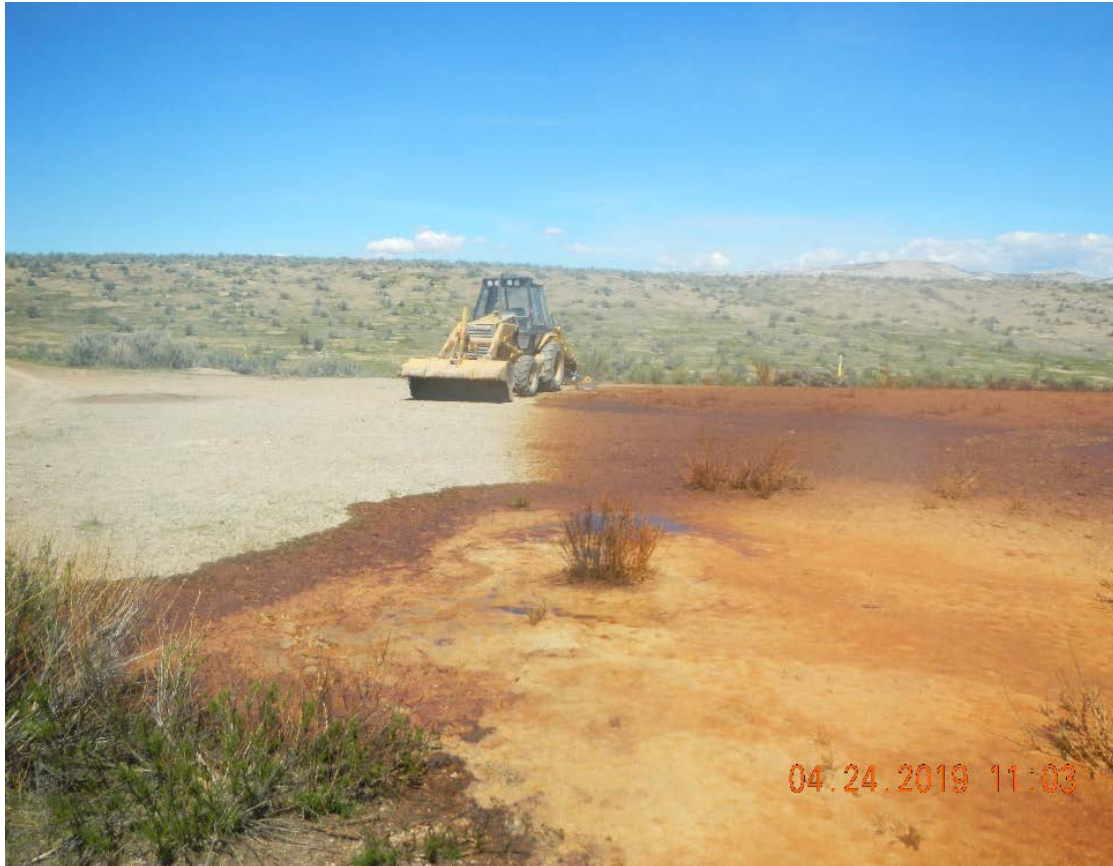
Photo 2-Wellhead is behind and to the left of camera, looking north . Note: treater in right center at the edge of pad for reference. Note pooling of oil in truck ruts.

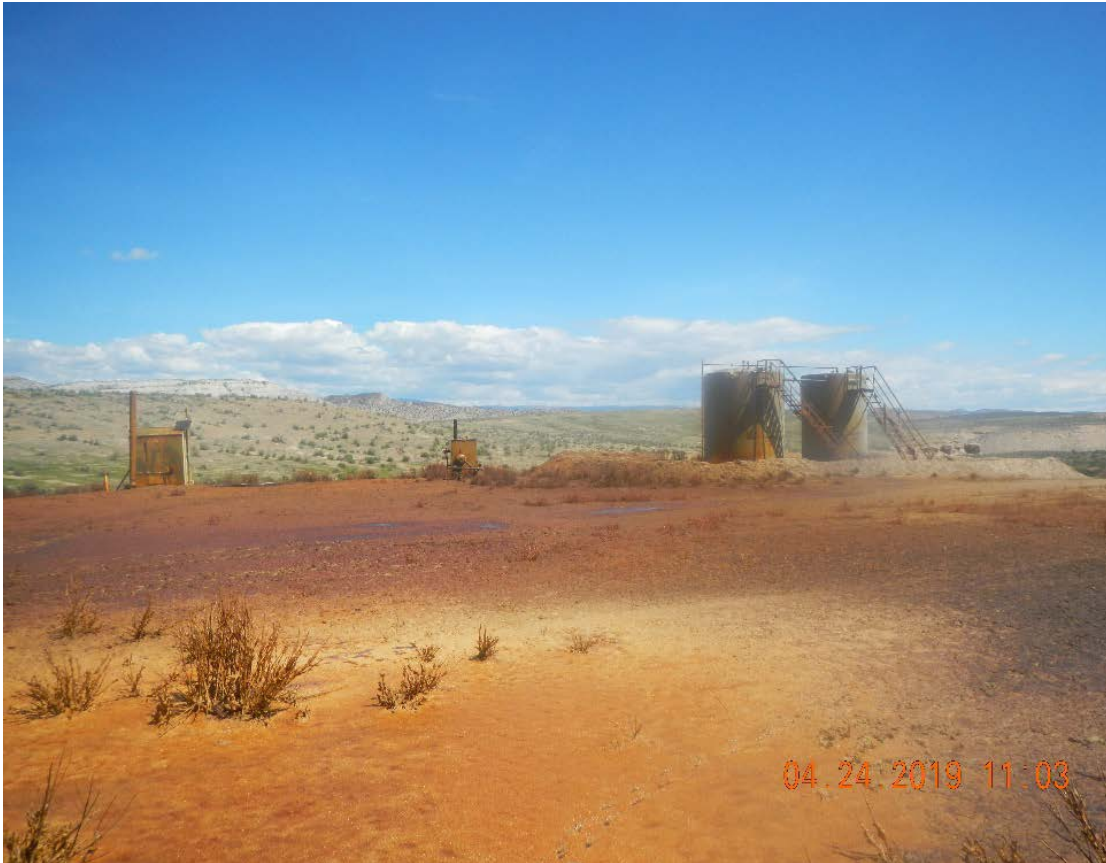
Photo 3-Looking north. Note pooling of oil on access road in truck ruts.

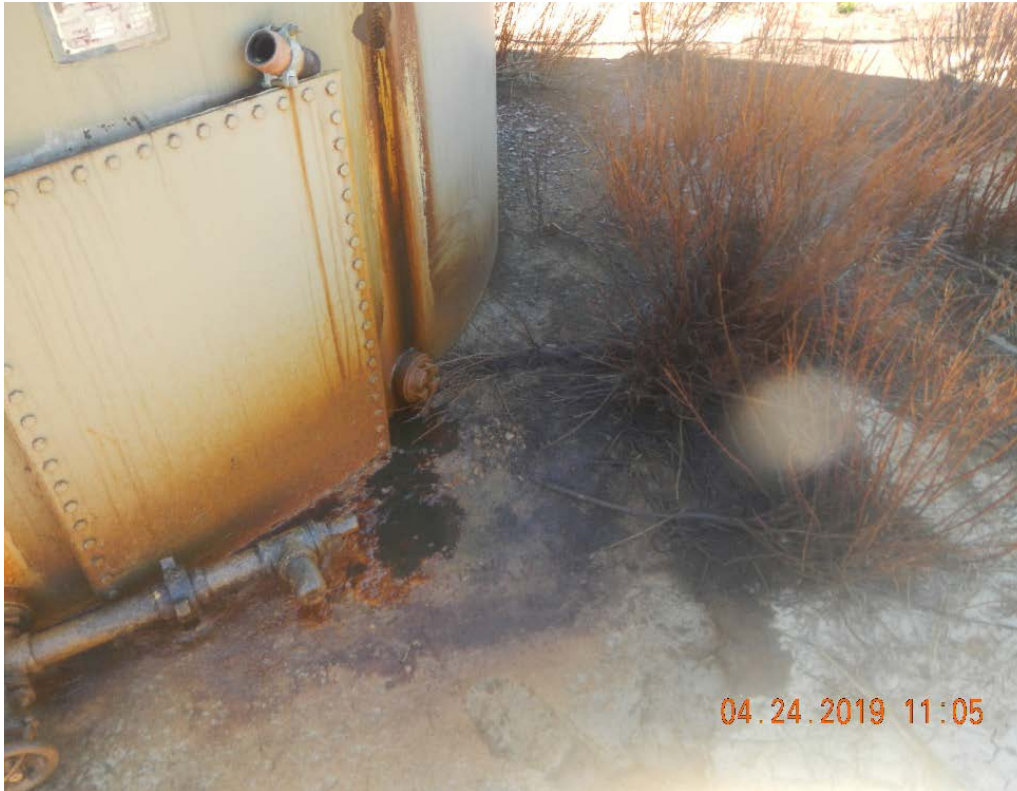
Photo 4-Close up of wester most tank. Fluid on ground inside tank battery. Tank was estimated to be mostly empty, tank was not gauged or observed from the gauge hatch, This tank was bulged out as if it had been over pressurized. The fluid appeared to be weathered oil, there may be a seep from the tank.

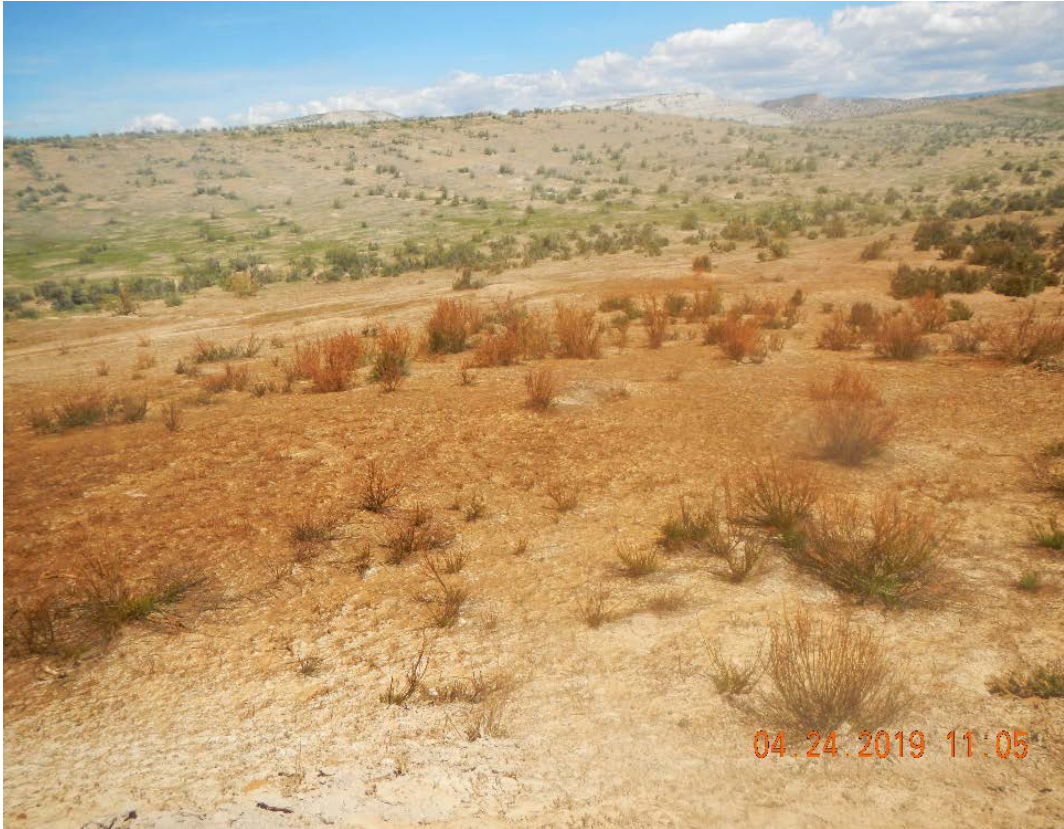
Photo 5- Area north of pad.

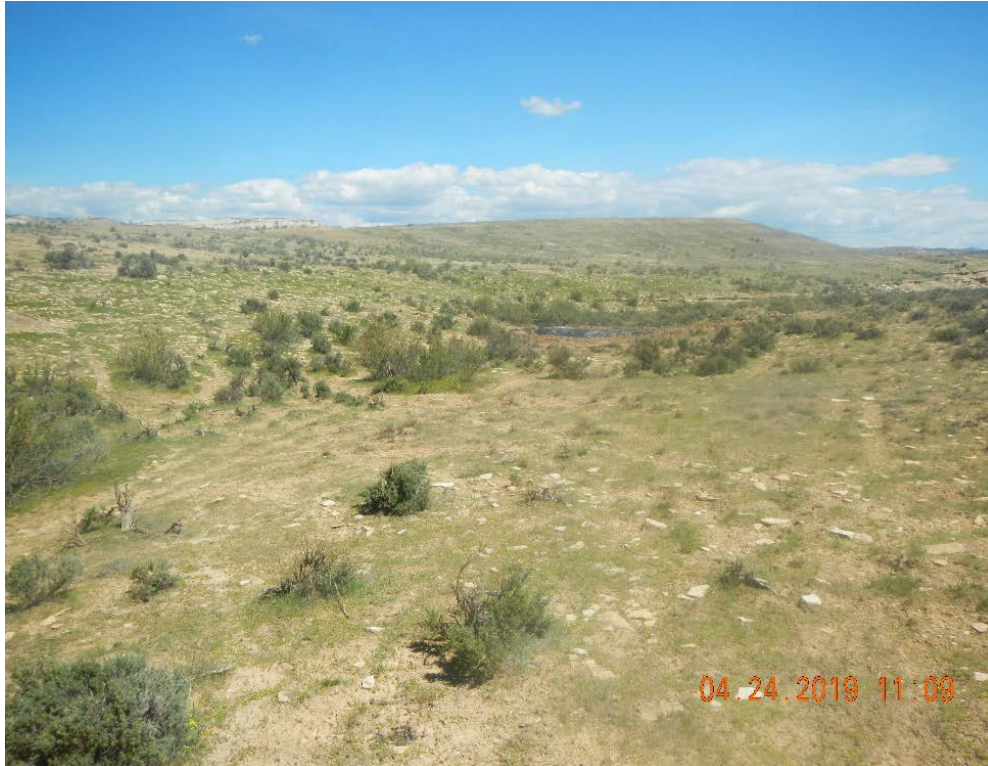
Photo 6-Area north of obvious impacted area. Note: black temporary surface water impoundment. It was discovered from email with BLM that they had this installed to contain runoff from location. The area was dry at time of inspection. NO fluid was observed to be migrating out of initial spill area.

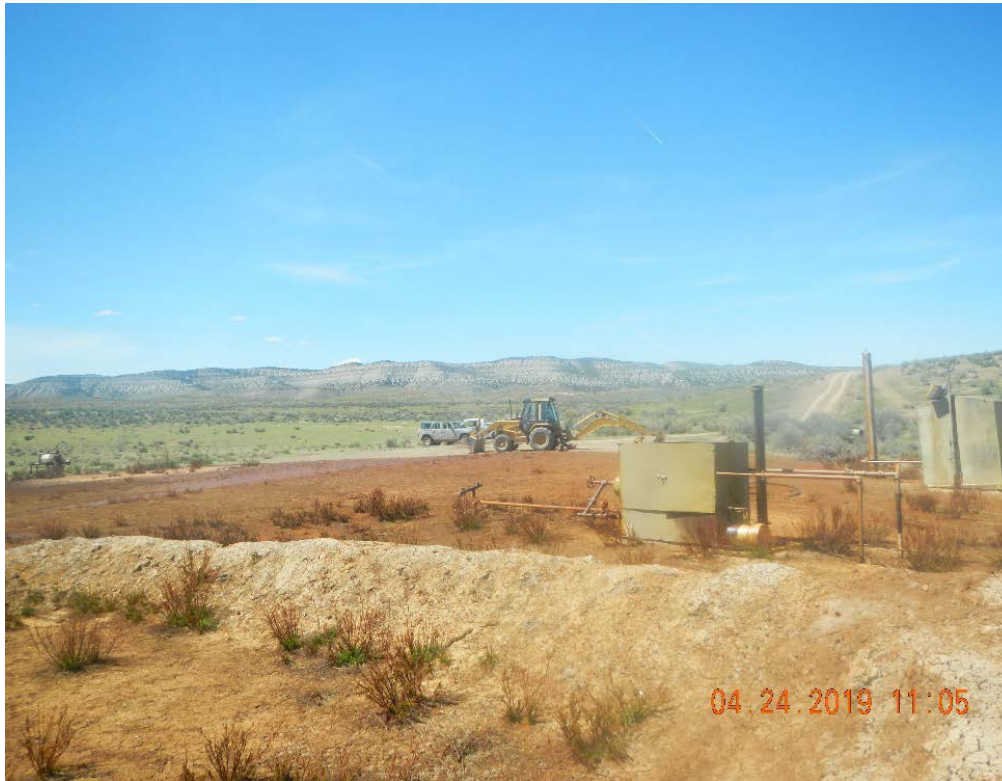
Photo 7-Looking southwest. Note: backhoe is parked perpendicular to the access road that crosses pad. Tank battery berm in foreground.

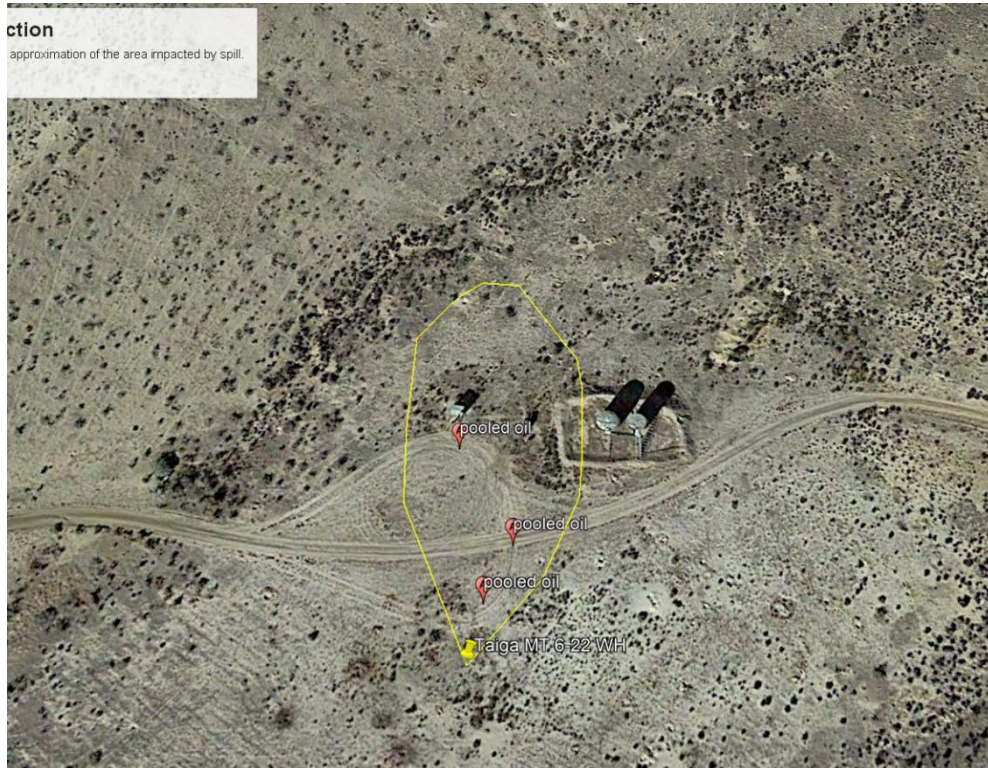
approximation of the area impacted by spill.

Photo 8-COGCC approximation of spill area and areas of pooling on pad. This document will be a separate attachment on inspection.
