# Inspection Photos

API: 05-071-06678

Operator: Evergreen Natural Resources

Inspection Date: 4/24/2019

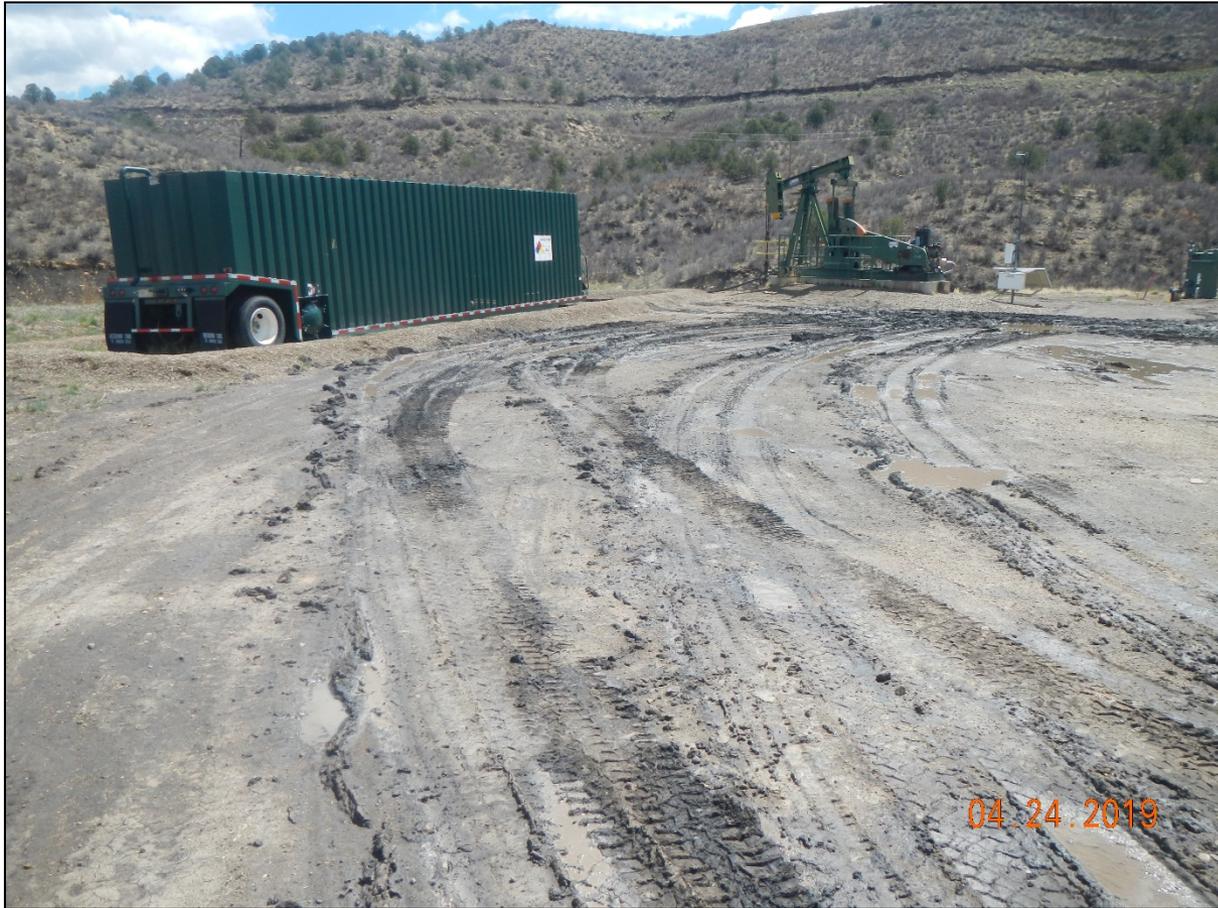
**Photo 1.** Facing toward the wellhead. There is some vehicle rutting this area may need more gravel.

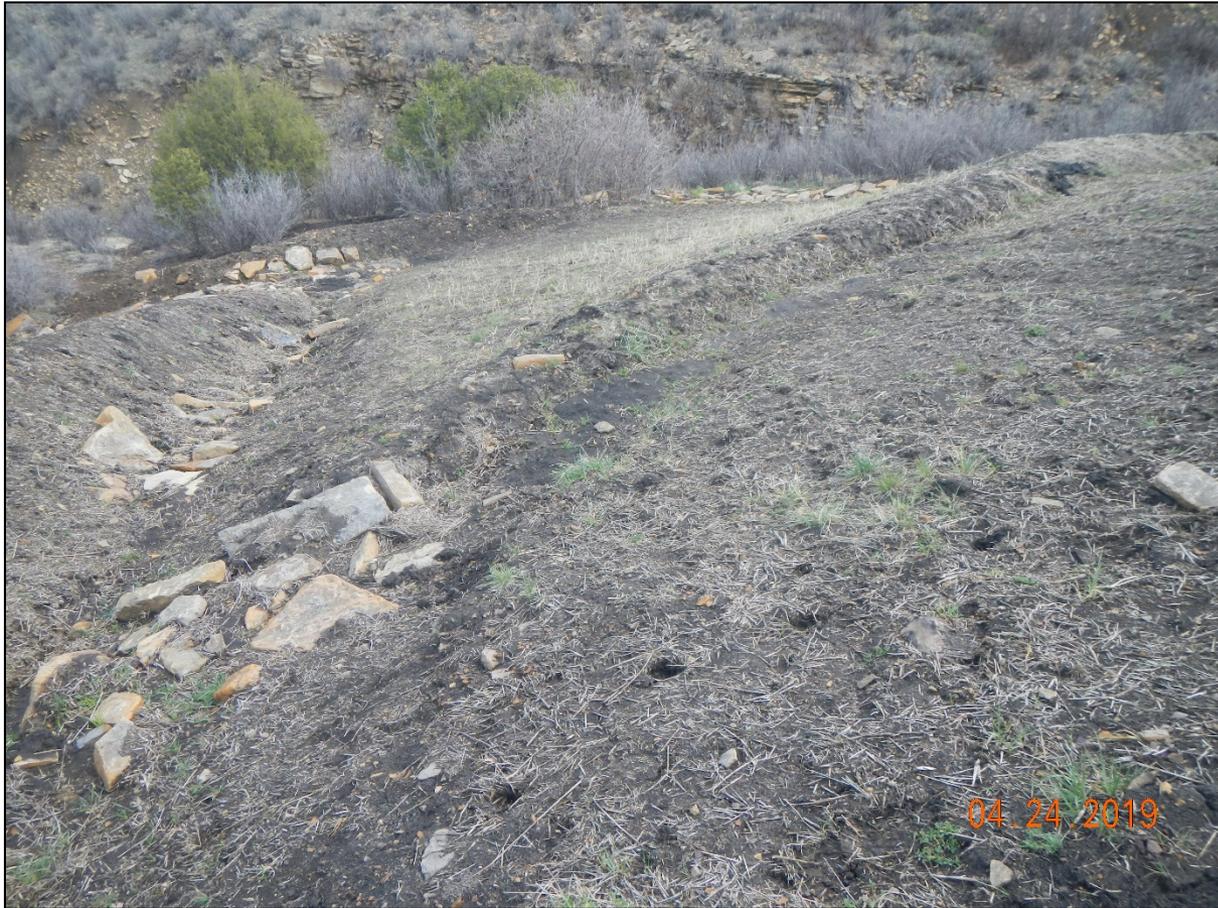
**Photo 2.** Facing off the north fill slope. Berms and rock rip/rap are installed for stormwater control.

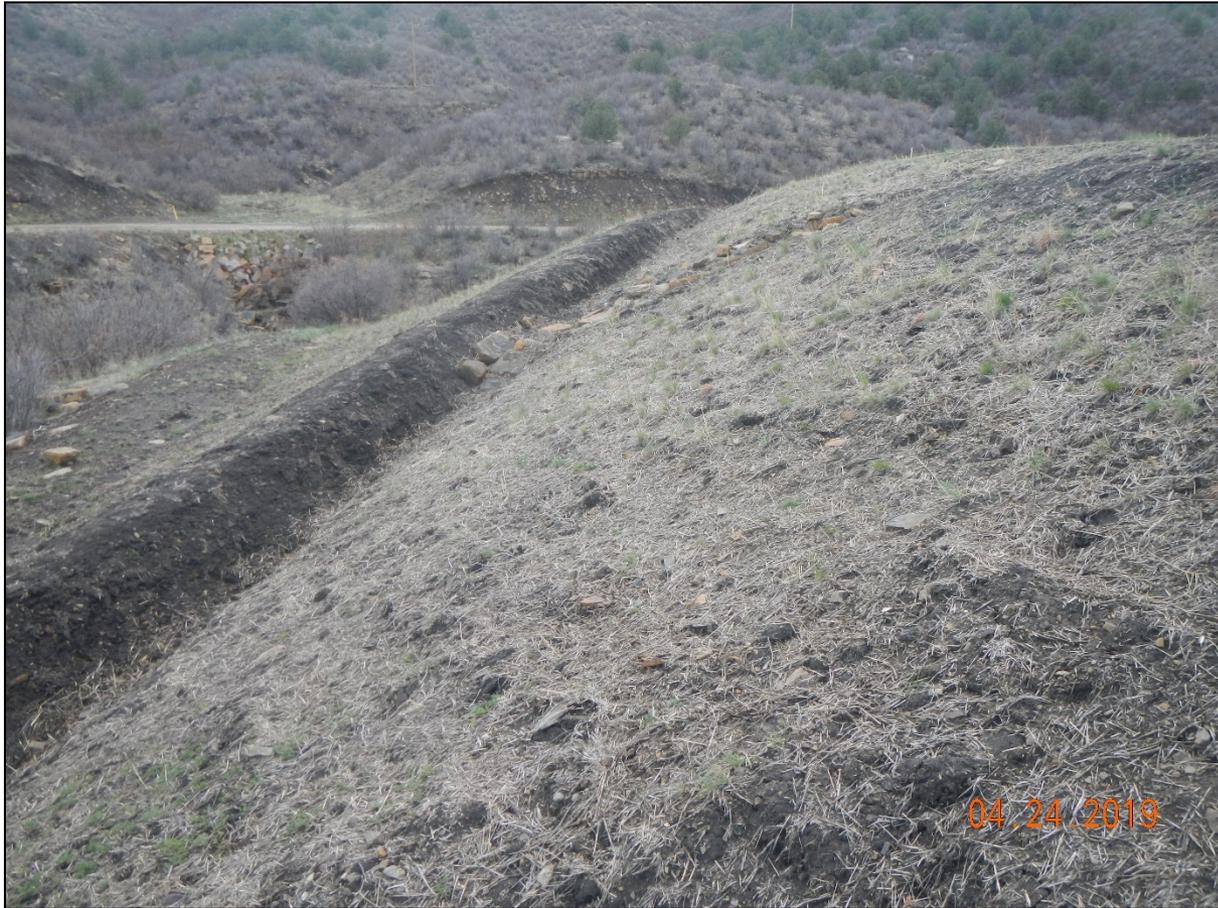
**Photo 3.** The fill slope was mulched and seeded. Vegetation is beginning to establish.
