# Construction and Storm Water Inspection

April 25, 2019

Operator: KERR MCGEE OIL & GAS ONSHORE LP – 47120

Location ID: 463802

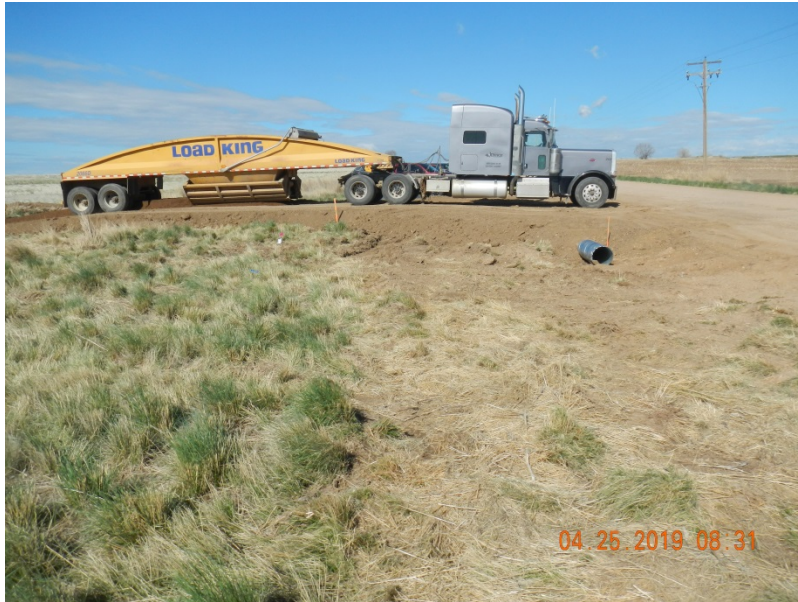
**Photo 1.** Photo taken from the entrance of the location off CR 30, facing North. Appears the Operator is currently building the access road.

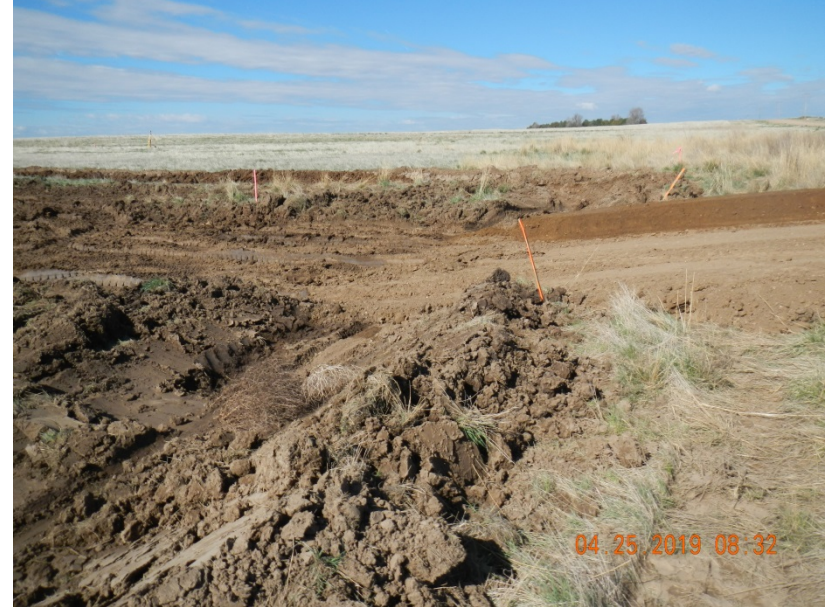
**Photo 2.** Photo taken from the southwestern perimeter of the location, facing North. Photo illustrates the ditch and berm BMP that has been installed around the perimeter of the location. However, parts of the ditch and berm BMP remain unconsolidated.

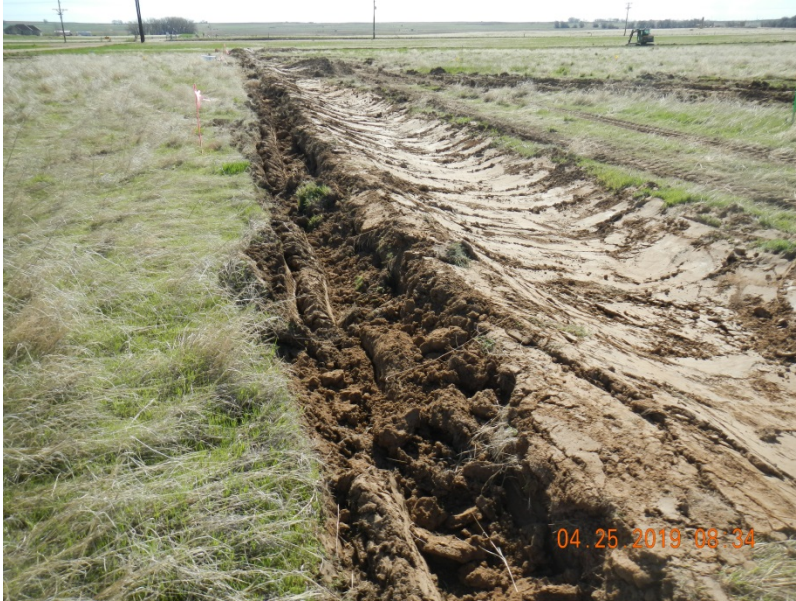
**Photo 3.** Photo taken from the northern perimeter of the location, facing East. See comments from Photo 2.

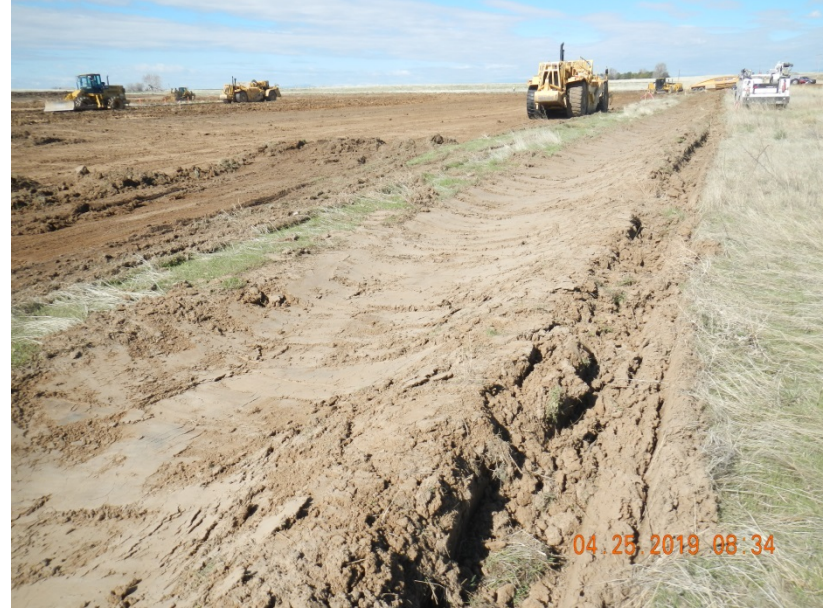
**Photo 4.** Photo taken from the southwestern perimeter of the location, facing West. See comments from Photo 2.

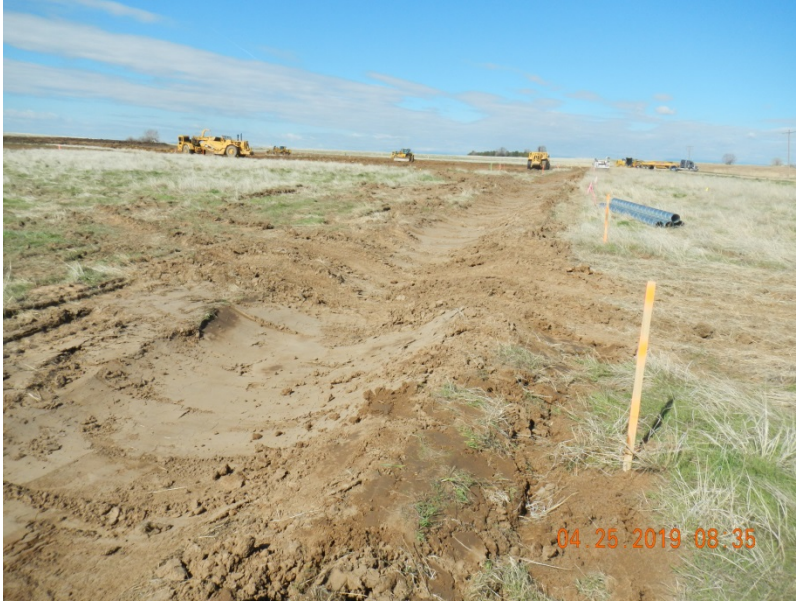
**Photo 5.** Photo taken from the northern perimeter of the location, facing East. See comments from Photo 2.

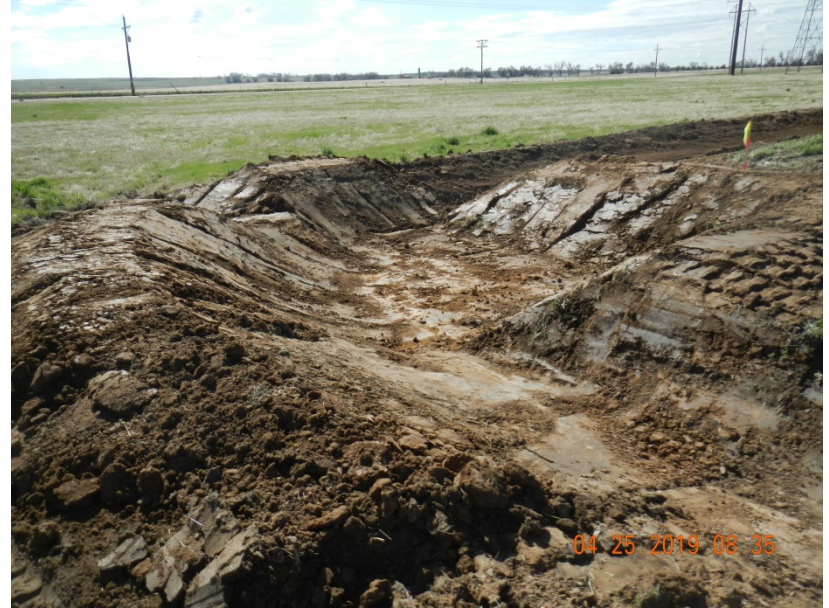
**Photo 6.** Photo taken from the northeastern perimeter of the location, facing East. Appears the Operator is installing sediment traps with stabilized outlets around the location.

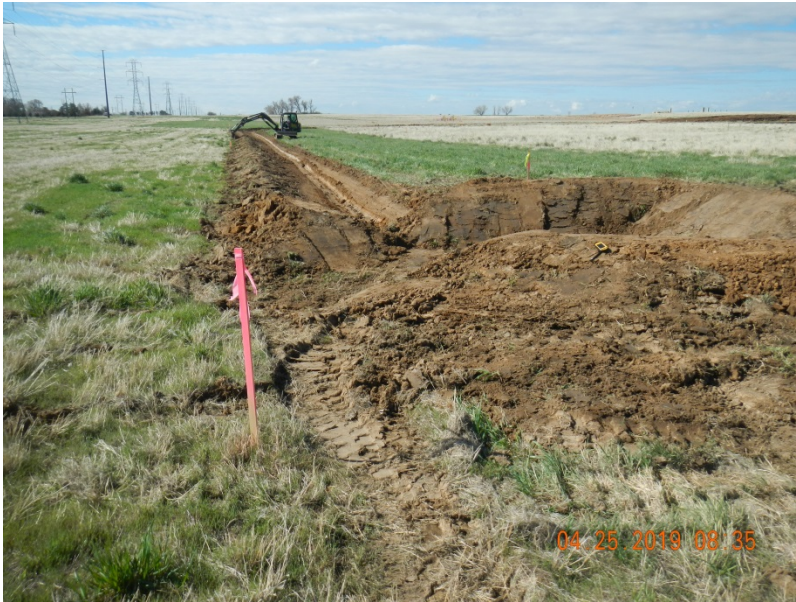
**Photo 7.** Photo taken from the northeastern perimeter of the location, facing South. See comments from Photos 2 and 6.

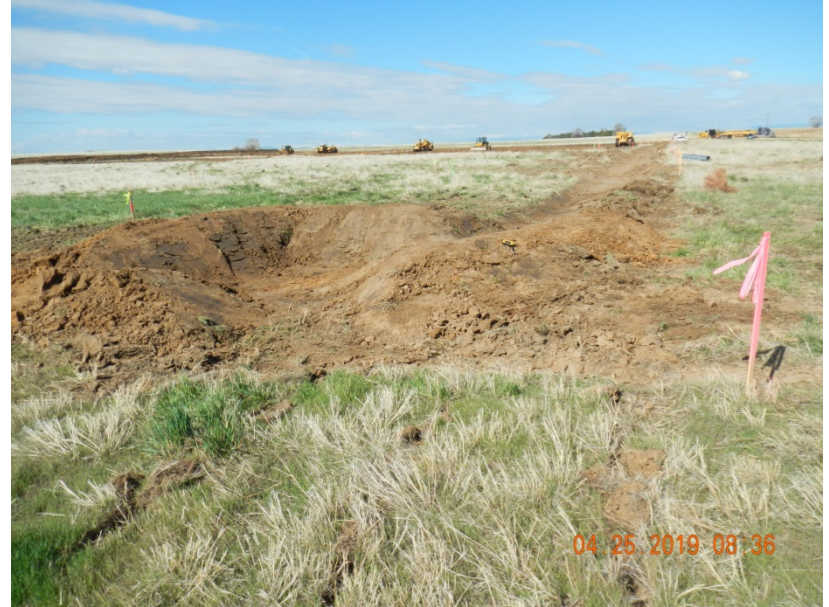
**Photo 8.** Photo taken from the northeastern perimeter of the location, facing West. See comments from Photos 2 and 6.

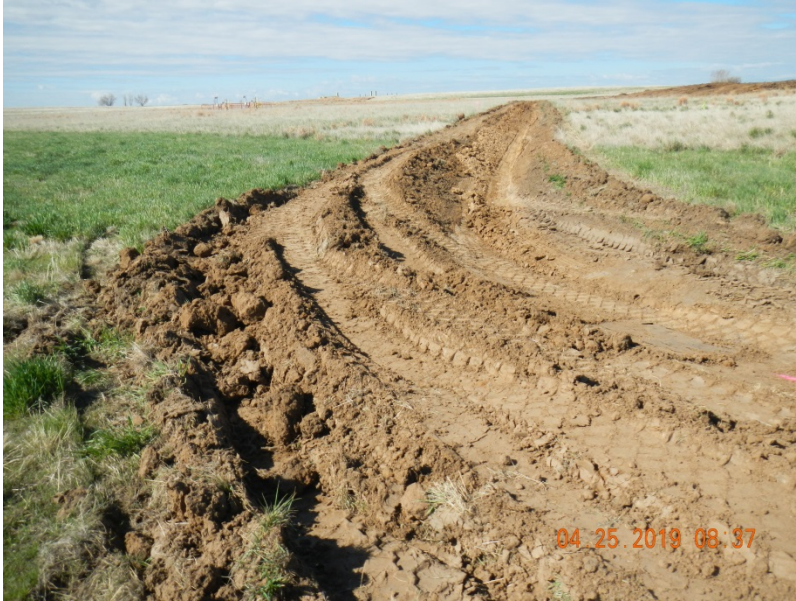
**Photo 9.** Photo taken from the southeastern perimeter of the location, facing West. See comments form Photo 2.

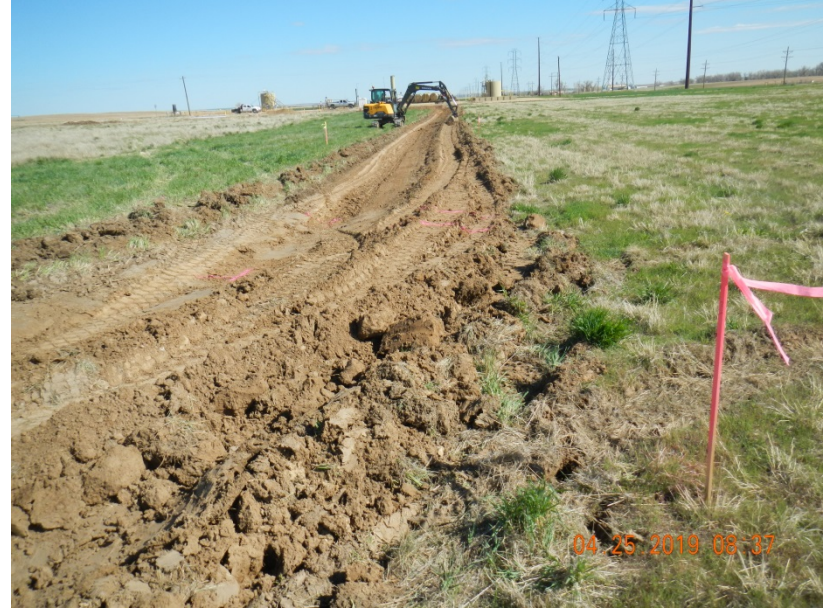
**Photo 10.** Photo taken from the southeastern perimeter of the location, facing North. See comments form Photo 2.

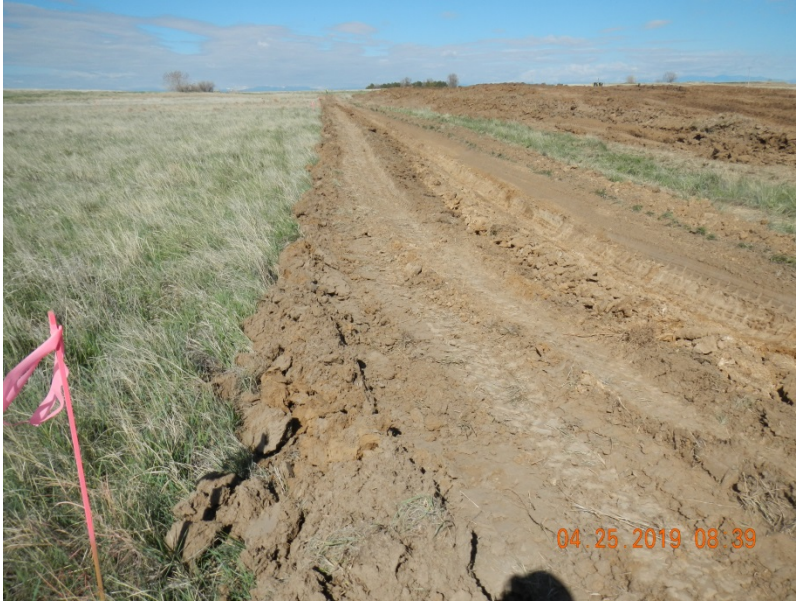
**Photo 11.** Photo taken from the southern perimeter of the location, facing West. See comments from Photo 2.

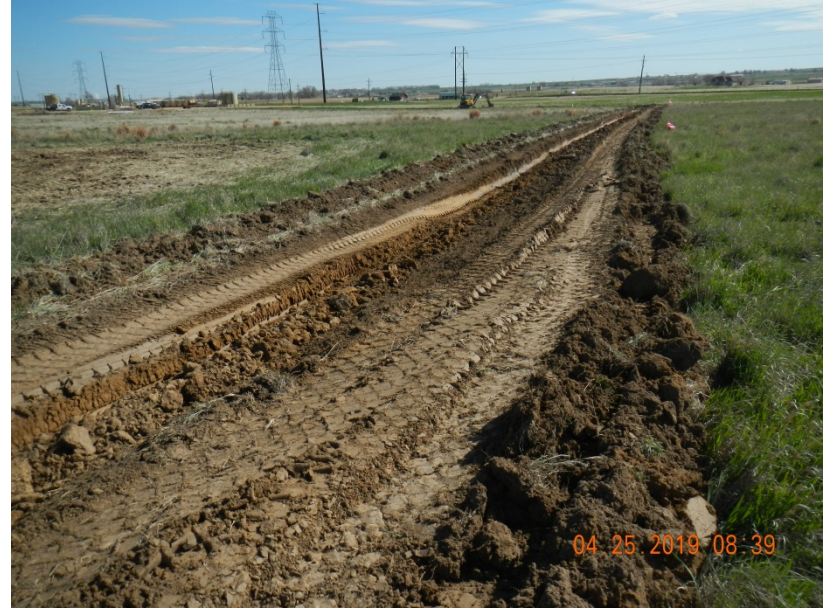
**Photo 12.** Photo taken from the southern perimeter of the location, facing Northeast. See comments from Photo 2.

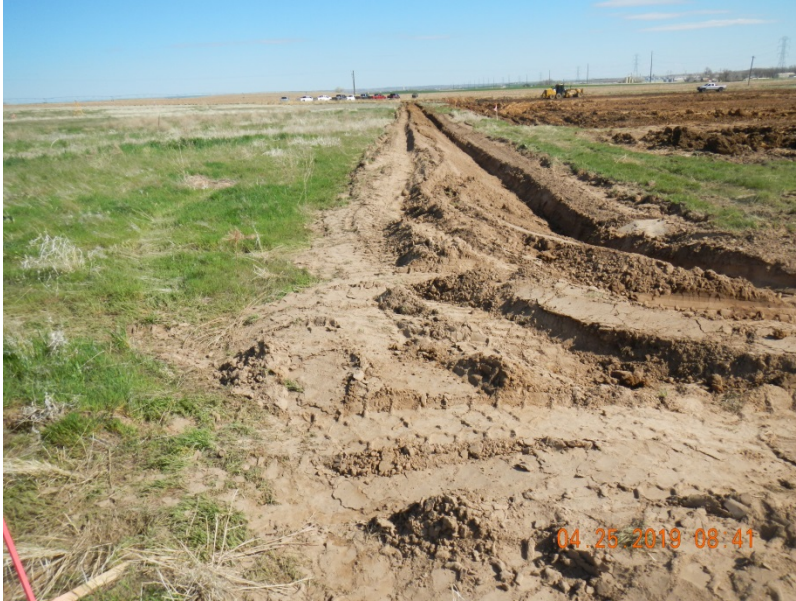
**Photo 13.** Photo taken from the southwestern perimeter of the location, facing North. See comments from Photo 2.

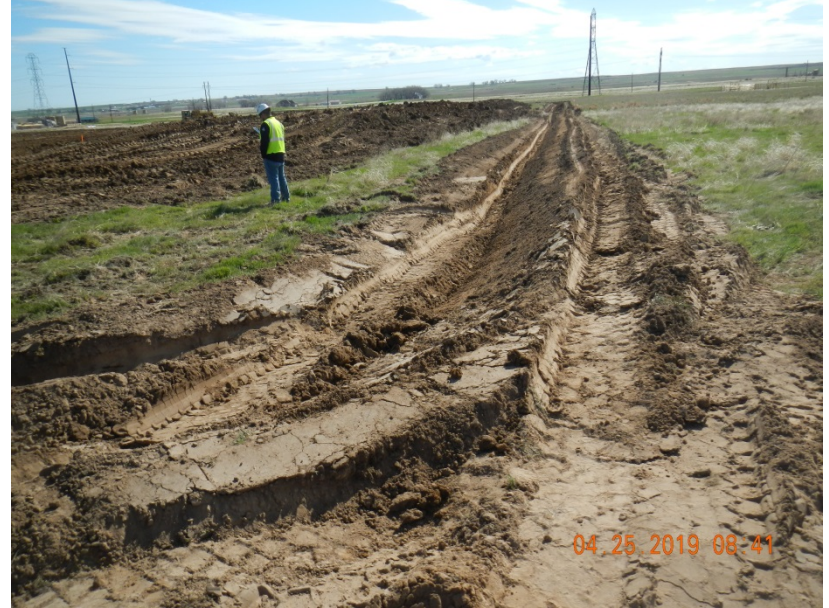
**Photo 14.** Photo taken from the southwestern perimeter of the location, facing East. See comments from Photo 2.

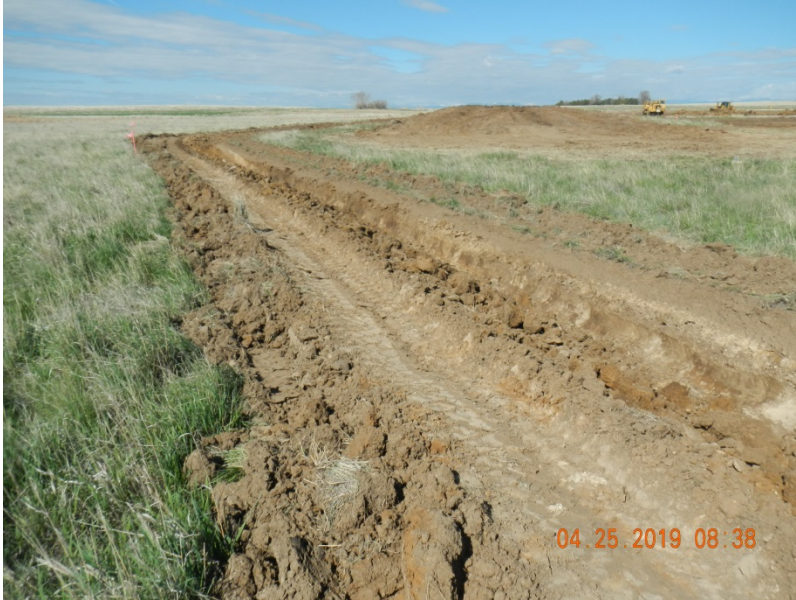
**Photo 15.** Photo taken from the southern perimeter of the location, facing West. Photo depicts the Operator is currently salving top soil and is being stored at the western end of the location.

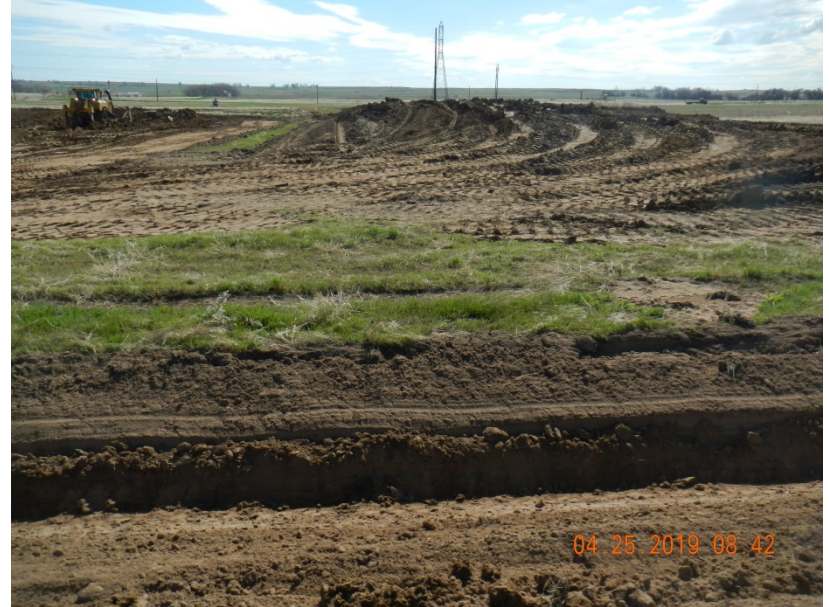
**Photo 16.** Photo taken from the northern perimeter of the location, facing South. See comments from Photo 15.
