# Inspection Photos

API: 05-071-08803

Operator: TIMBER CREEK OPERATING LLC

Inspection Date: 4/25/2019

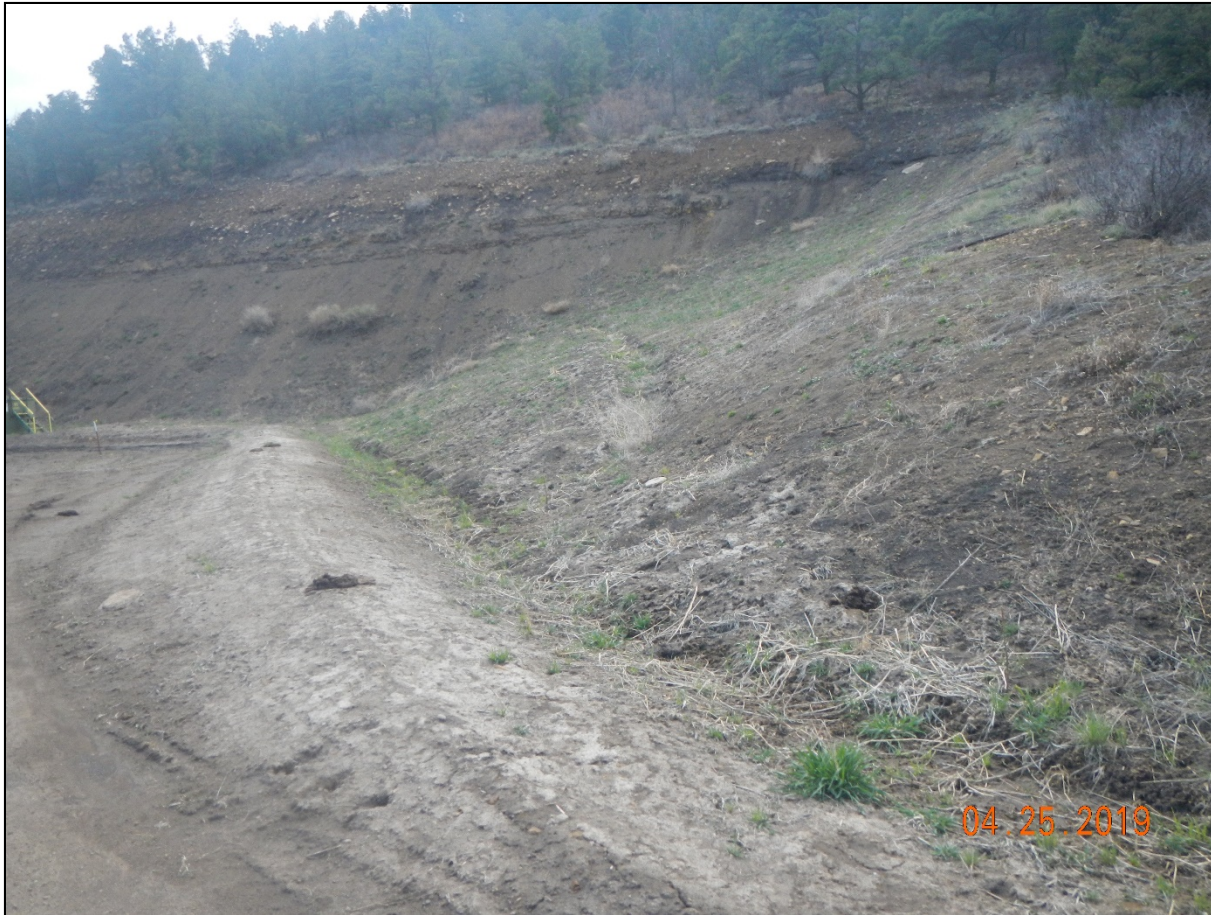
**Photo 1.** Facing toward the cut slope. This area appears to have been reseeded and stabilized with mulch. Diversion ditch has been cleaned out.

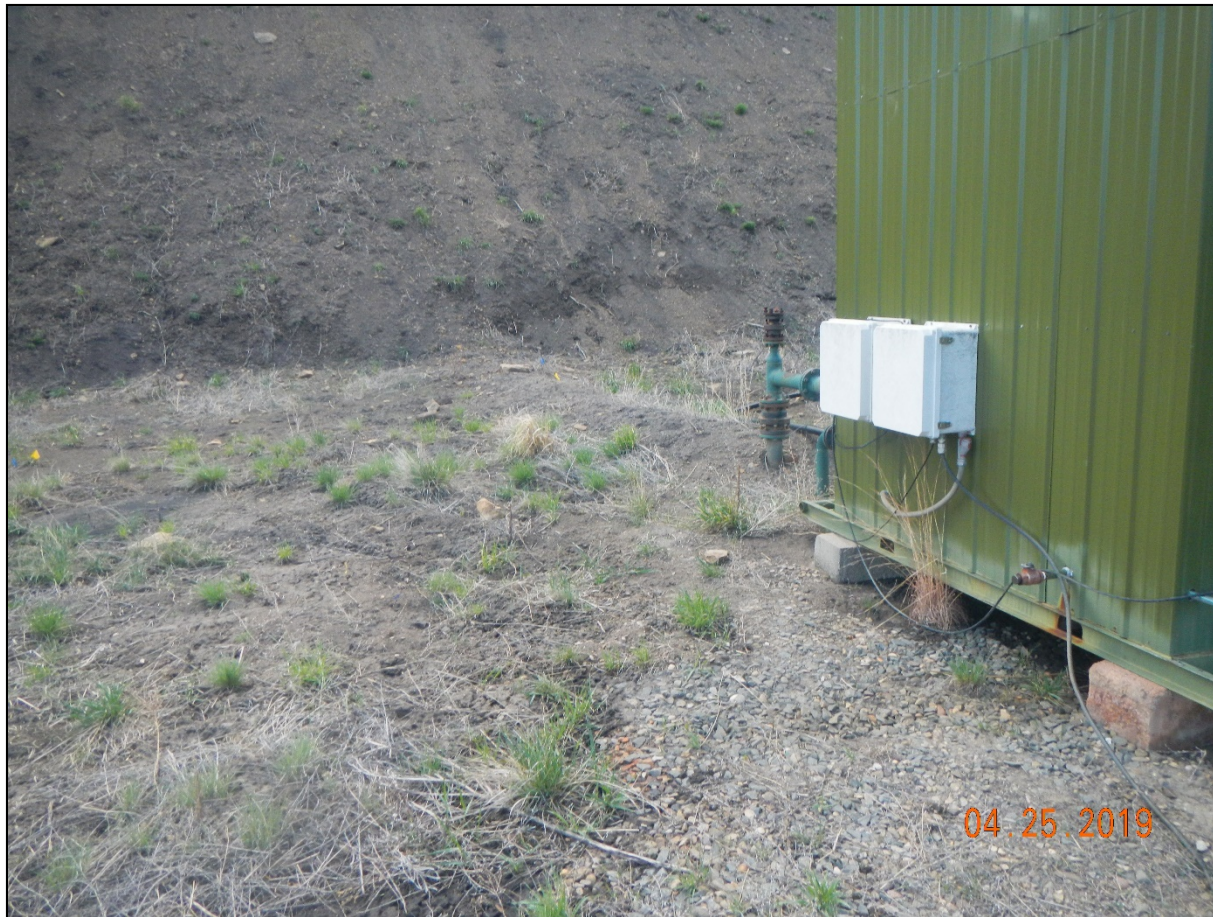
**Photo 2.** Oil stained soil appears to have been removed.

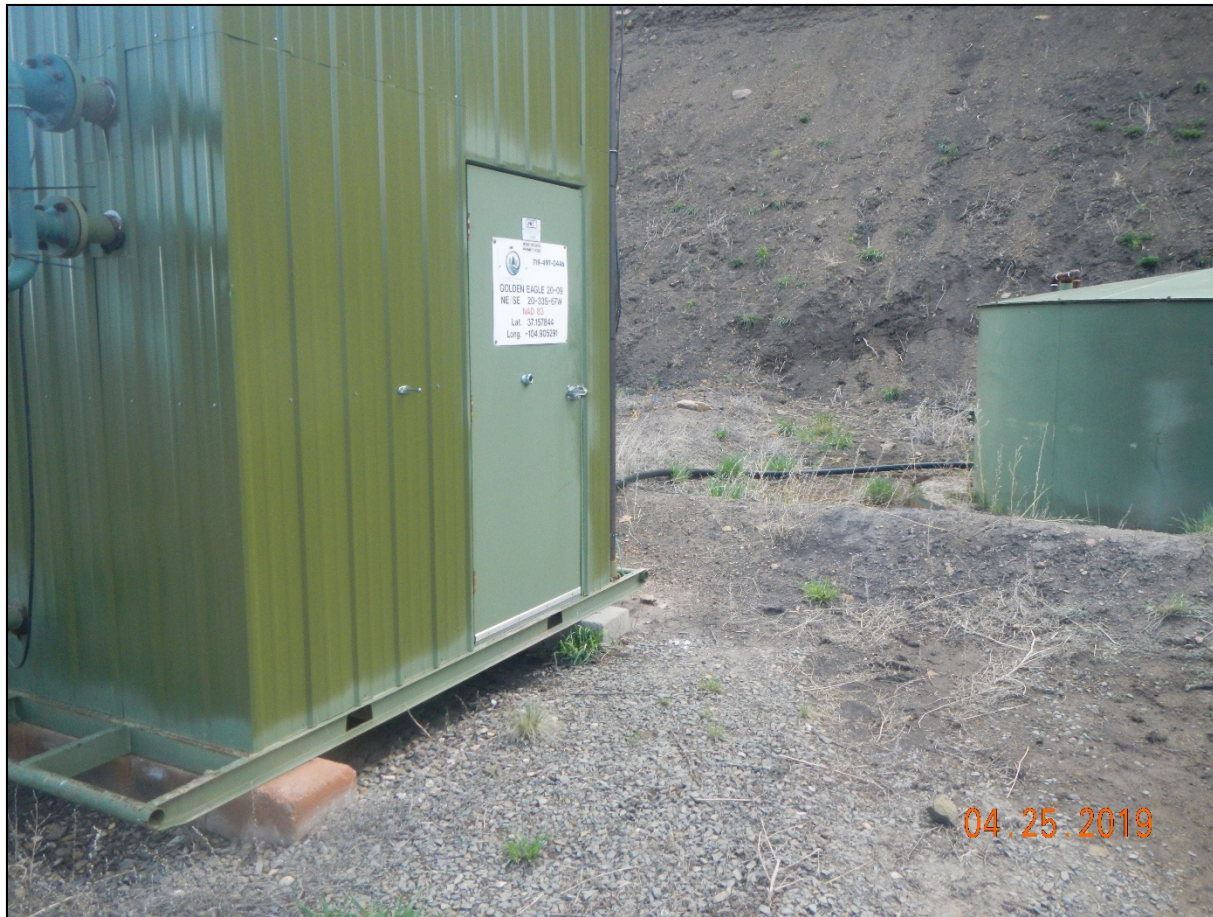
**Photo 3.** Well sign located at meter shed.

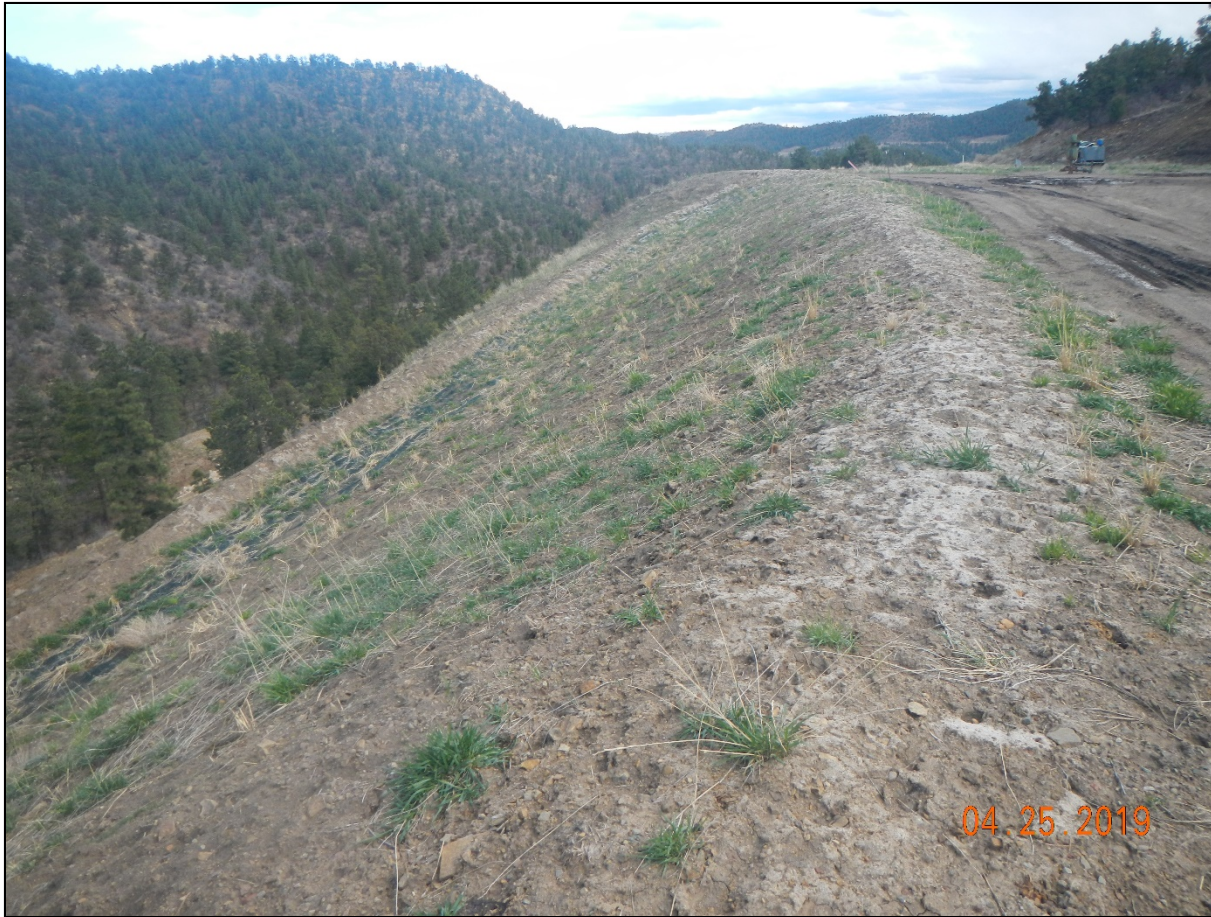
**Photo 4.** Erosion issues along the fill slope have been fixed. A diversion ditch with EC blanket was installed.
