Inspection Photos

API: 05-071-09682

Operator: TIMBER CREEK OPERATING LLC

Inspection Date: 4/25/2019

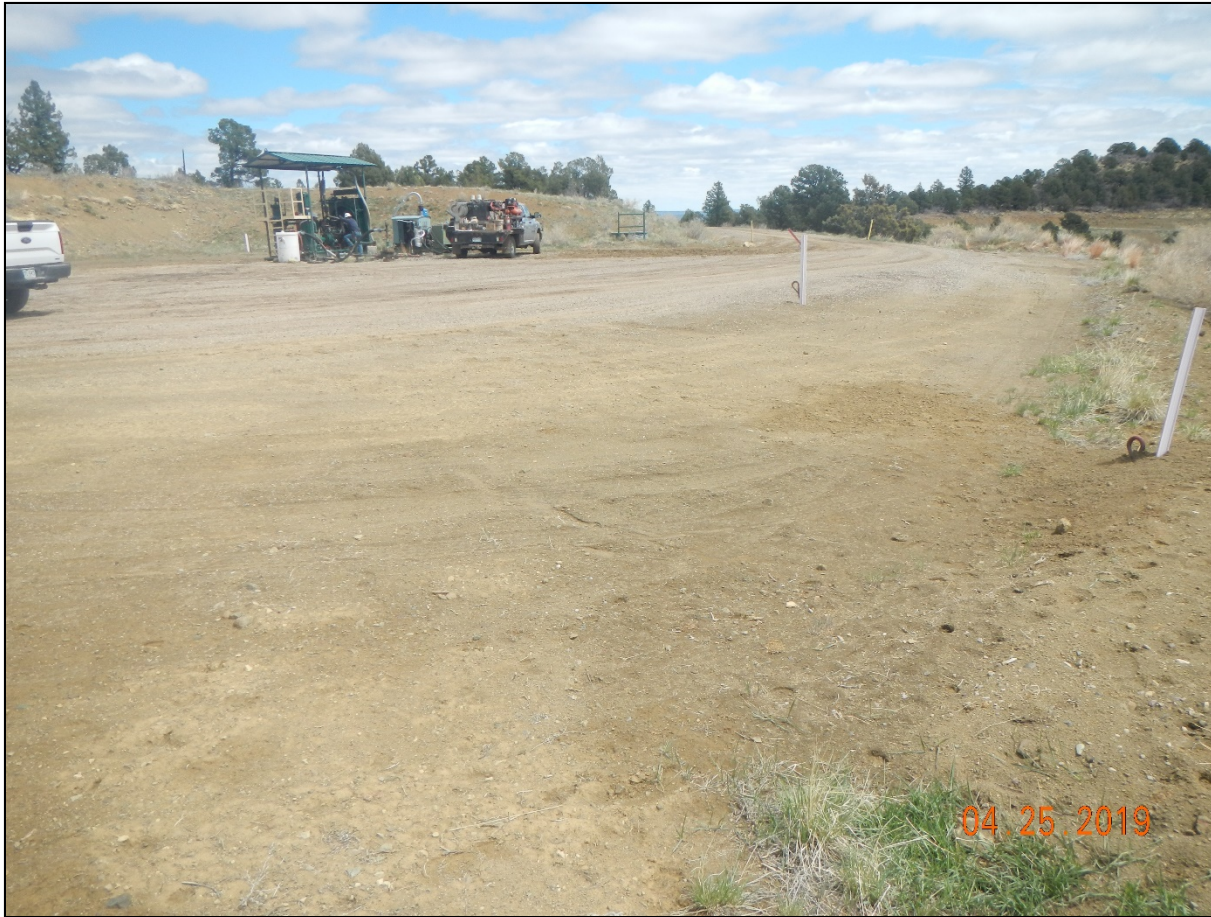
Photo 1. Facing northeast at the location. Maintenance was being performed at the well engine during inspection.

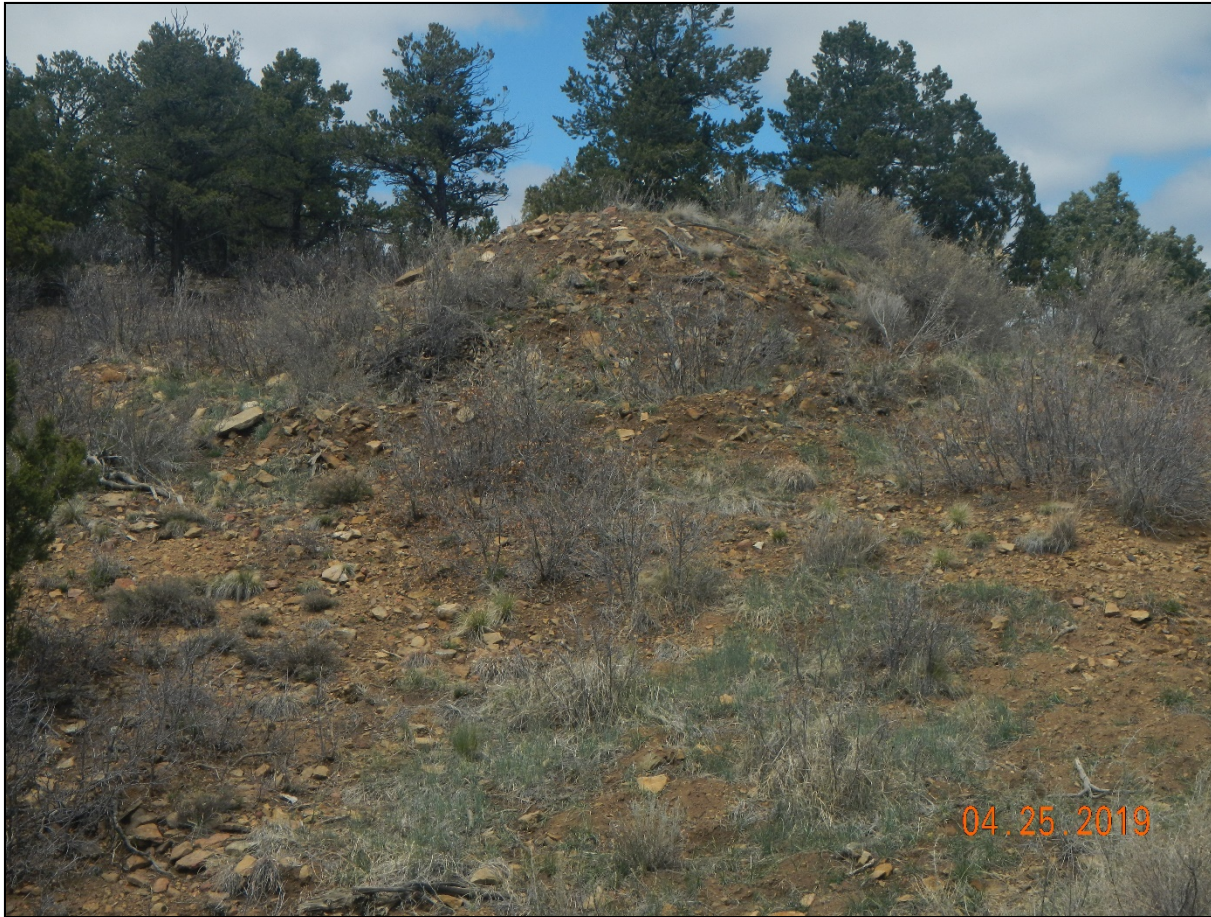
Photo 2. Topsoil pile at the north side of the location appears to be stabilized.

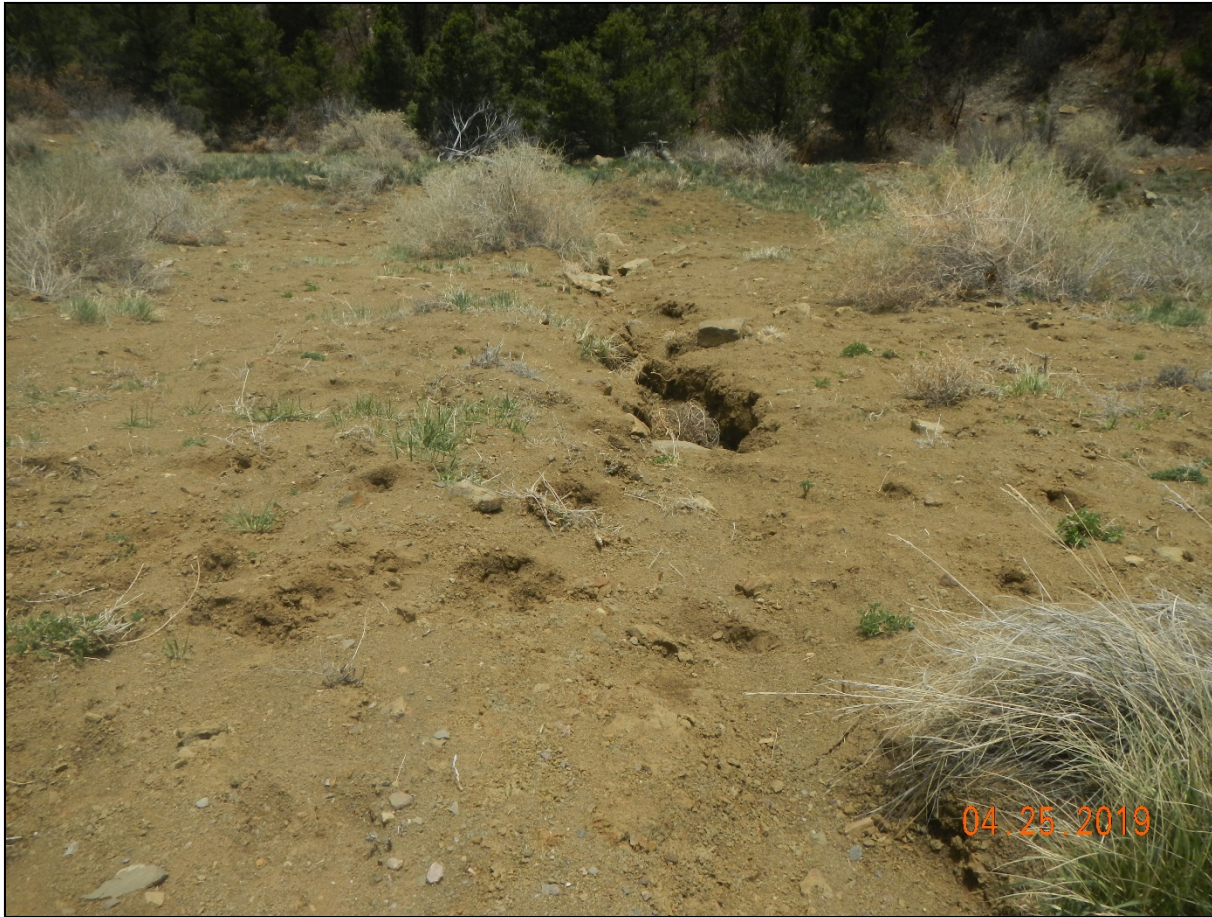
Photo 3. There is an erosion channel that formed at the south fill slope.

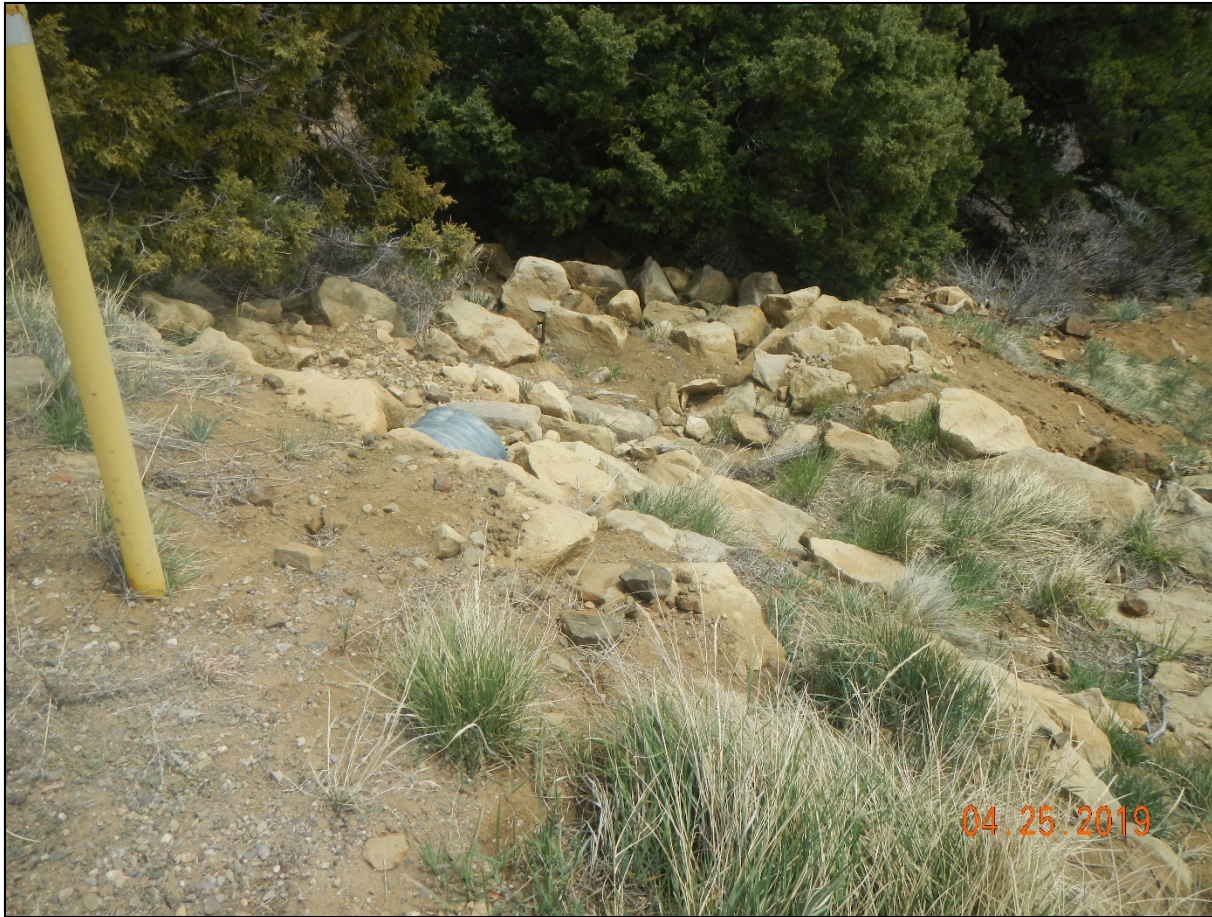
Photo 4. Culverts appear to be properly installed and maintained.
