Inspection Photos
Location Name: North York 13-12#3
Location ID: 320313

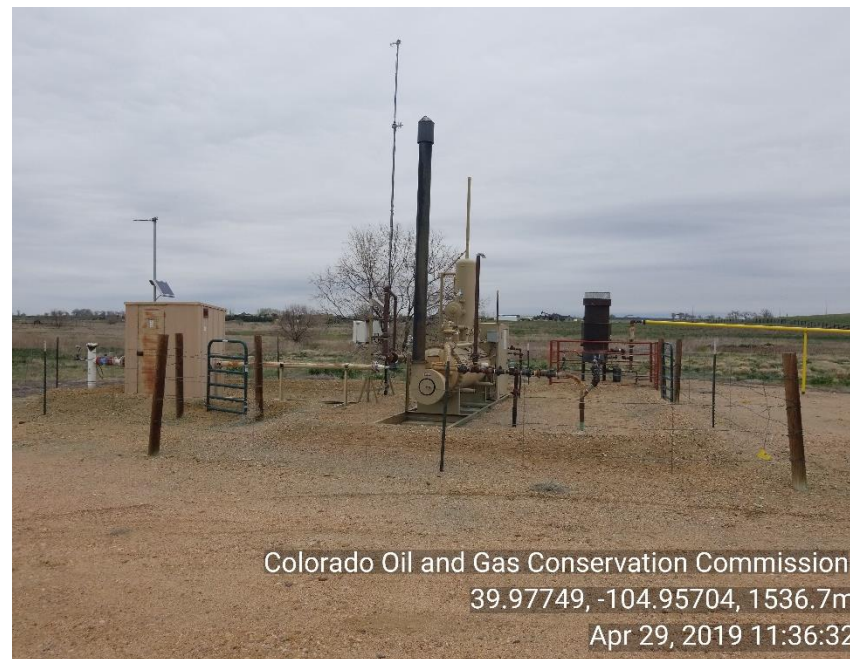
Photo 2 sep/meter house and ECD. Location located in a flood plain equipment not properly anchored and inadequate berm.

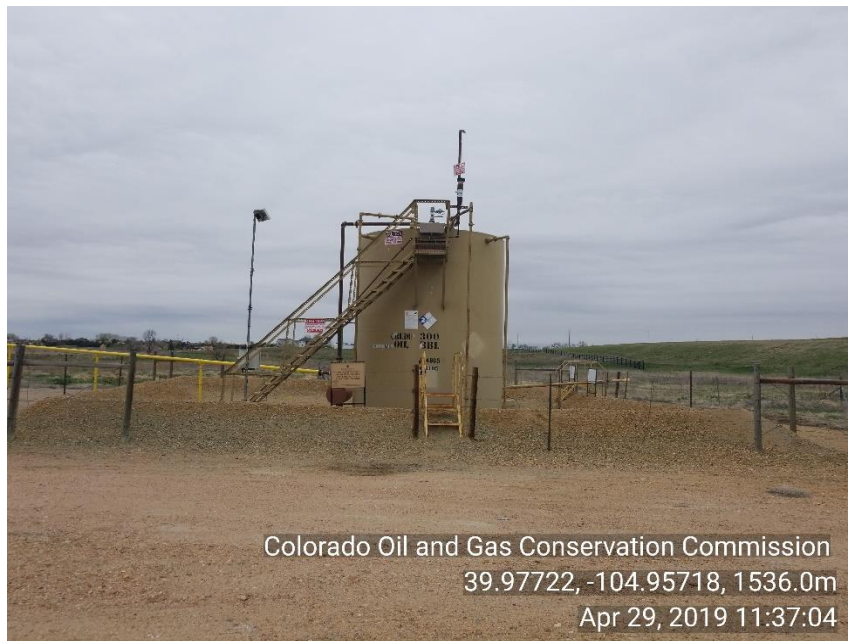
**Photo 3 TNK BTRY. Location located in a flood plain
equipment not properly anchored and inadequate berm.**

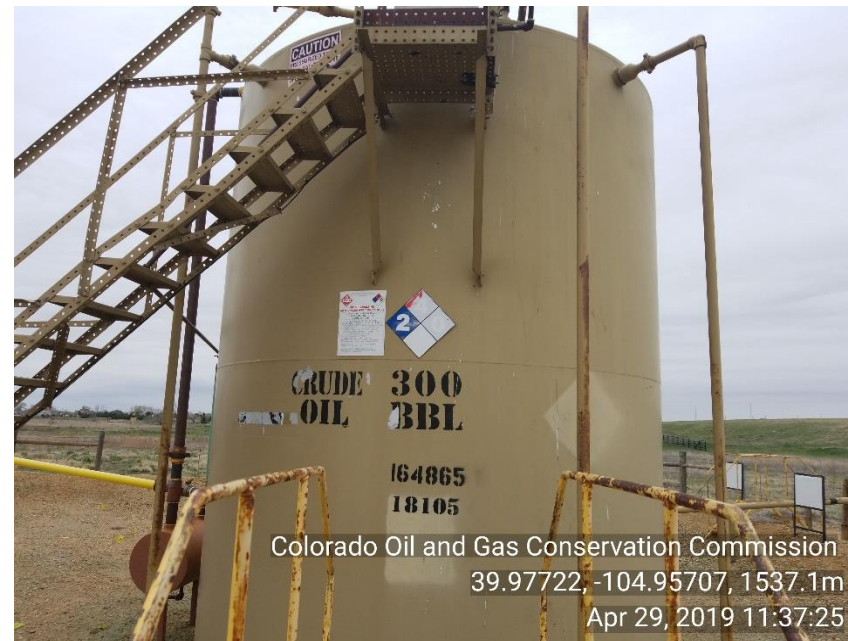
Photo 4 NFPA placard faded and illegible.

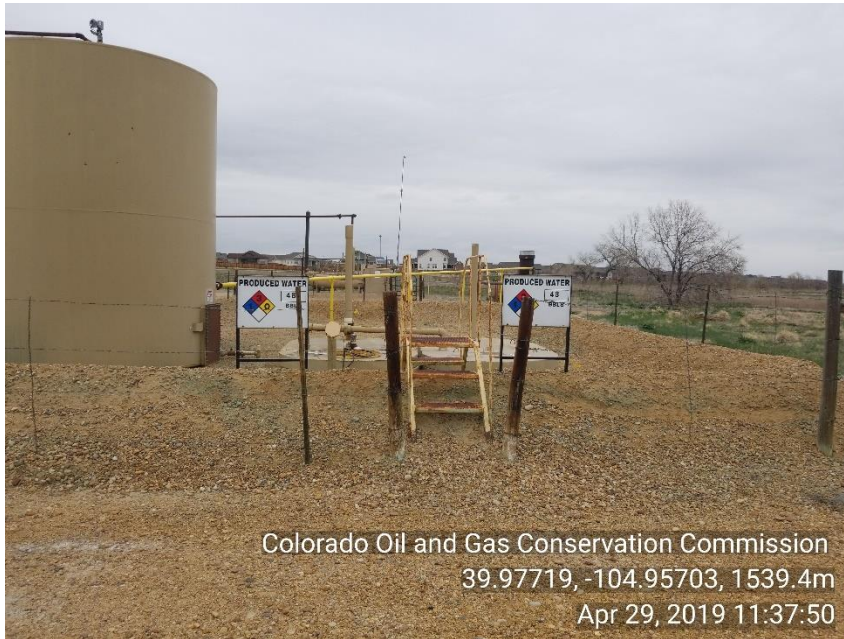
Photo 5 TNK BTRY. Production tanks Location located in a flood plain equipment not properly anchored and inadequate berm.

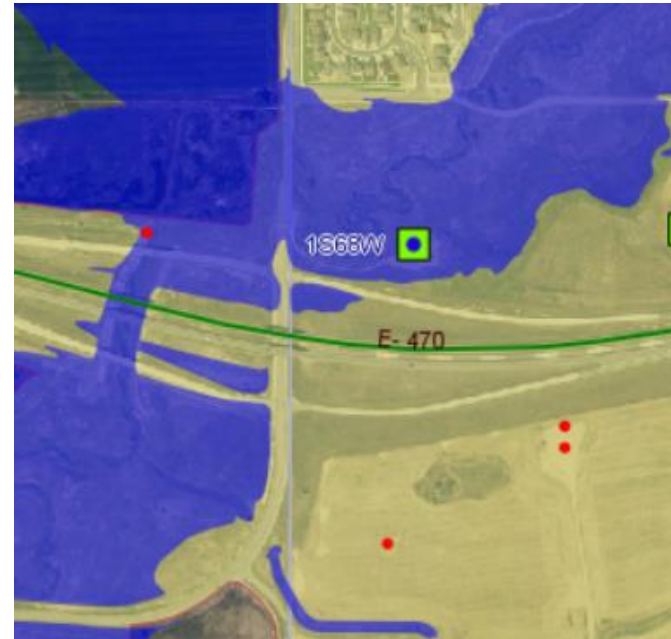
Photo 6 Location is located in a flood plain.
