Inspection Photos
Location Name: Duncan Van Schaick Unit 1 2
API: 05-081-06834

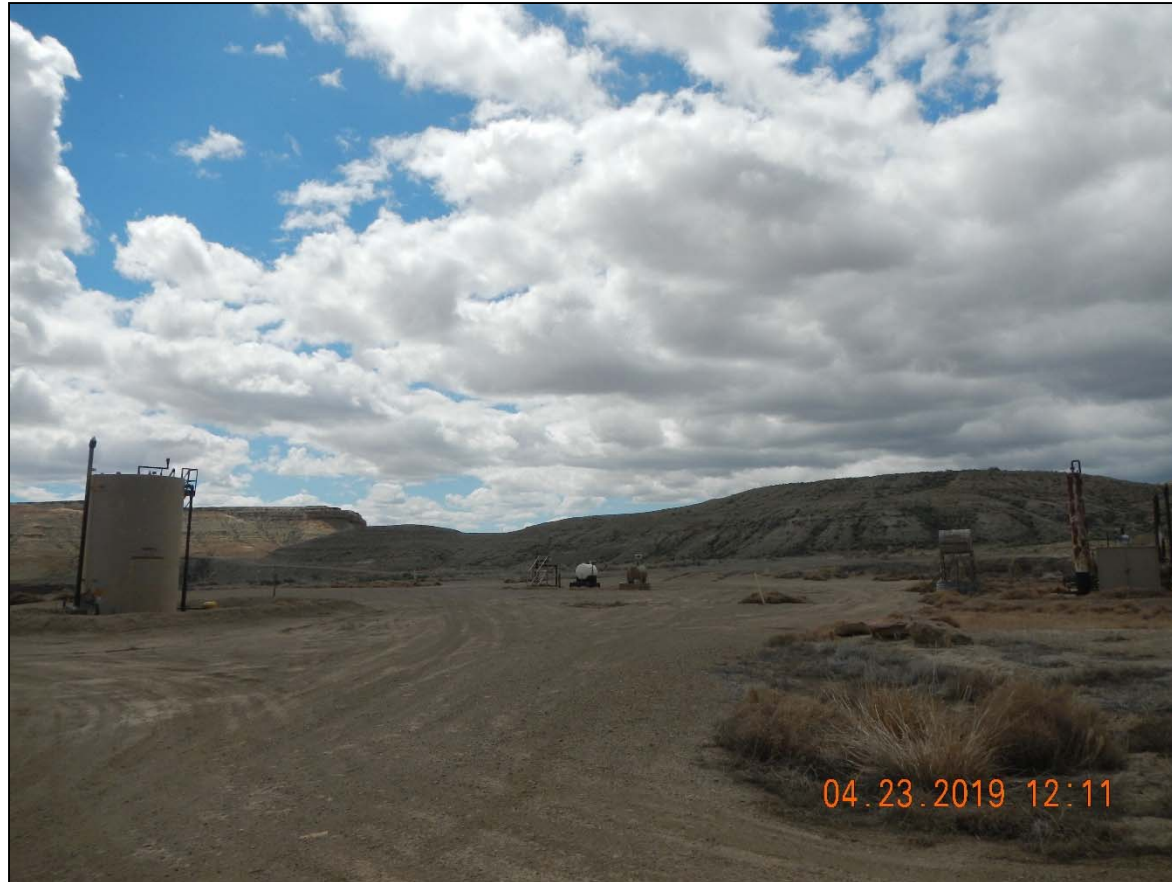
Photo 1. Overview of location taken at entrance facing southeast.
