Inspection Photos

Operator: Enduring Resources
Location/API #: 067-07650
Date: 4-22-2019

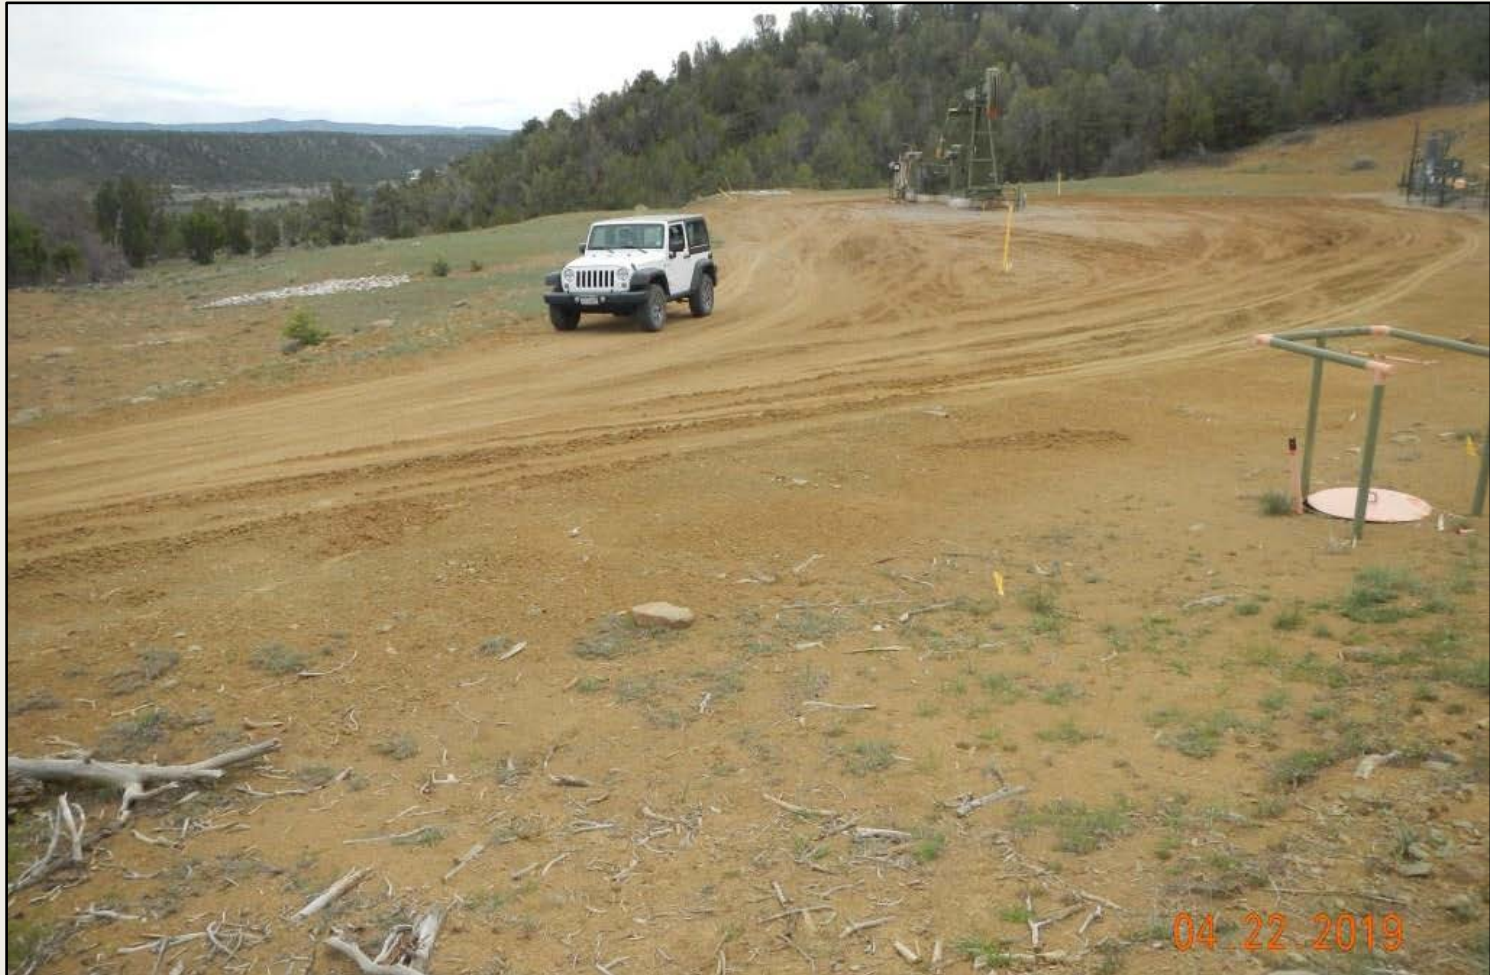
Photo 1. View of the project area from the northeastern edge facing center.

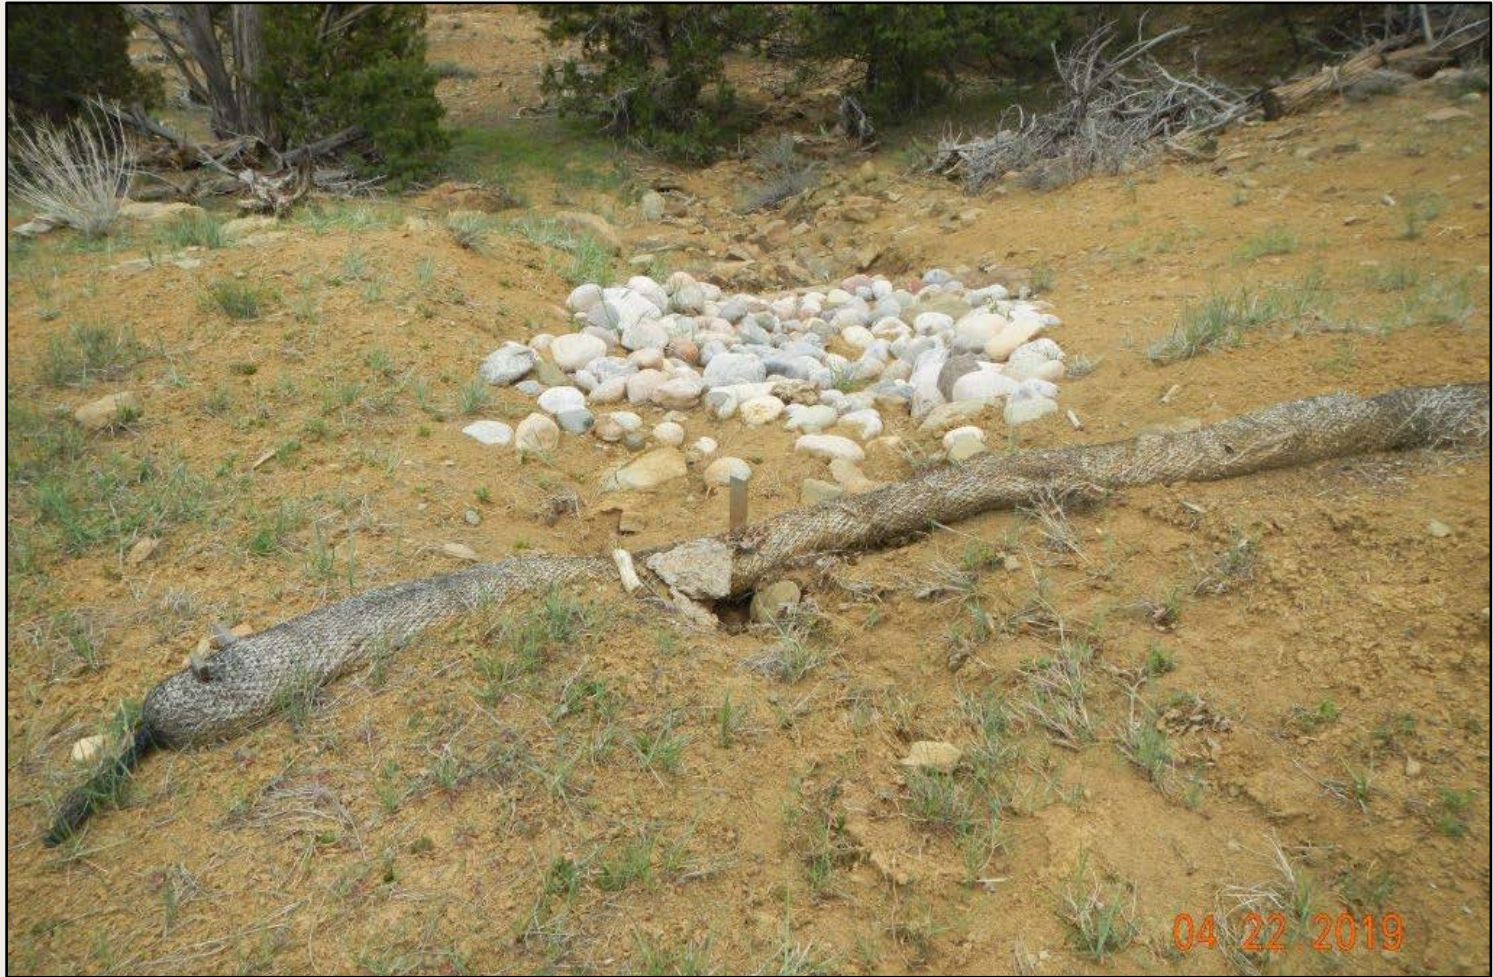
Photo 2. View of wattles and sediment deposition within the southeastern project area. Stormwater controls are not sufficient in this area.

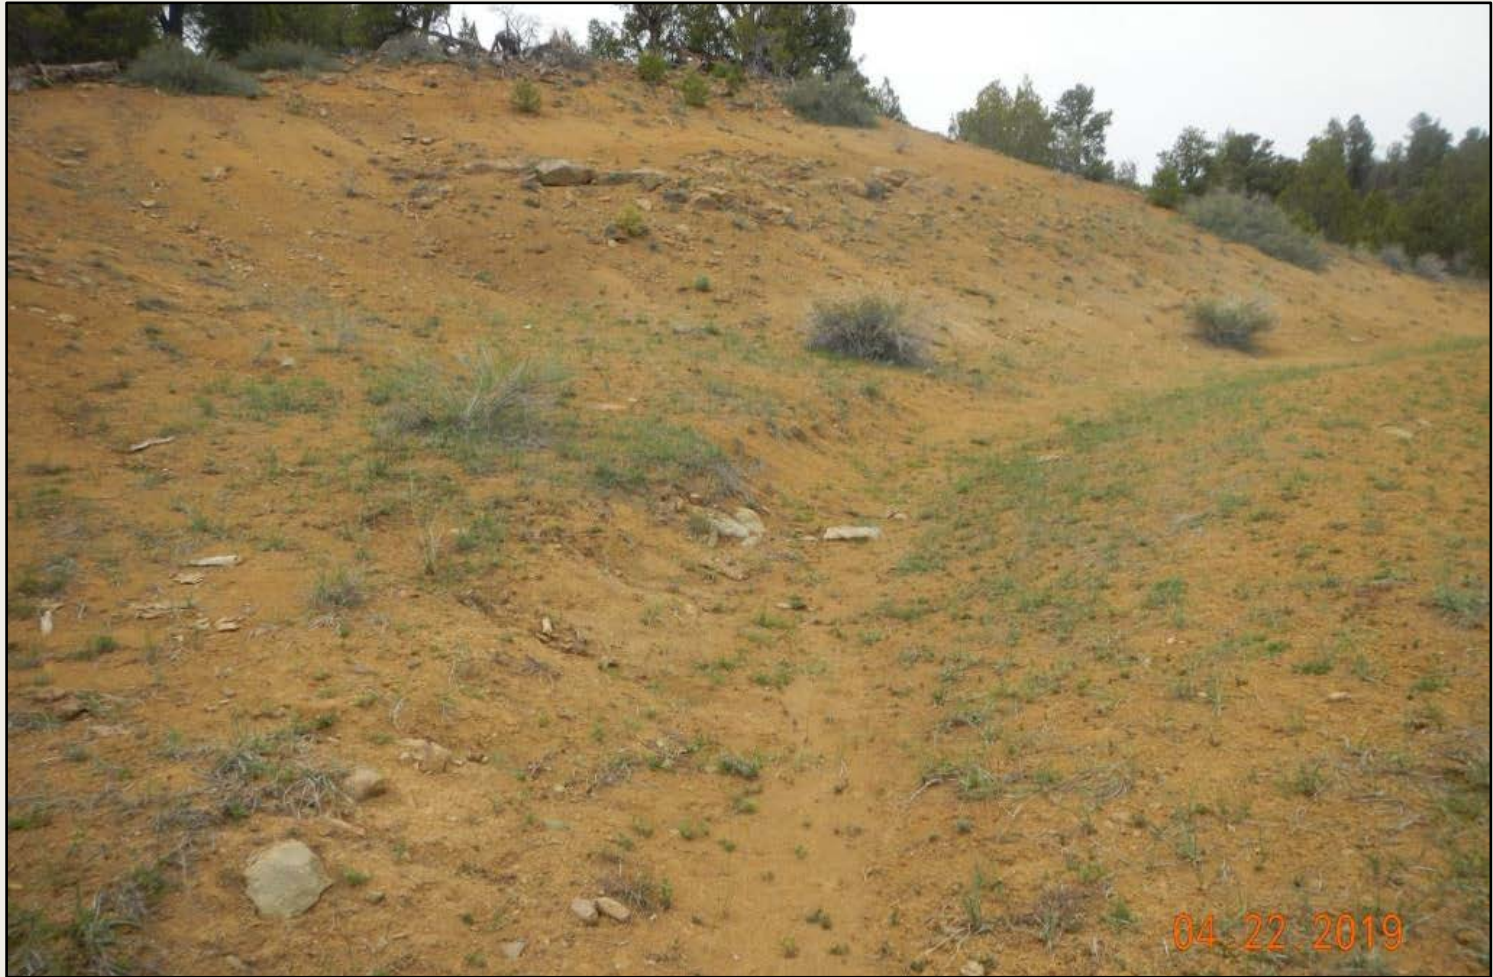
Photo 3. View of the southwestern cut-slope that is not stabilized

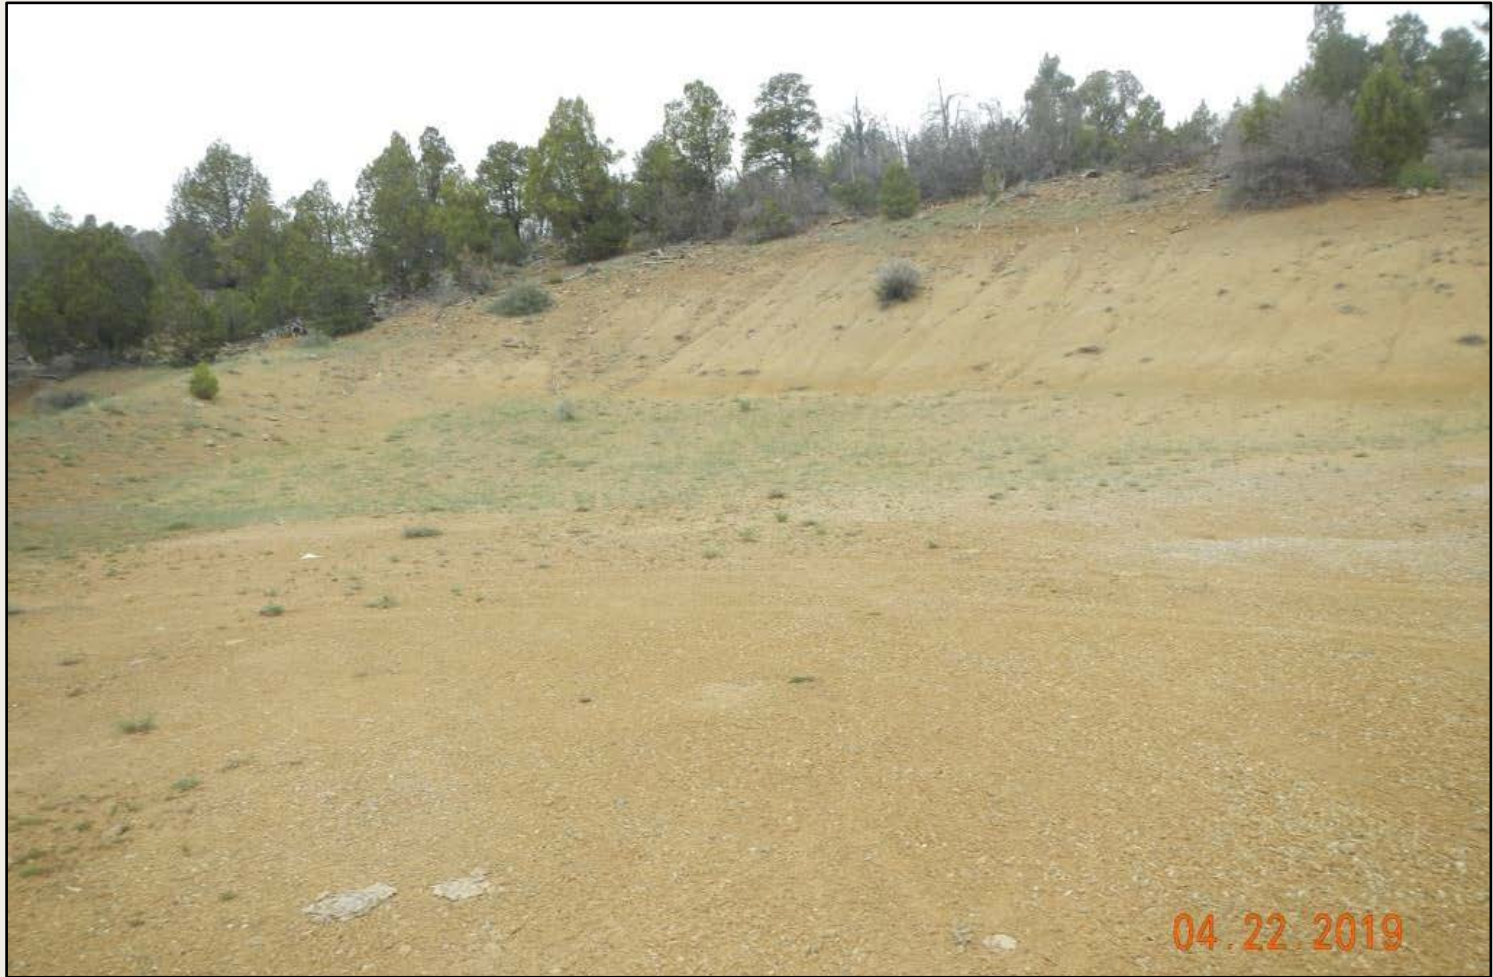
Photo 4. View of the northwestern cut-slope that is not stabilized.

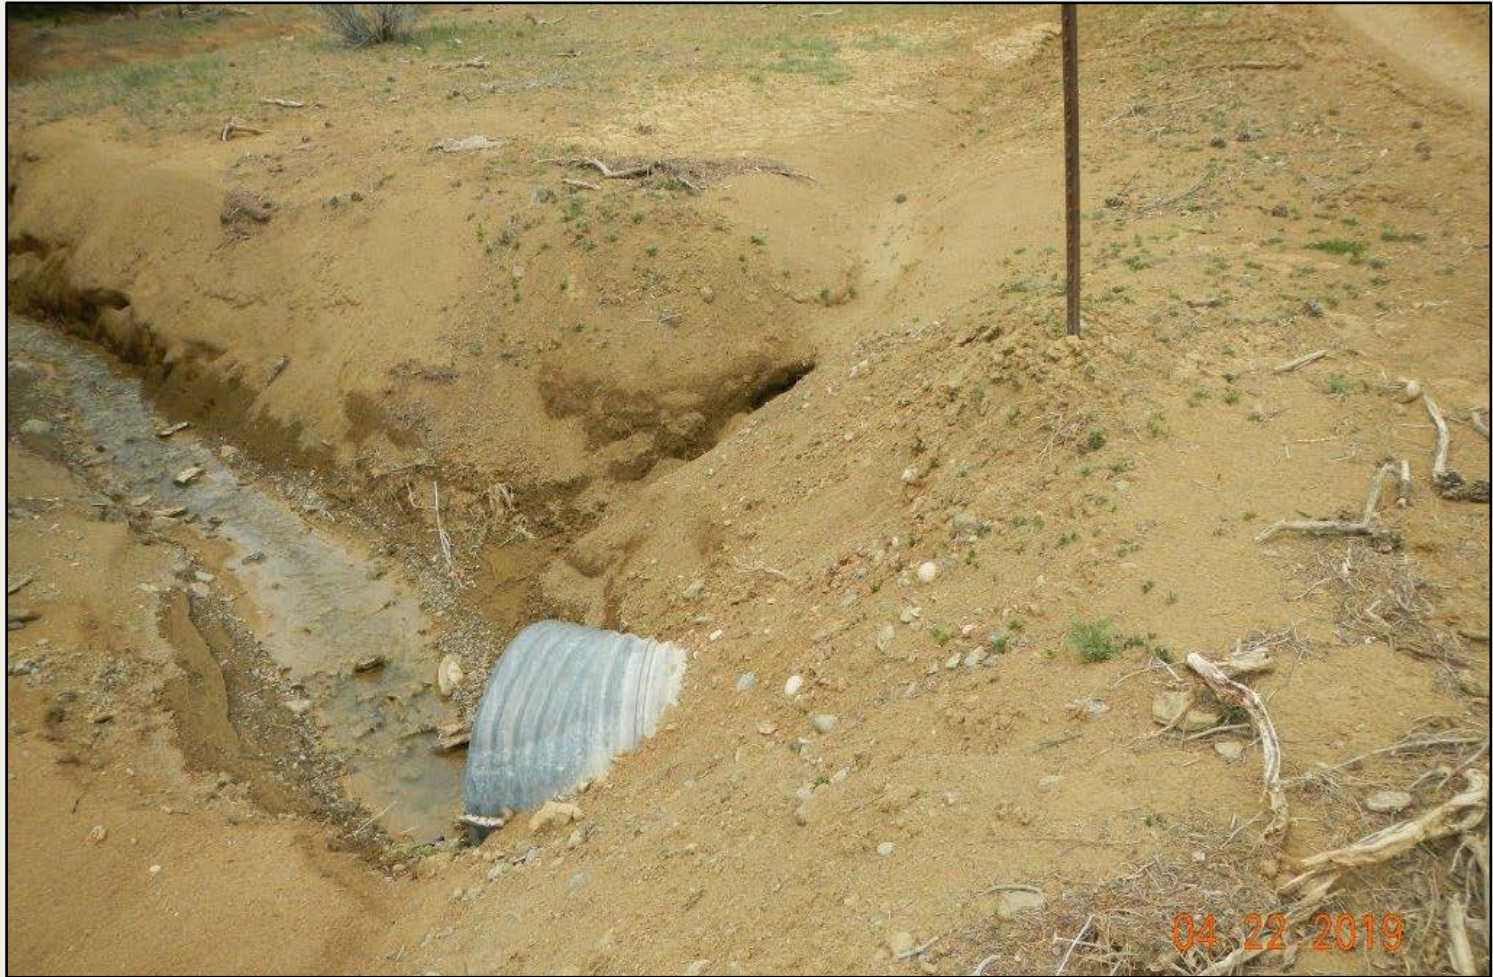
Photo 5. View of culvert inlet along the access road that is not stabilized. Runoff from the road flows into the stream and is not sufficiently managed.
