Inspection Photos

API: 05-071-06130

Operator: TIMBER CREEK OPERATING LLC

Inspection Date: 5/1/2019

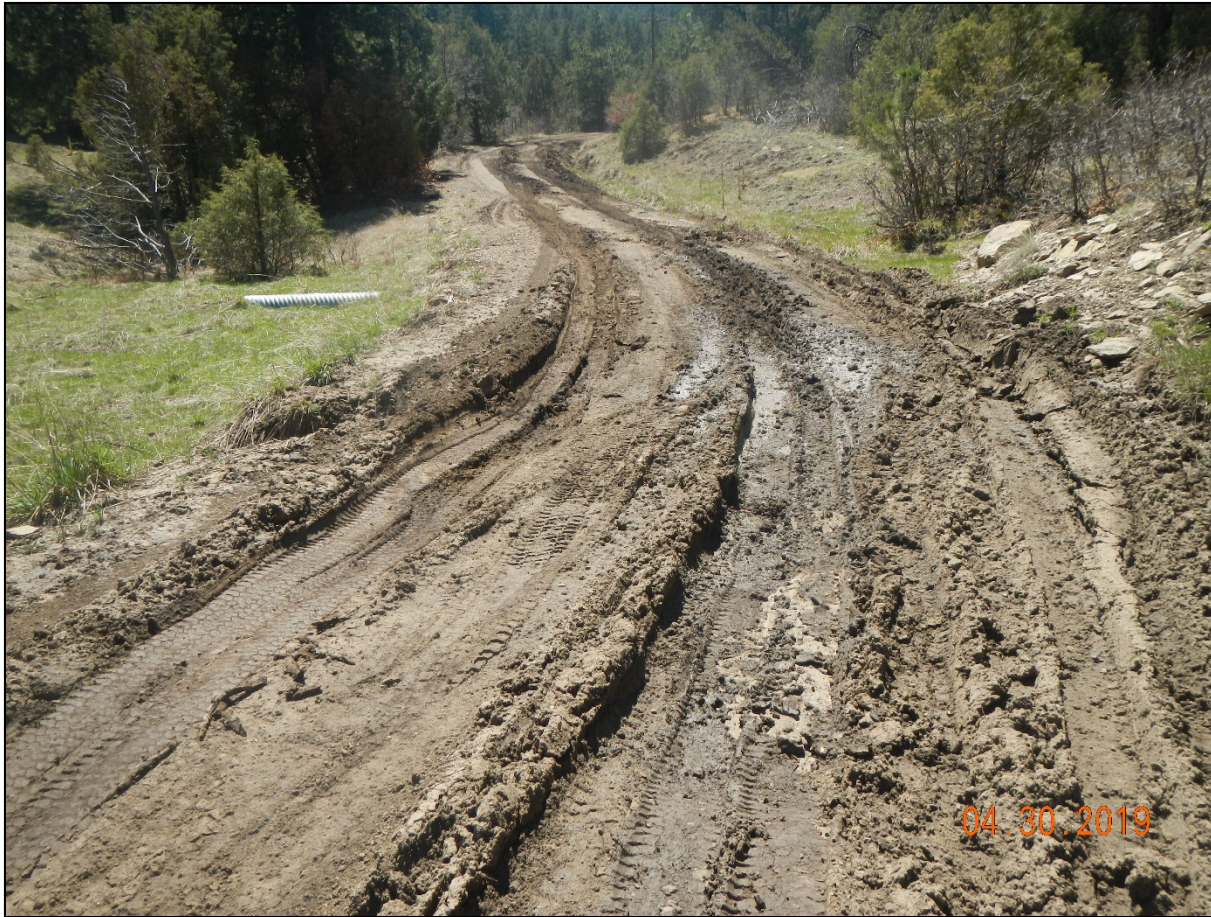
Photo 1. Facing west along the main access road. There is vehicle rutting along the road causing widening of the road.

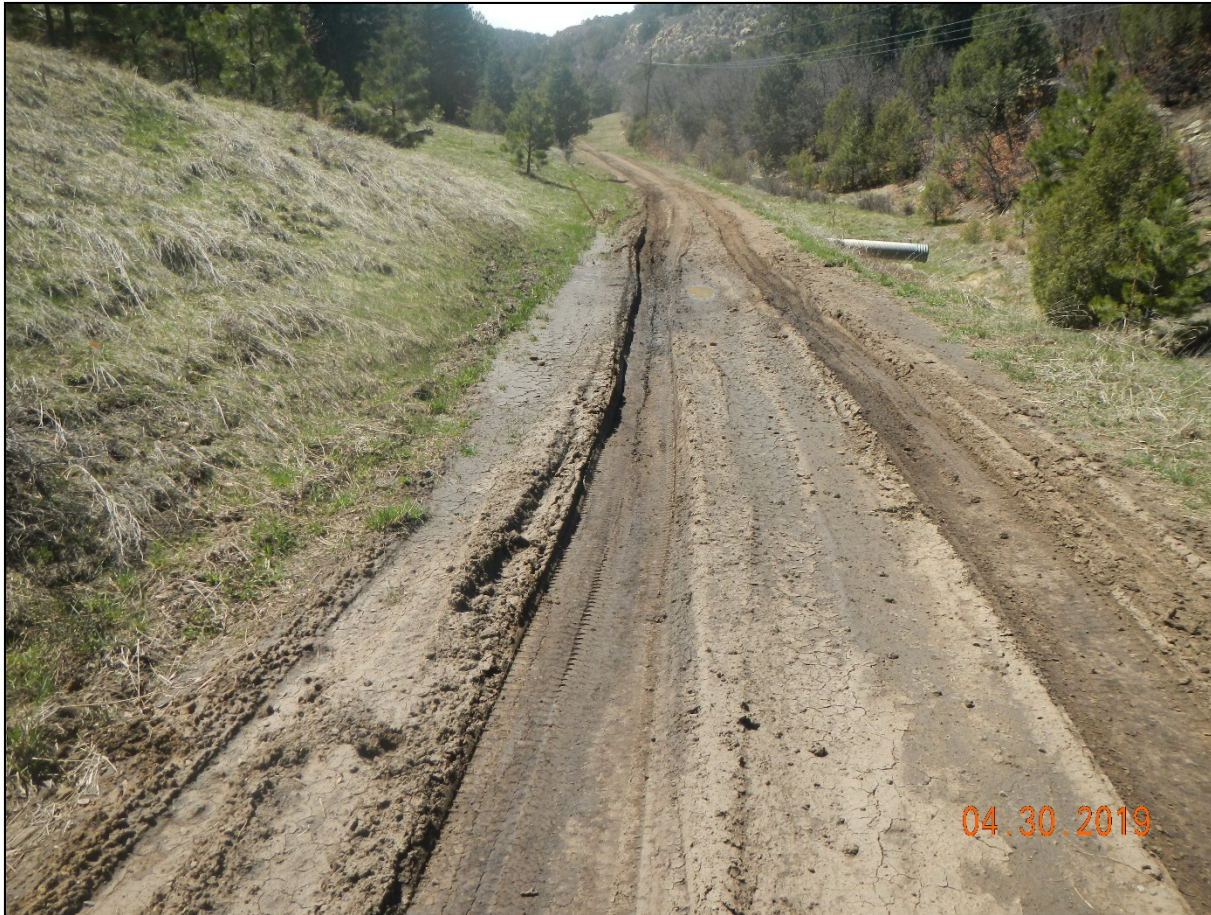
Photo 2. There are deep vehicle ruts along the road.

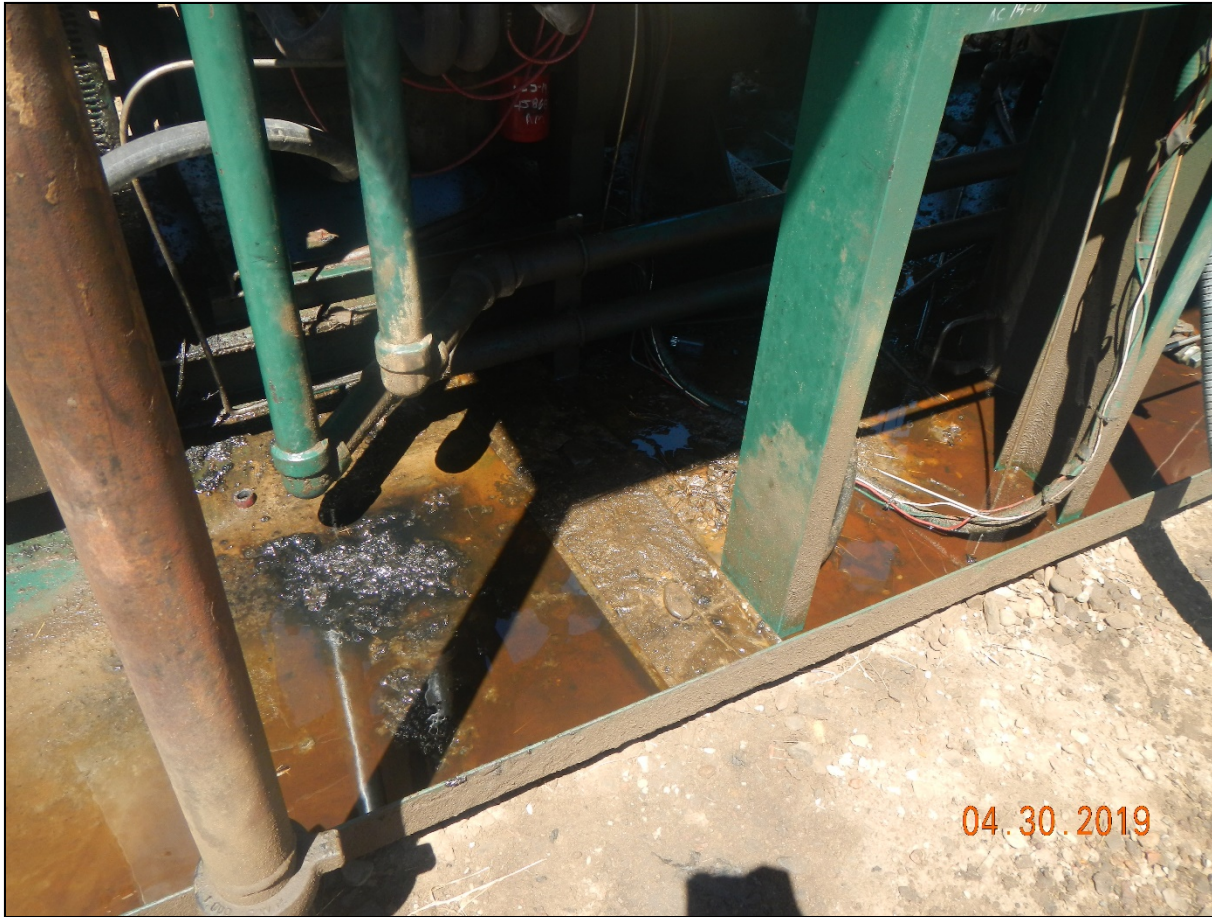
Photo 3. There is oily waste at the engine skid.
