Inspection Photos

API: 05-071-07437

Operator: TIMBER CREEK OPERATING LLC

Inspection Date: 5/1/2019

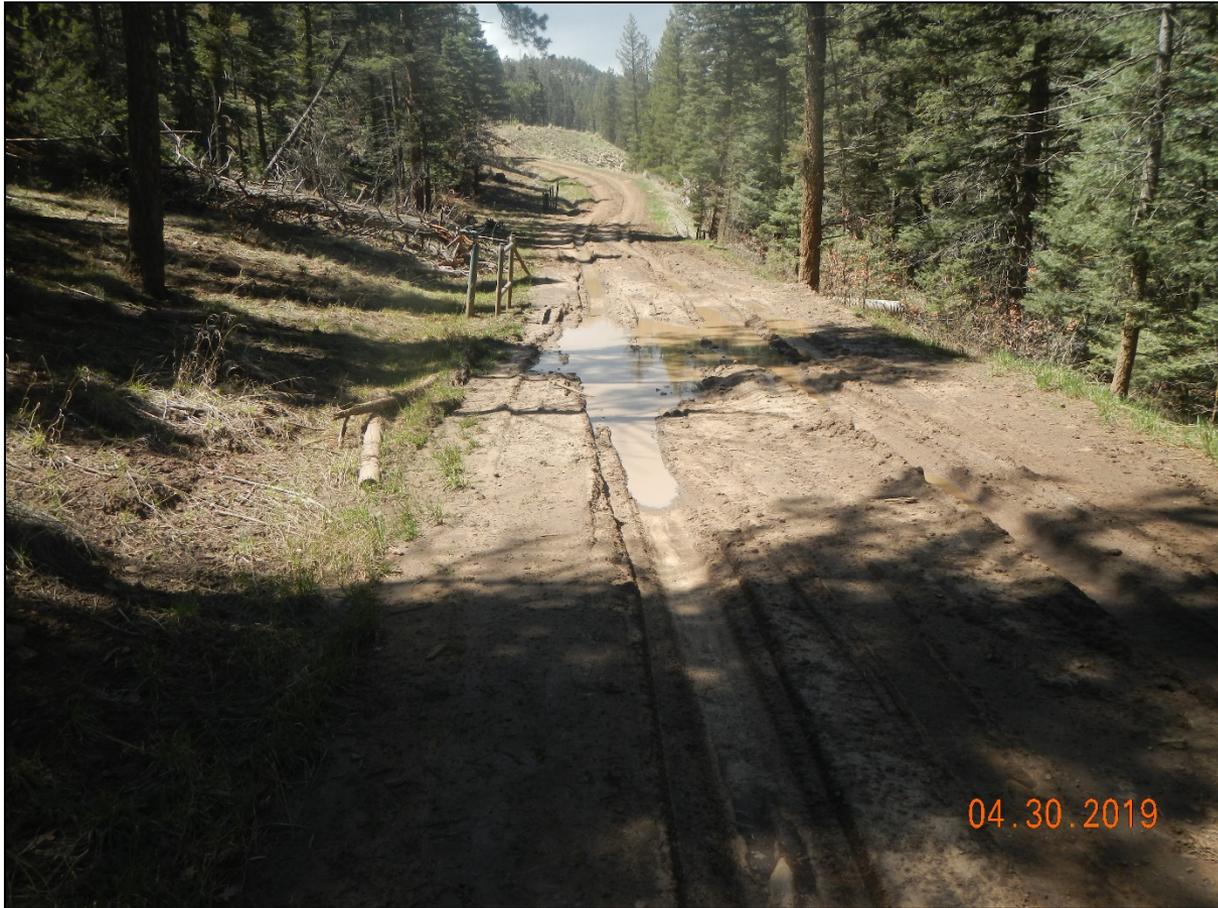
Photo 1. Facing west along the main access road. There is vehicle rutting along the road causing road damage. Stormwater is accumulating on the road.

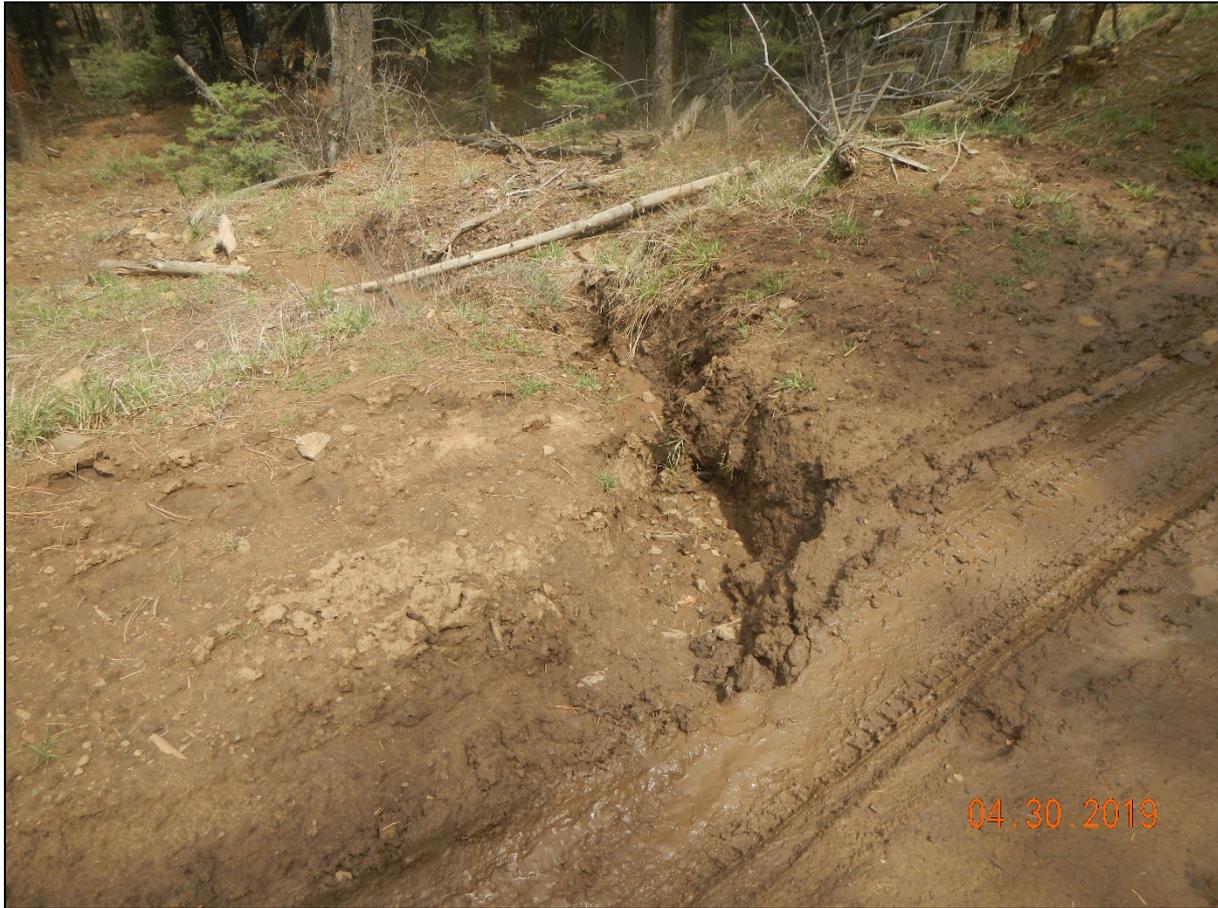
Photo 2. Stormwater flowing across the road in the previous photo is eroding the side of the road.

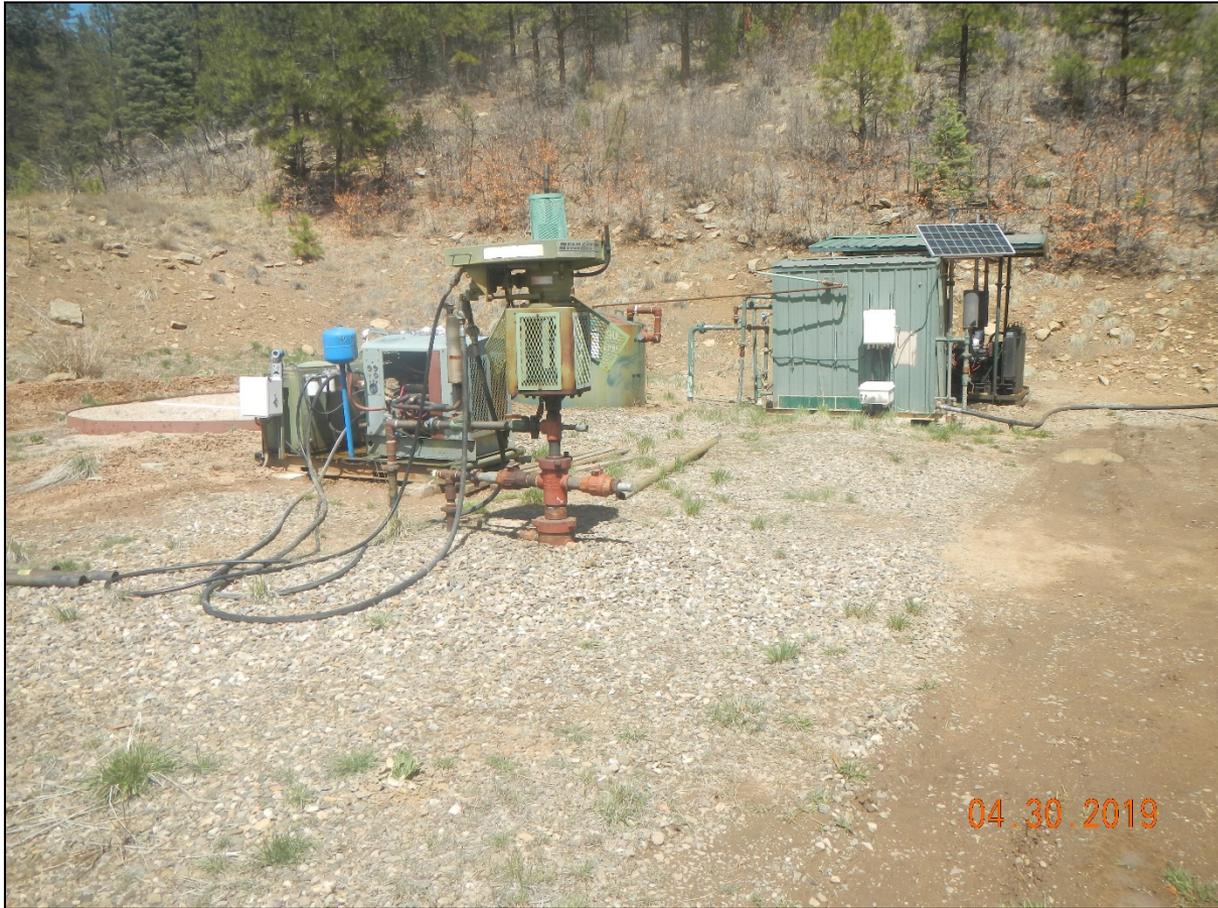
Photo 3. Facing toward the wellhead. No location sign was present anywhere on location.

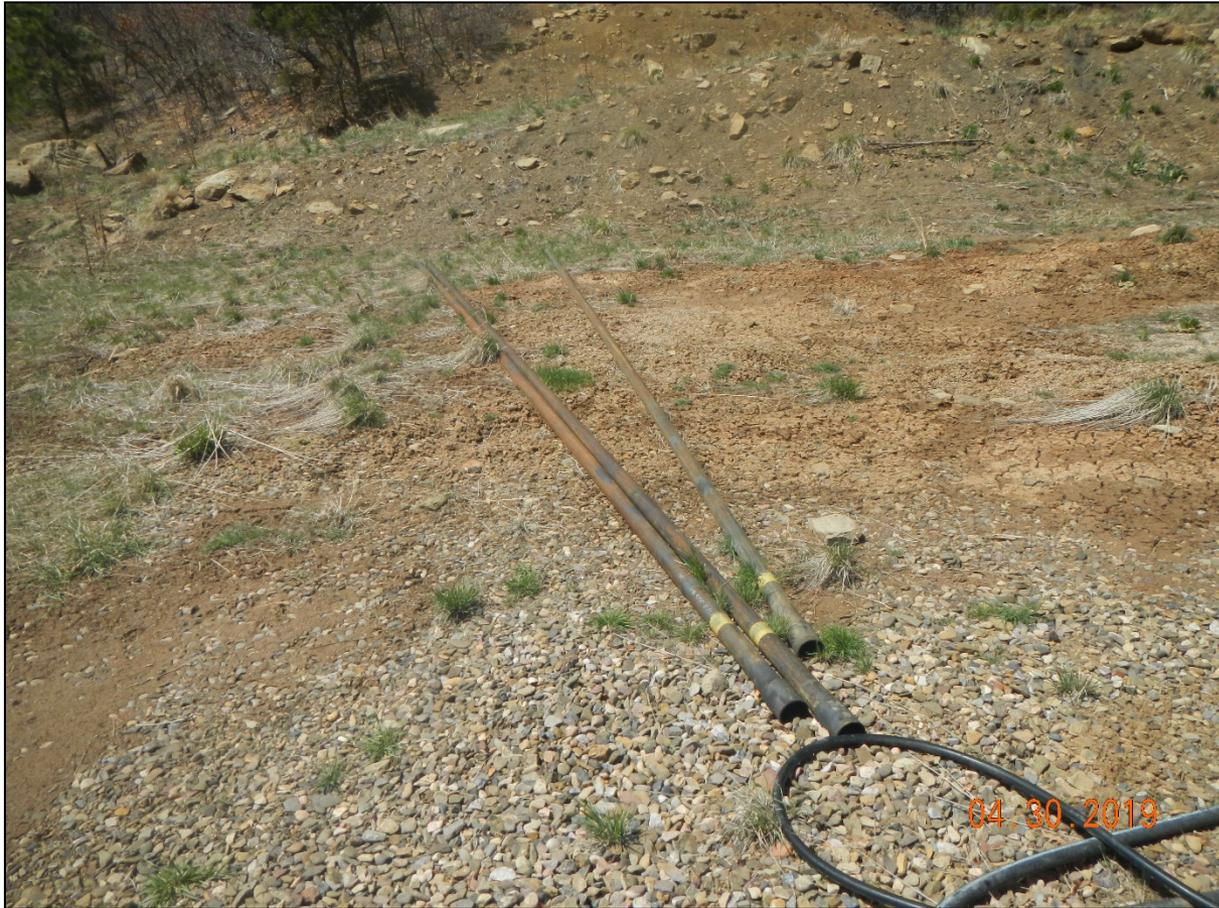
Photo 4. Unused pipe remains at the location.

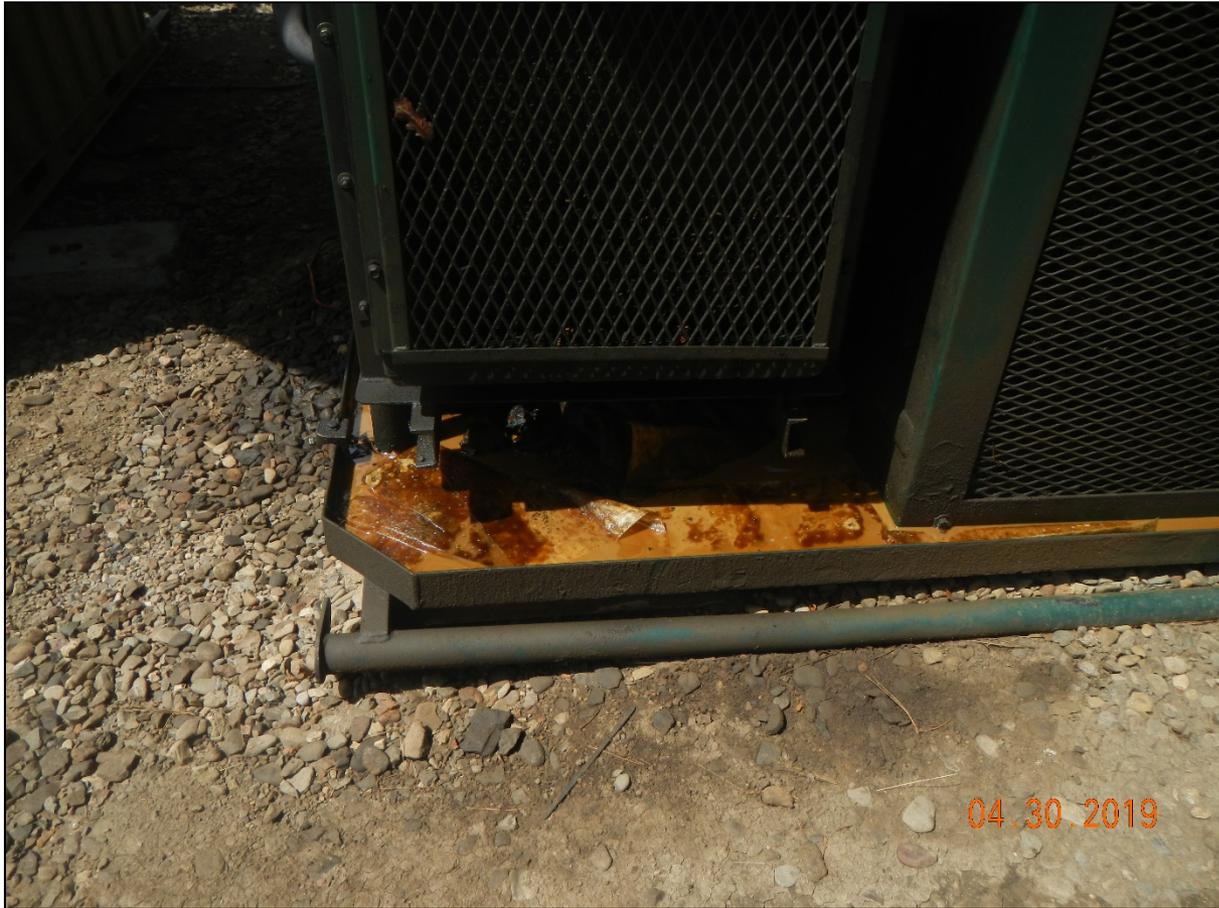
Photo 5. There is oily waste in the engine skid.
