Inspection Photos
Operator: Enduring Resources
Location/API #: 067-08658
Date: 4-22-2019

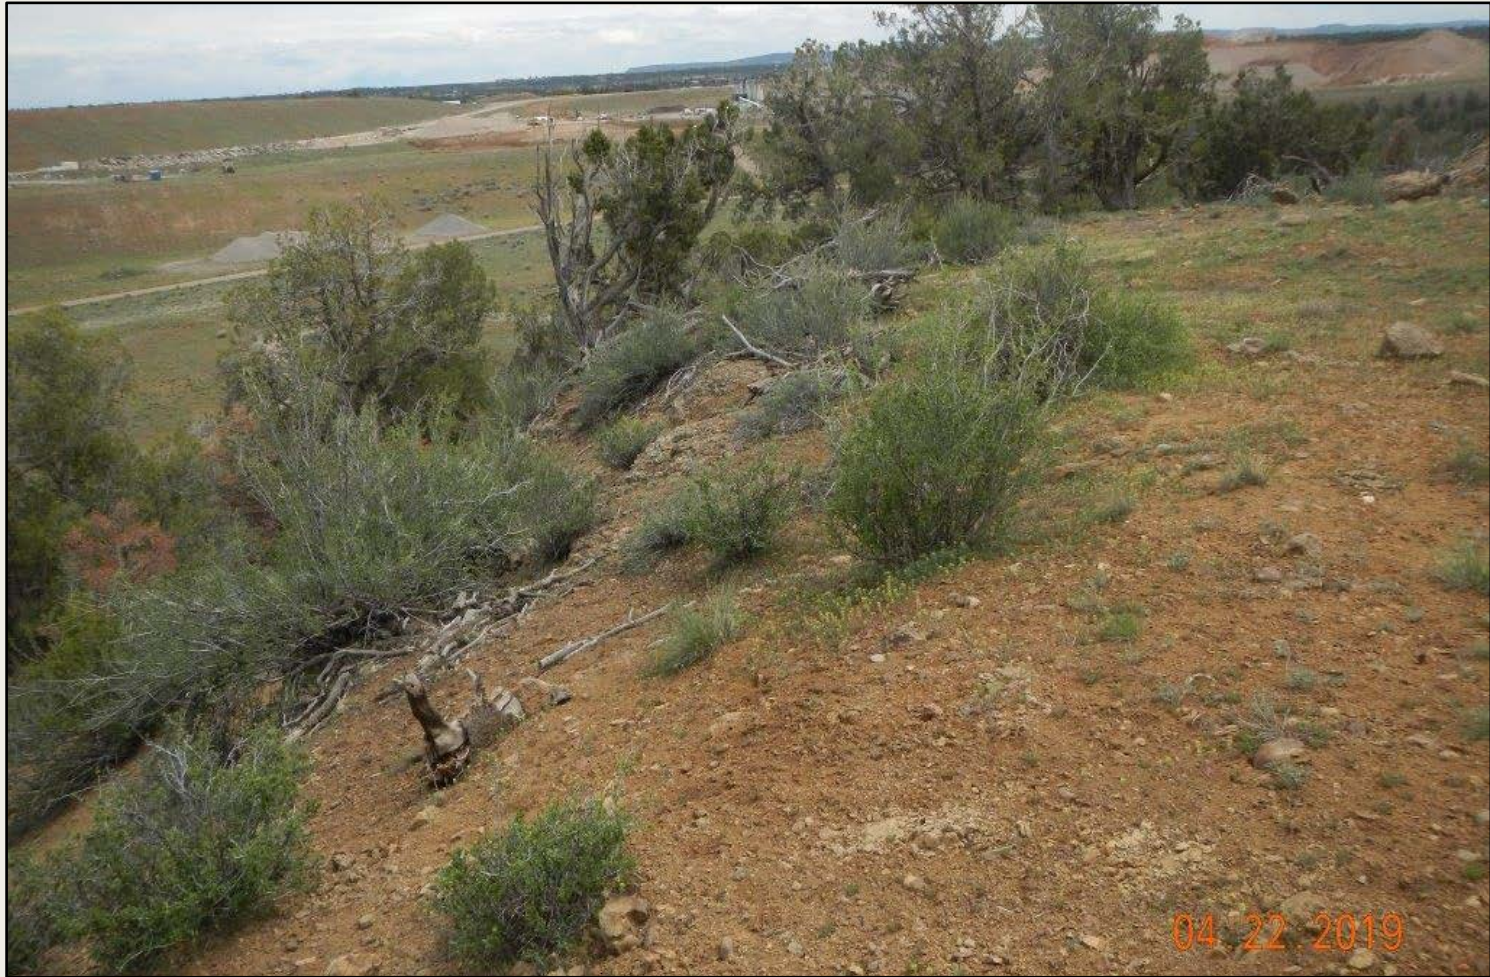
Photo 1. View of the western fill slope from the northeastern edge facing southeastward.

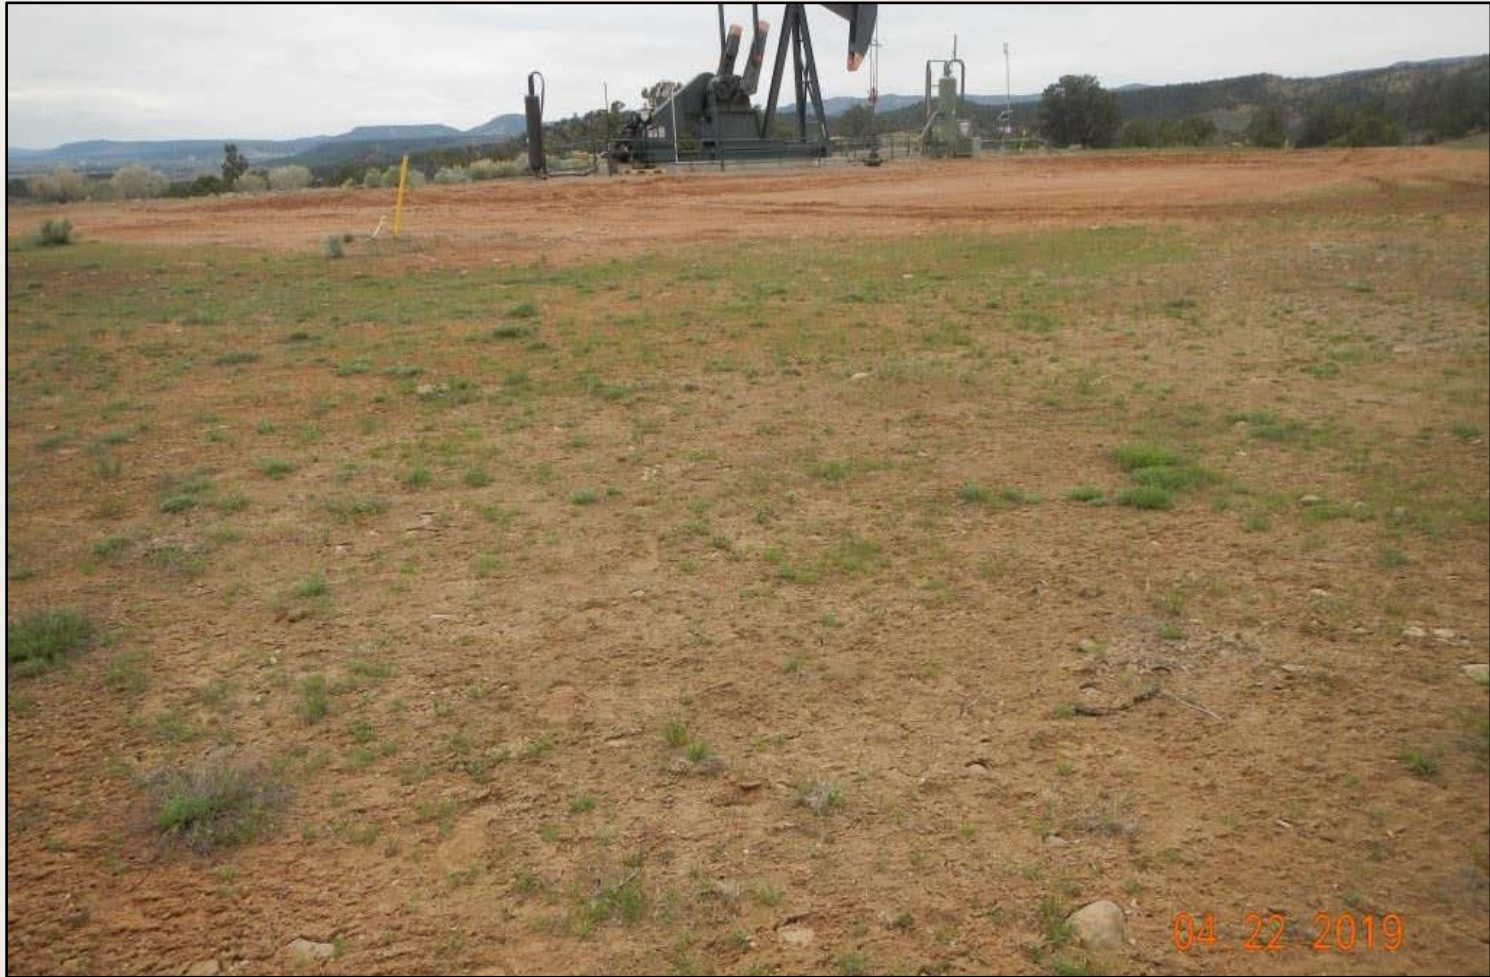
Photo 2. View of the project area from the northwestern edge facing center. Revegetation is progressing within revegetation areas, although remains sparse at this early point in the growing season and should be monitored.
