Inspection Photos

API: 05-055-06179

Operator: PETROGLYPH OPERATING CO

Inspection Date: 5/1/2019

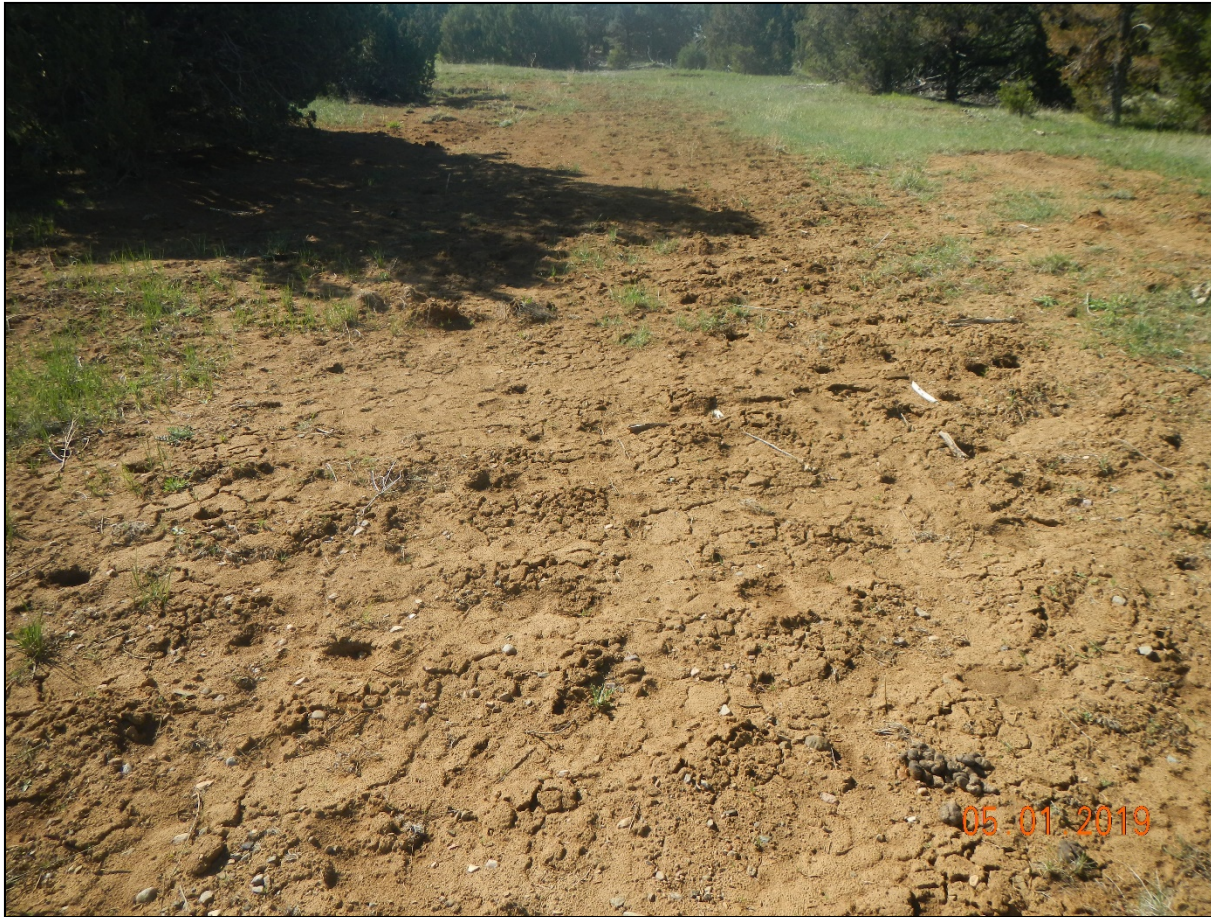
Photo 1. Facing south toward the access road. Vegetation has not established in this area.

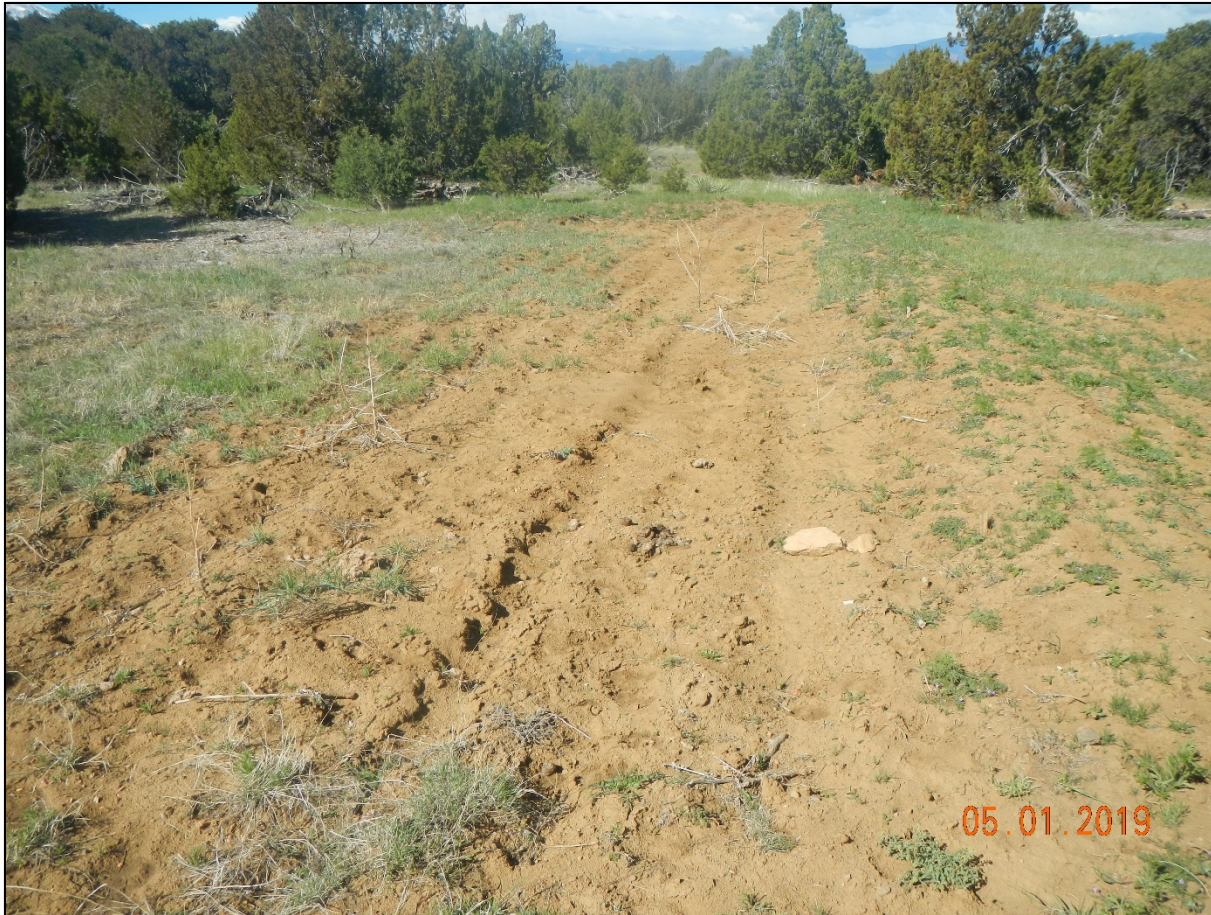
Photo 2. Bare area near the west side of the location.

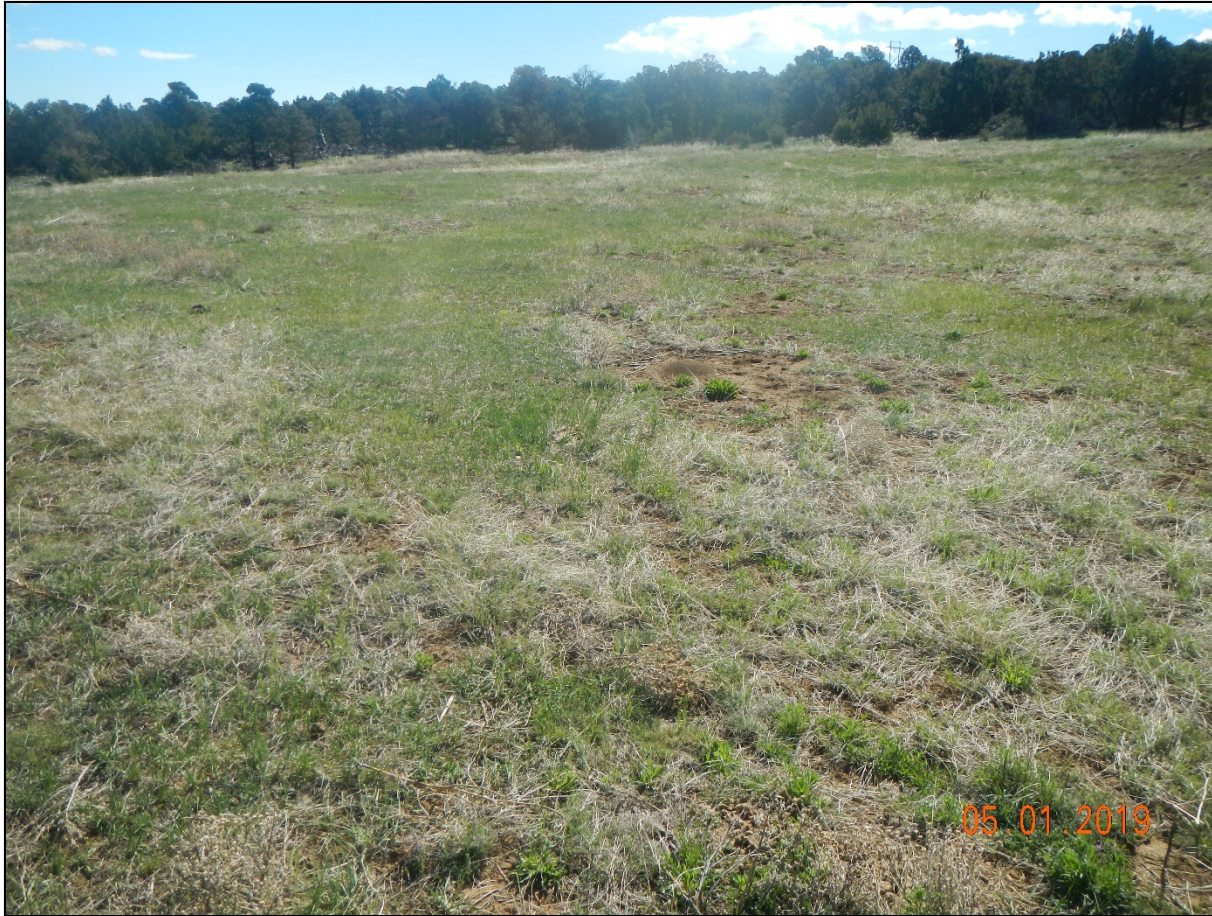
Photo 3. Facing east toward the location. Vegetation is well established at the location.

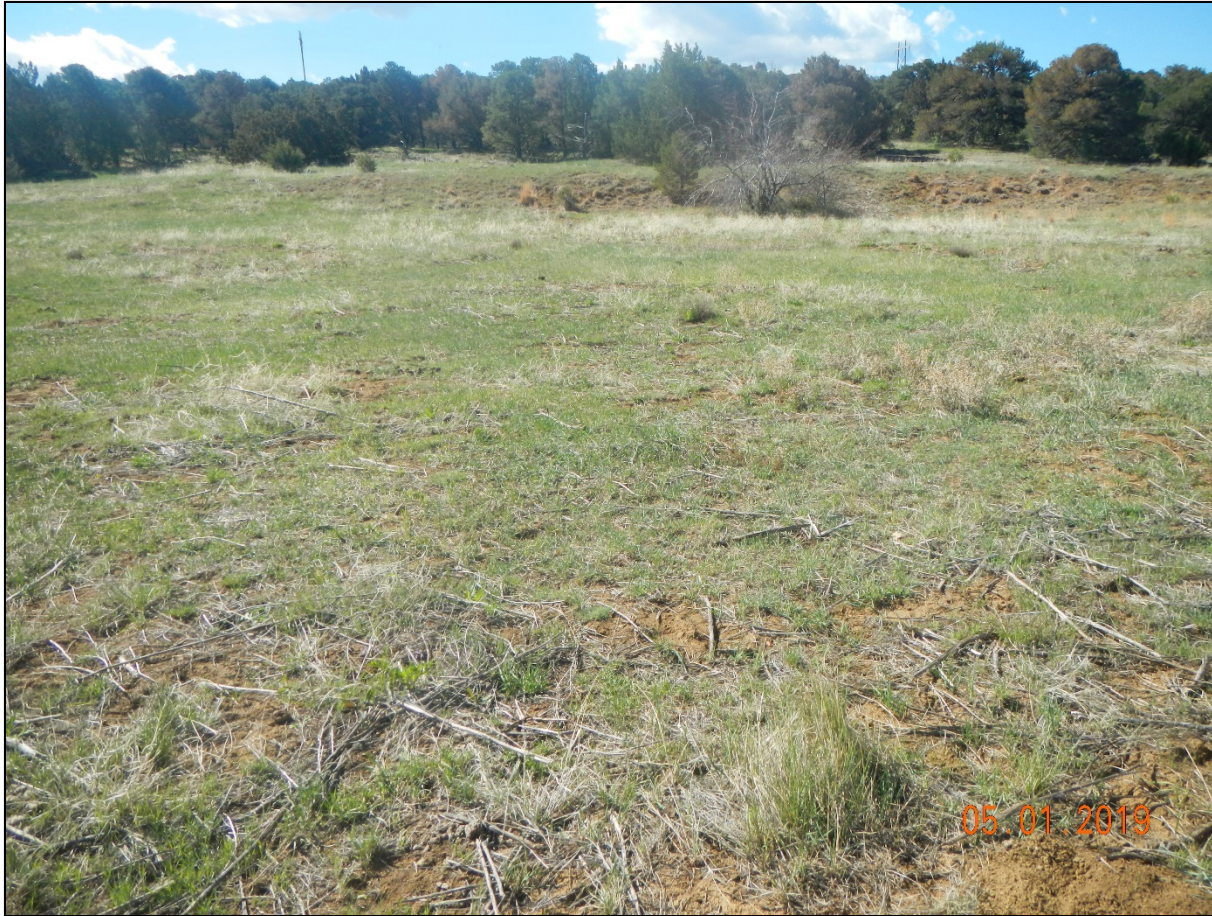
Photo 4. Facing south toward the location.

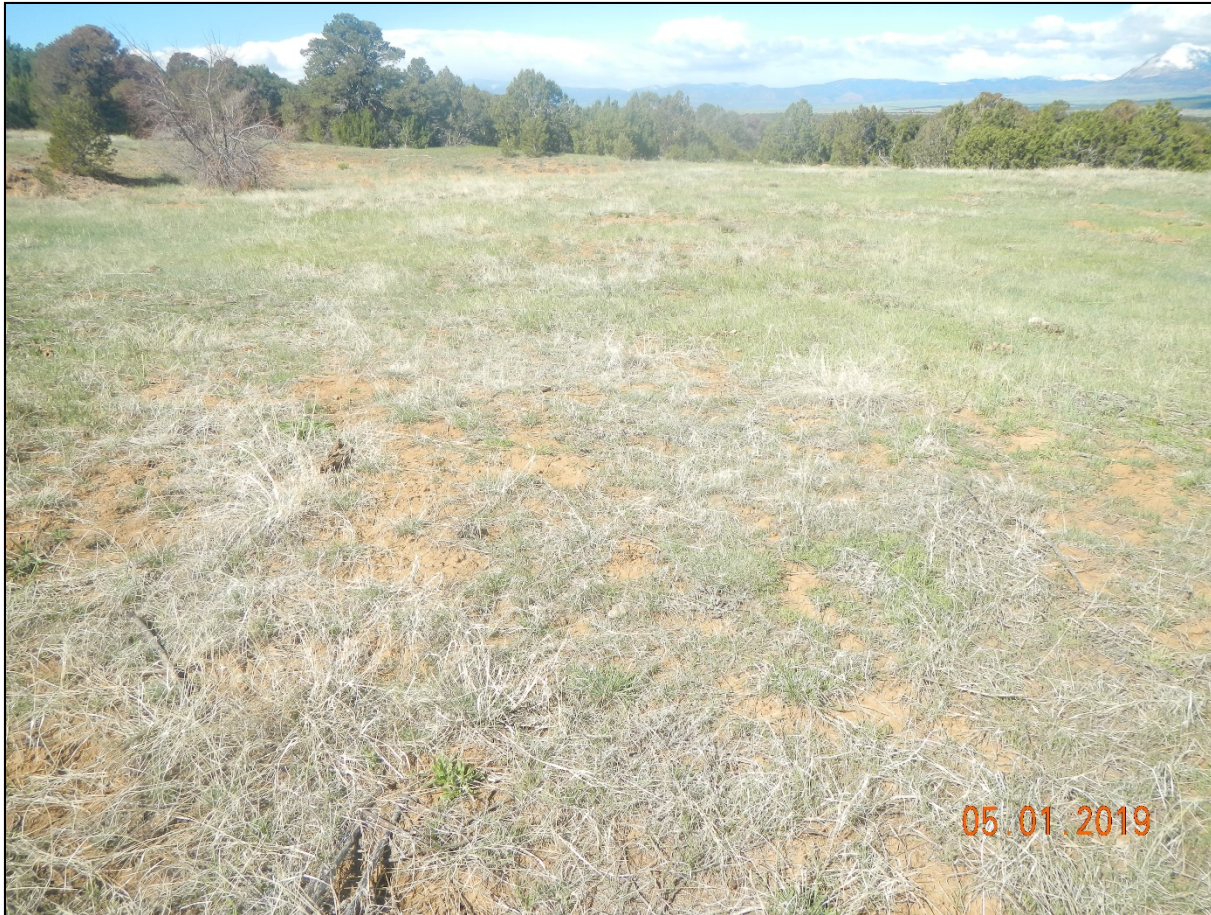
Photo 5. Facing west toward the location..

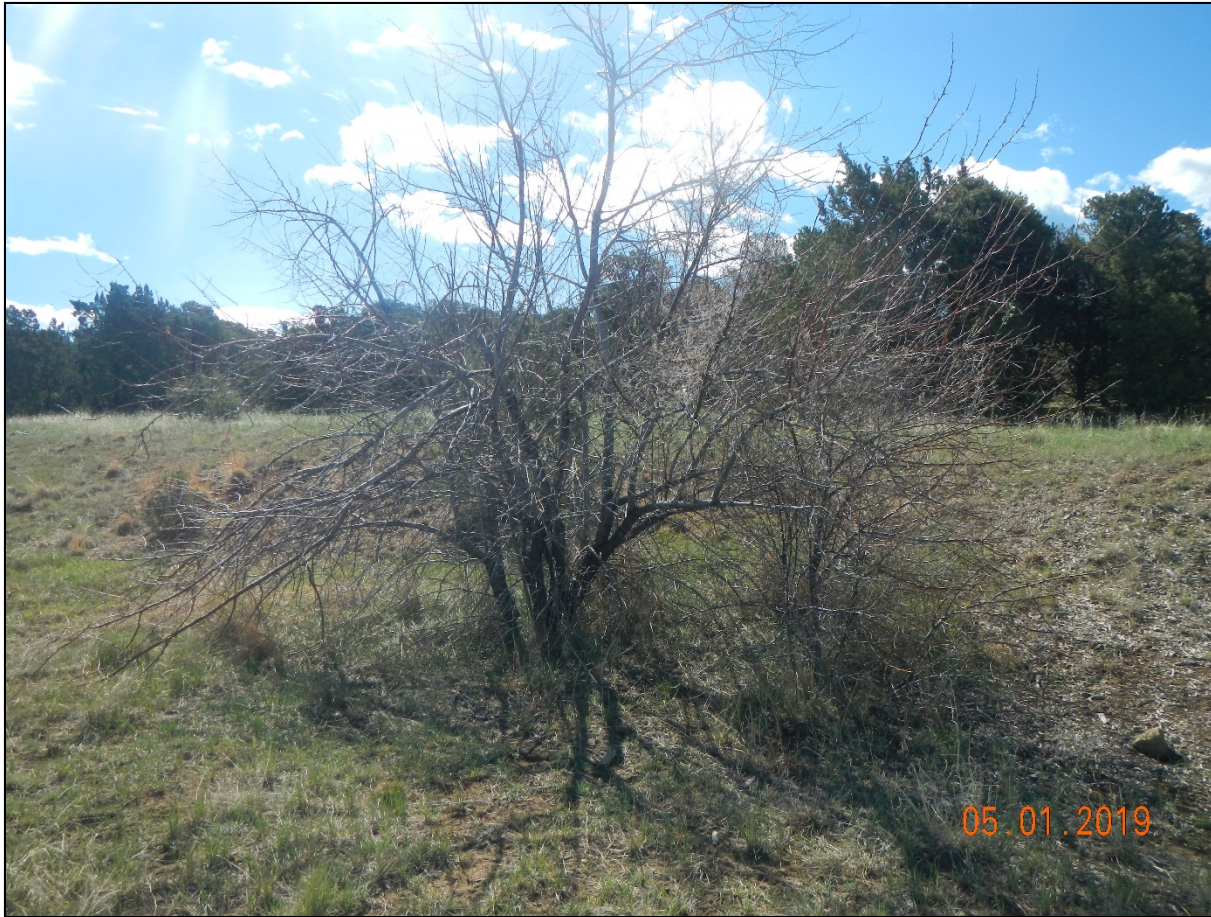
Photo 6. There is a Russian olive (List B noxious weed) at the south side of the location.

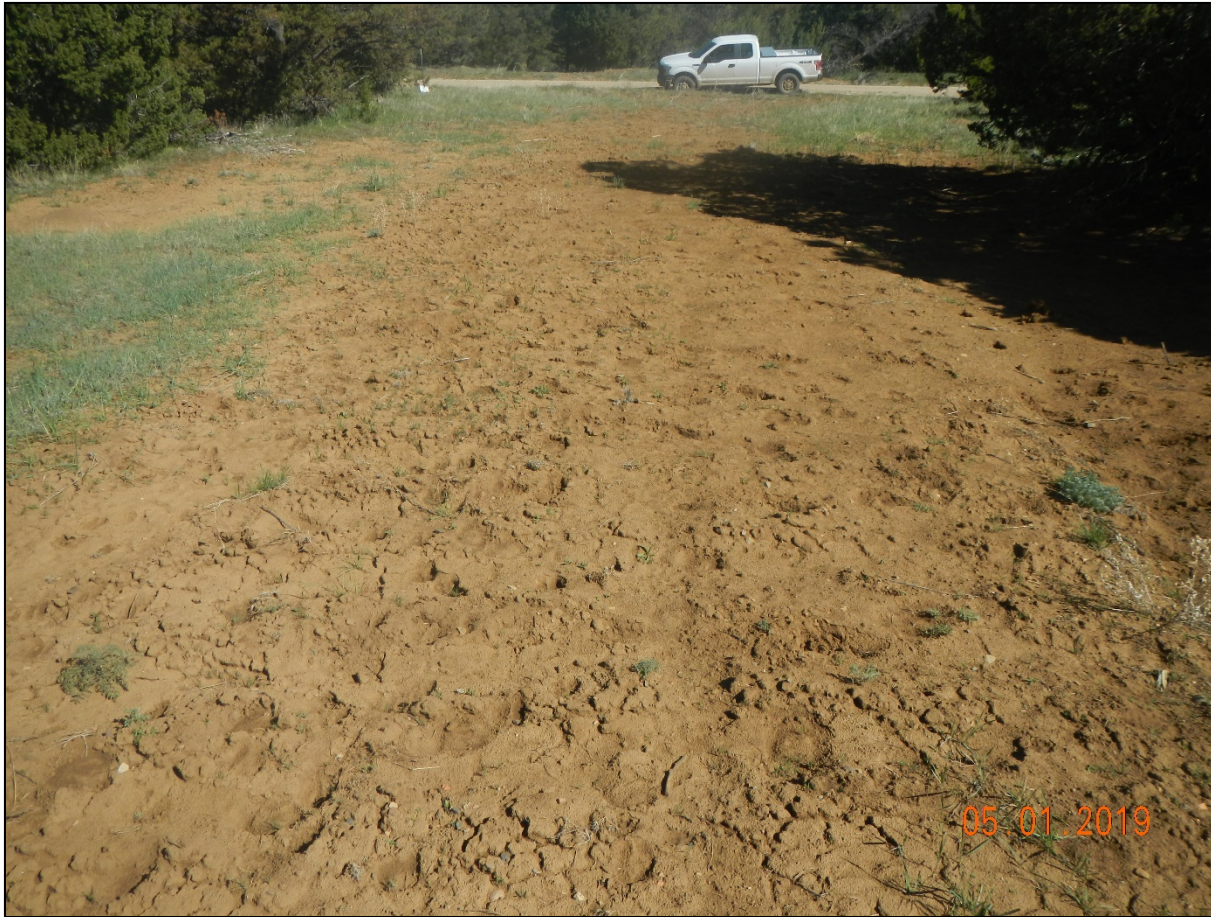
Photo 7. Facing toward the access road. This area needs reseeding.
