Inspection Photos

API: 05-055-06153

Operator: PETROGLYPH OPERATING CO

Inspection Date: 5/1/2019

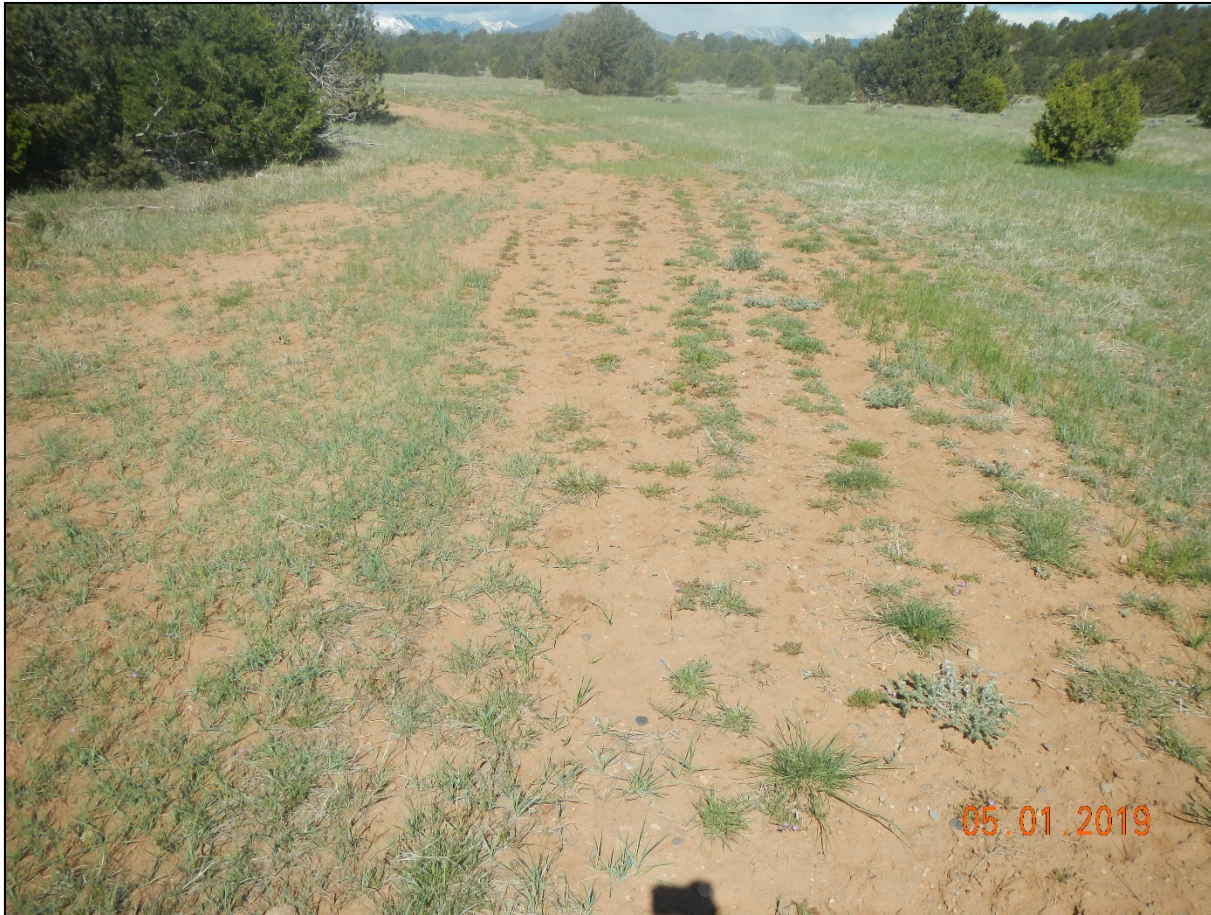
Photo 1. Facing west along the access road. Vegetation is sparse in this area.

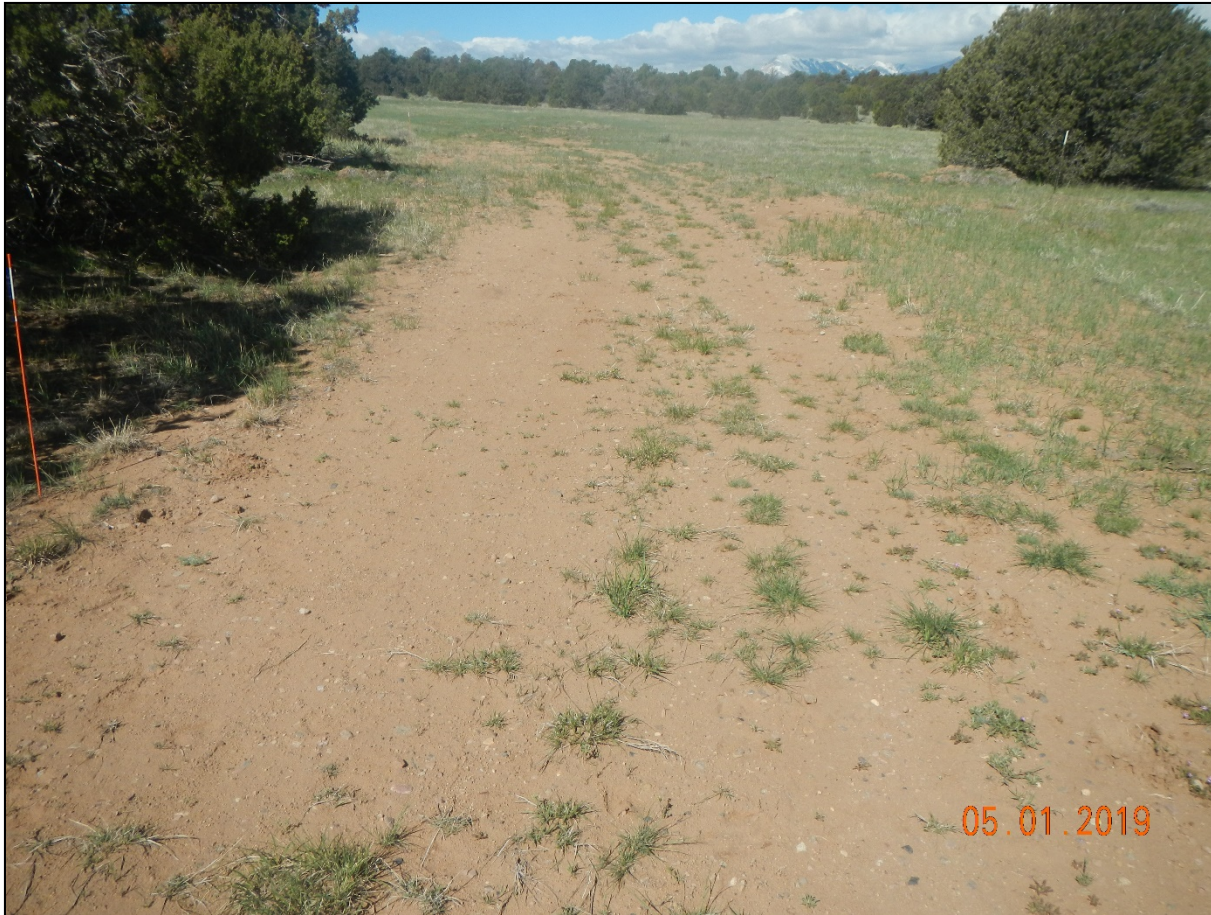
Photo 2. Facing west along the access road. Vegetation is sparse in this area.

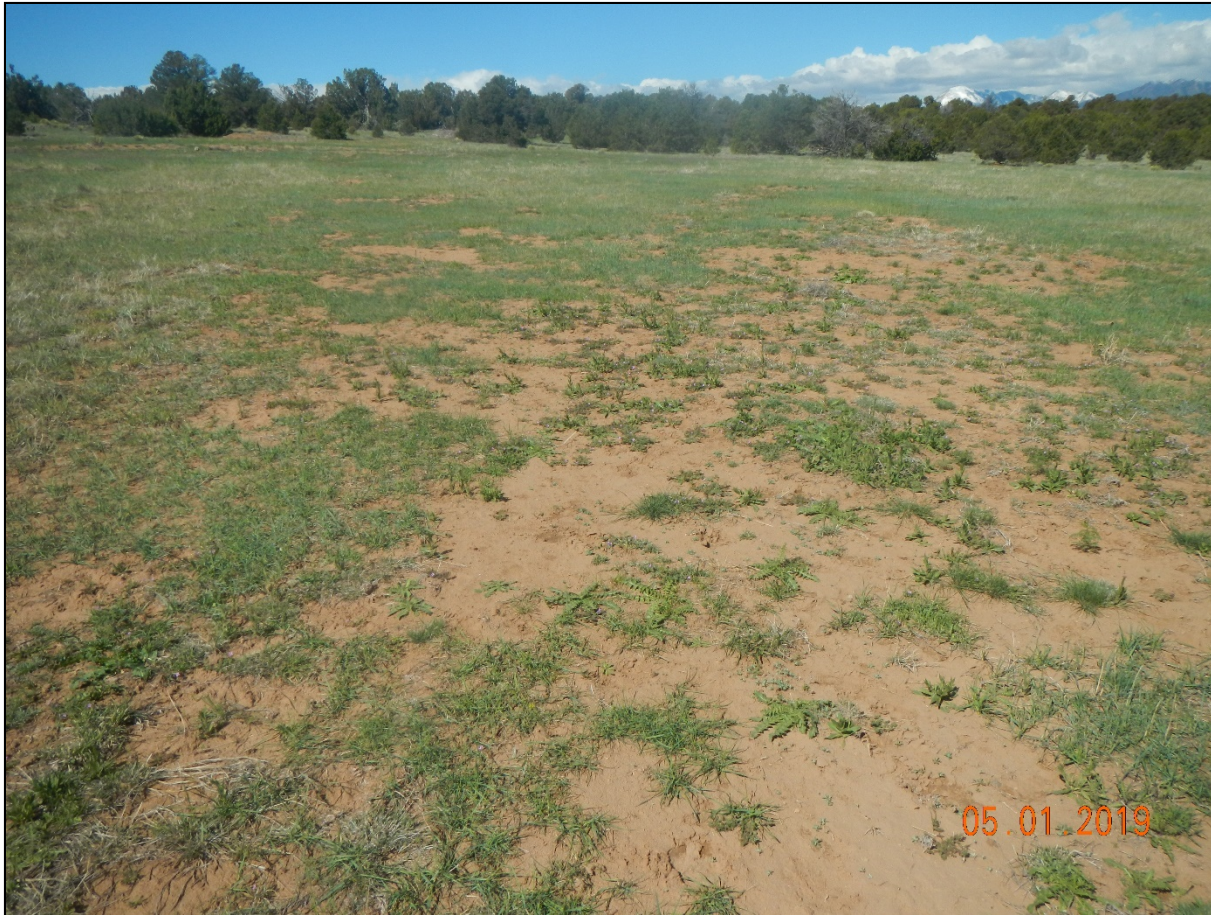
Photo 3. Facing west toward the location.

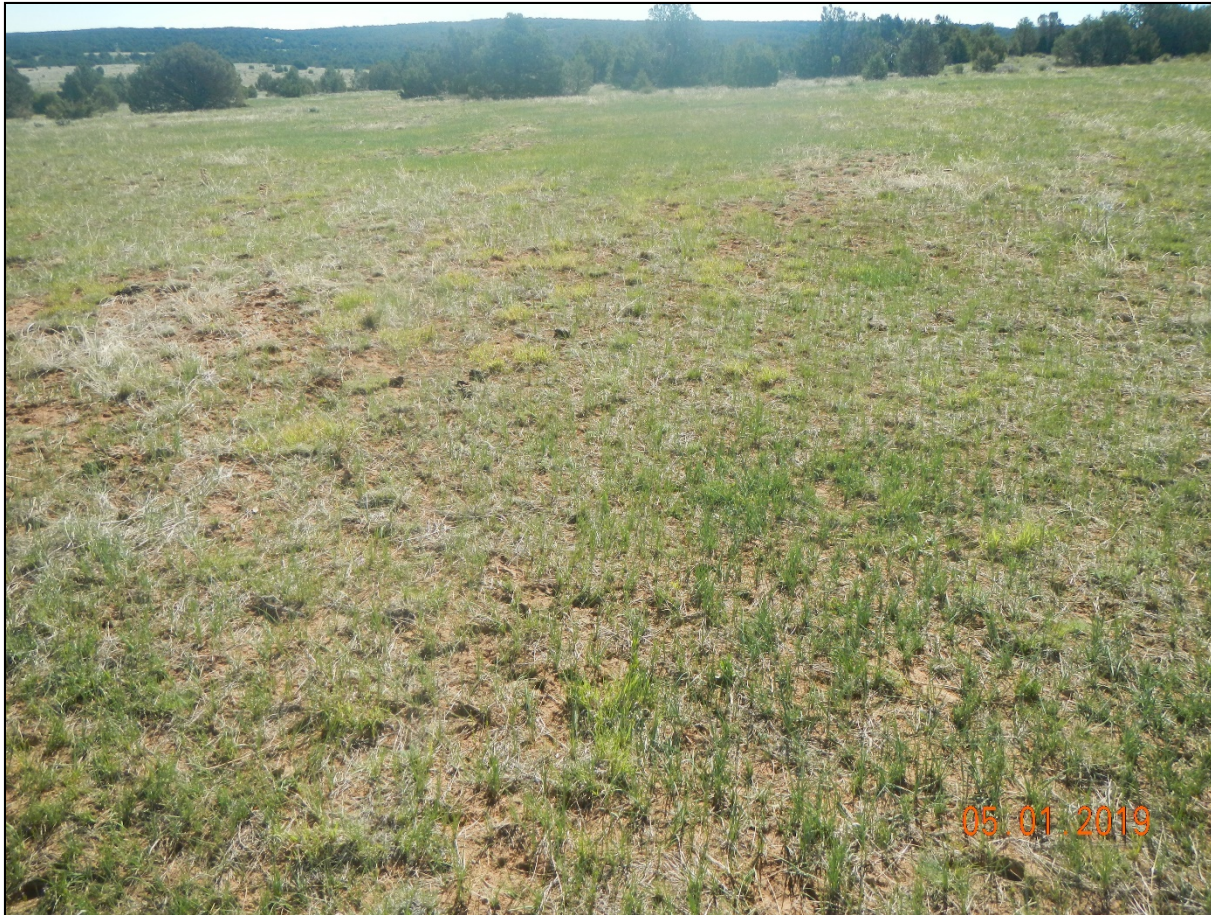
Photo 4. Facing east toward the location. Vegetation is well established at the location.

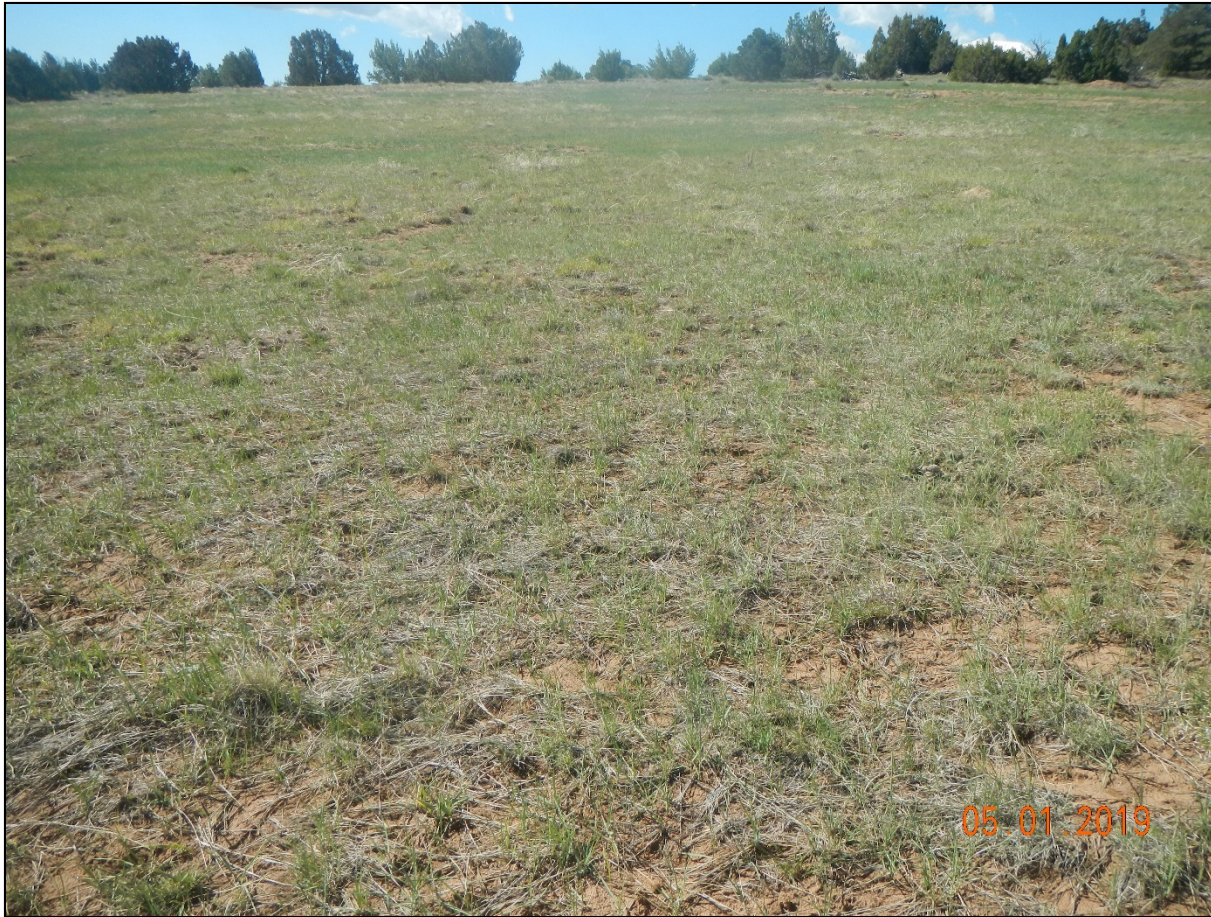
Photo 5. Facing south toward the location. Vegetation is well established at the location.
