Caerus Piceance LLC
Api # 05-045-11594
Inspection # 696600039

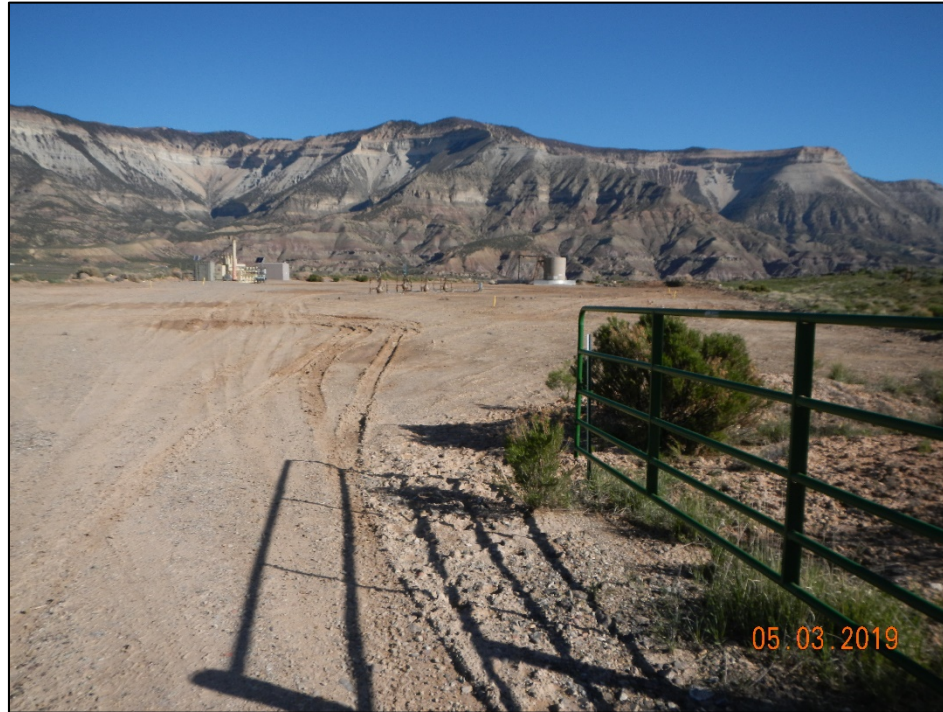
Photo at entrance to location. No tank battery sign at time of inspection

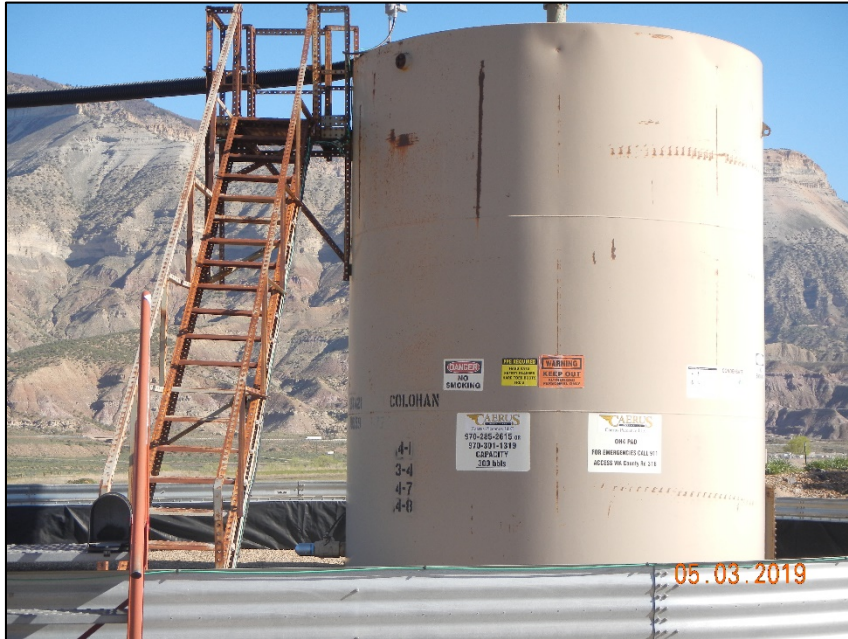
Tank Battery , No tank battery sign at time of inspection.

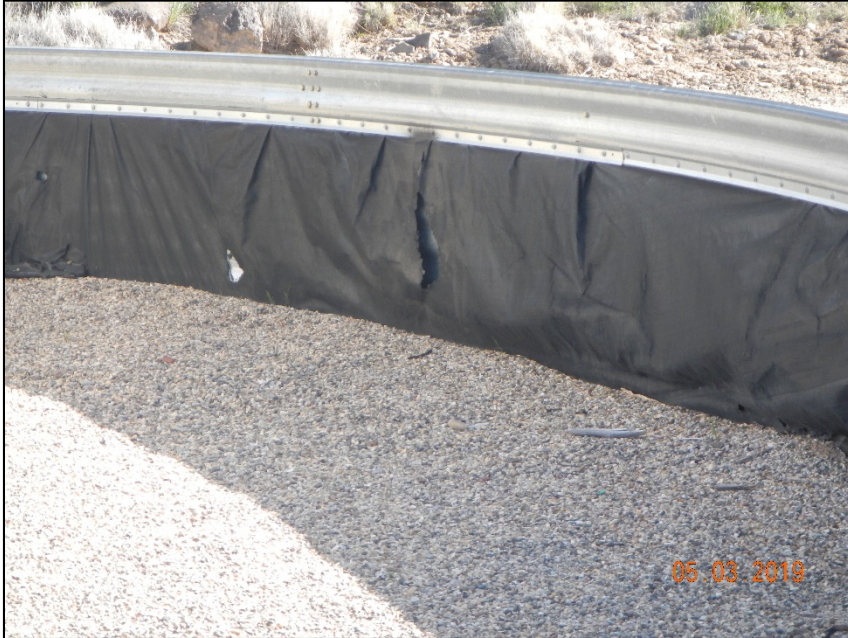
Holes in Tank Containment liner.

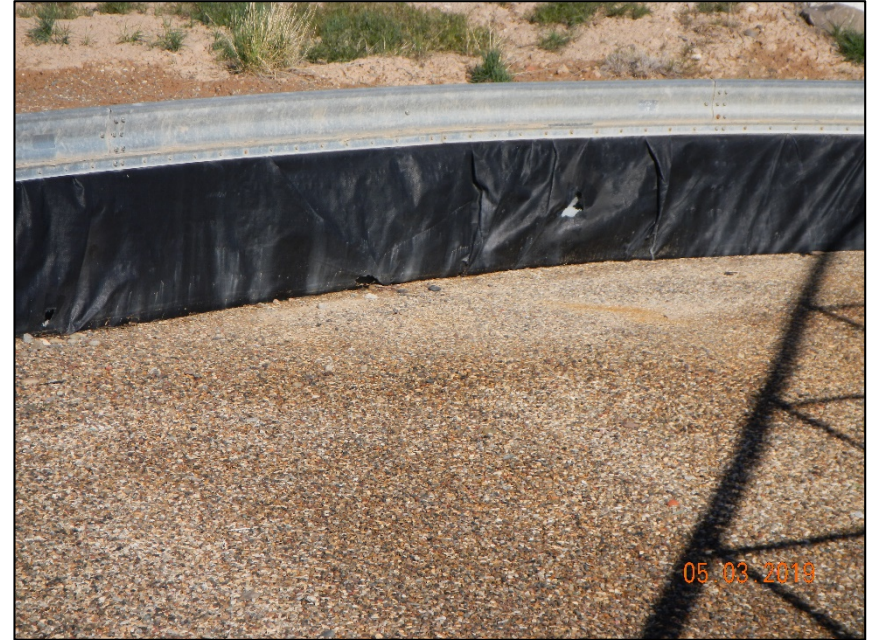
More holes in tank liner.

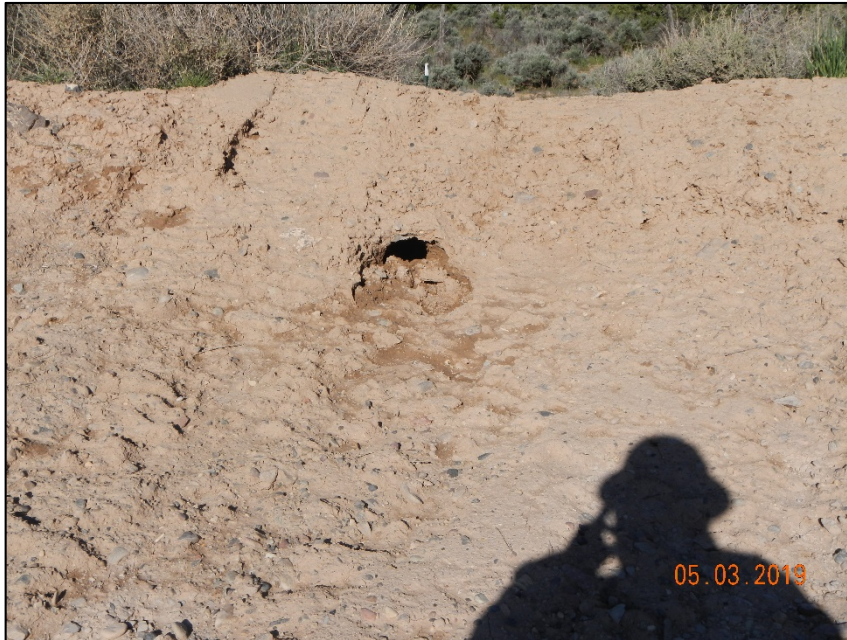
Hole in berm causing storm water to not be controlled

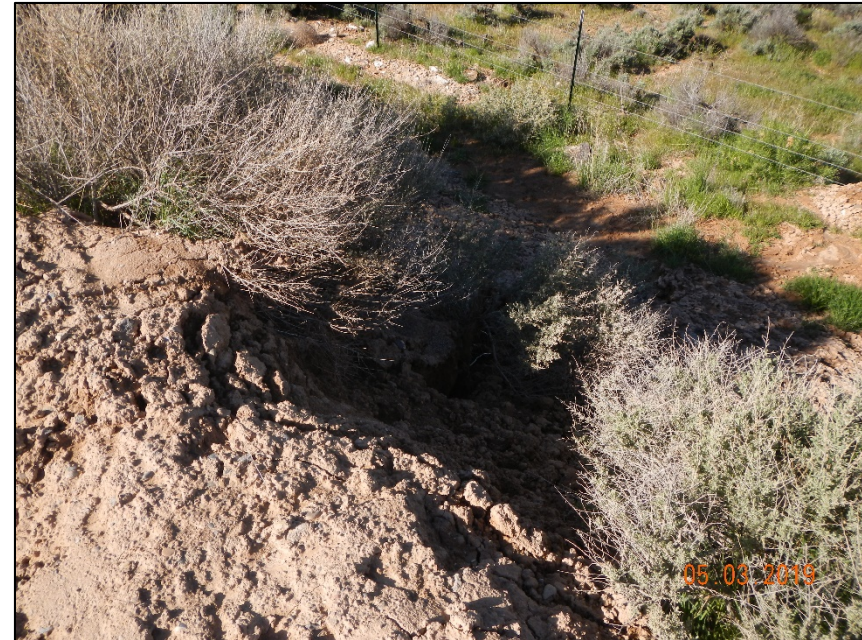
Opposite side of hole in berm, shows a heavy erosions channel and sediment gathering in bottom by fence, off location. .
