Inspection Photos  
Location Name: Patriot 0880 13-32H5  
API: 05-057-06618

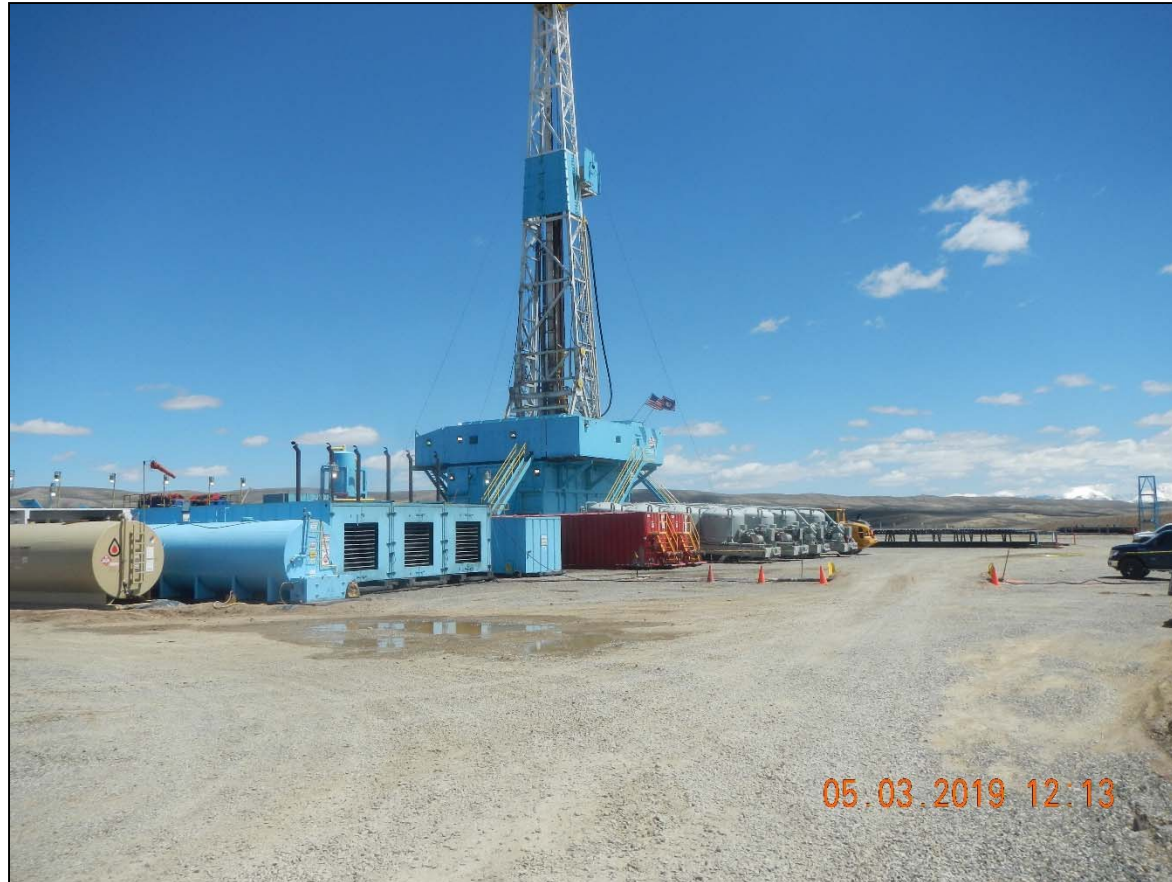
**Photo 1. Overview of location taken at entrance facing northeast.**

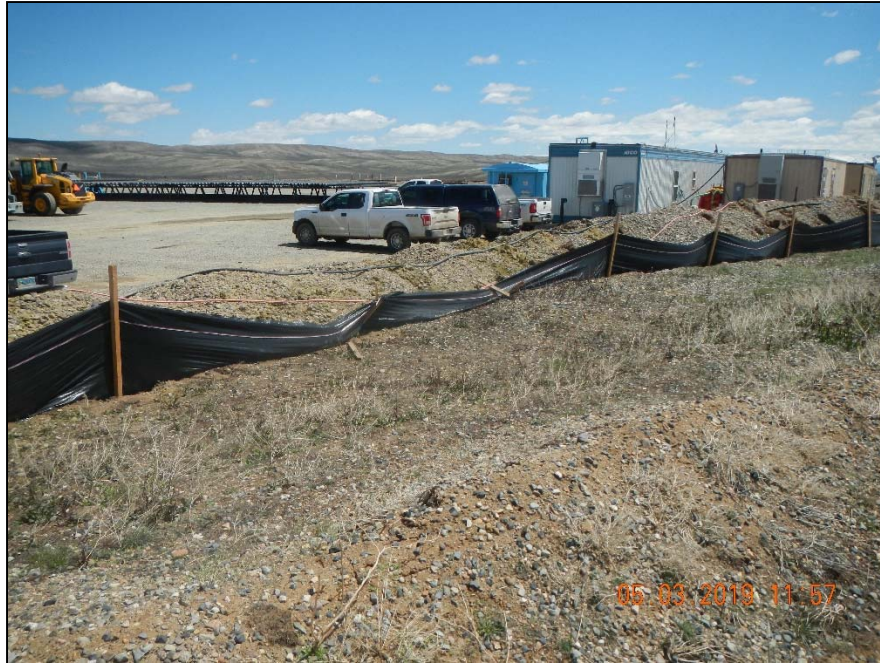
**Photo 2. Silt fence compromised.**

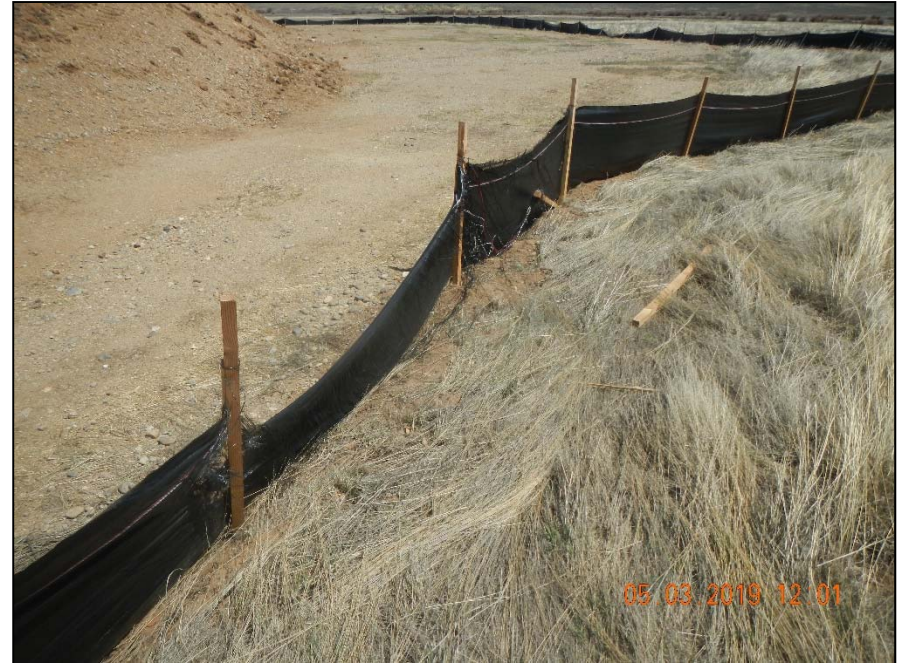
**Photo 3. Silt fence compromised.**

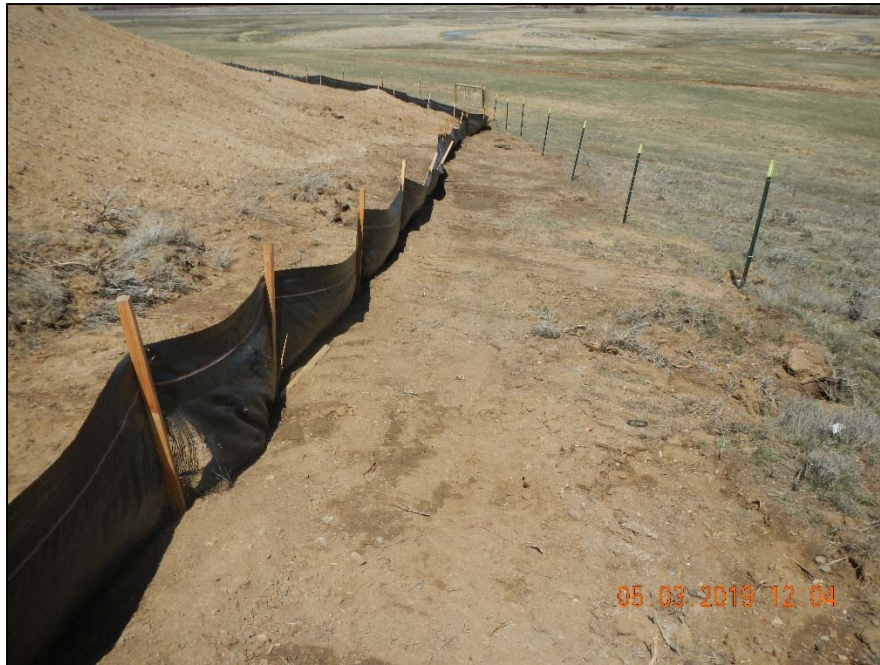
**Photo 4. Silt fence compromised.**

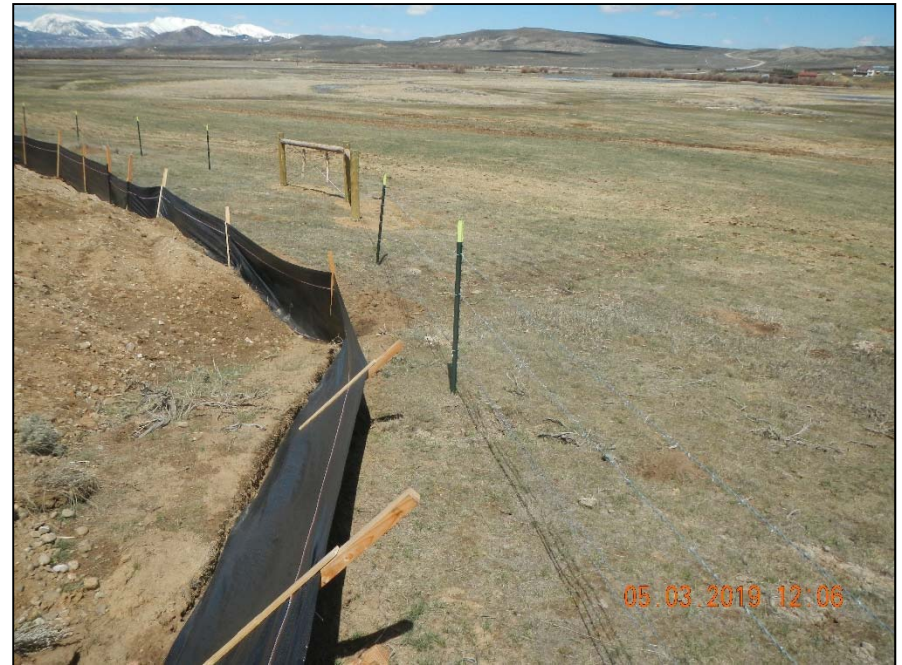
**Photo 5. Silt fence compromised. Sediment leaving location.**

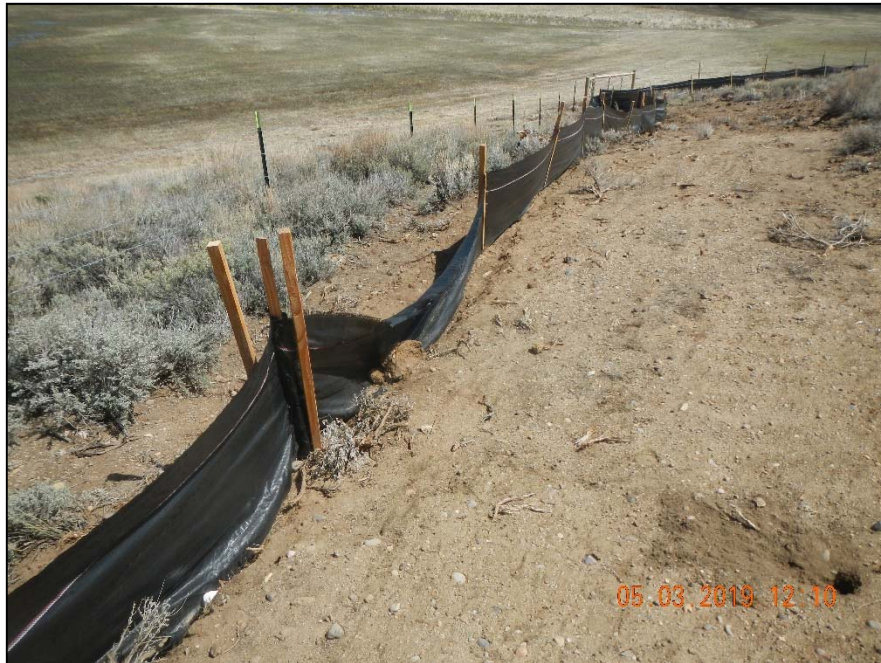
**Photo 6. Silt fence compromised.**

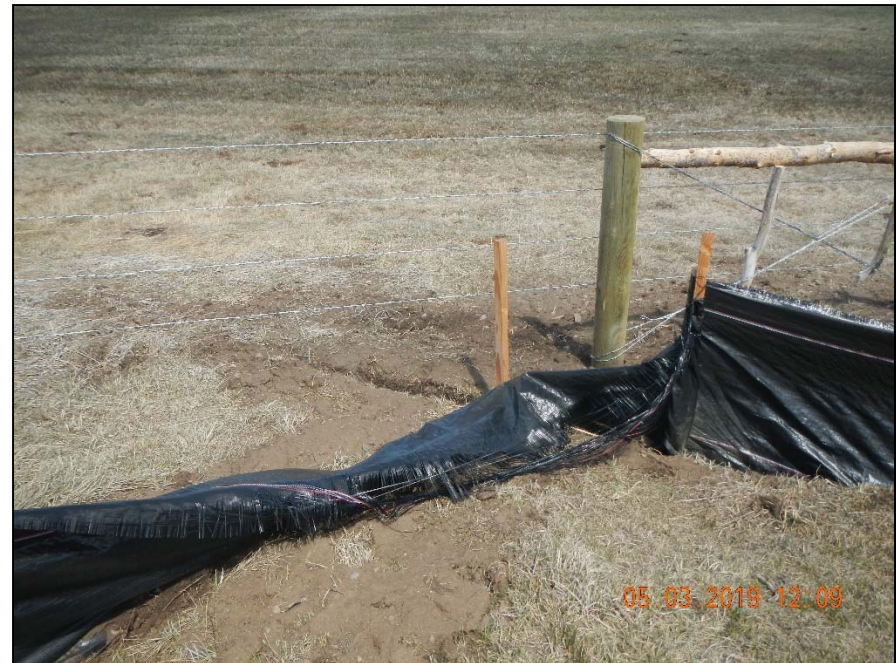
**Photo 7. Silt fence compromised. Sediment leaving location.**

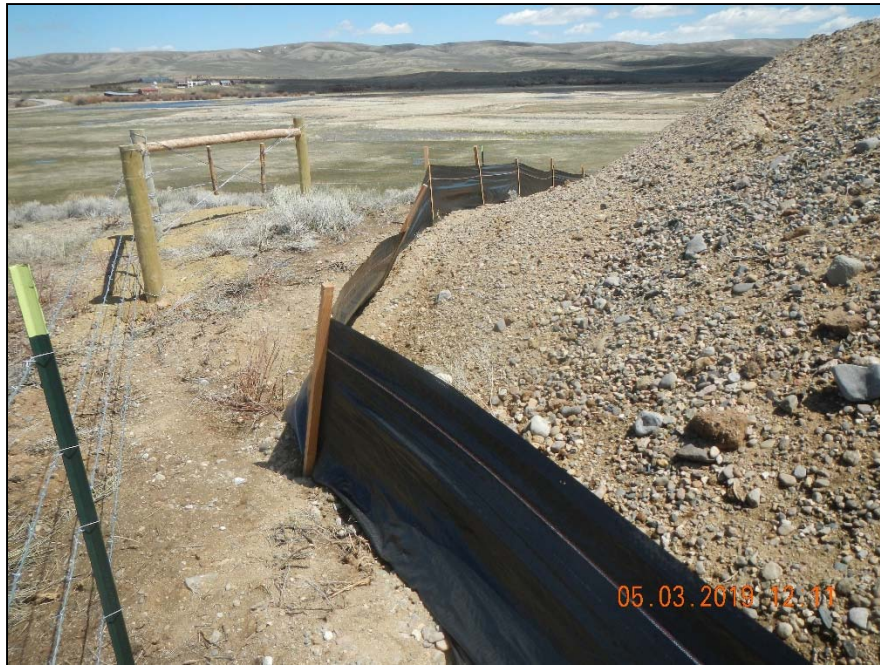
**Photo 8. Silt fence compromised.**

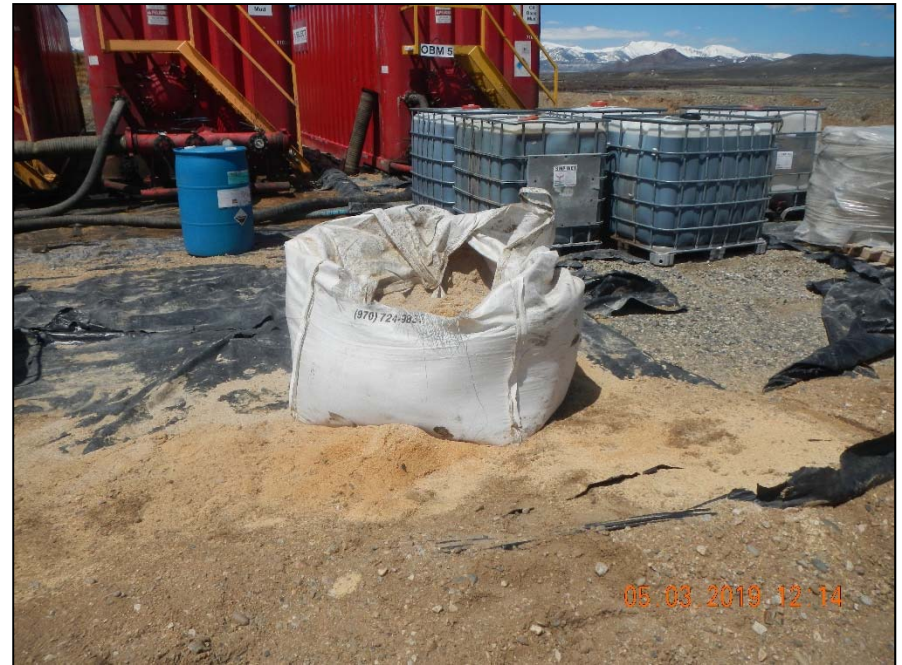
**Photo 9. Uncovered additives.**

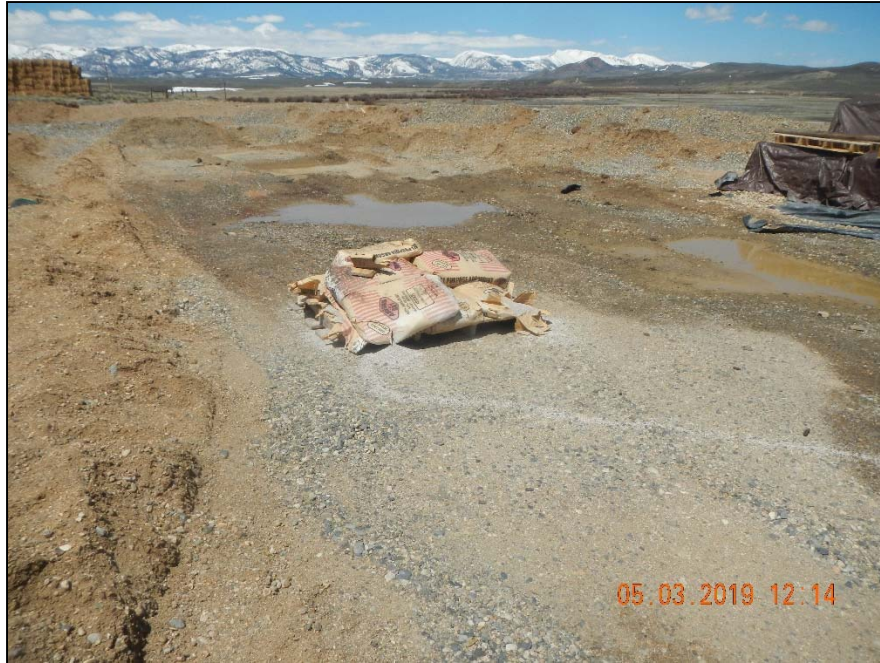
**Photo 10. Uncovered additives.**

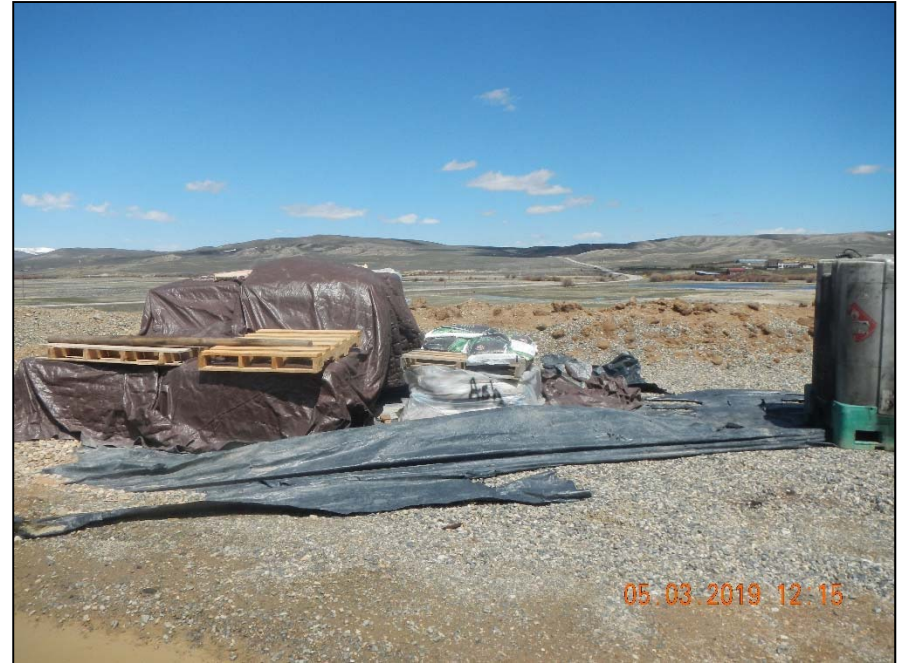
**Photo 11. Uncovered additives.**

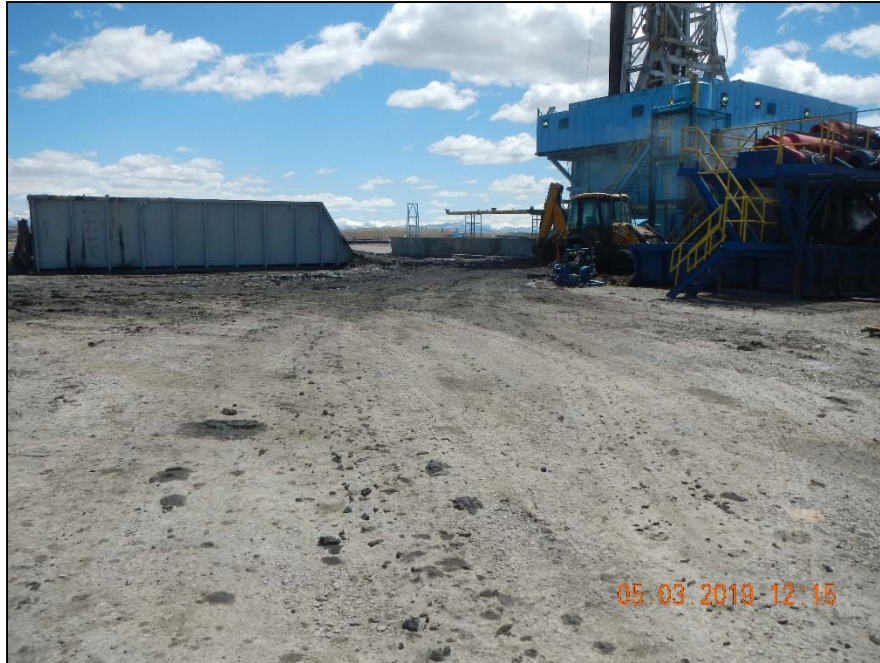
Photo 12. Cuttings area, cuttings leaving area.

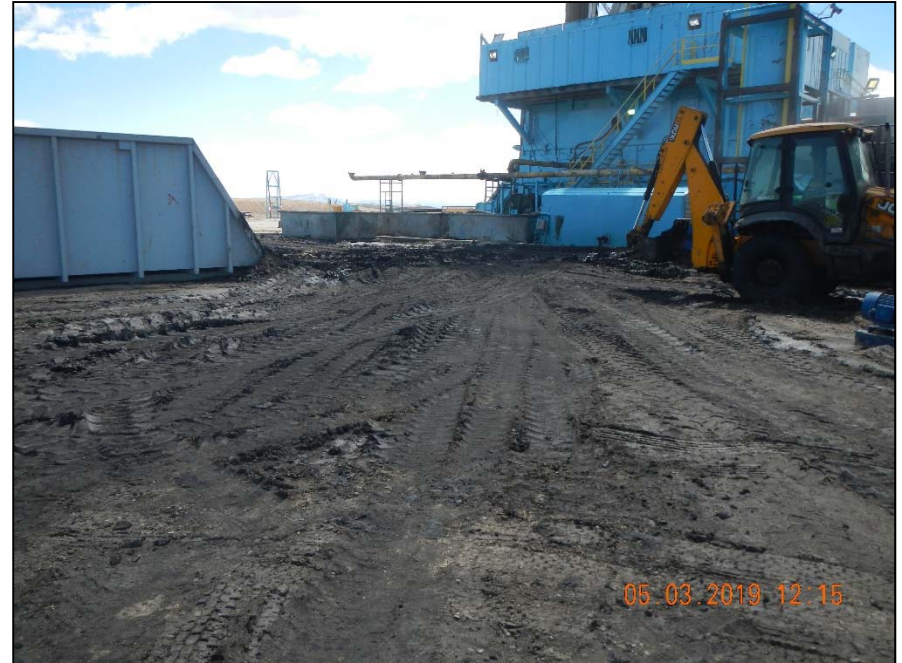
Photo 13. Cuttings area.

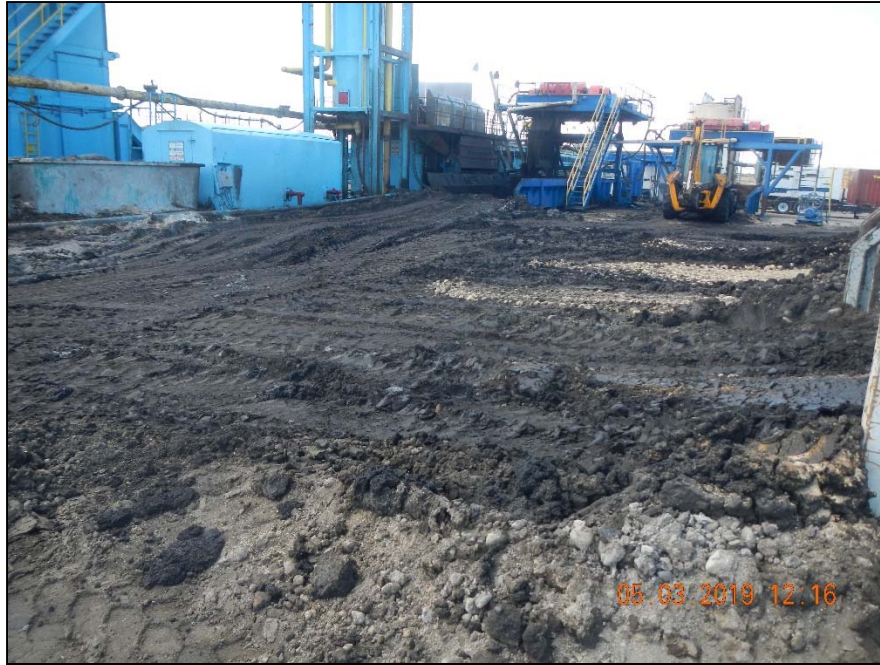
Photo 14. Cuttings area.

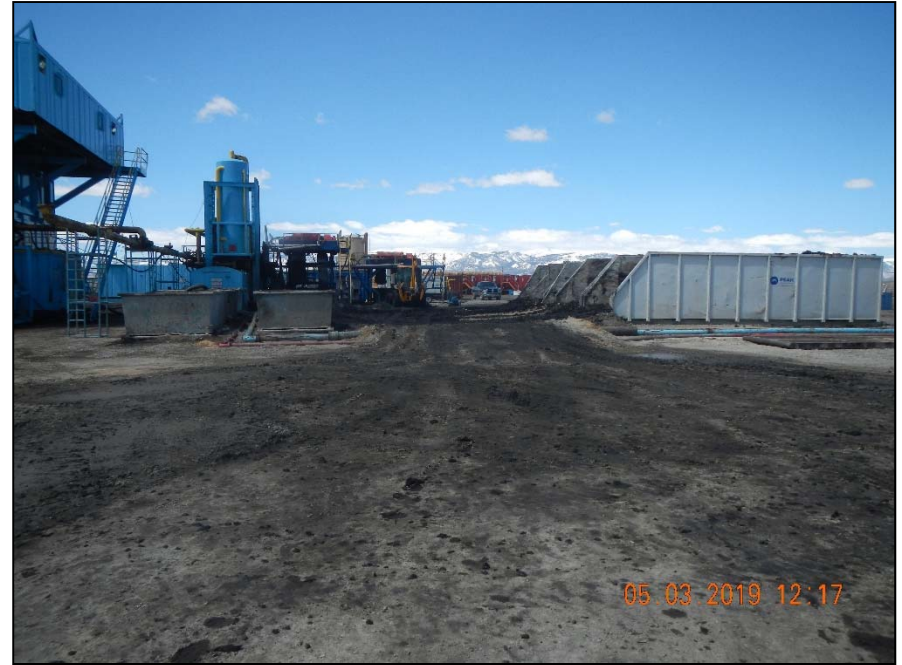
Photo 15. Cuttings area, cuttings leaving area.
