## Inspection Photos

Location Name: IRISH EYES 33-21

API #: 05-071-08658

INSP. #:695100599

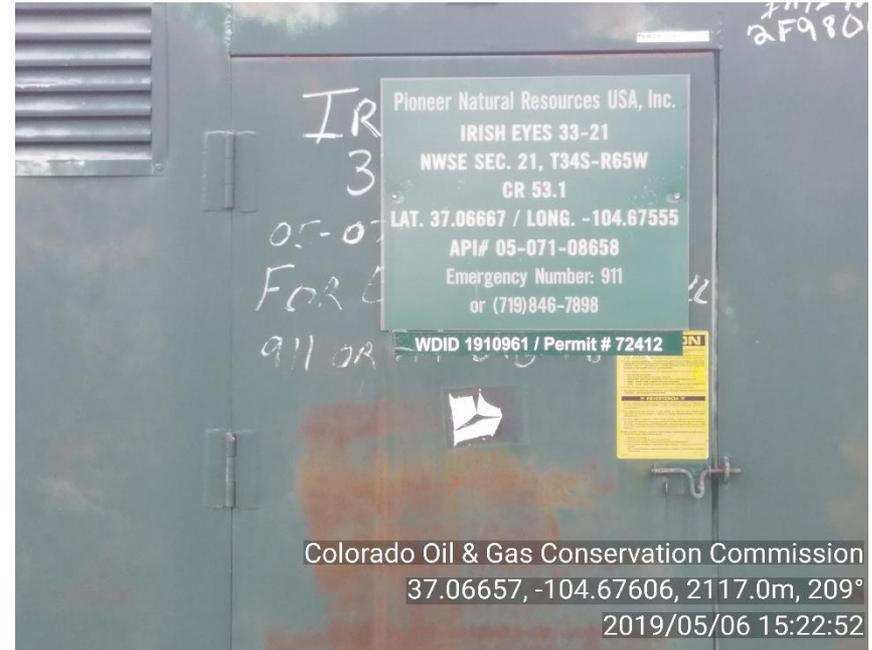
PHOTO 2: WELL SIGN/ OPERATOR ON POSTED WELL SIGN IS INACCURATE **Install sign to comply with Rule 210.b.**

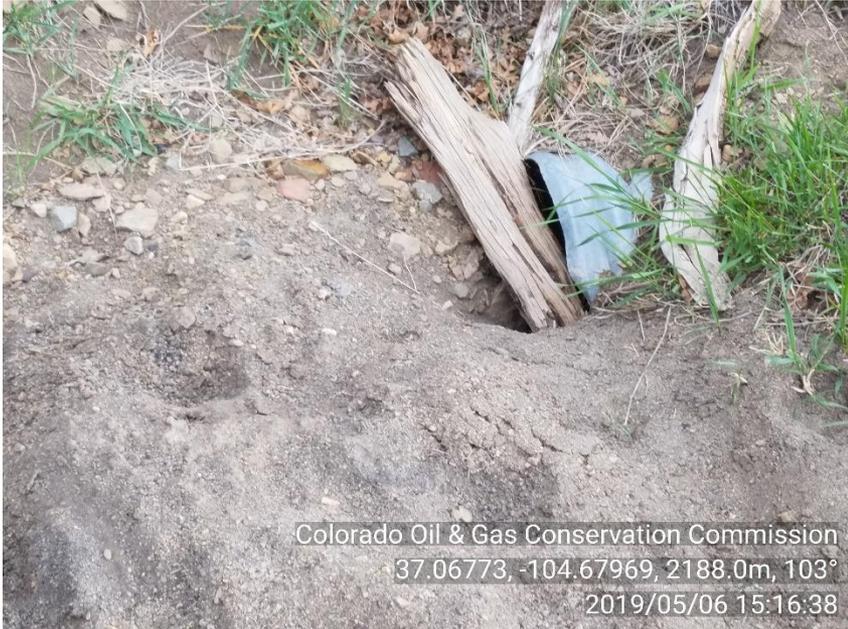
**PHOTO 3: CULVER ON ROW NORTHWEST OF LOCATION IS PLUGGED. Install or repair required BMPs per Rule 1002.f.**

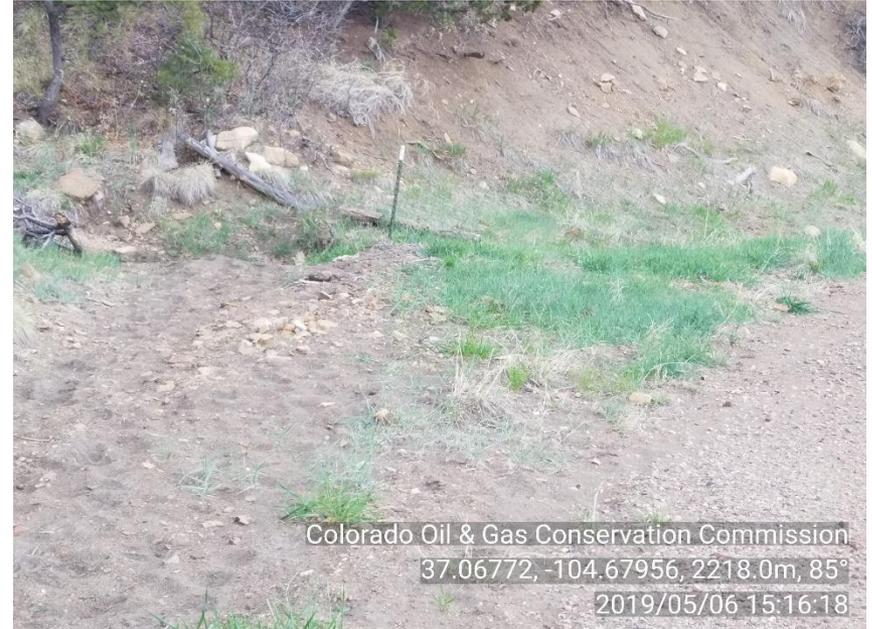
**PHOTO 4: SEDIMENT HAS FILLED STORMWATER DRAIN ON UPSLOPE SIDE OF PLUGGED CULVERT**

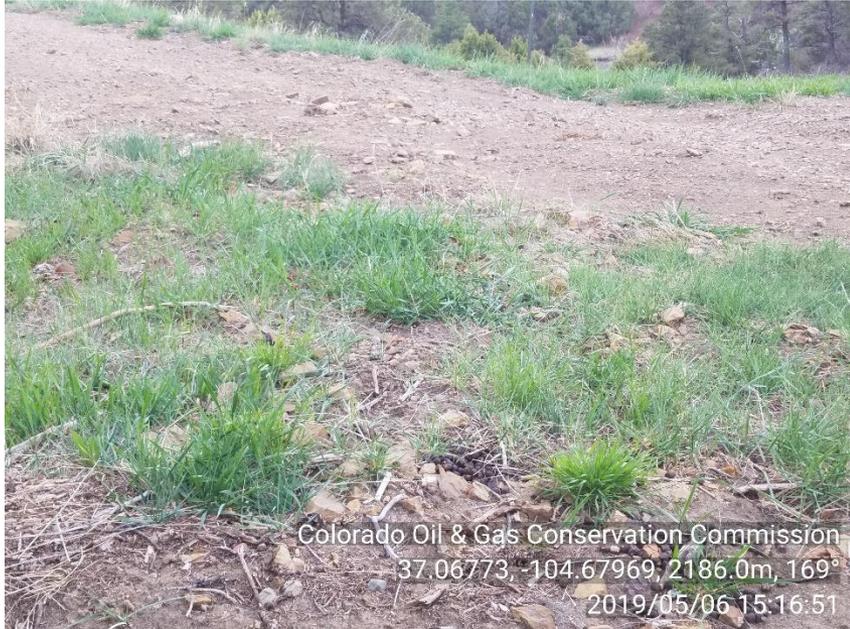
**PHOTO 5: SEDIMENT HAS CAUSED STORMWATER TO CROSS ROAD JUST INFRONT OF CULVERT**

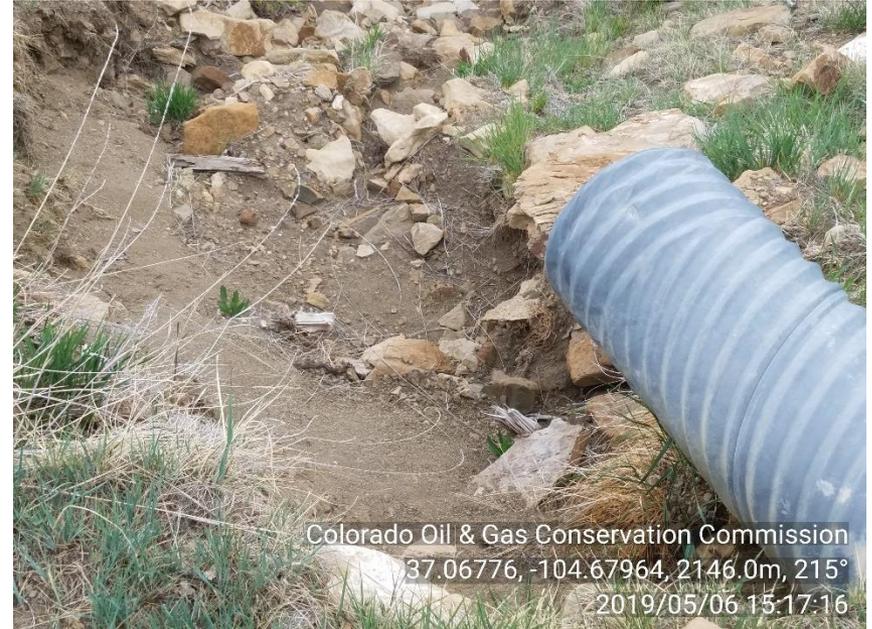
**PHOTO 6: STORMWATER EROSION AROUND CULVERT OUTLET. *Install or repair required BMPs per Rule 1002.f.***
