Inspection Photos
Location Name: Loehr Larry R#1
Location ID: 322864

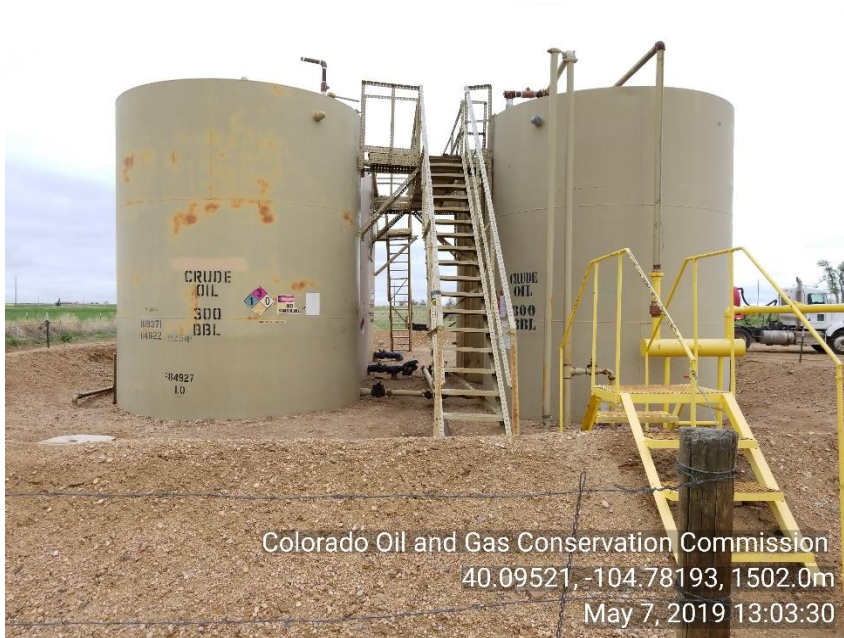
Photo 3 Stained soil inside containment appears to be removed.

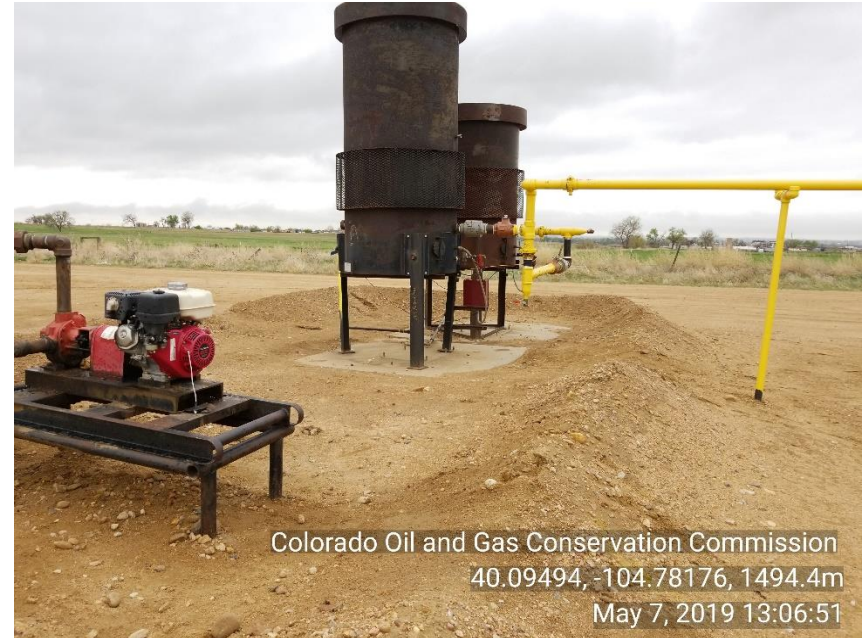
Photo 4 Stained soil under recir pump appears to be removed and 1 ECD running and other shut in.

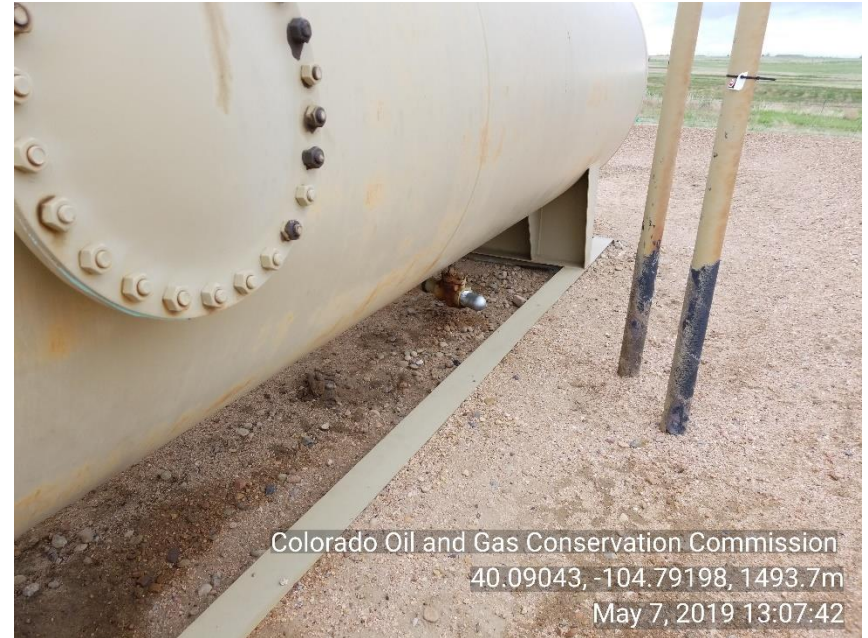
Photo 6 bull plug installed.
