## Inspection Photos

Location Name: UPTOWN FEDERAL 22-27

API #: 05-071-06725

INSP. #:695100605

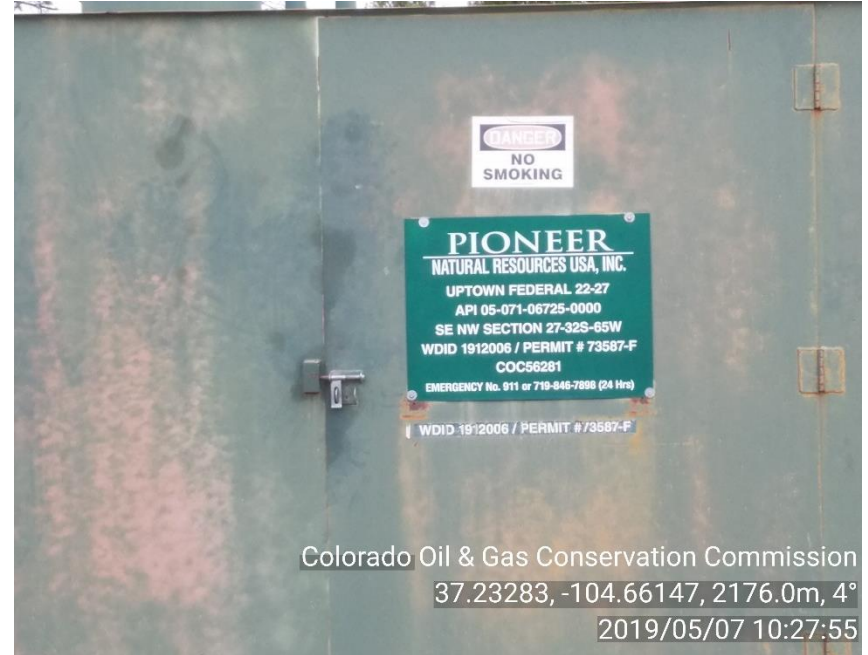
**PHOTO 2: WELL SIGN/ OPERATOR ON POSTED WELL SIGN IS  
INACCURATE Install sign to comply with Rule 210.b. CA DUE DATE  
7/7/19**

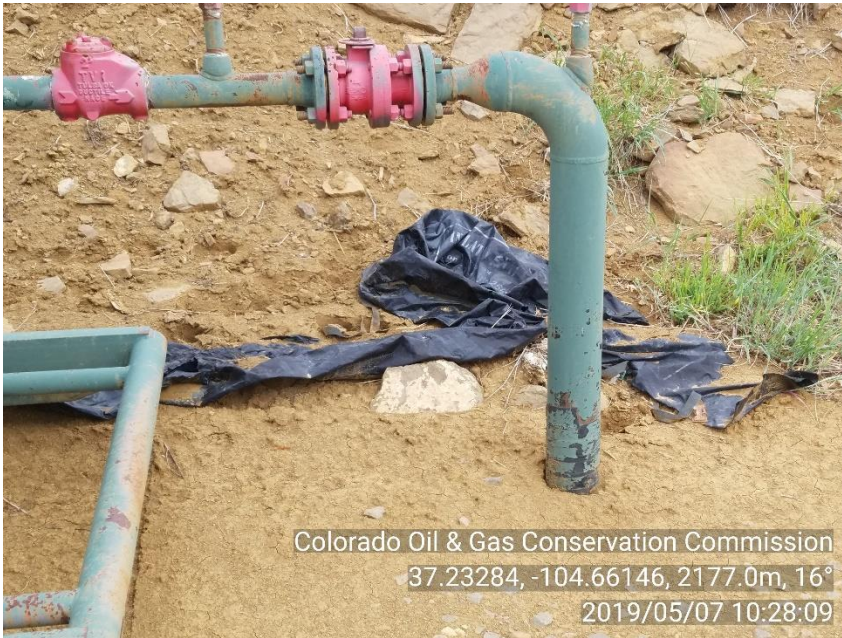
**PHOTO 3: TRASH NEAR METER HOUSE. COMPLY WITH RULE 210.b. CA DUE DATE 5/17/19**

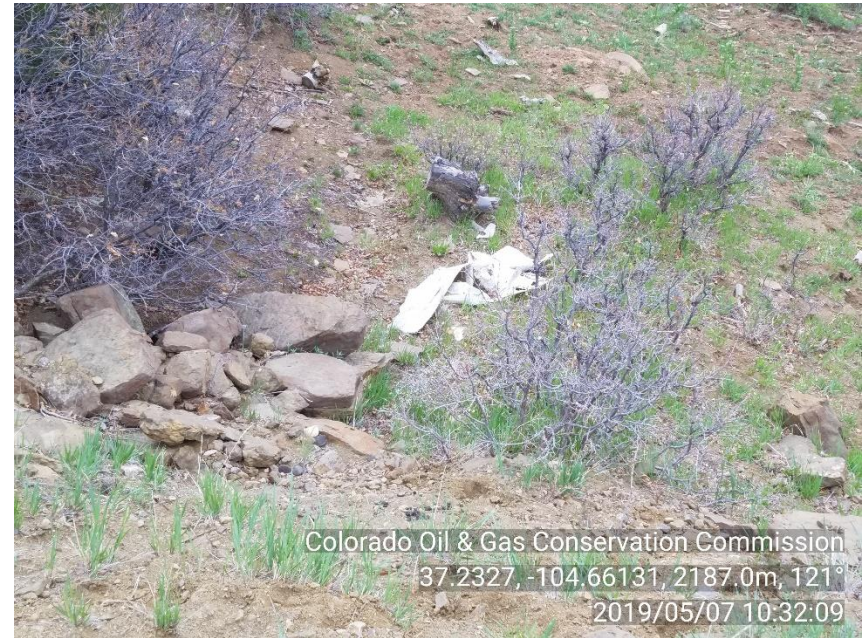
**PHOTO 4: TRASH OFF THE EAST EDGE OF LOCATION. COMPLY WITH RULE 210.b. CA DUE DATE 5/17/19**

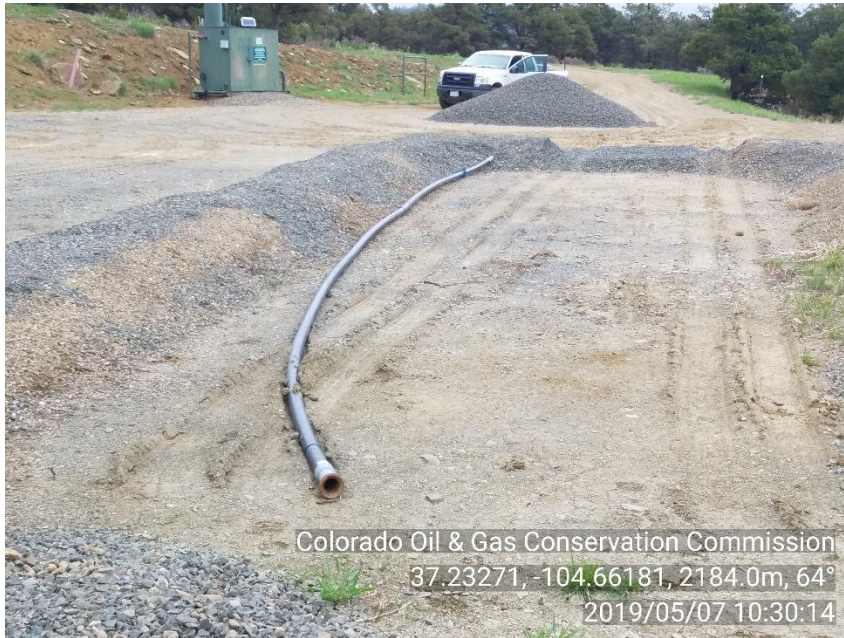
**PHOTO 5: UNUSED EQUIPMENT. COMPLY WITH RULE 603.f.  
CA DUE DATE 6/7/19**

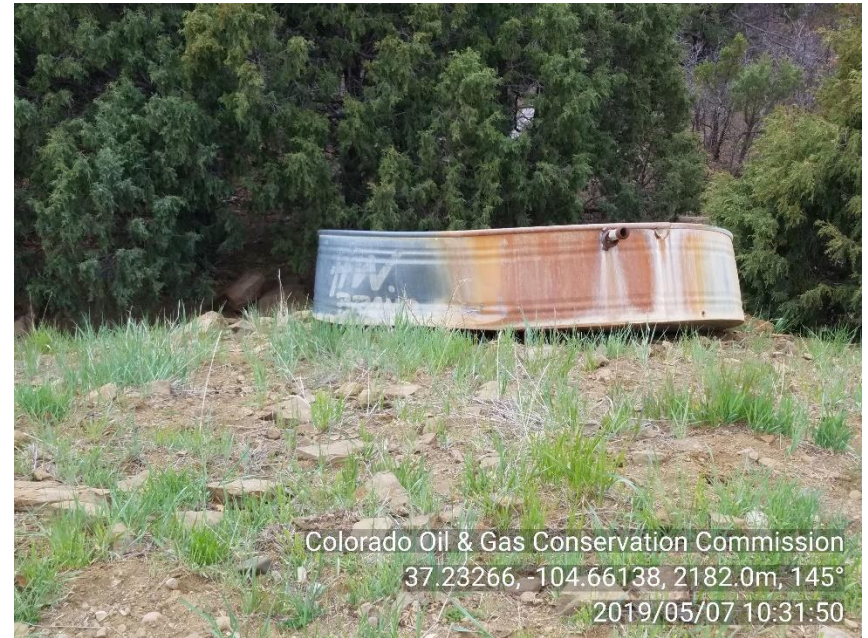
**PHOTO 6: UNUSED EQUIPMENT OFF SOUTHEAST EDGE OF  
LOCATION. COMPLY WITH RULE 603.f. CA DUE DATE 6/7/19**

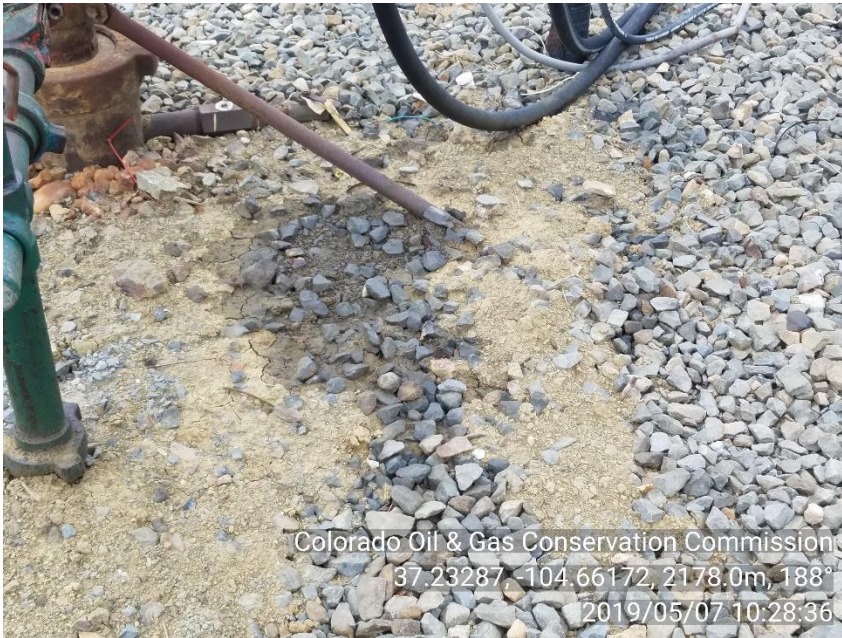
**PHOTO 7: IMPACTED SOIL NEXT TO WELLHEAD BENEATH DRIVEHEAD MOTOR.** Securely fasten all valves, pipes, and fittings to ensure good mechanical condition, inspect at regular intervals and maintain in good mechanical condition per Rule 605.d. Non E&P Waste not properly stored, handled, transported, treated, or disposed per Rule 907A. CA DATE 6/7/19

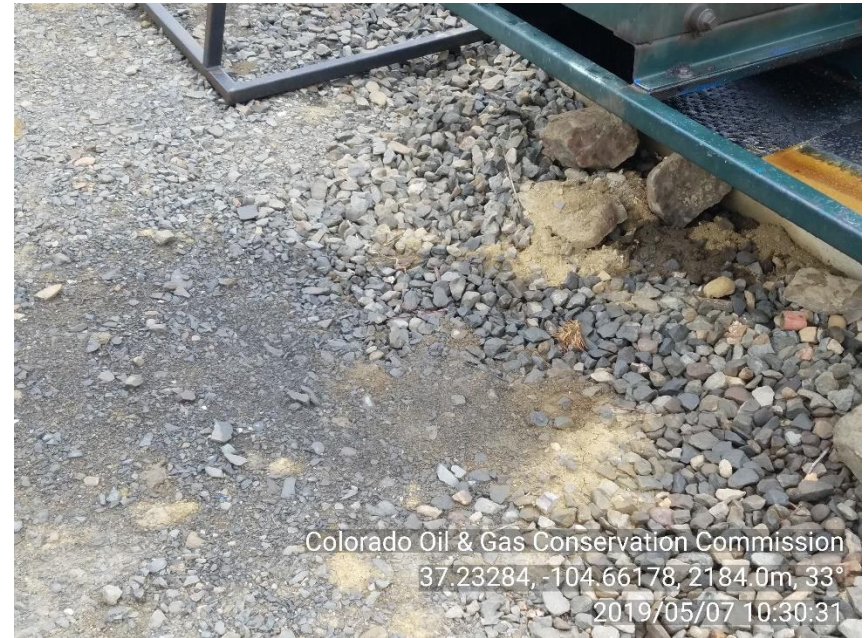
**PHOTO 8: IMPACTED SOIL ON WEST SIDE OF ENGINE SKID.** Securely fasten all valves, pipes, and fittings to ensure good mechanical condition, inspect at regular intervals and maintain in good mechanical condition per Rule 605.d. Non E&P Waste not properly stored, handled, transported, treated, or disposed per Rule 907A. CA DATE 6/7/19

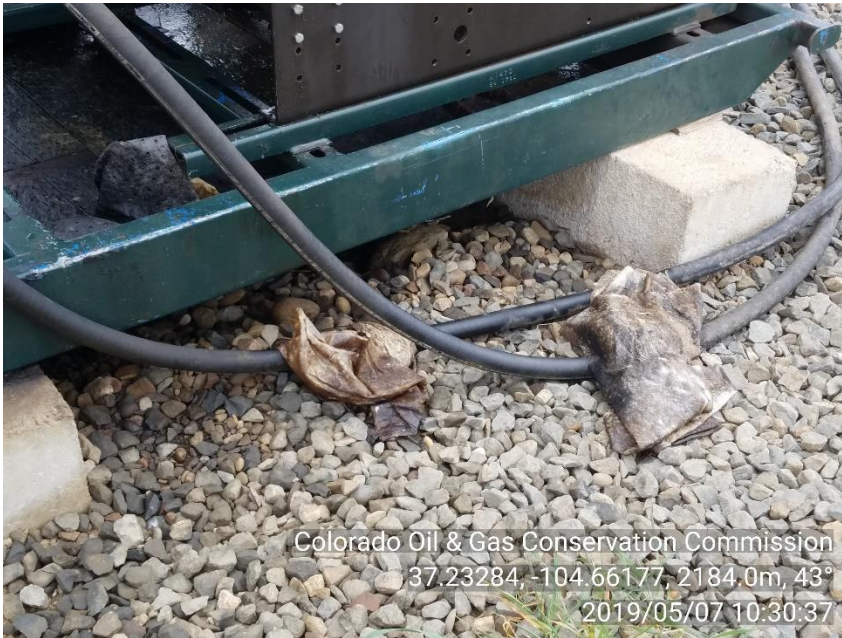
**PHOTO 9: IMPACTED SOIL ON SOUTH SIDE OF ENGINE SKID.** Securely fasten all valves, pipes, and fittings to ensure good mechanical condition, inspect at regular intervals and maintain in good mechanical condition per Rule 605.d. Non E&P Waste not properly stored, handled, transported, treated, or disposed per Rule 907A. **CA DATE 6/7/19**

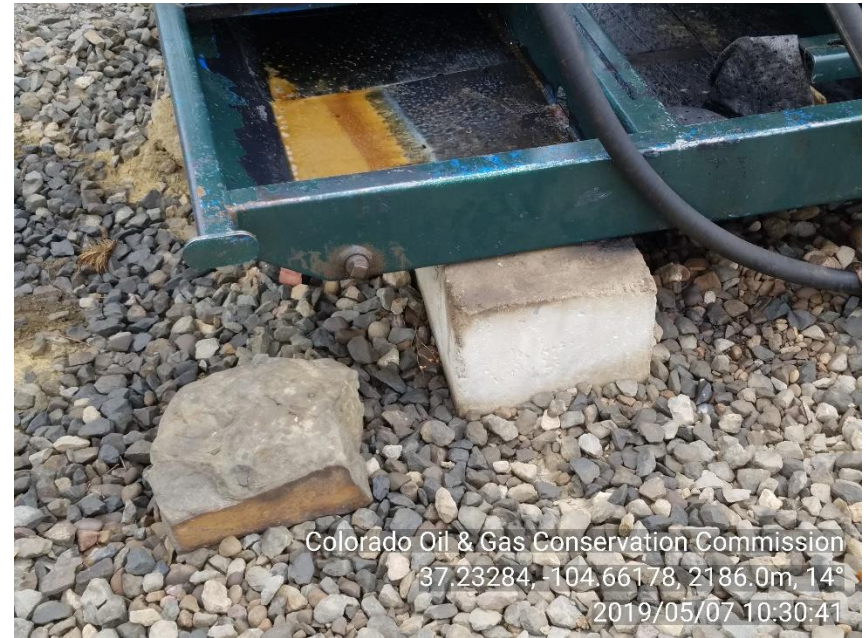
**PHOTO 10: IMPACTED SOIL ON WEST SIDE OF ENGINE SKID.** Securely fasten all valves, pipes, and fittings to ensure good mechanical condition, inspect at regular intervals and maintain in good mechanical condition per Rule 605.d. Non E&P Waste not properly stored, handled, transported, treated, or disposed per Rule 907A. **CA DATE 6/7/19**
