Inspection Photos

Location Name: Puckett 31-23D
Location # 335383

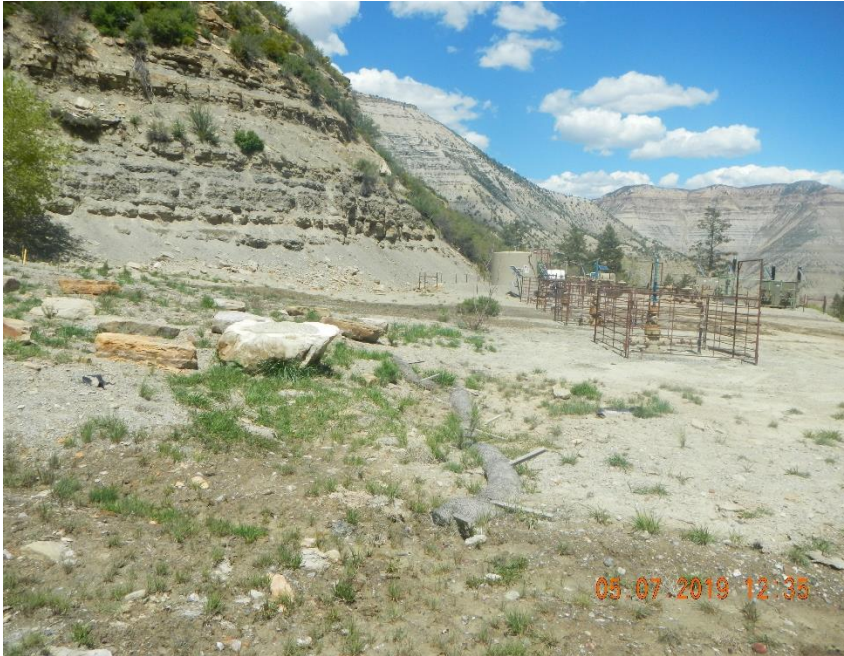
Photo 3
Damaged waddles

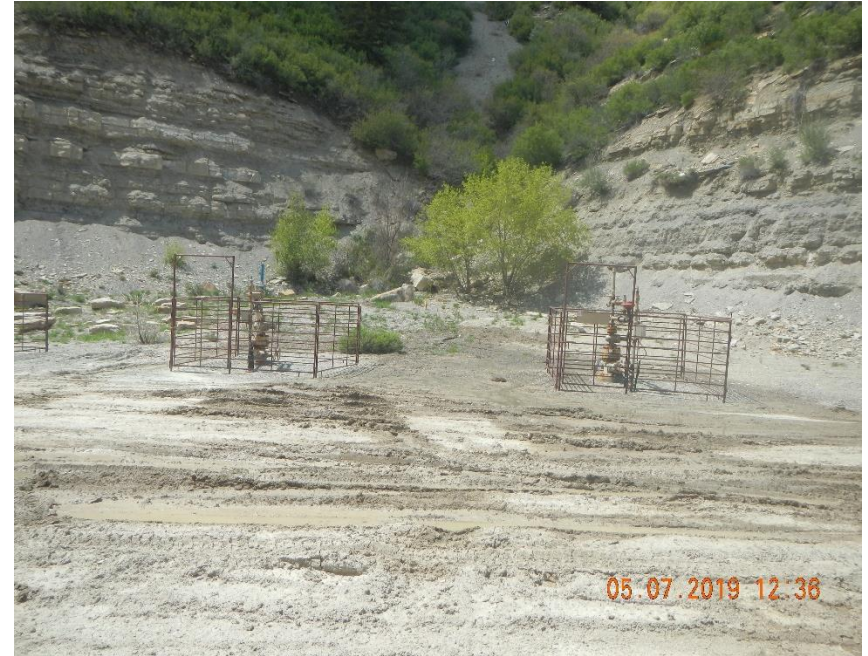
Photo 4
Run off storm water flow on to and across location.

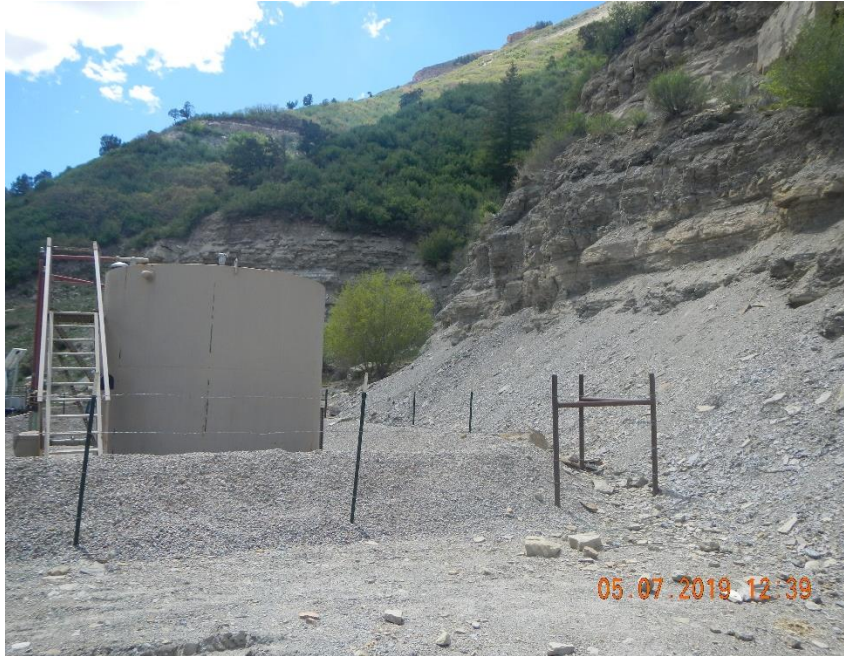
Photo 5
Shale, rock and sediment sloughing of cut slope against tank berm.

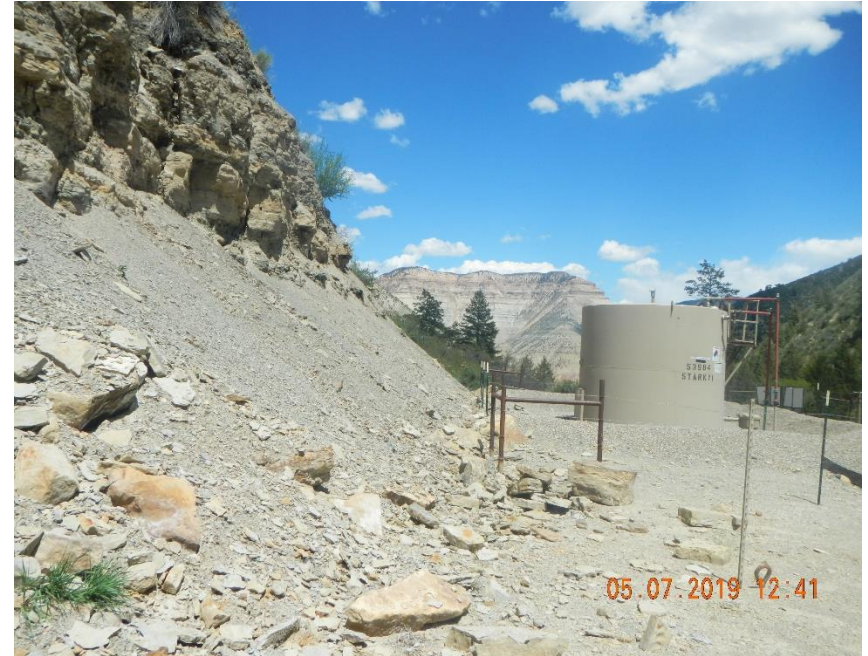
Photo 6
Shale, rock and sediment sloughing of cut slope against tank berm.
