# Inspection Photos

5/07/2019

Operator: WESTERN OPERATING COMPANY -  
95620

Location ID: 319767

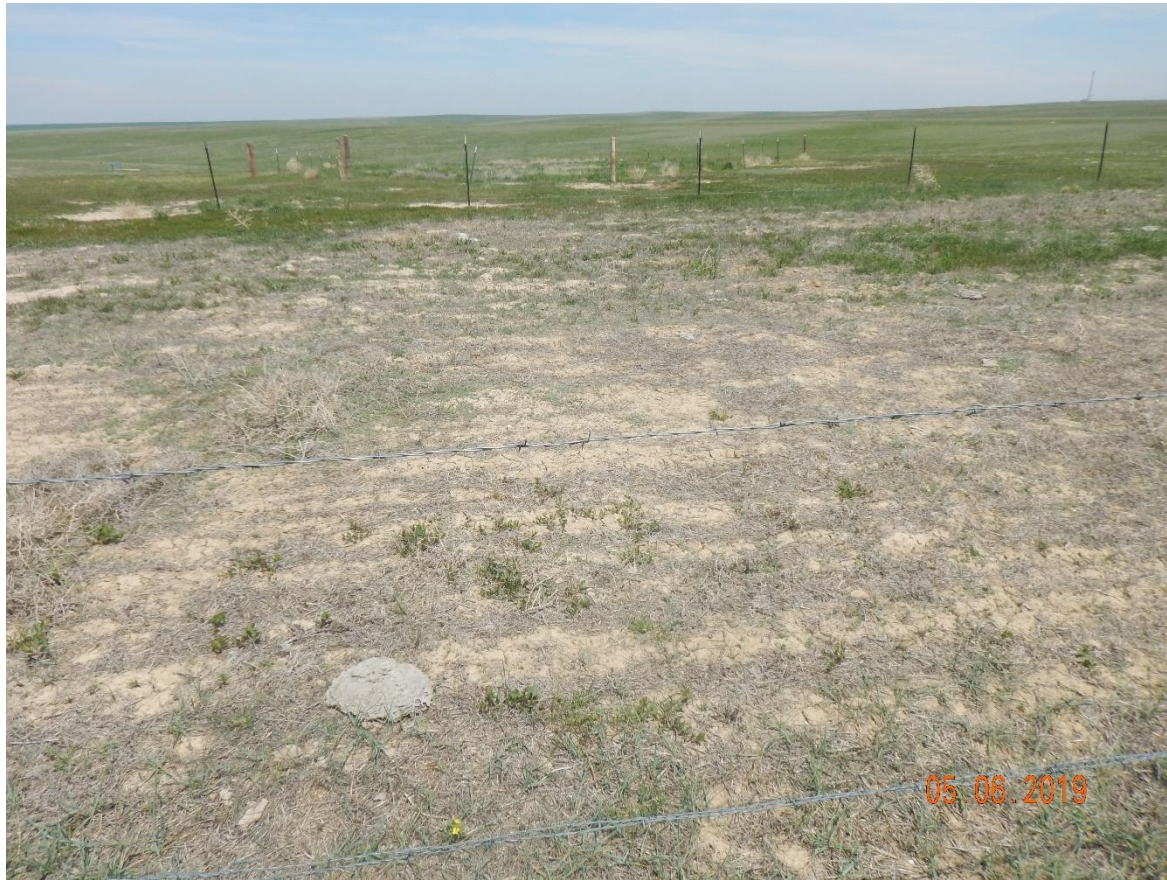
**Photo 1:** Photo taken from the south end of the tank battery location, facing north. Photo shows vegetation over the reclamation is predominantly undesirable weedy plant species.

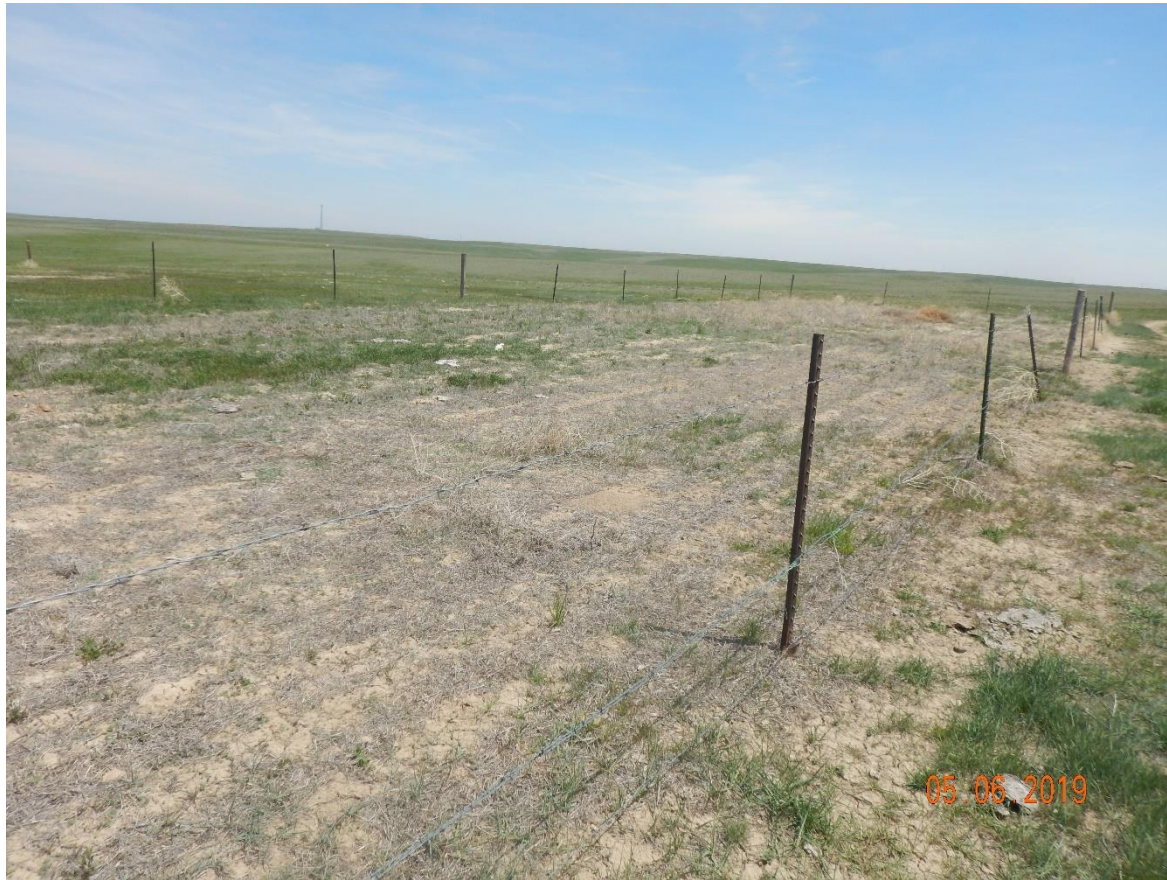
**Photo 2:** Photo taken from the south end of the tank battery location, facing east. Photo shows overview of the location, and that the vegetation over the reclamation is predominantly undesirable weedy plant species.

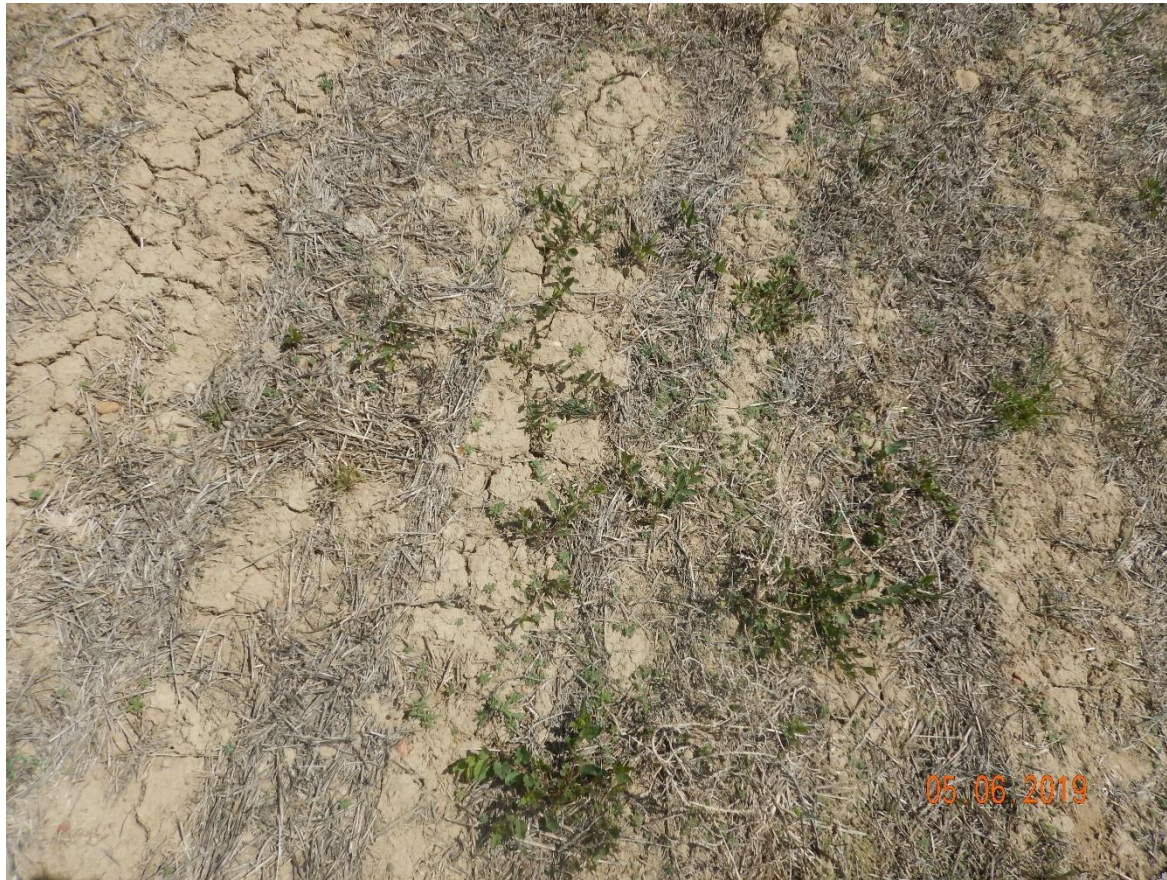
**Photo 3:** Photo taken from the battery location. Photo shows bindweed (*Convolvus arvensis*) appears to be establishing on the location. This is a Colorado State listed noxious weed. Previous inspections required operator to conduct noxious weed management.

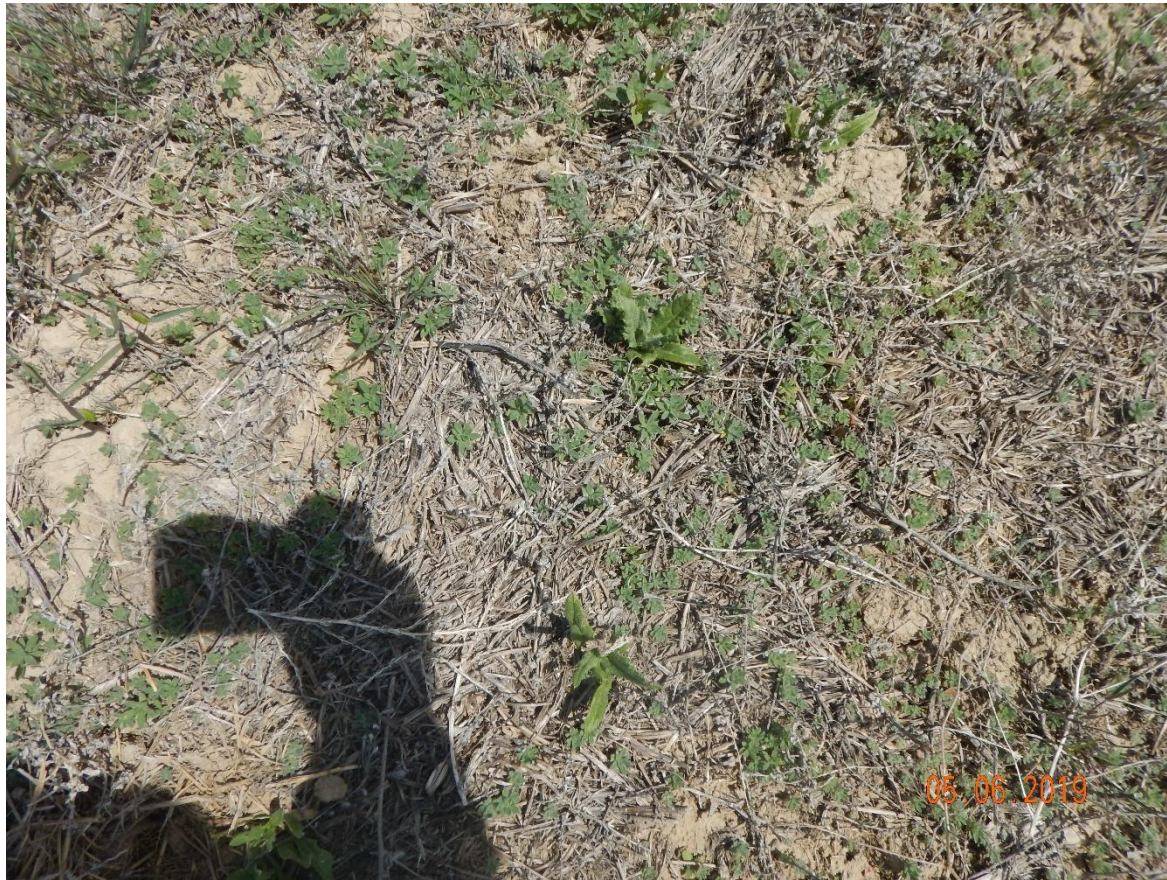
**Photo 4:** Photo taken from the battery location. Photo shows what appears to be bindweed (*Convolvus arvensis*) is establishing on the location. This is a Colorado State listed noxious weed. Previous inspections required operator to conduct noxious weed management.

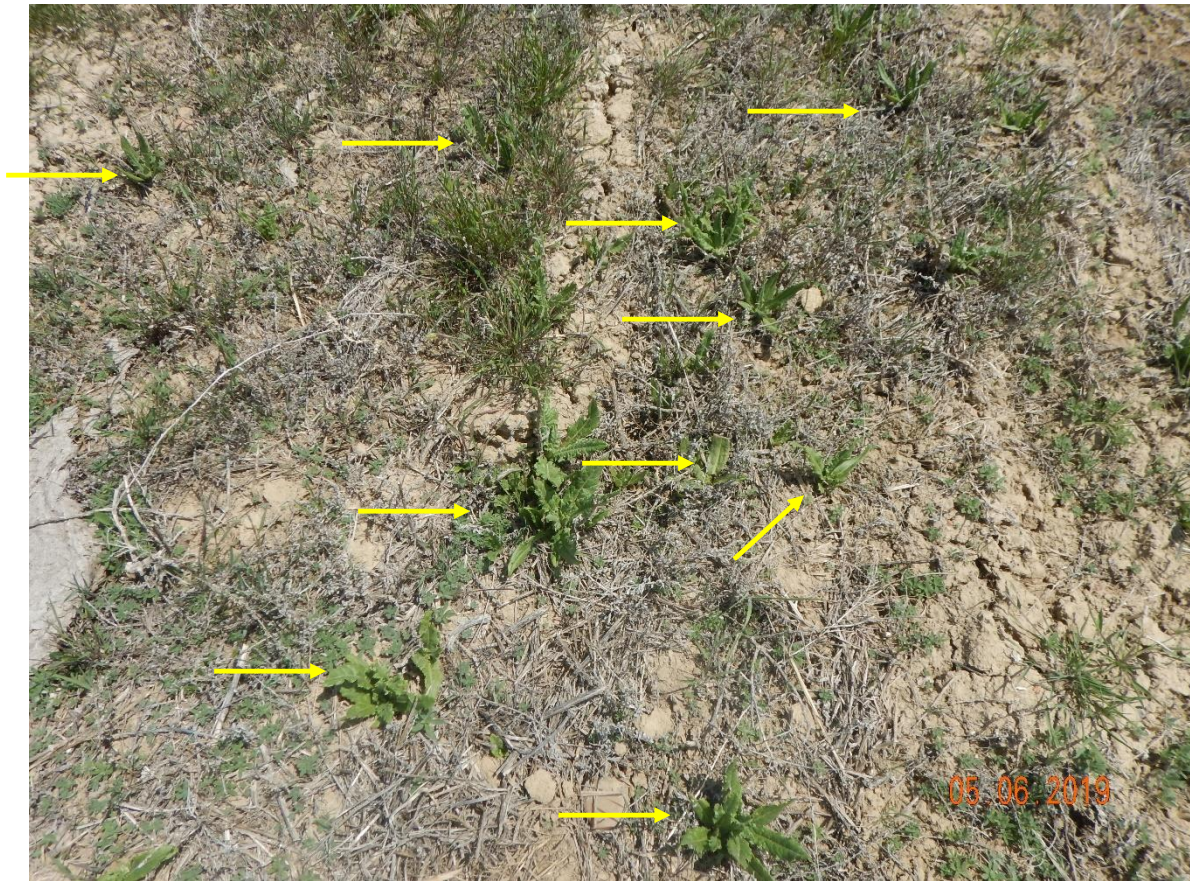
**Photo 5:** Photo taken from the battery location. Photo shows Canada thistle rosettes (*Cirsium arvense*) establishing on the location. This is a Colorado State listed noxious weed. Previous inspections required operator to conduct noxious weed management.

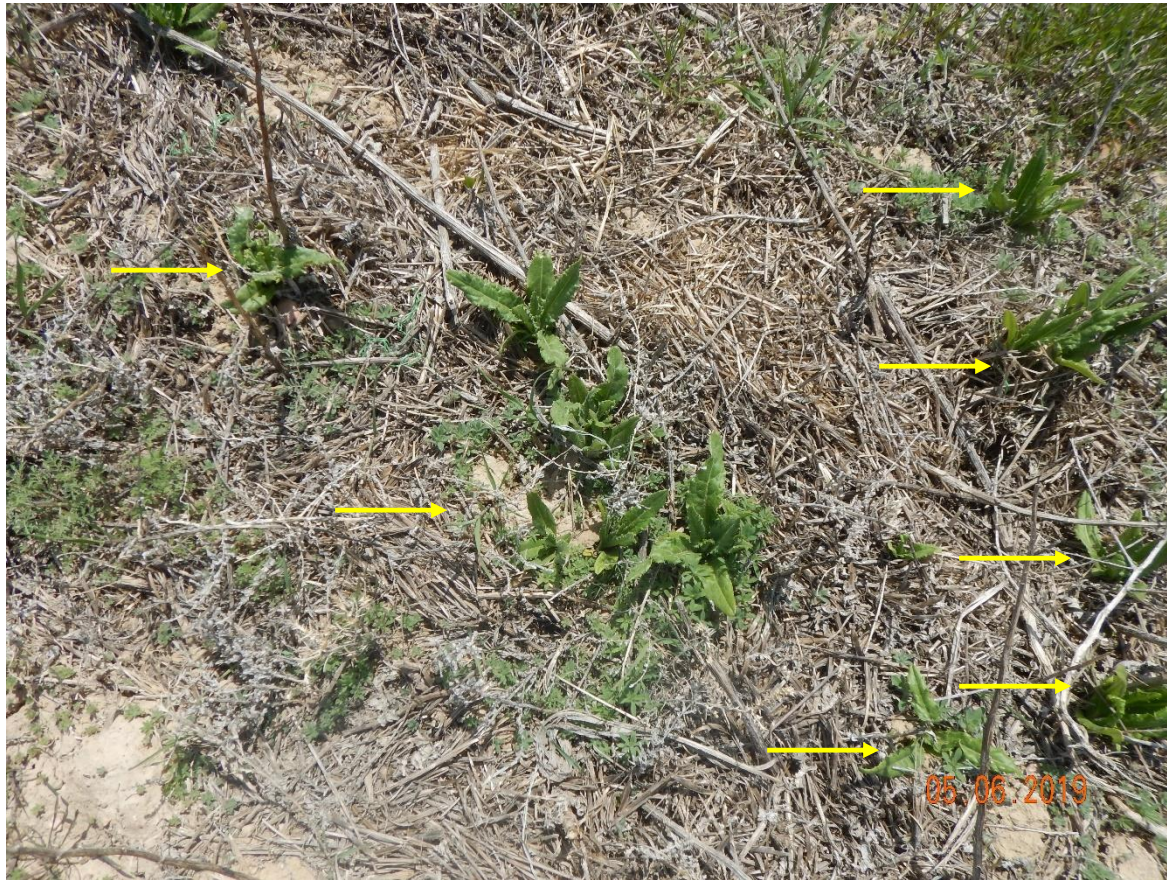
**Photo 6:** See comments under photo 5.

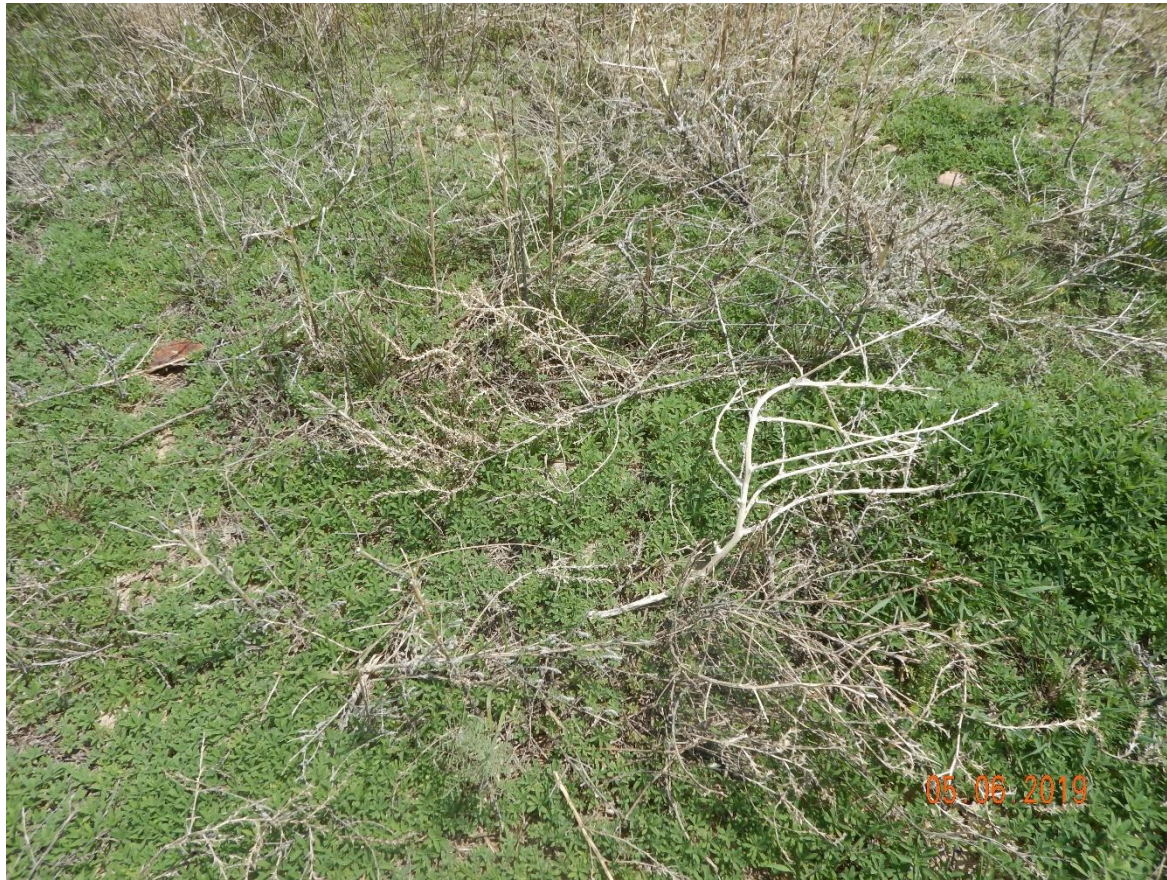
**Photo 7:** Photo taken from the battery location. Green vegetation observed in photo is undesirable weedy plant species observed throughout the location

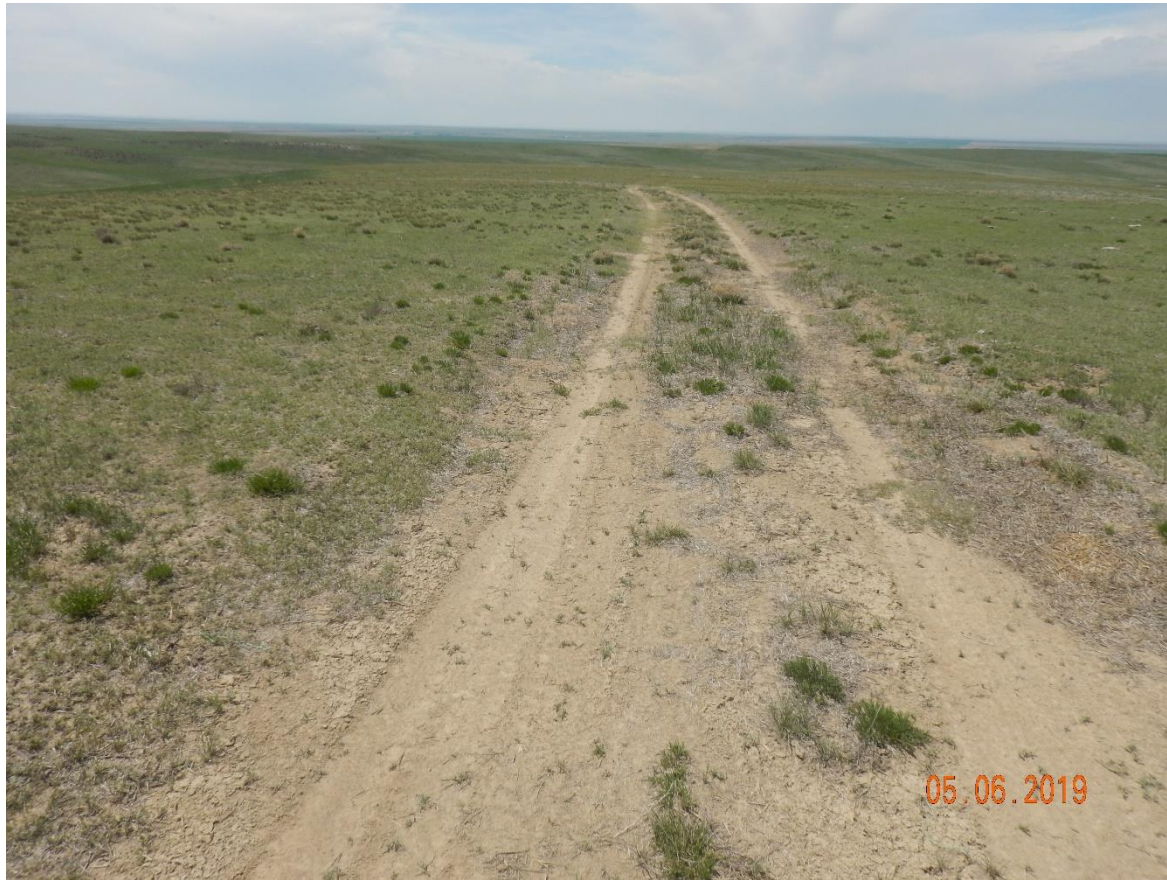
**Photo 8:** Photo taken from the west end of the battery location, facing southwest. Photo shows access road that leads to the well location has not been reclaimed in accordance with 1000 series rules and corrective actions (compaction alleviation, re-contouring, regrading, etc..).

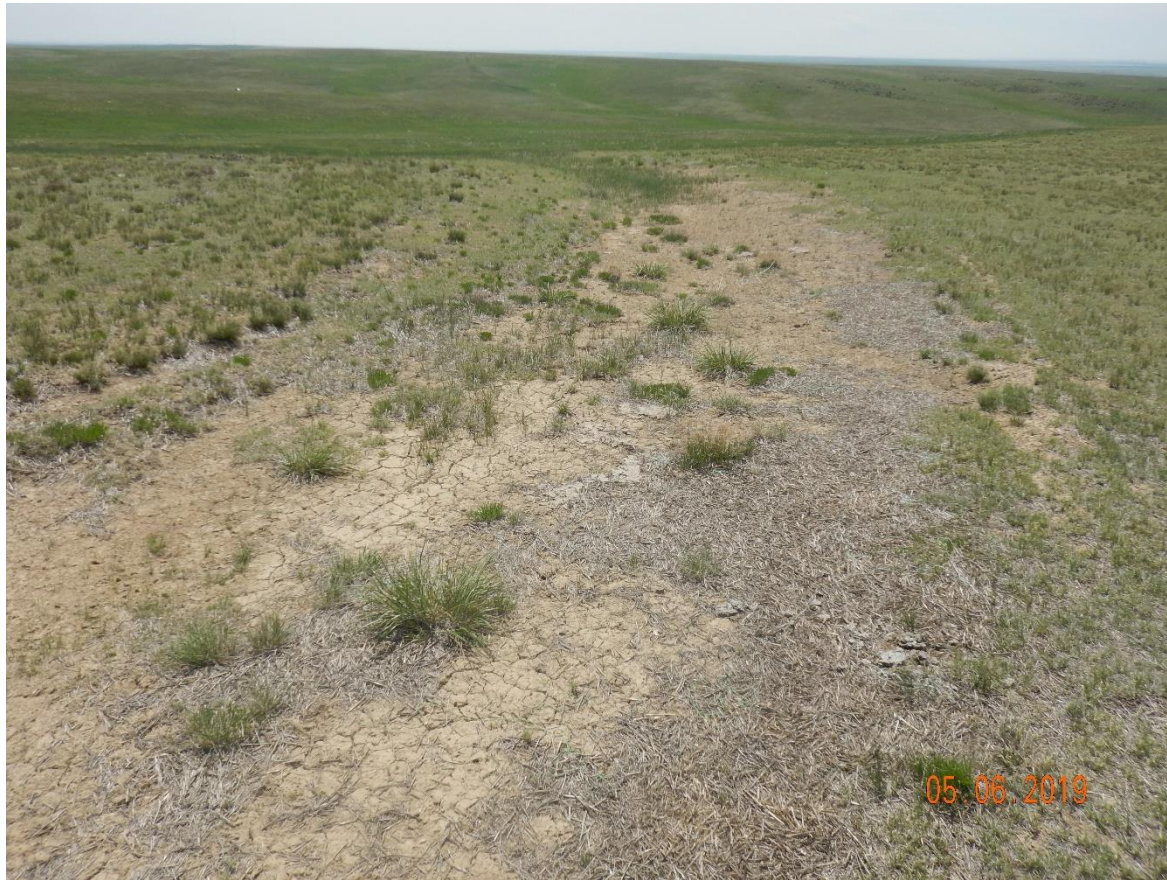
**Photo 9:** Photo taken from the access road west of the well location, facing south. Photo shows access road that leads to the well location has not been reclaimed in accordance with 1000 series rules and corrective actions (compaction alleviation, re-contouring, regrading, etc..).

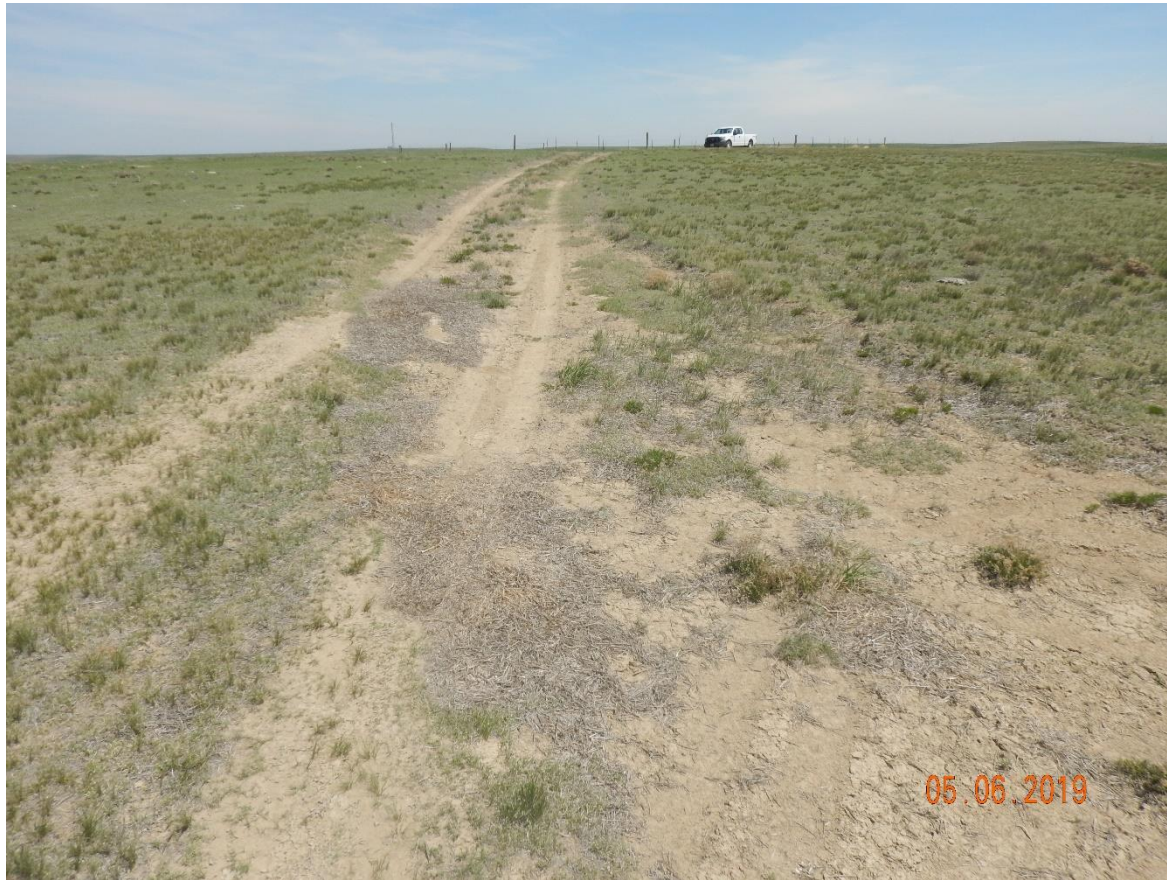
**Photo 10:** Photo taken from the access road west of the well location, facing north. Photo shows access road that leads to the well location has not been reclaimed in accordance with 1000 series rules and corrective actions (compaction alleviation, re-contouring, regrading, etc..).

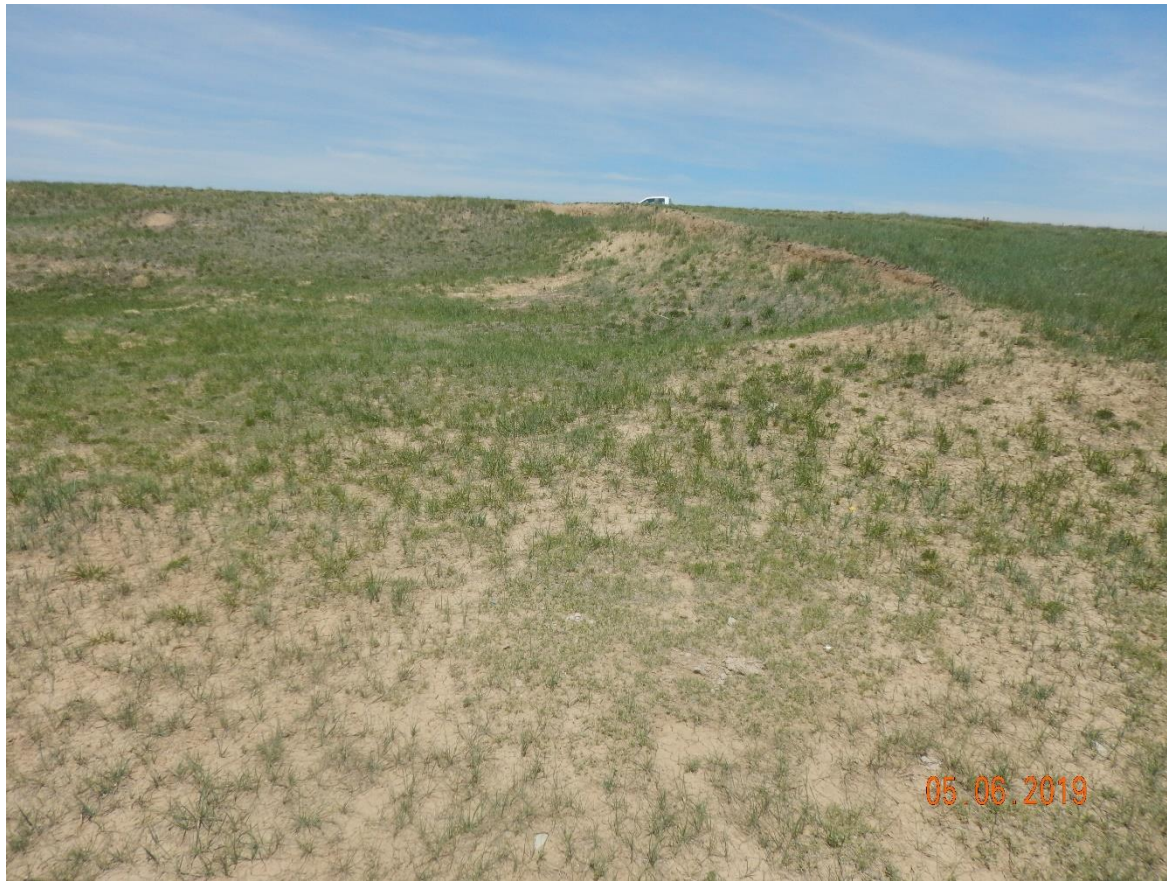
**Photo 11:** Photo taken from the east end of the location, facing north. Photo shows operator has failed to reclaim the entire location in accordance with 1000 series rules and corrective actions (re-contour/re-grade)

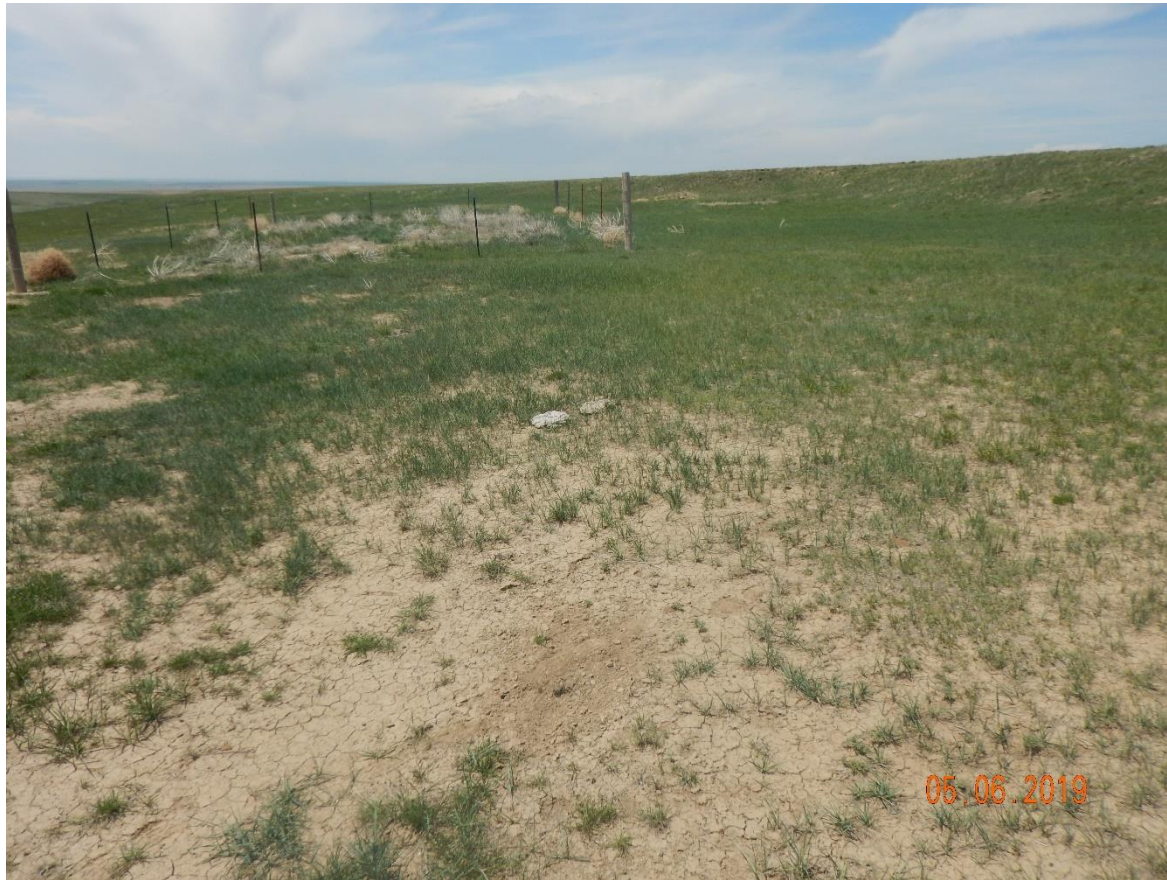
**Photo 12:** Photo taken from the east end of the location, facing west. Photo shows operator has failed to reclaim the entire location in accordance with 1000 series rules and corrective actions (re-contour/re-grade)

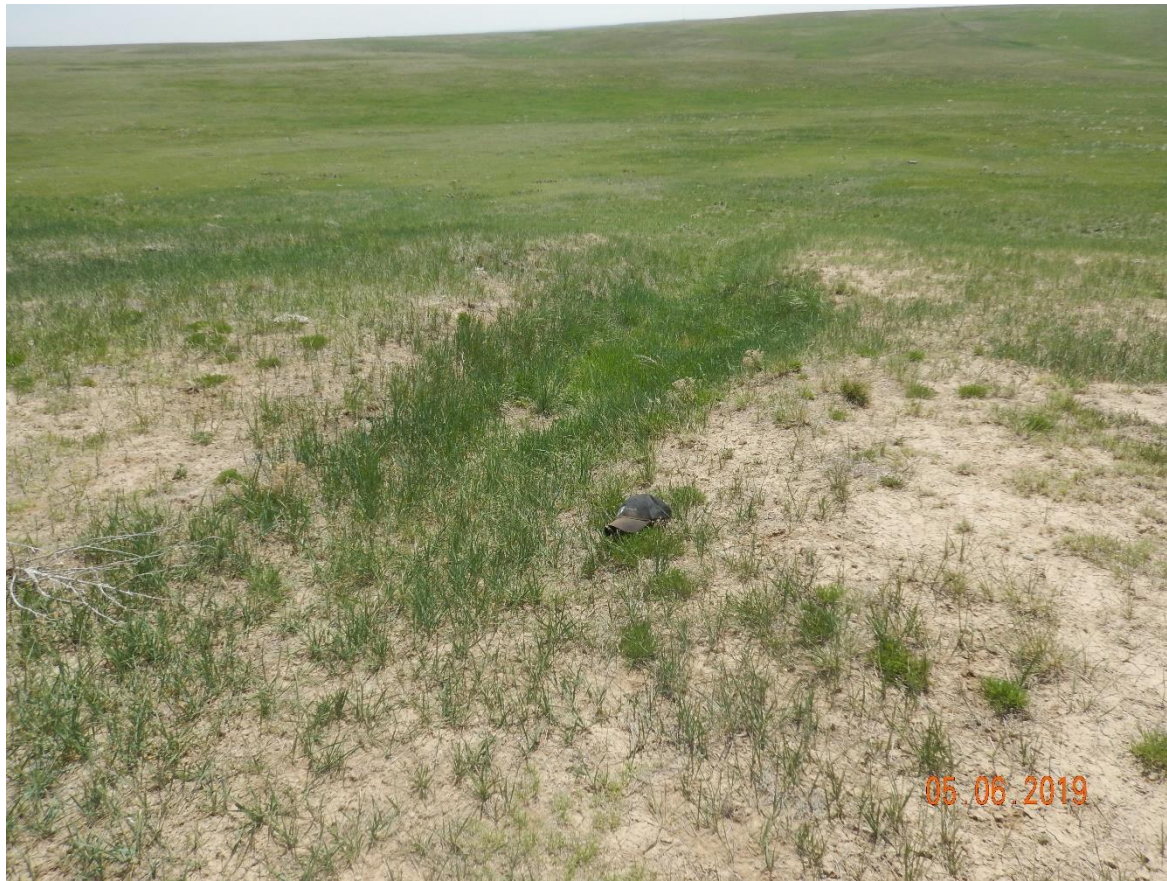
**Photo 13:** Photo taken from the south end of the location, facing south. Photo shows gully erosion on the fill slopes of the location. Hat for reference.

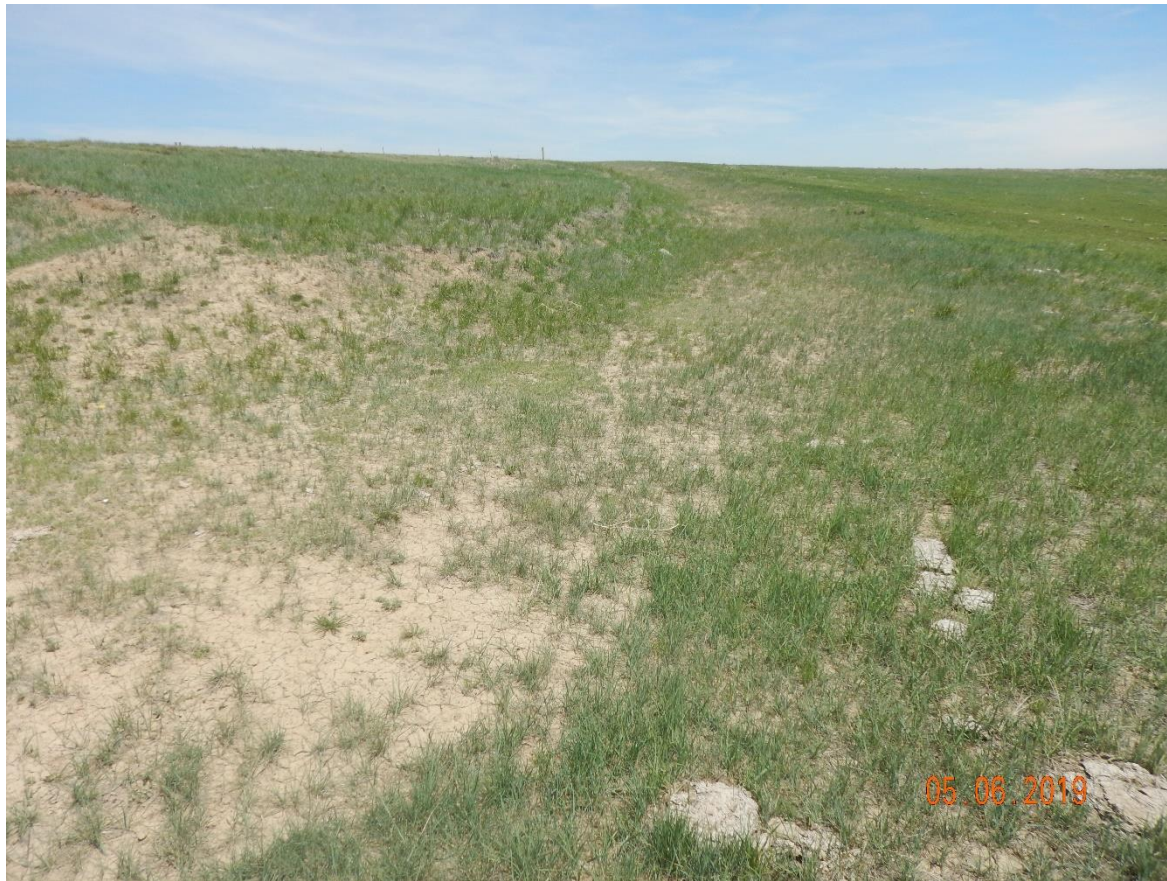
**Photo 14:** Photo taken from the east end of the location, facing north. See comments under photo 10.

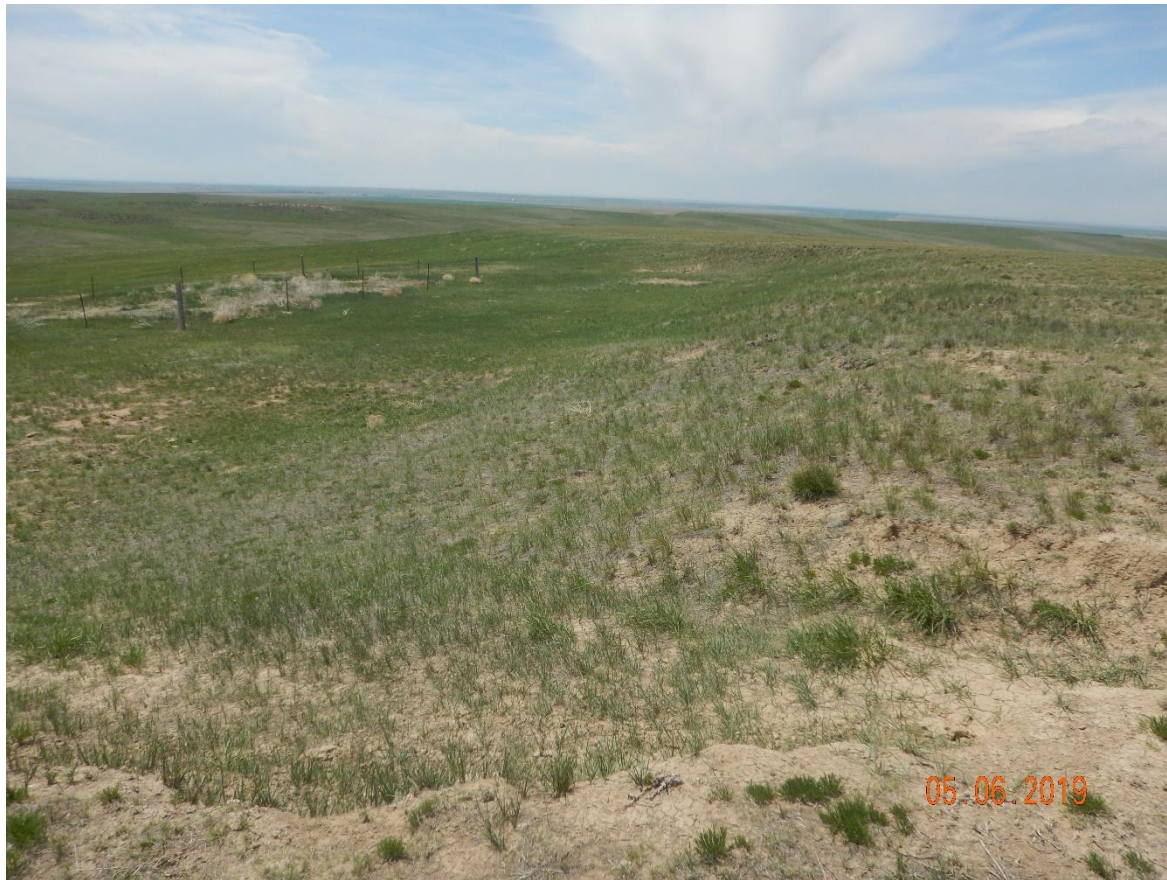
**Photo 15:** Photo taken from the northeast end of the location, facing west. Photo shows operator has failed to reclaim the entire location in accordance with 1000 series rules and corrective actions (re-contour/re-grade)

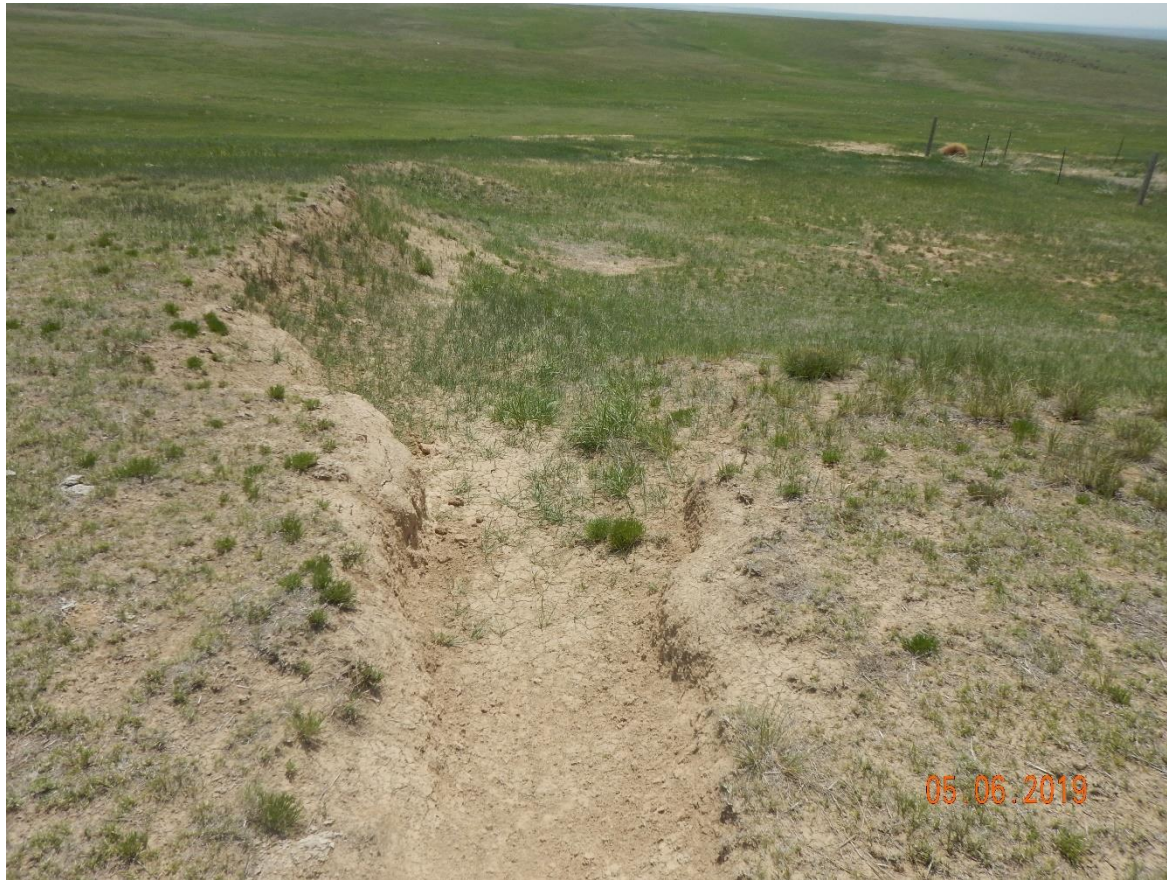
**Photo 15:** Photo taken from the northeast end of the location, facing south. Photo shows operator has failed to reclaim the entire location in accordance with 1000 series rules and corrective actions (re-contour/re-grade). Photo also shows erosion degradation on the cut slopes.
