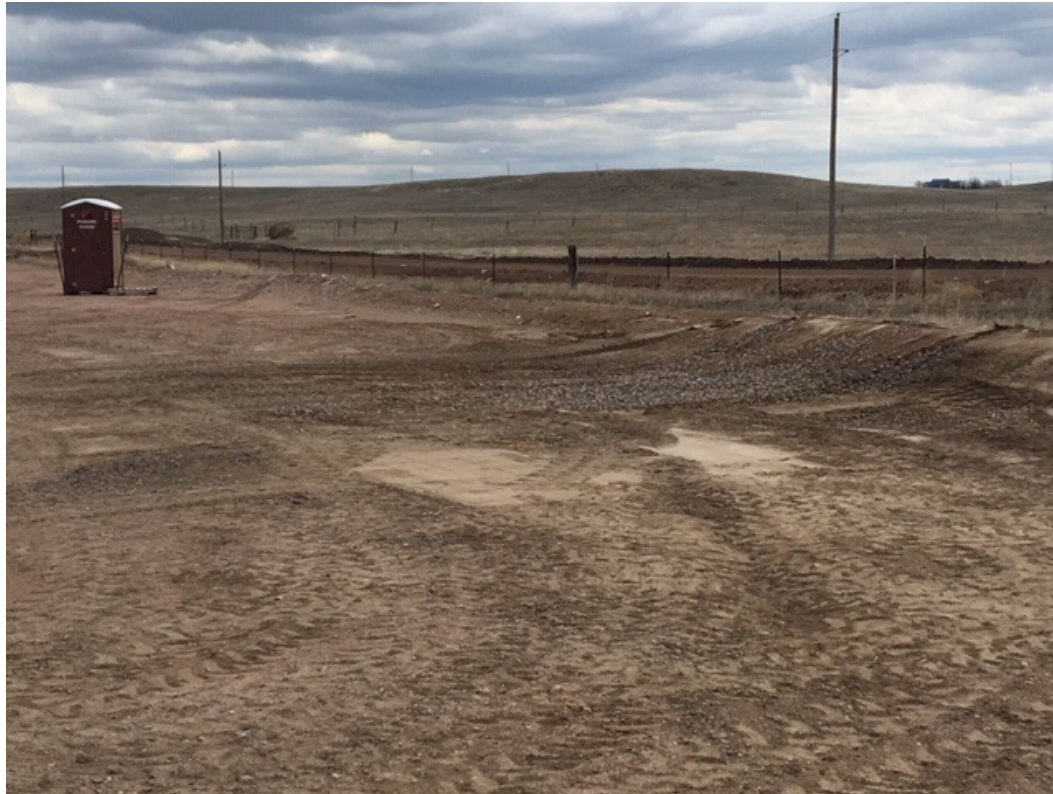
Photo 1 – Motu East Location ID 439459
200 BBL Steel AST Removed
Corresponds to photo #9&10 of 4/15/2019 Inspection

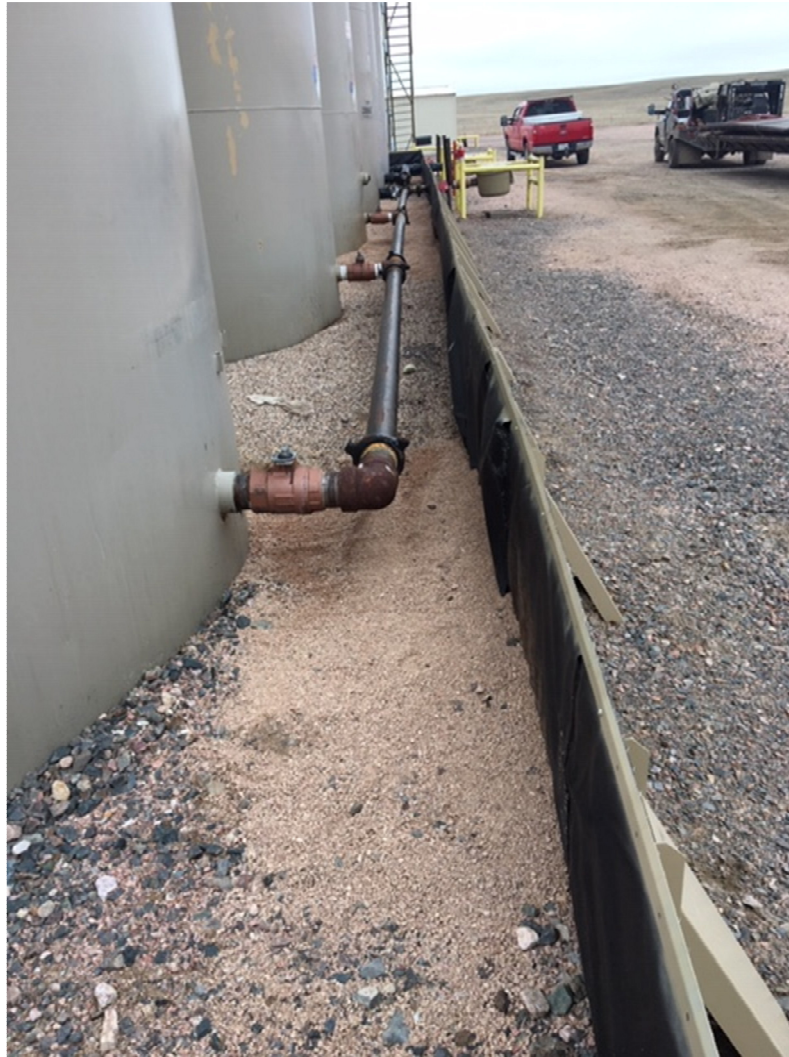
Photo 2 – Motu East Location ID 439459
Crude oil liquid load out line reclaimed

Corresponds to photo 3 of
4/15/2019 inspection

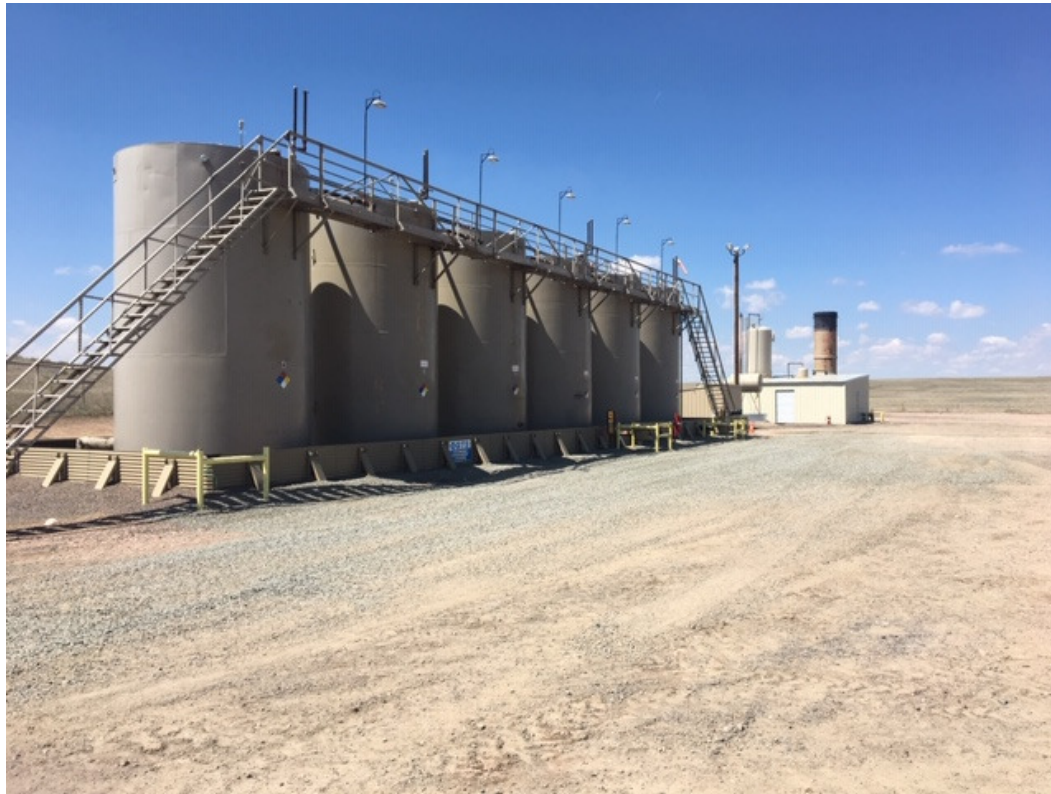
Photo 3 – Motu East Location ID 439459
Stained soil outside containment at crude oil
loadout reclaimed.
Corresponds to photo 2&8 of 4/15/2019 inspection

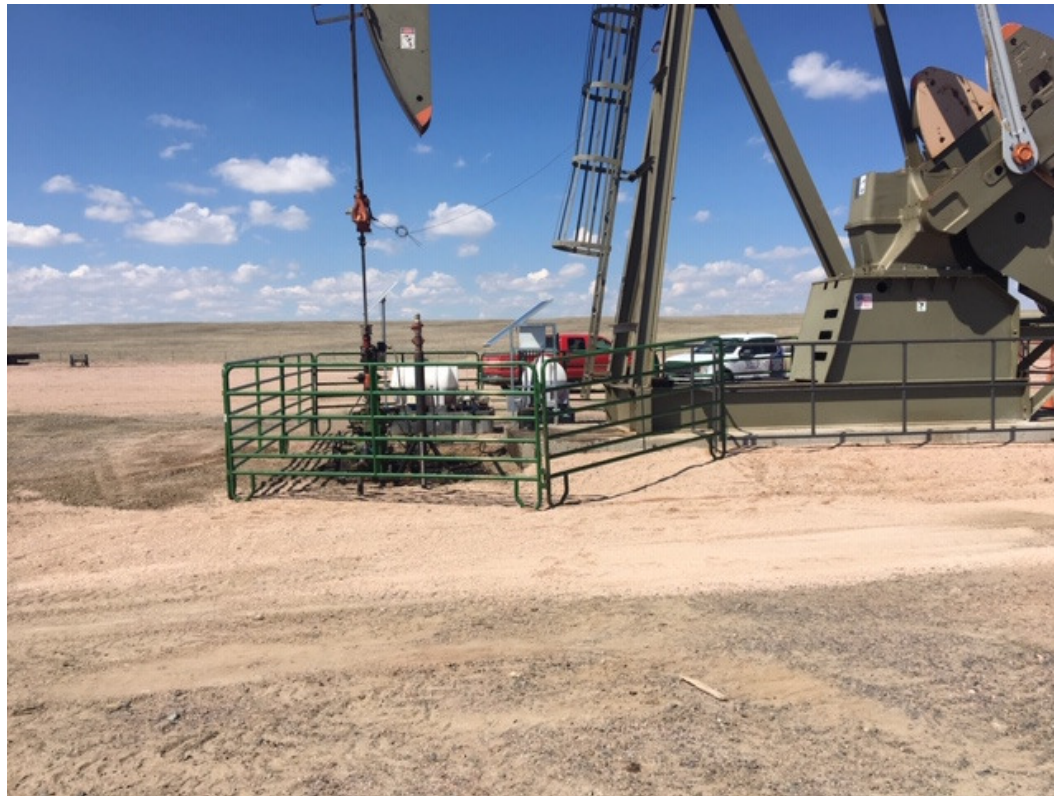
Photo 4 – Motu East Location ID 439459
Stained soil around wellhead and pumpjack
reclaimed
Corresponds with photo 6&7 of 4/15/2019 inspection

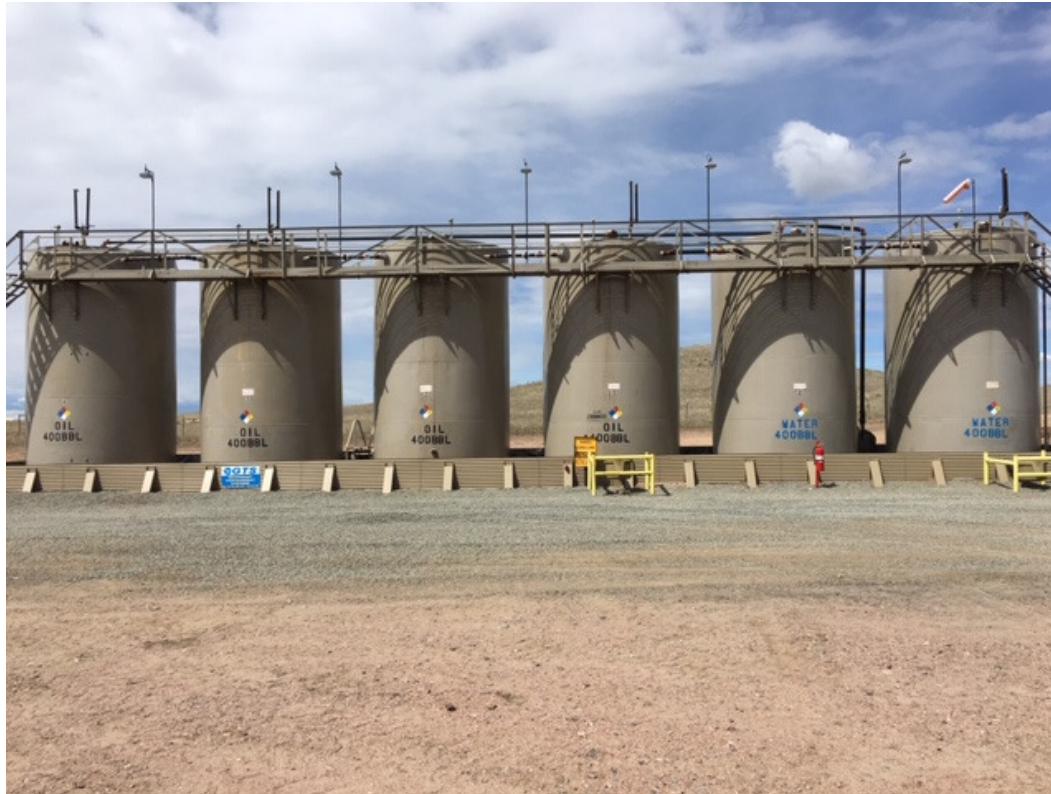
Photo 5 – Motu East Location ID 43945
Capacity volumes marked on tanks
Corresponds with photo 2 of 4/15/2019 inspection

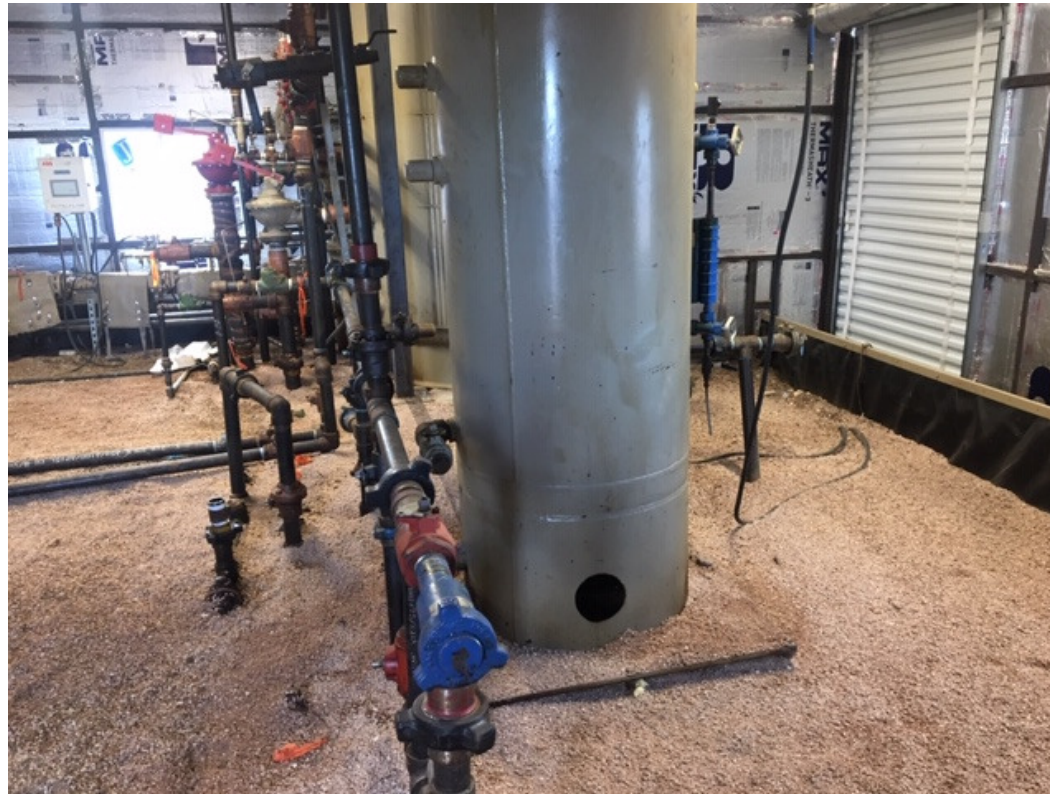
Photo 6 – Motu East Location ID 43945
Leaks within treater building reclaimed
Corresponds with photo 4&5 of 4/15/2019 inspection

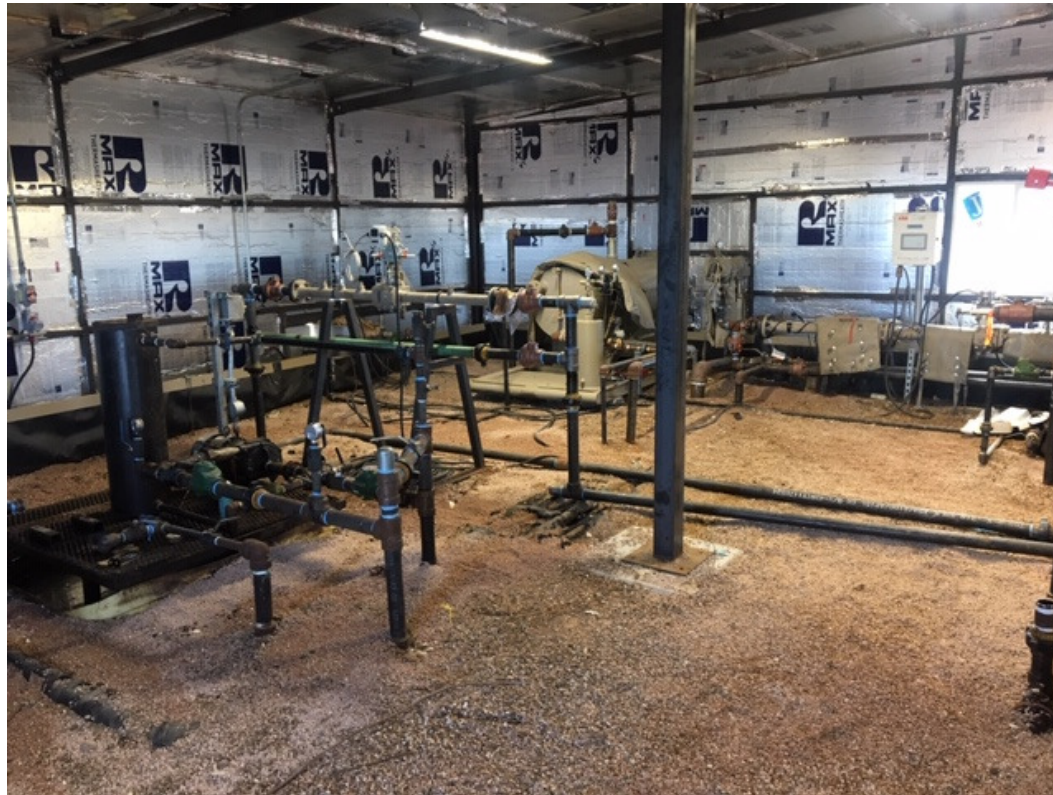
Photo 7 – Motu East Location ID 43945
Leaks within treater building reclaimed
Corresponds with photo 4&5 of 4/15/2019 inspection
