# Inspection Photos

Operator: SWN PRODUCTION COMPANY LLC -  
10396

Location ID: 427955

Inspection Doc. Number: 696200023  
Adams County, CO

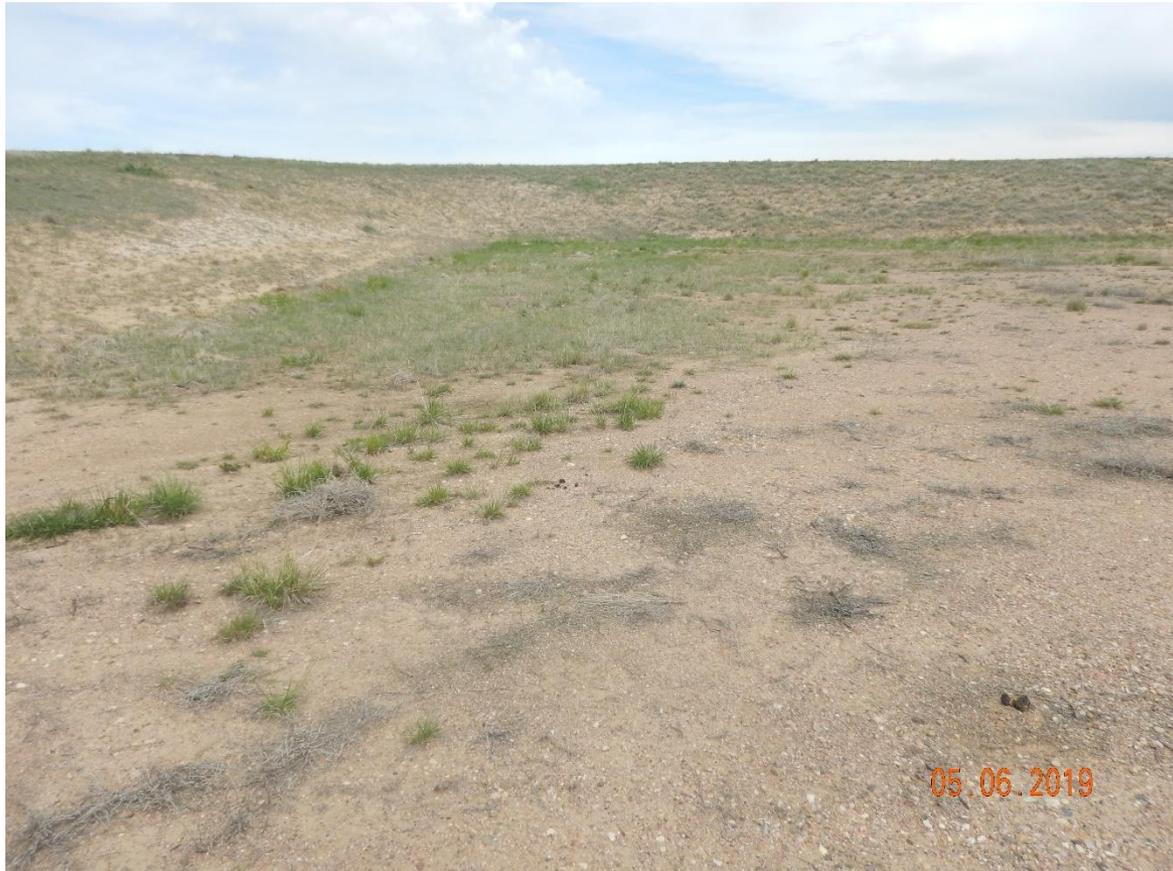
**Photo 1:** Photo taken from the north end of the location, facing east. Photos 1-4 provide an overview of the location from east, southeast, southwest, to west. Corrective actions and COAs required operator to conduct reclamation and reduce the location's disturbance area to 0.92 acres. Photos show reclamation has not been conducted; disturbance area has not been reduced.

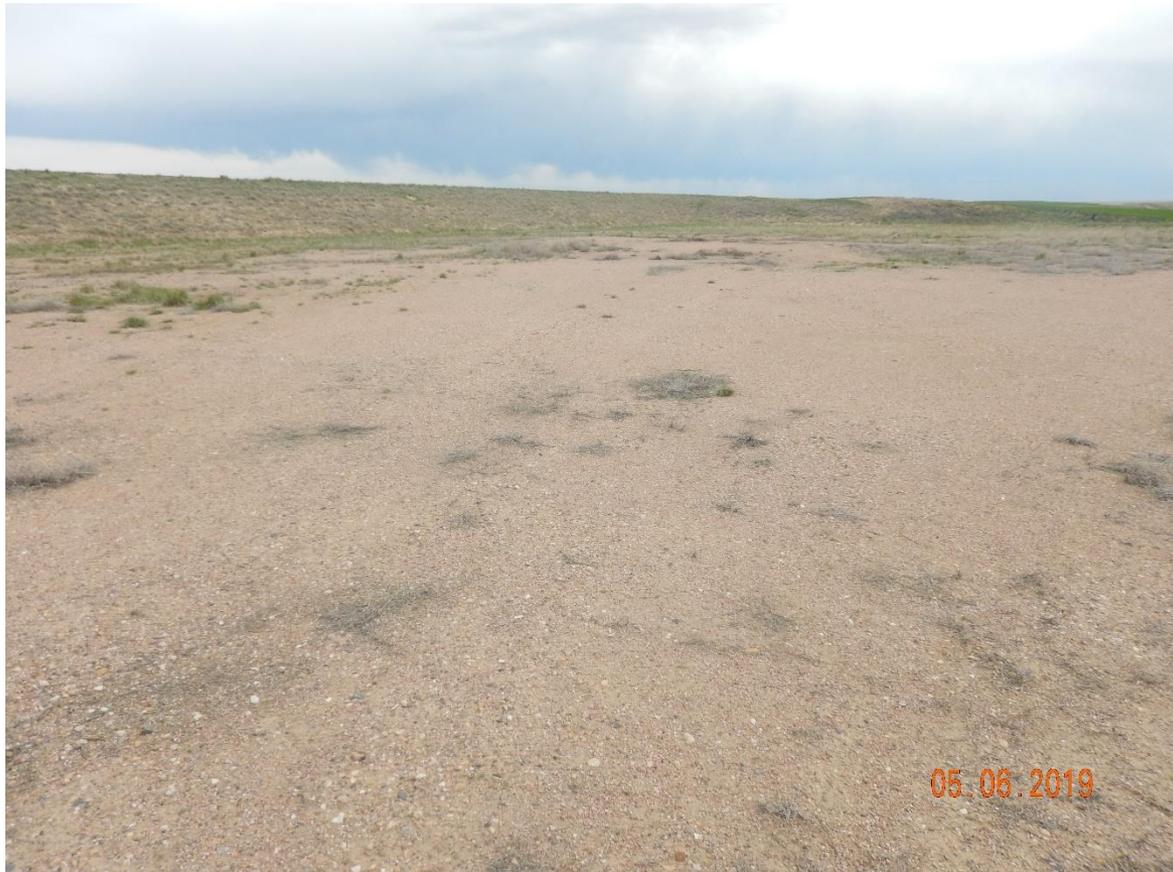
**Photo 2:** See comments under photo 1.

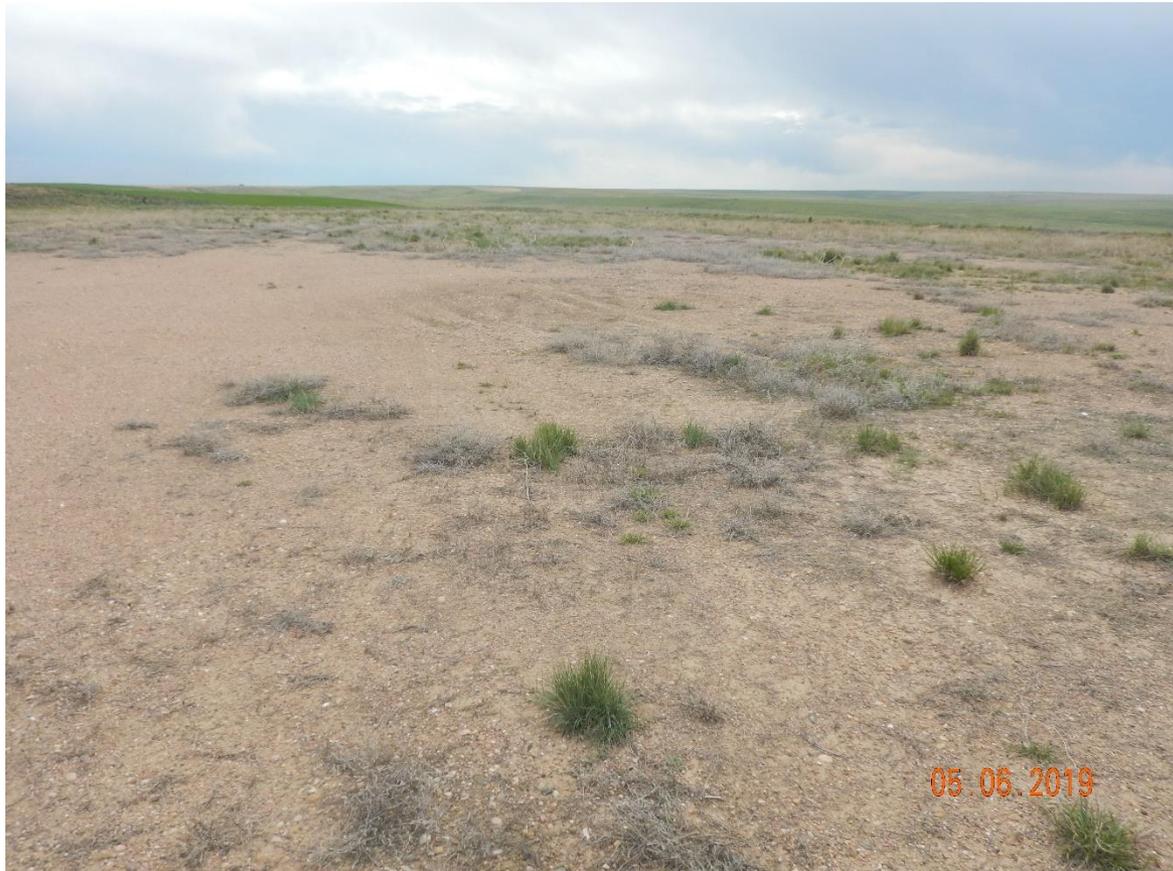
**Photo 3:** See comments under photo 1.

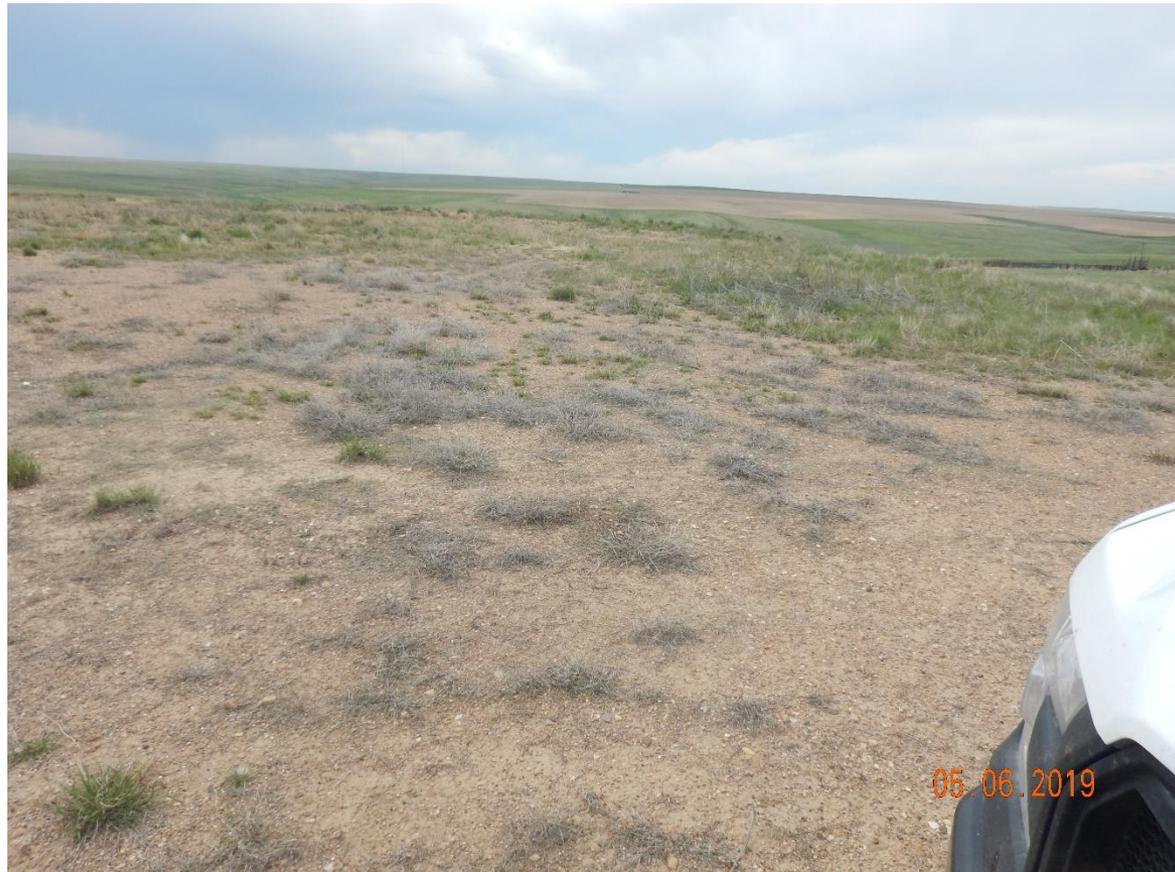
**Photo 4:** See comments under photo 1.

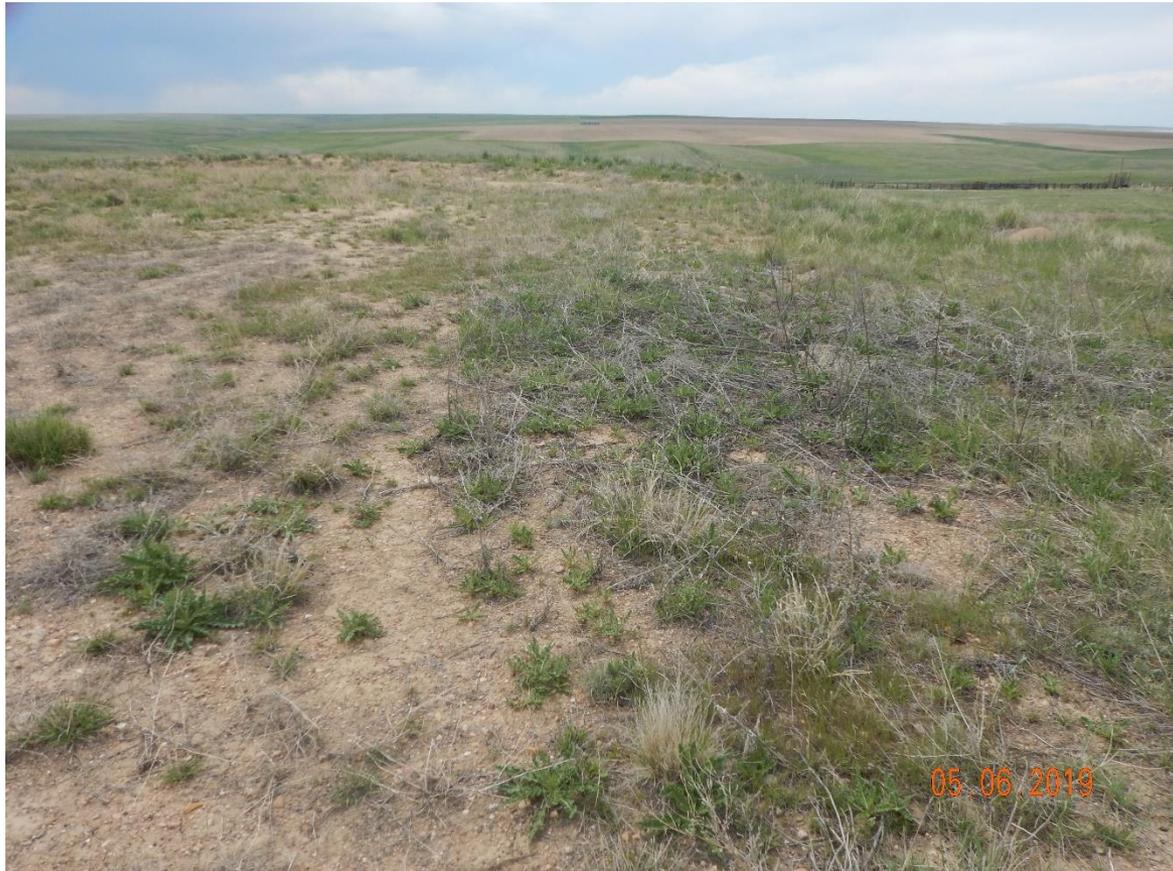
**Photo 5:** Photo taken from the north end of the location, facing west. Photo shows area where a patch of Canada thistle was documented. Canada thistle remains evident within this area, and appears to have expanded throughout larger areas of the location. Operator does not appear to be conducting ongoing weed management.

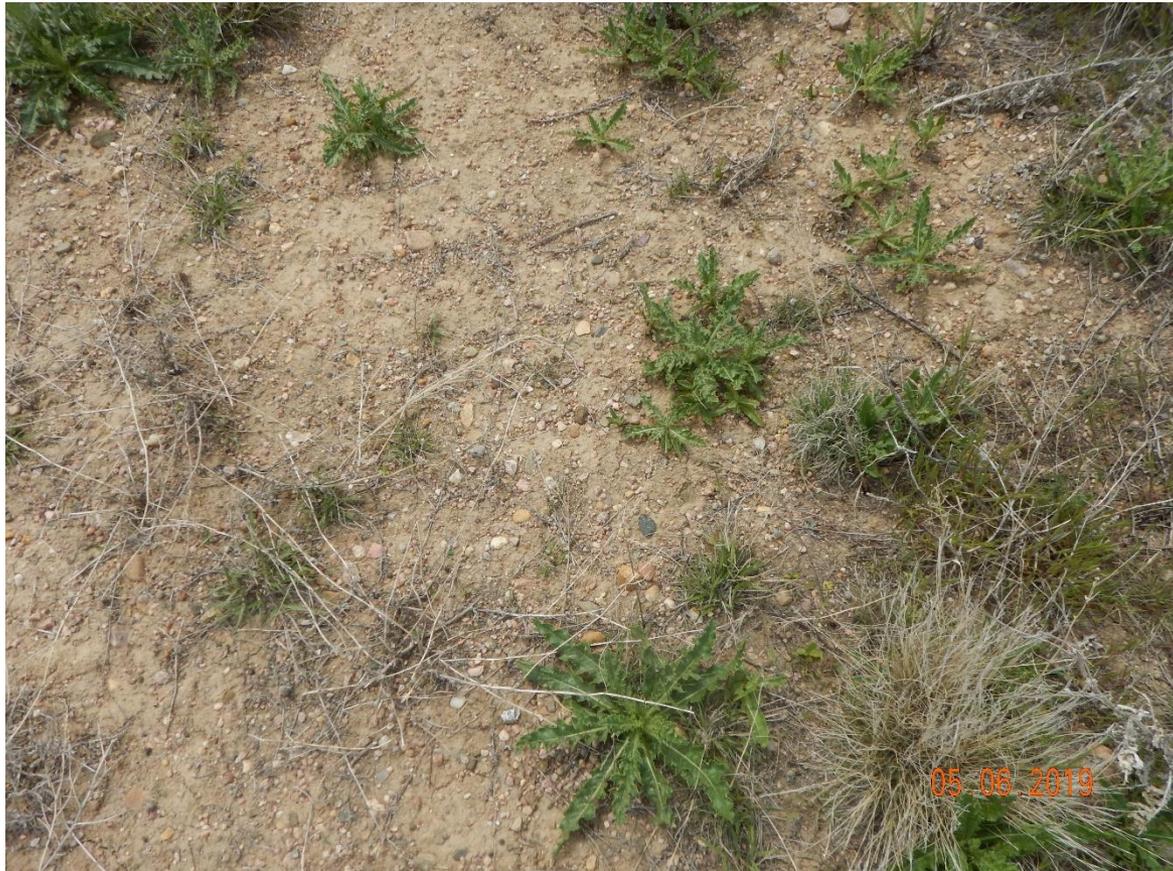
**Photo 6:** Continued from photo 5. Photo shows Canada thistle rosettes on location. Operator does not appear to be conducting ongoing weed management.

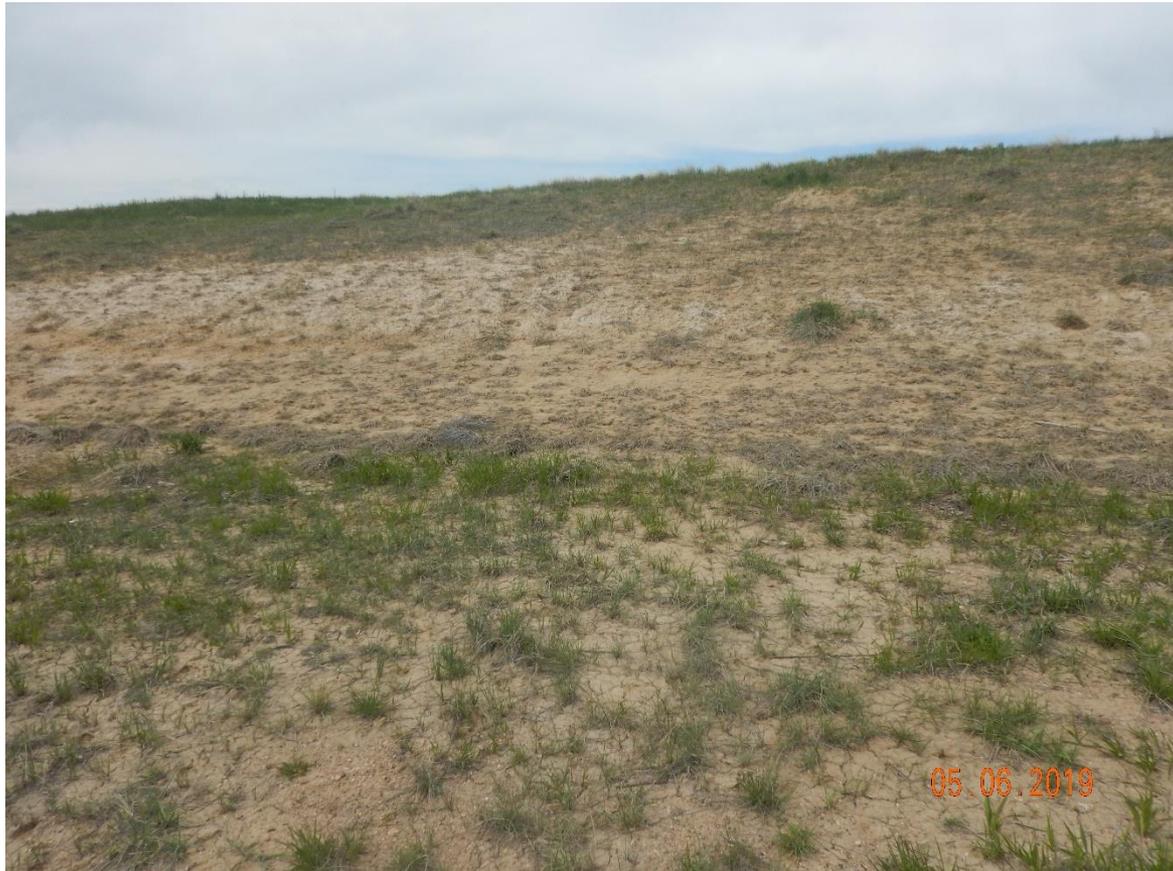
**Photo 7:** Photo taken from the northeast end of the location, facing north. Previous inspections documented that the cut slopes on the east end of the location remain predominantly bare and exposed soil with erosion degradation evident. Photos 7-10 show erosion degradation has not been repaired, no BMPs have been installed, and no revegetation activities appear to have been conducted.

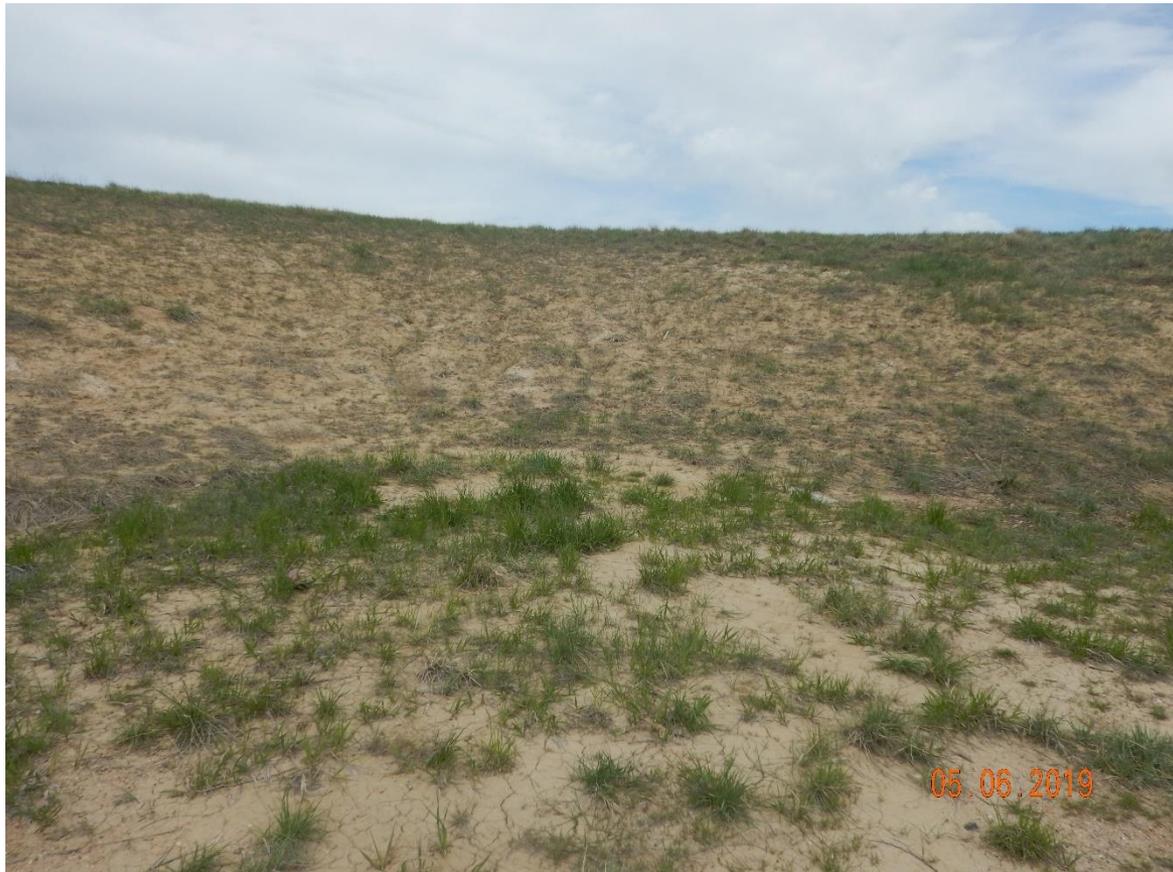
**Photo 8:** See comments under photo 7.

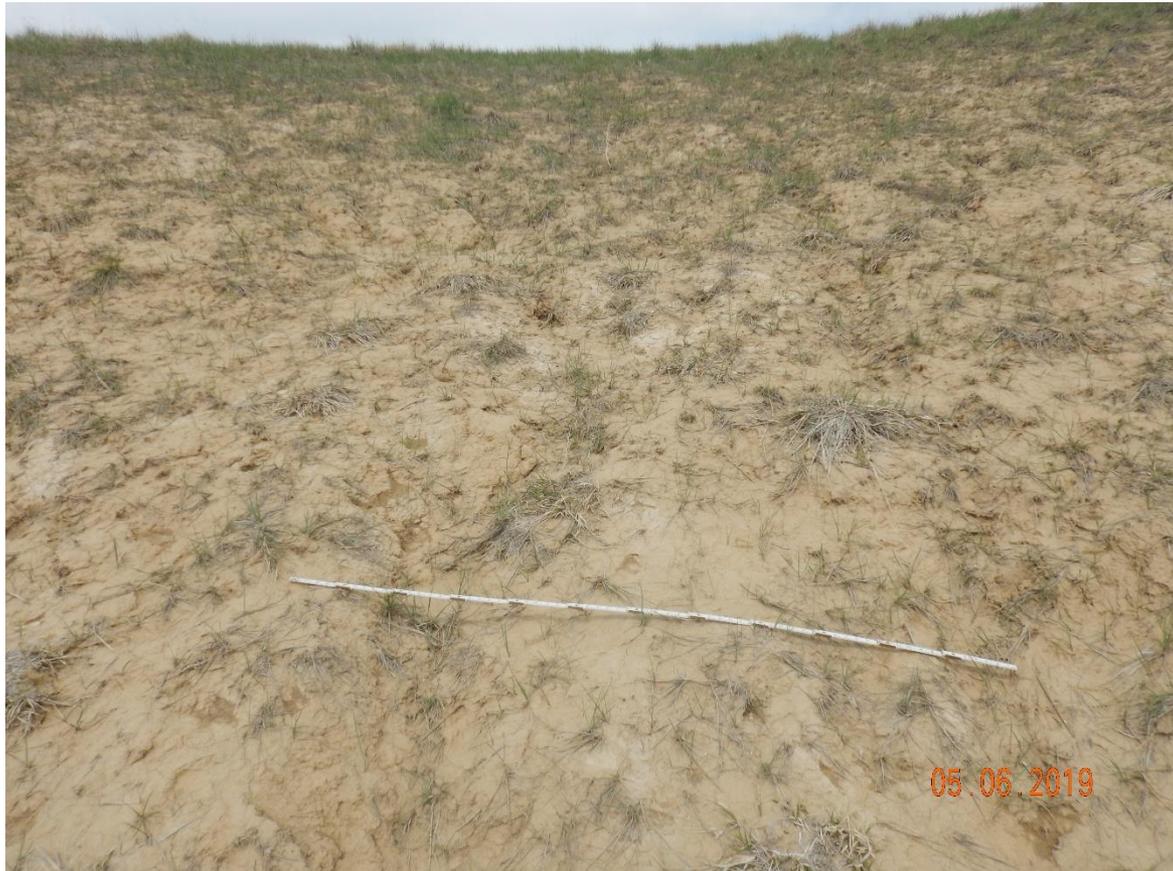
**Photo 9:** See comments under photo 7. 6 foot measuring stick for reference.

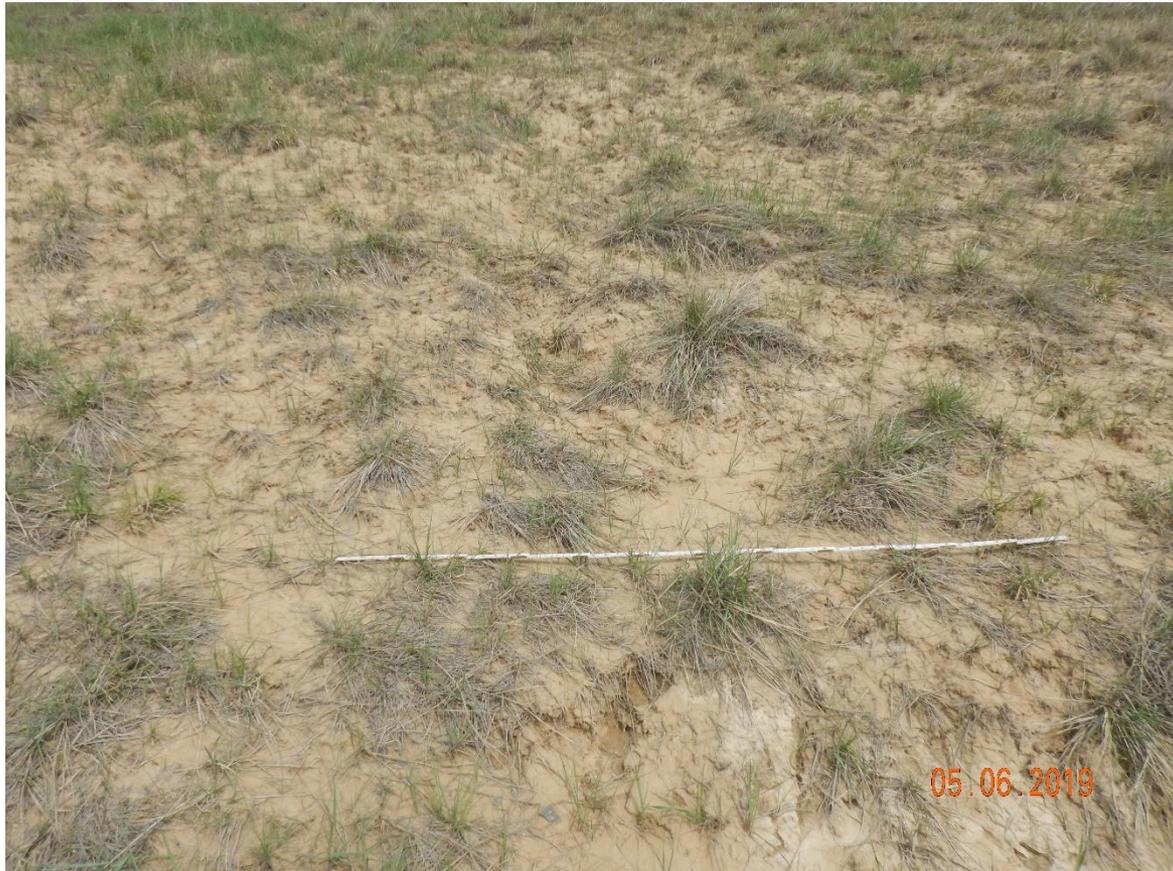
**Photo 10:** See comments under photo 7. 6 foot measuring stick for reference.

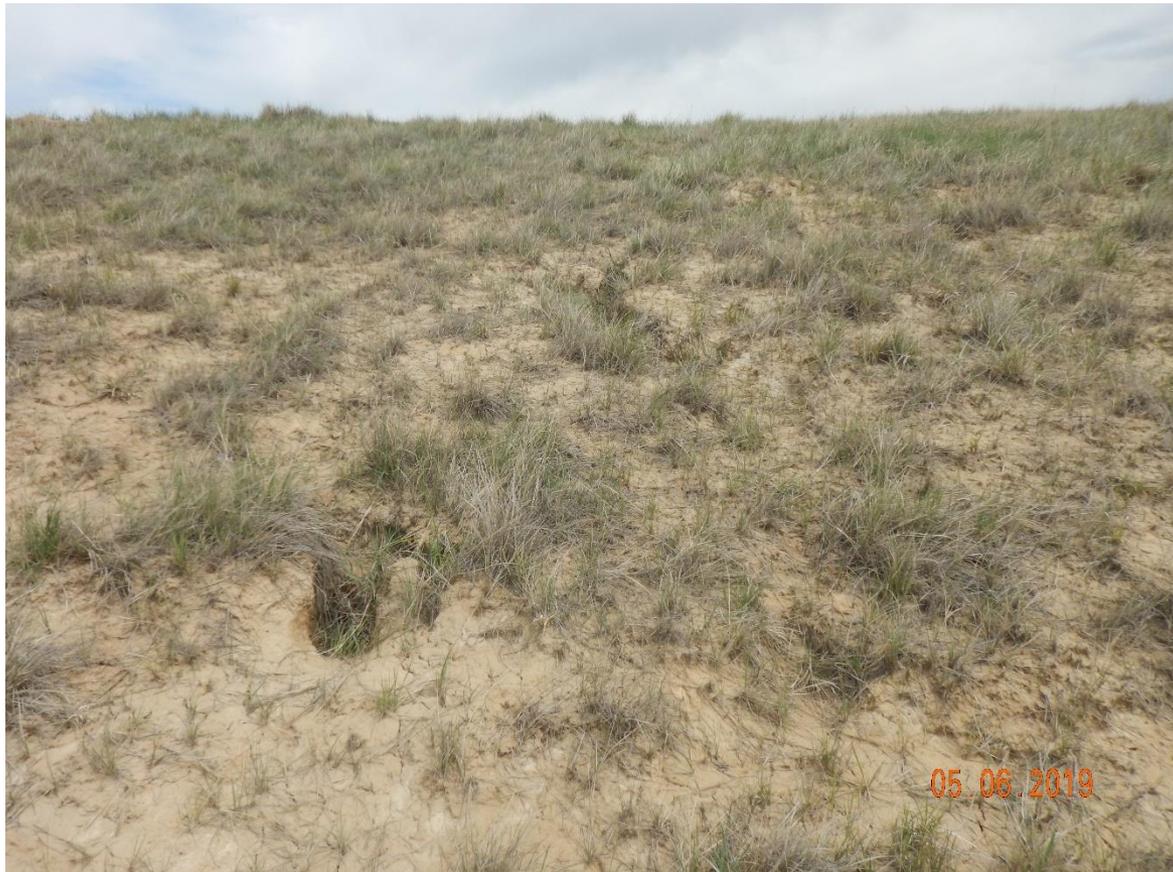
**Photo 11:** Photo taken from the southeast end of the location, facing east. See comments under photo 7.

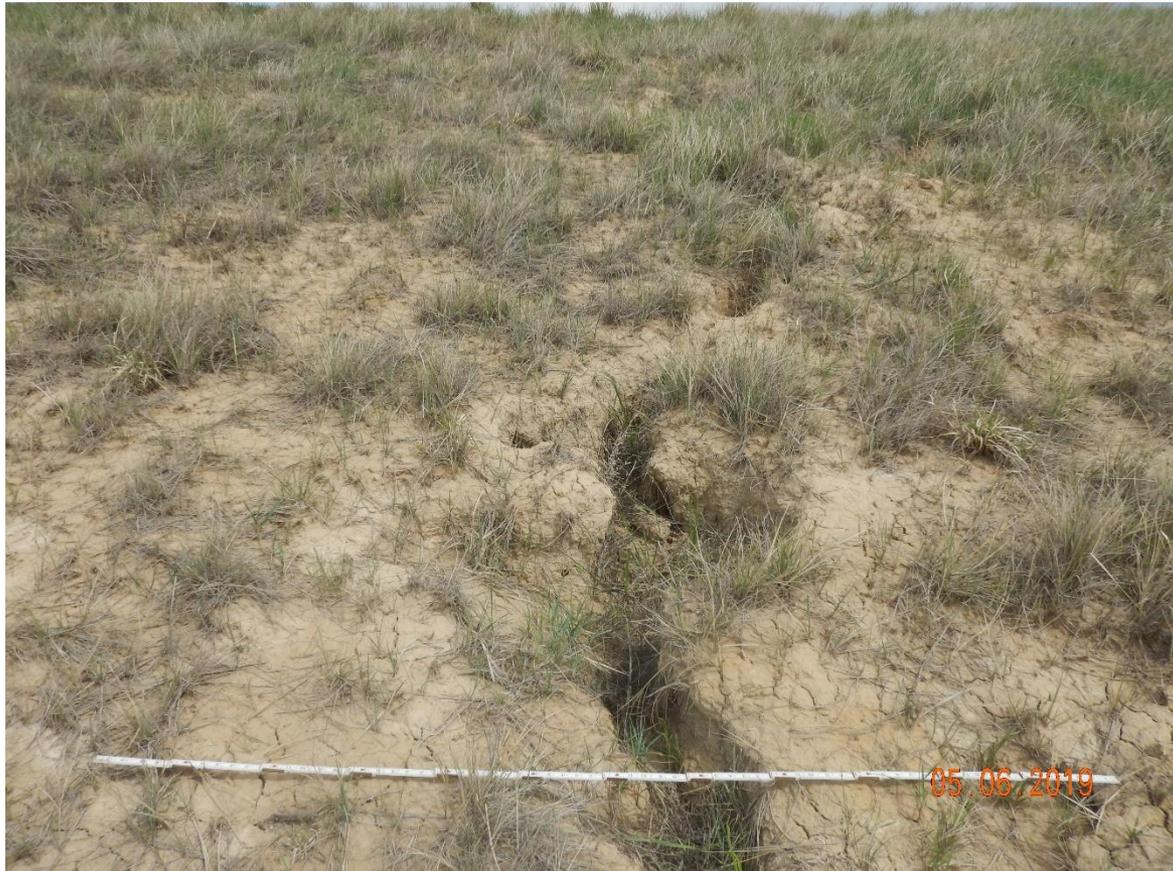
**Photo 12:** Photo shows gully erosion on the southeast end of the location. 6 foot measuring stick for reference.

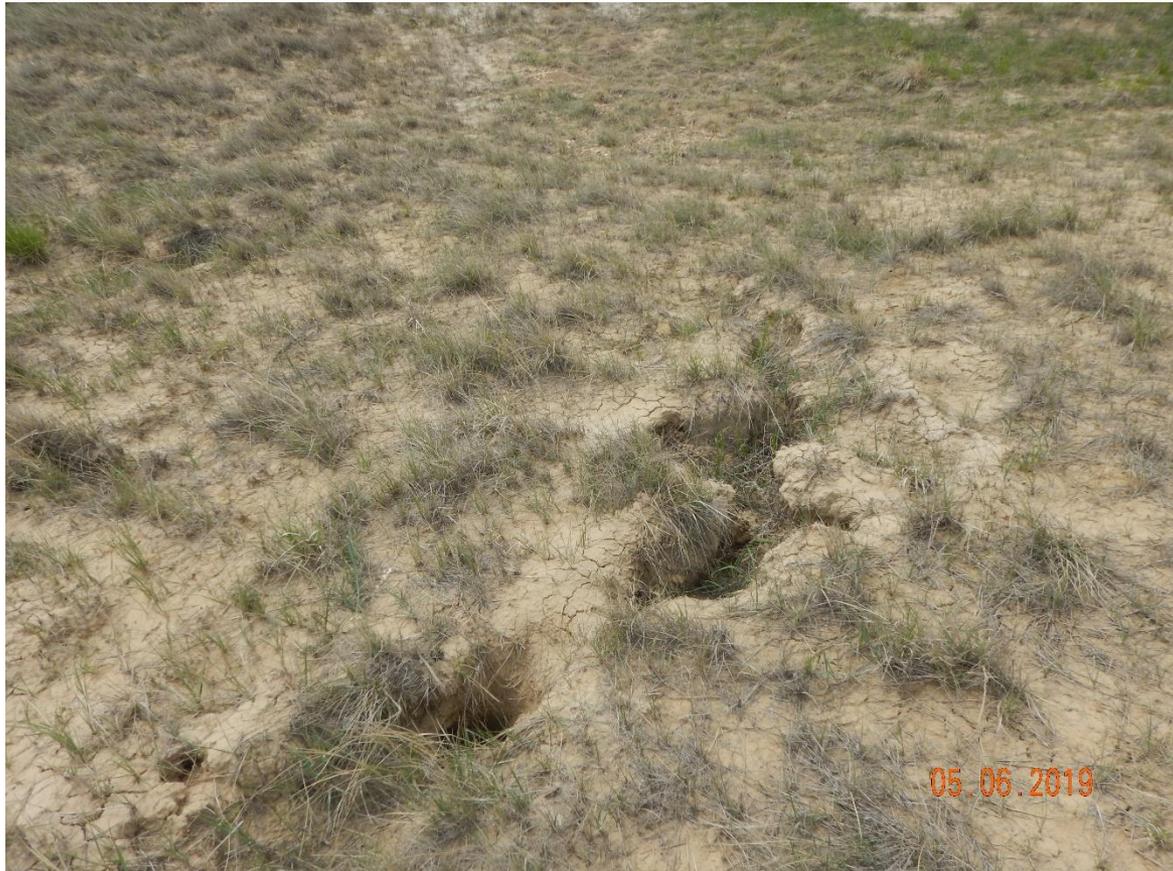
**Photo 13:** Photo shows gully erosion on the southeast end of the location.

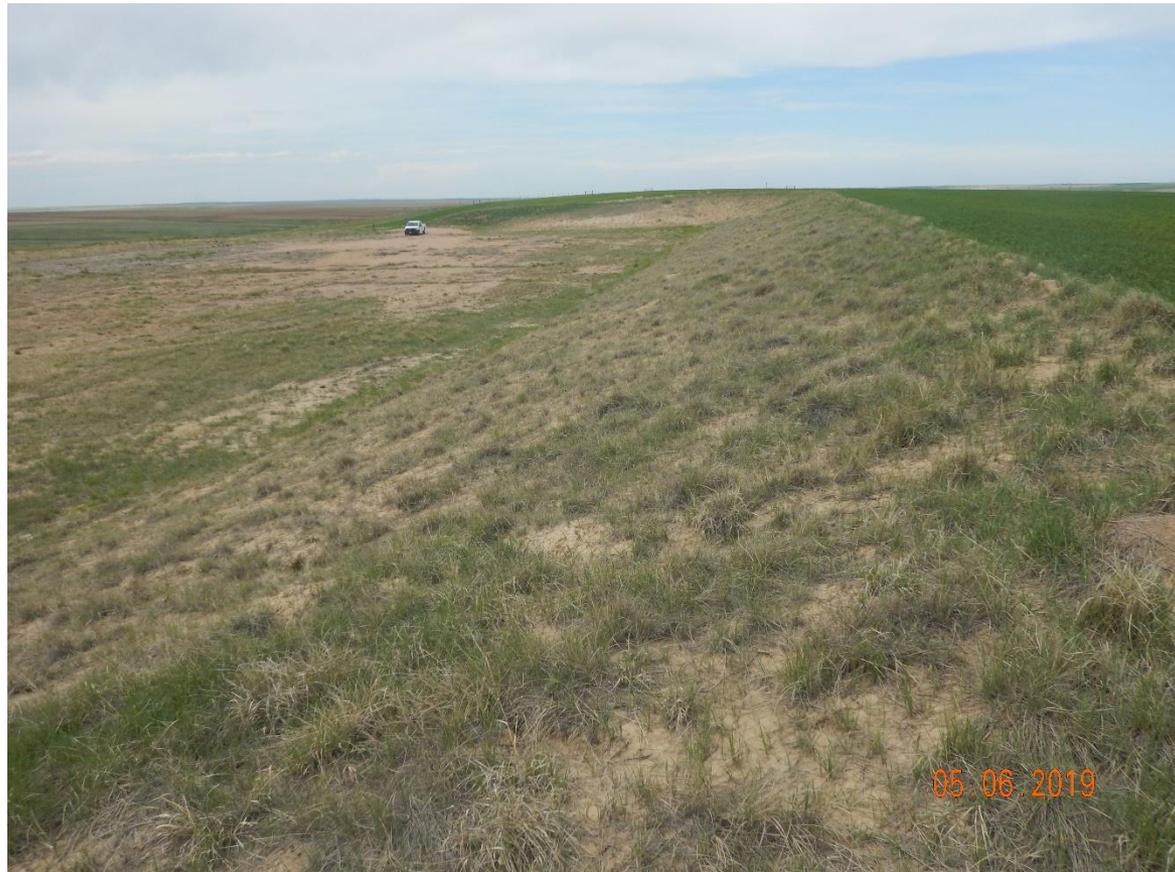
**Photo 14:** Photo taken from the southeast end of the location, facing north. Corrective actions and COAs required operator to conduct reclamation and reduce the location's disturbance area to 0.92 acres. Photo shows reclamation has not been conducted; disturbance area has not been reduced.

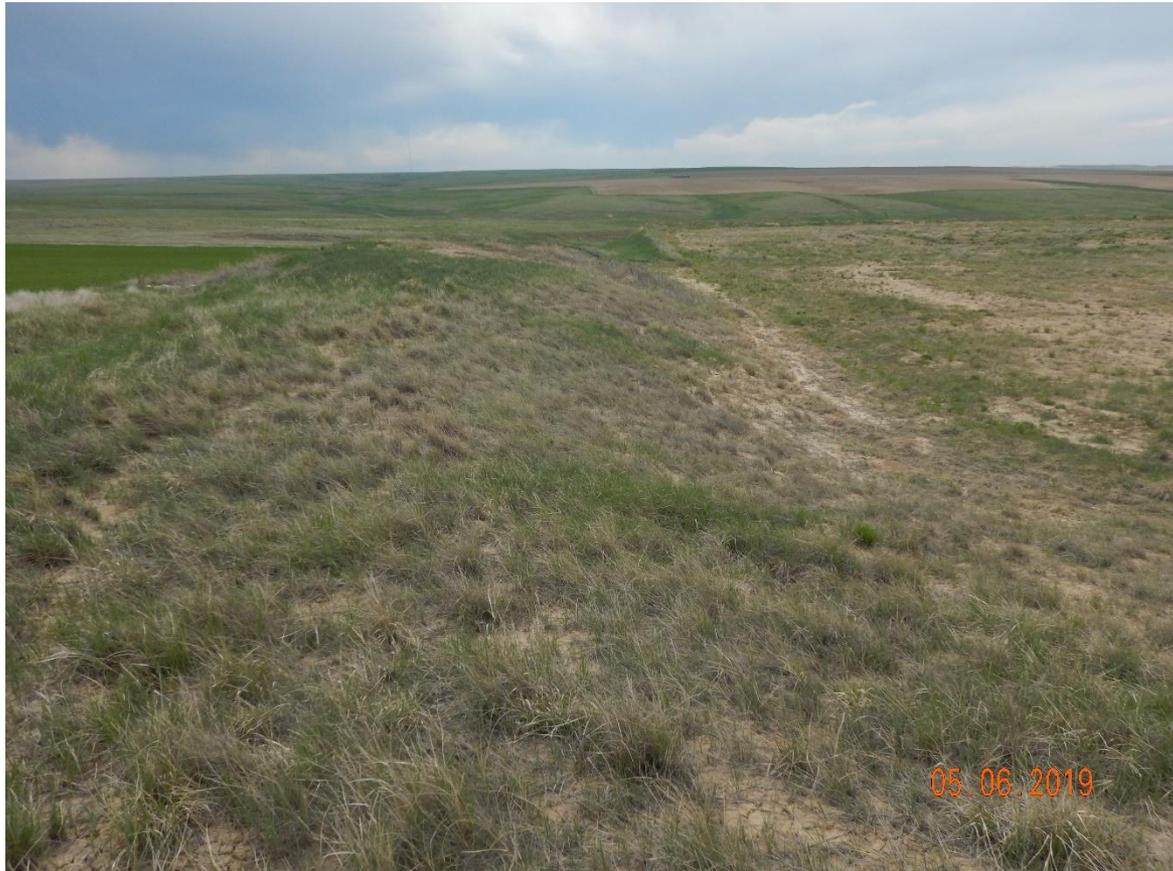
**Photo 15:** Photo taken from the southeast end of the location, facing west. Corrective actions and COAs required operator to conduct reclamation and reduce the location's disturbance area to 0.92 acres. Photo shows reclamation has not been conducted; disturbance area has not been reduced.

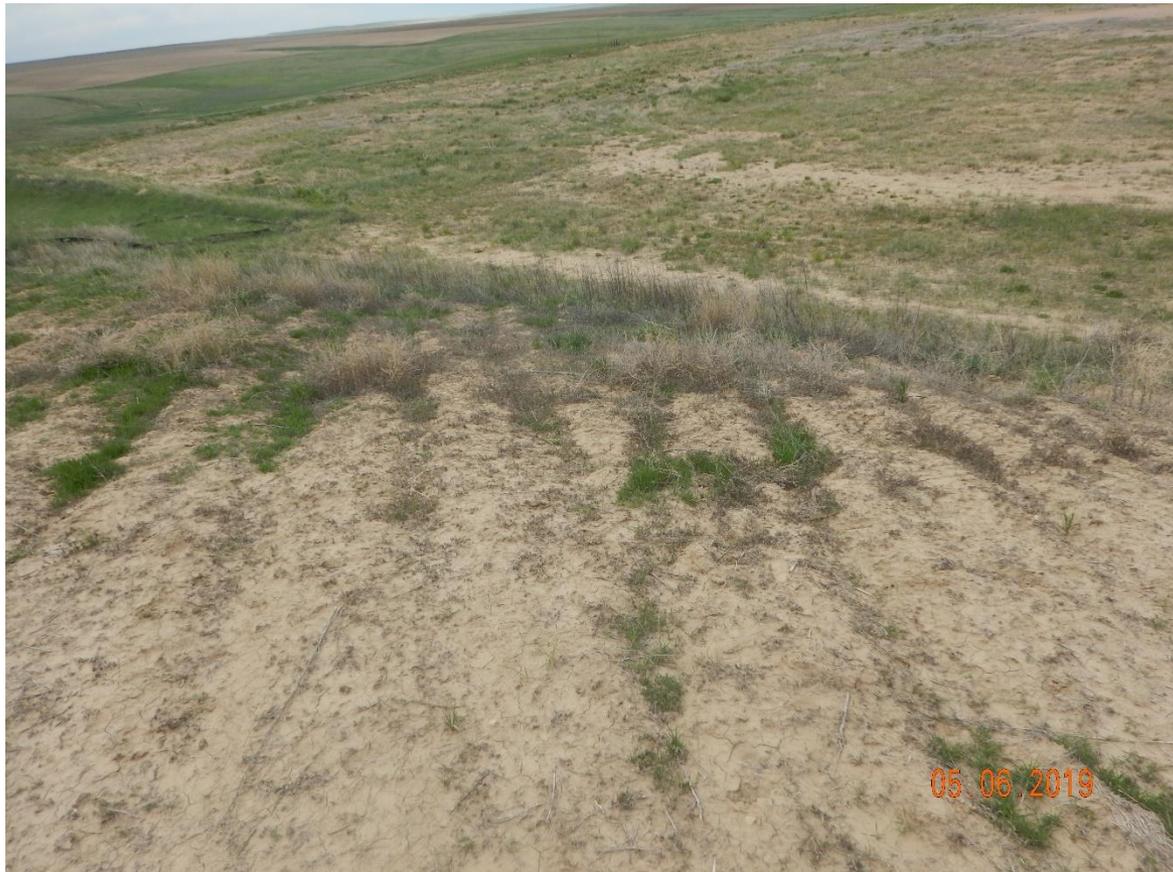
**Photo 16:** Photo taken from the “spoils” stockpile on the south end of the location, facing northwest. Photo shows areas of bare and exposed soil with large furrows. Previous inspections required operator to repair erosion and stabilize slopes. Photo shows erosion has not been repaired and BMP’s have not been installed. Photo also shows reclamation activities have not been conducted per CAs and COAs

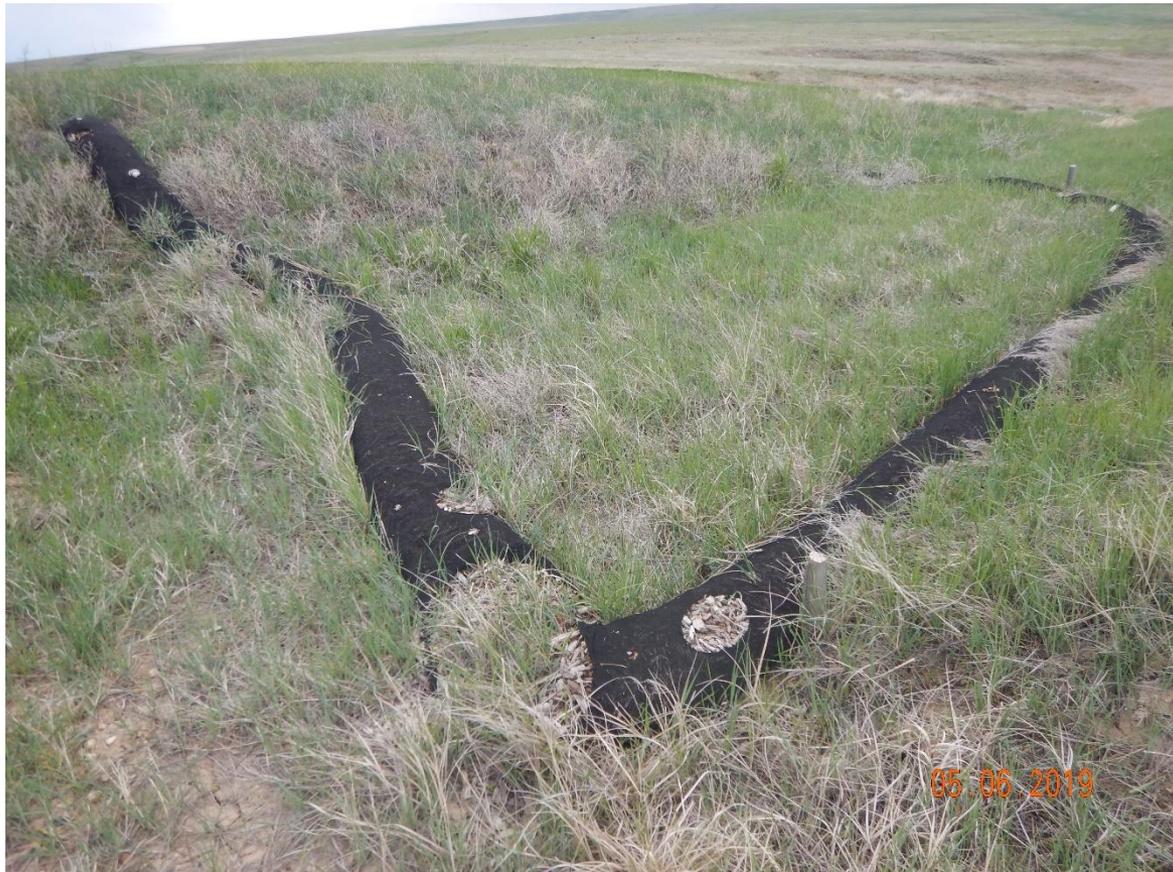
**Photo 17:** Photo taken from south end of the location, facing southwest. Photo shows wood-mulch wattle stormwater ponding BMP. Previous inspections documented BMP was degrading. Photo shows BMP has not been maintained/repared.

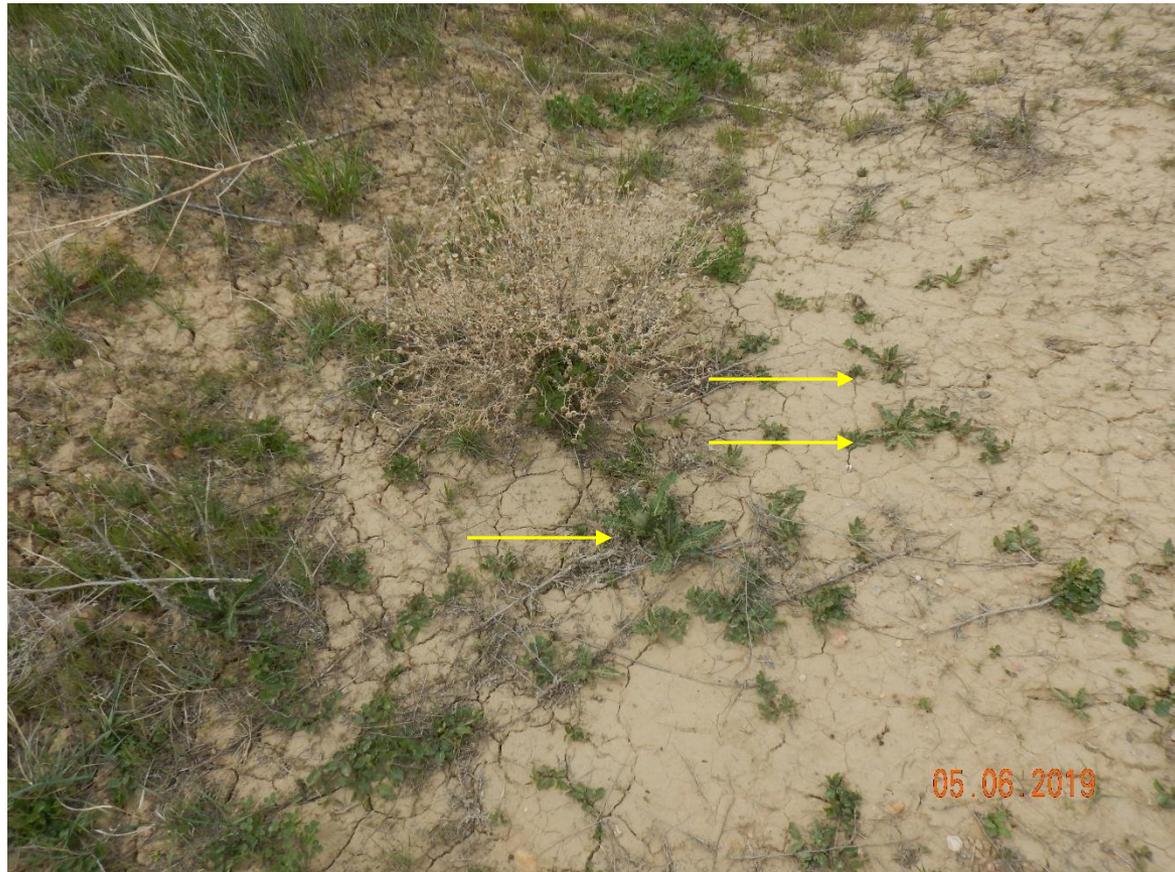
**Photo 18:** Photo taken from the southwest corner of the location. Photo shows Canada Thistle rosettes are now present on the southwest end of the location.

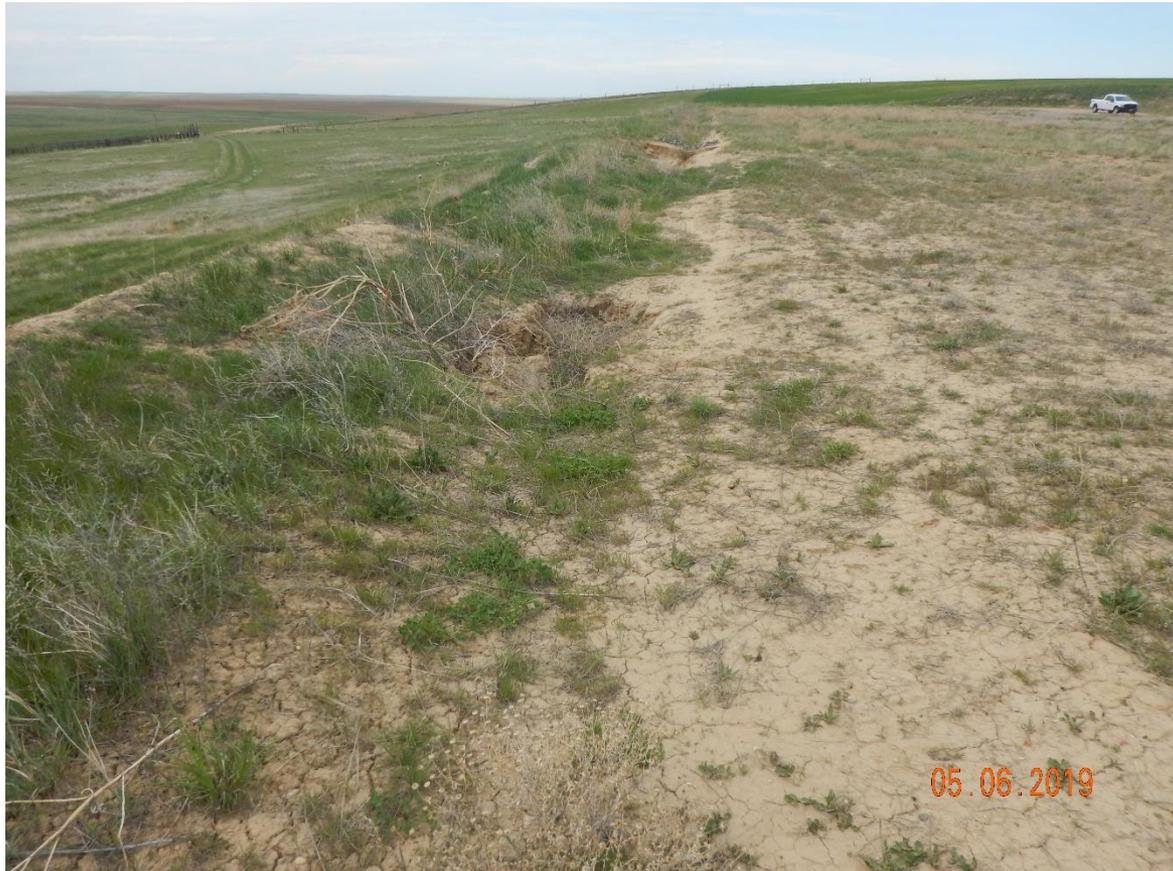
**Photo 19:** Photo taken from the southwest corner of the location, facing north. Photo shows stormwater ditch along perimeter of the pad.

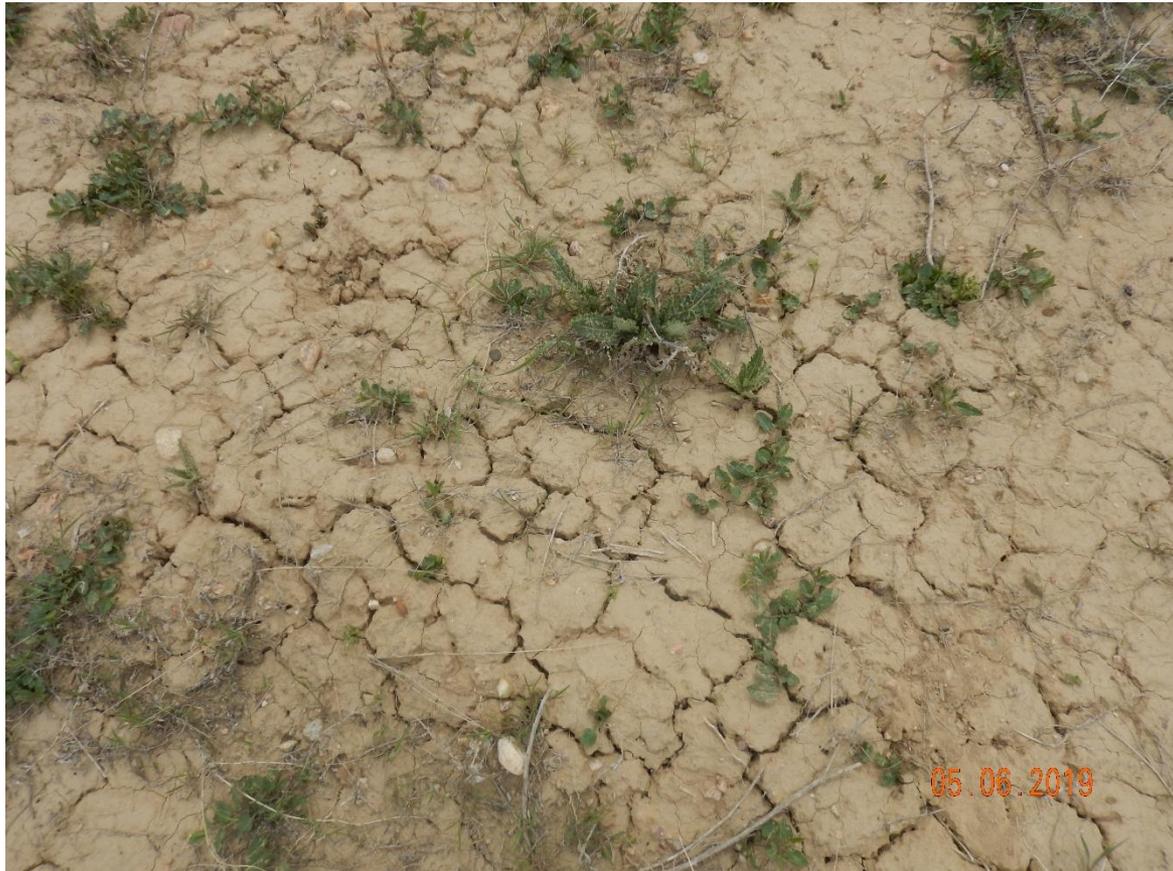
**Photo 20:** Photo taken from the ditch on the west end of the location. Photo shows Canada Thistle rosettes are now present on the west end of the location.

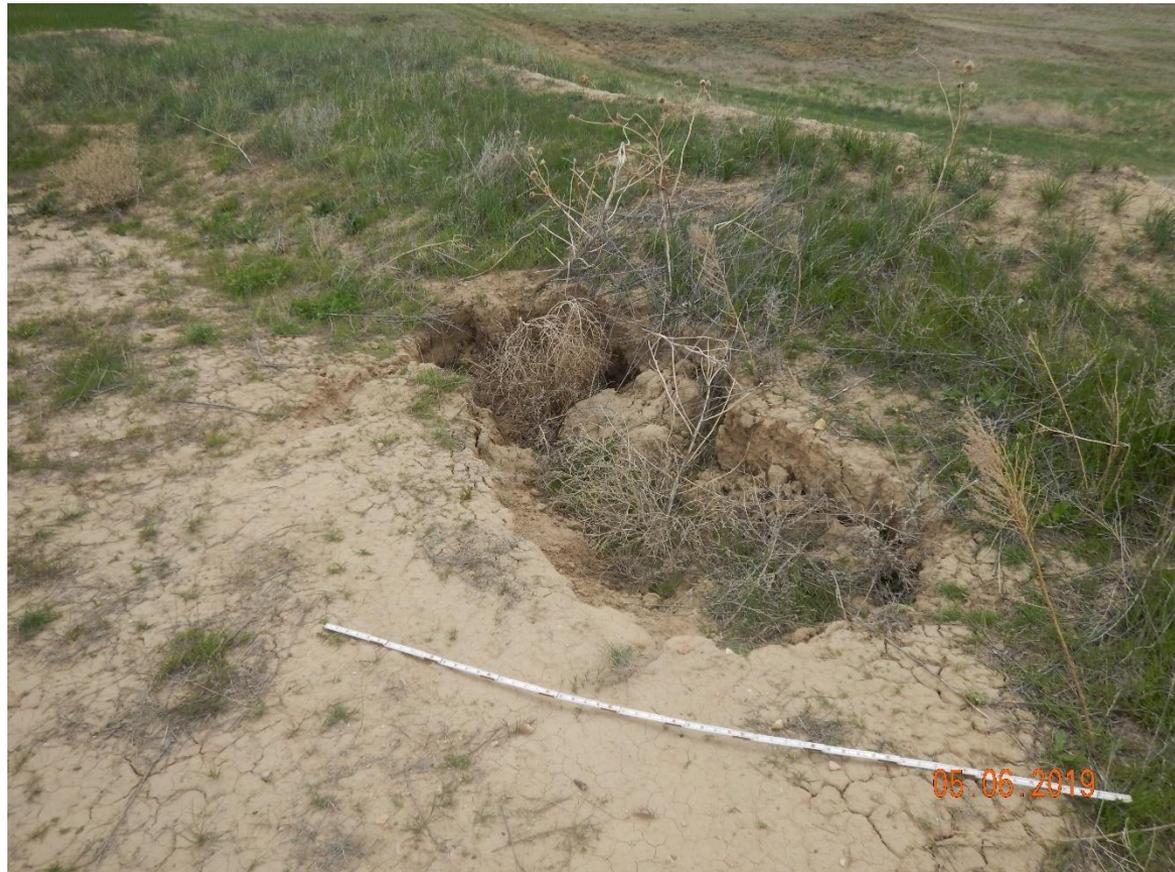
**Photo 21:** Photo taken from the ditch on the southwest corner of the location, facing southwest. Previous inspections documented that stormwater runoff has incised the ditch along the west end of the pad and created sinkholes within the ditch. Photo shows erosion degradation has not been repaired and stabilized. Stormwater has continued to incise within the ditch and sinkholes appear to be expanding. 6 foot measuring stick for reference.
