# Inspection Photos

Operator: SWN PRODUCTION COMPANY LLC -  
10396

Location ID: 427955

Inspection Doc. Number: 696200023  
Adams County, CO

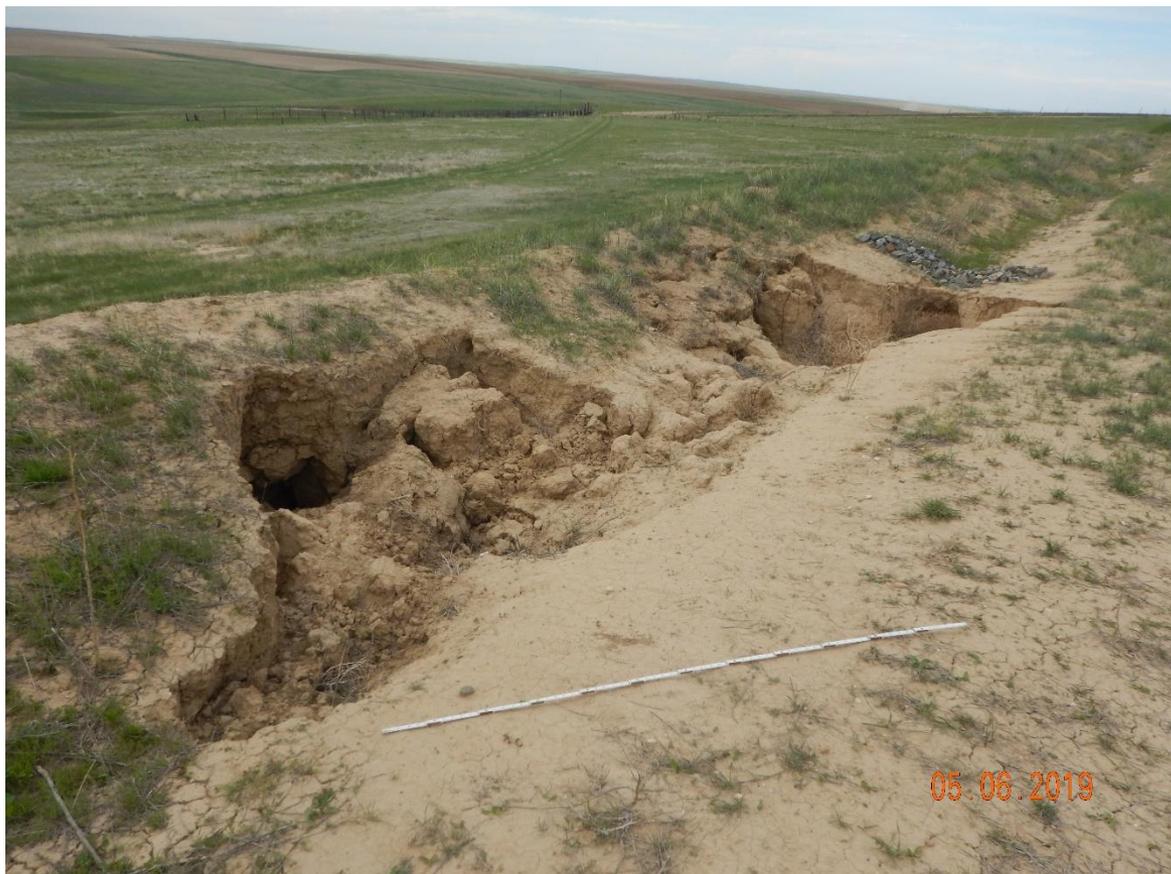
**Photo 20:** Photo taken from the ditch on the west end of the location. Photo shows Canada Thistle rosettes are now present on the west end of the location.

**Photo 22:** Photo taken from the ditch on the west end of the location, facing northwest. See comments under photo 20. 6 foot measuring stick for reference.

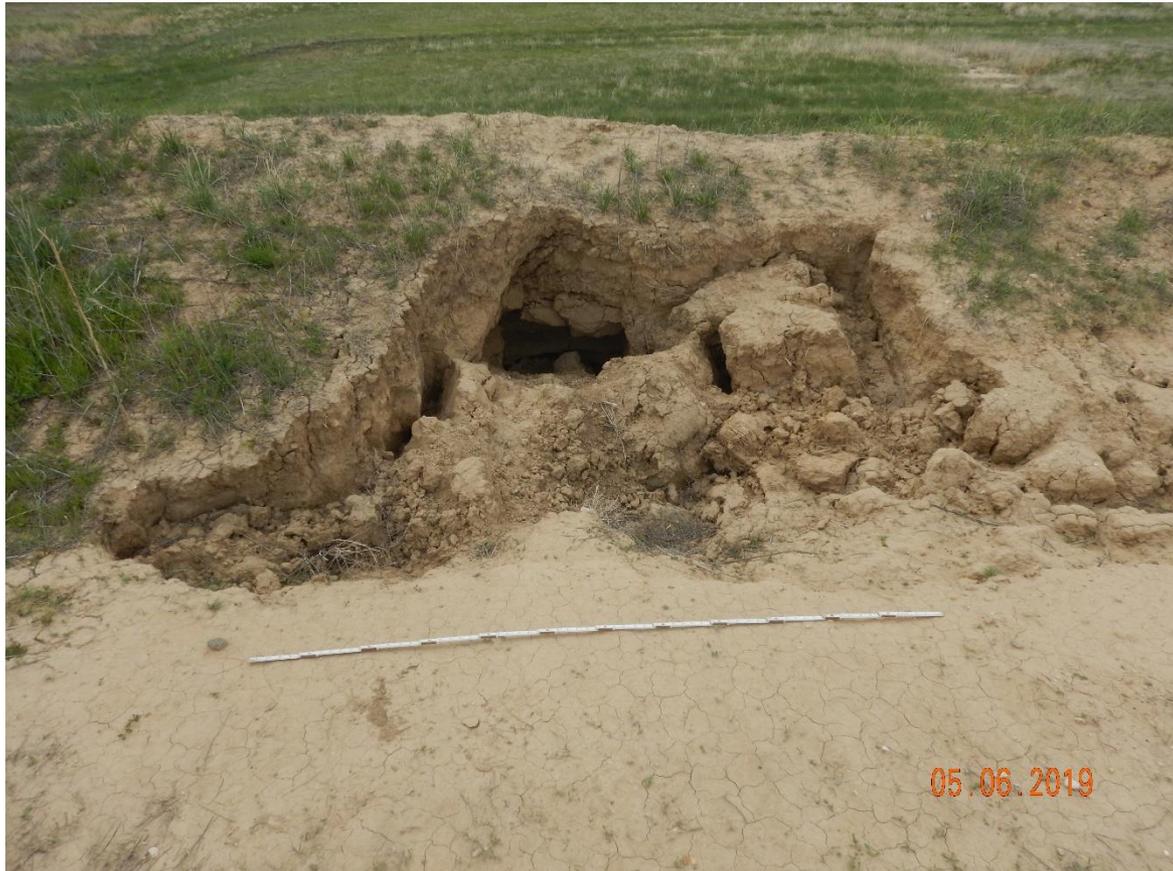
**Photo 23:** Photo taken from the ditch on the west end of the location, facing west. See comments under photo 20. 6 foot measuring stick for reference.

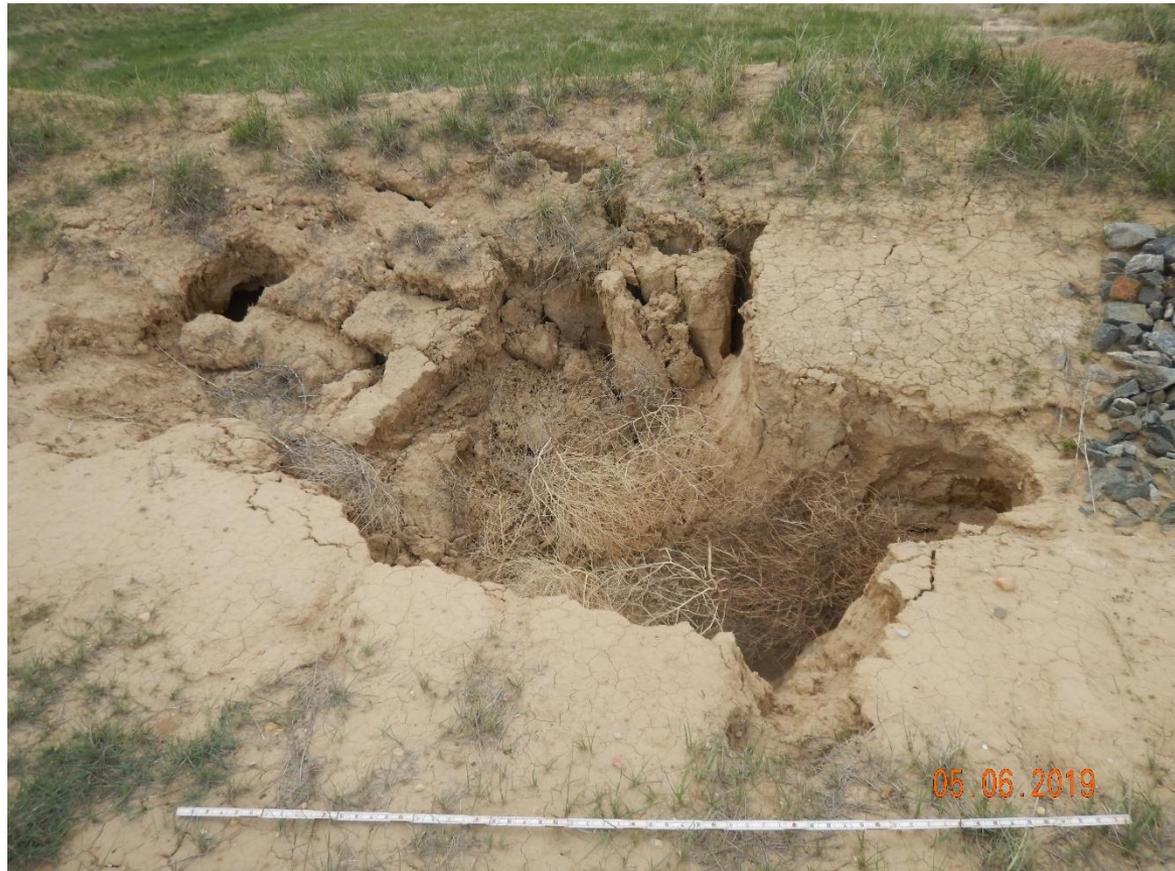
**Photo 24:** Photo taken from the ditch on the west end of the location, facing west. See comments under photo 20. 6 foot measuring stick for reference.

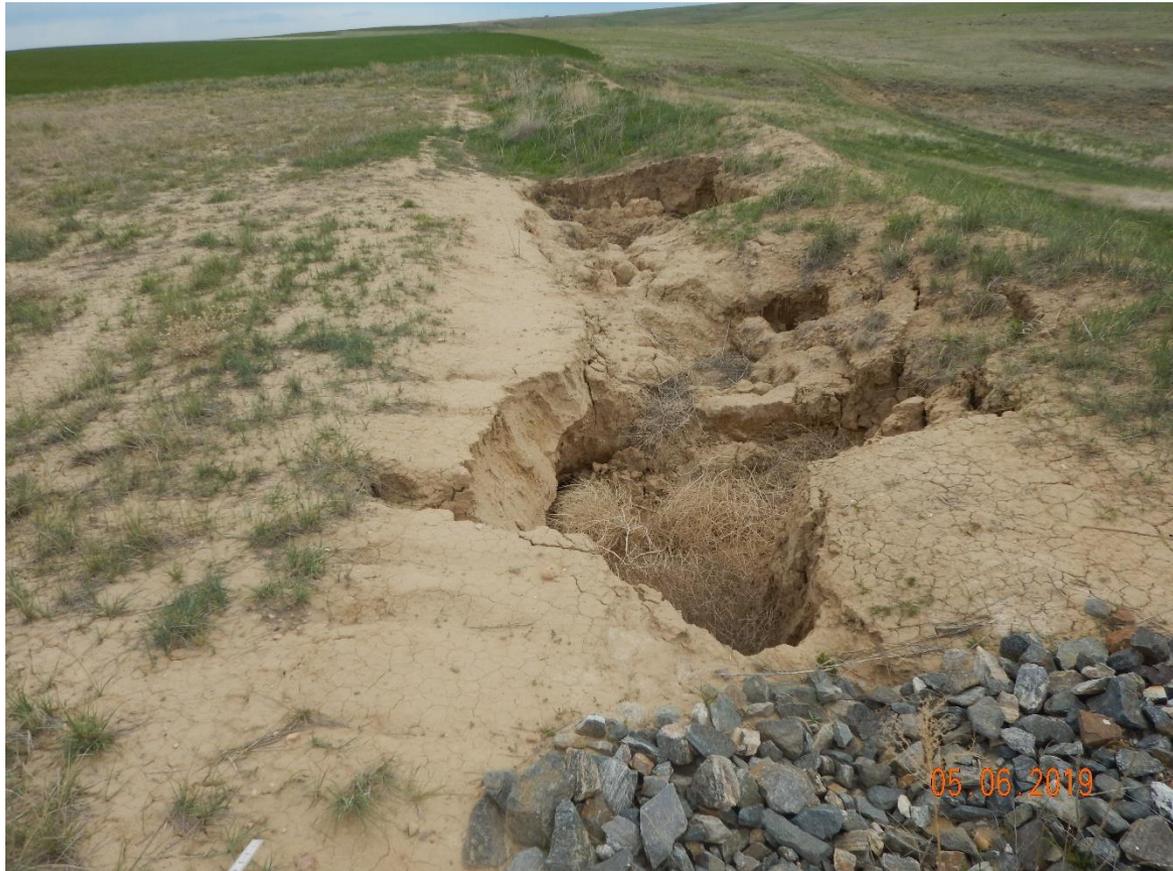
**Photo 25:** Photo taken from the ditch on the west end of the location, facing south. See comments under photo 20.

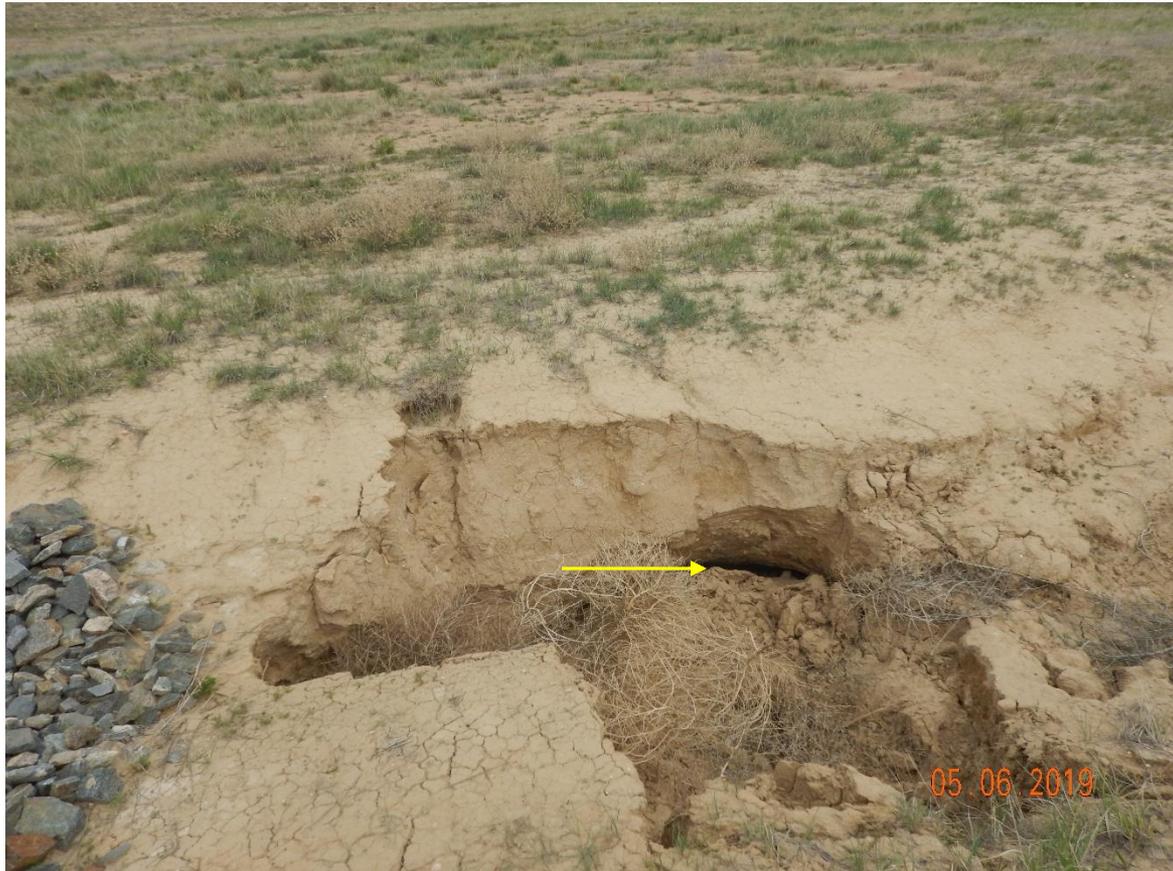
**Photo 26:** Photo taken from the ditch on the west end of the location, facing east. See comments under photo 20. Photo shows additional sinkhole from ditch expanding under pad. 6 foot measuring stick for reference.

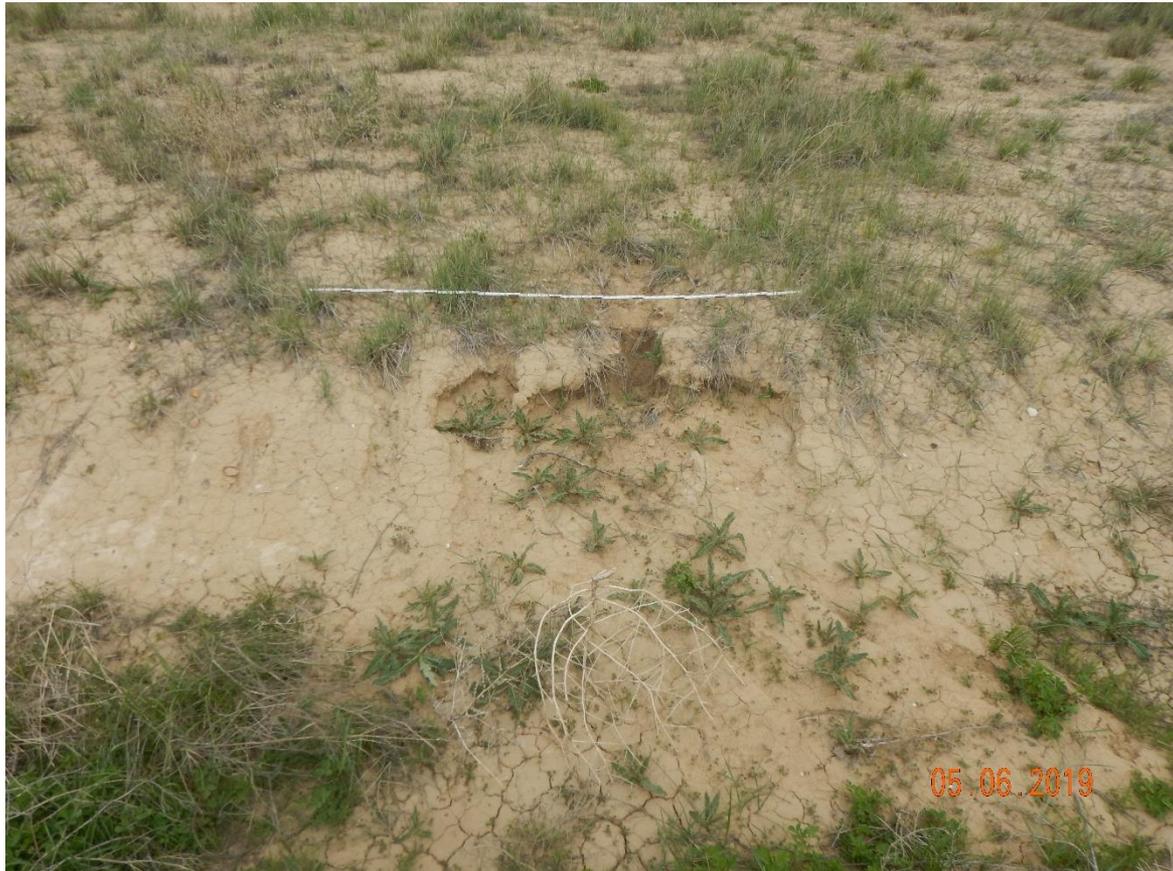
**Photo 27:** Photo taken from the ditch on the northwest end of the location, facing east. Photo shows erosion degradation cutting eastward into the pad has not been repaired or stabilized. 6 foot measuring stick for reference.

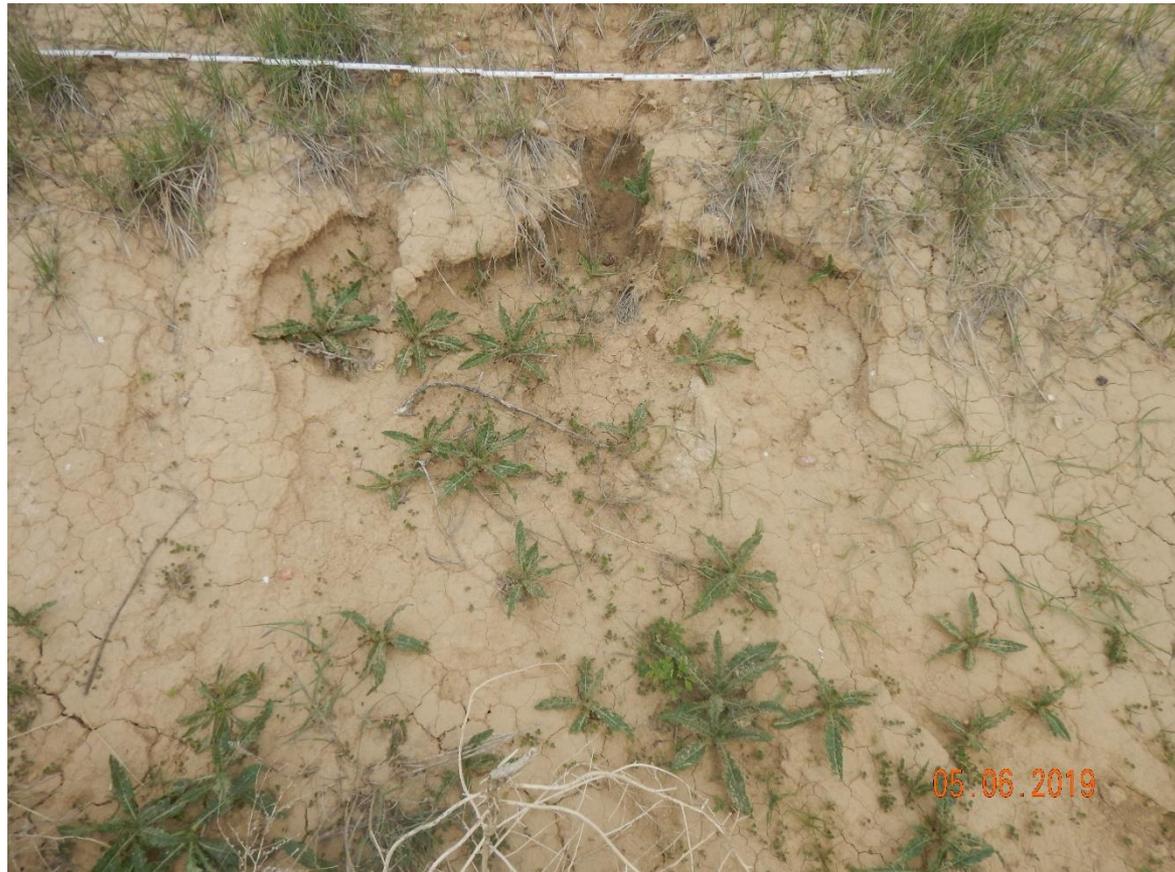
**Photo 28:** Continued from photo 26. Photo shows Canada thistle rosettes within ditch.

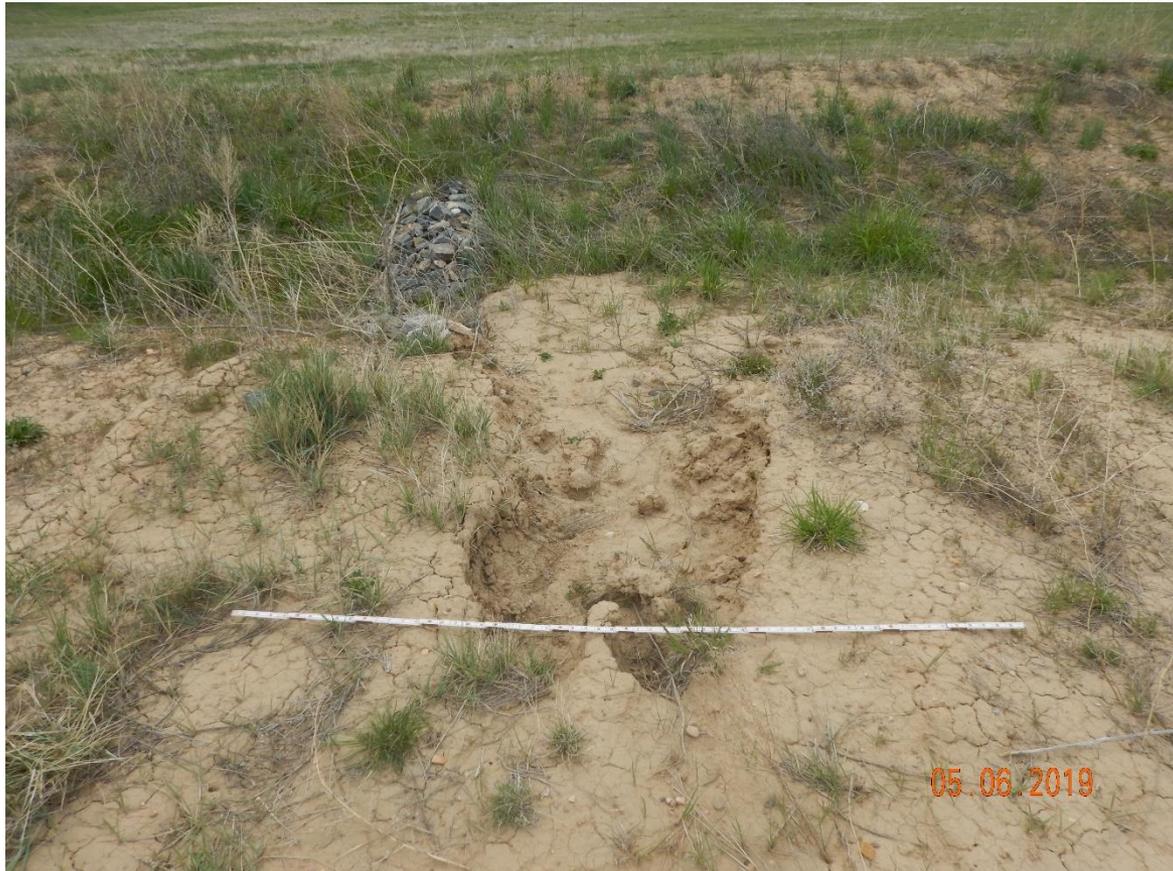
**Photo 29:** Photo taken from the ditch on the northwest end of the location, facing west. Photo shows erosion degradation cutting eastward into the pad has not been repaired or stabilized. 6 foot measuring stick for reference.

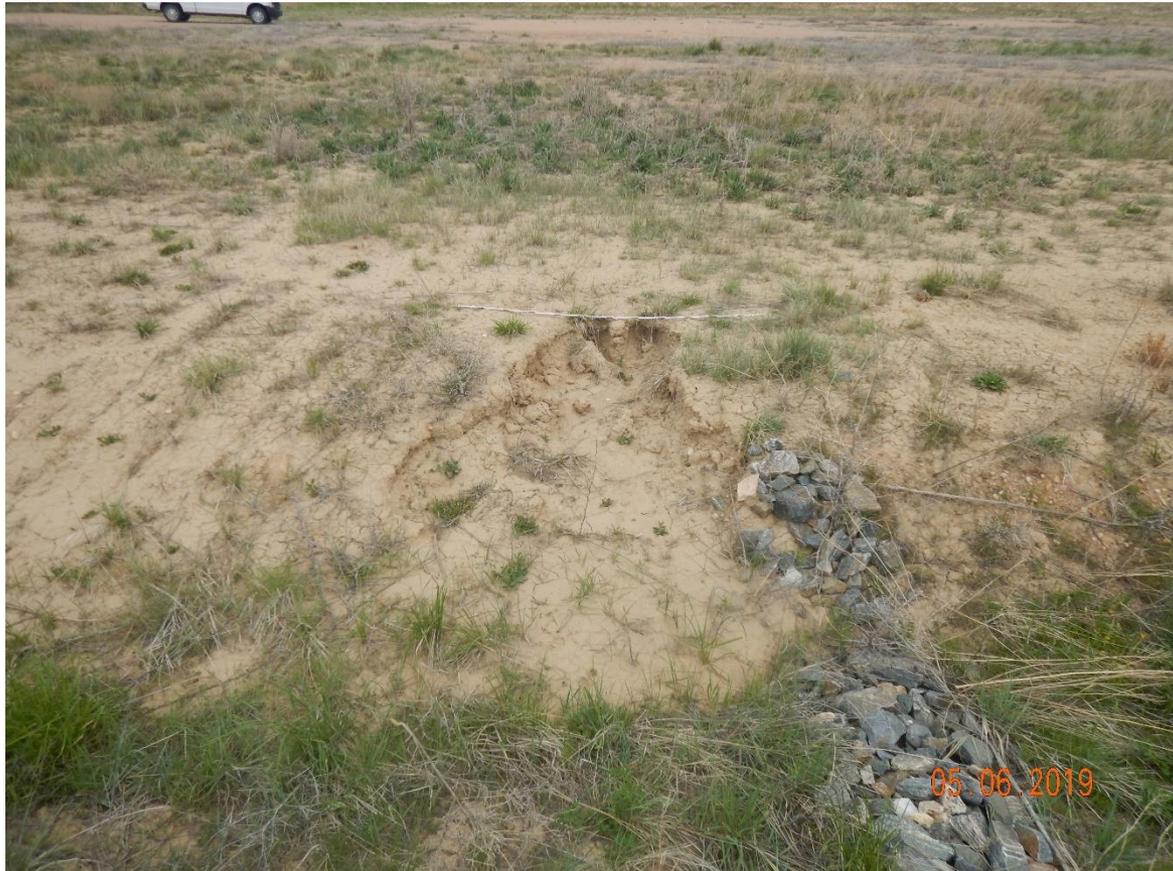
**Photo 30:** Photo taken from the ditch on the northwest end of the location, facing east. Photo shows erosion degradation cutting eastward into the pad has not been repaired or stabilized. 6 foot measuring stick for reference.

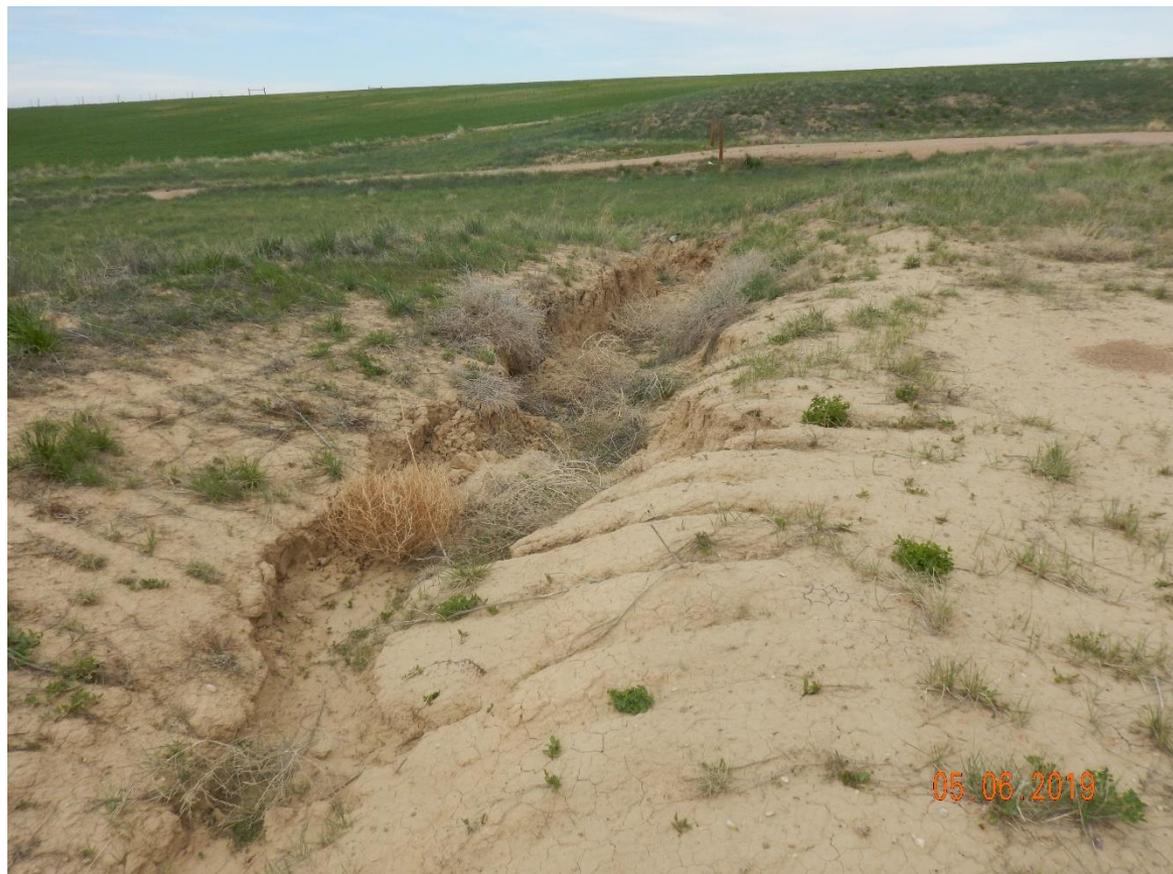
**Photo 31:** Photo taken from the north end of the location, facing northeast. Photo shows gully erosion due to stormwater runoff from the ditch has not been repaired or stabilized.

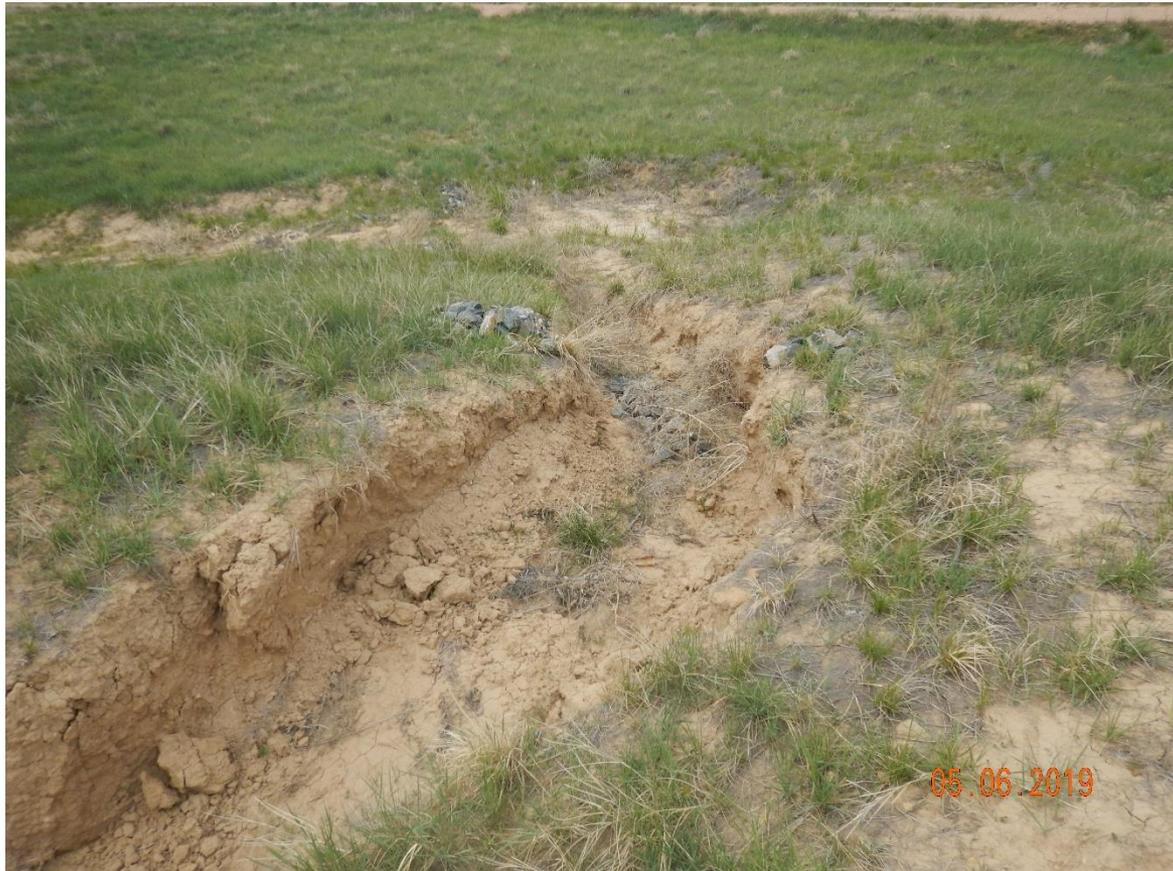
**Photo 32:** Photo taken from the north end of the location, facing north. Photo shows gully erosion due to stormwater runoff from the ditch has not been repaired or stabilized.

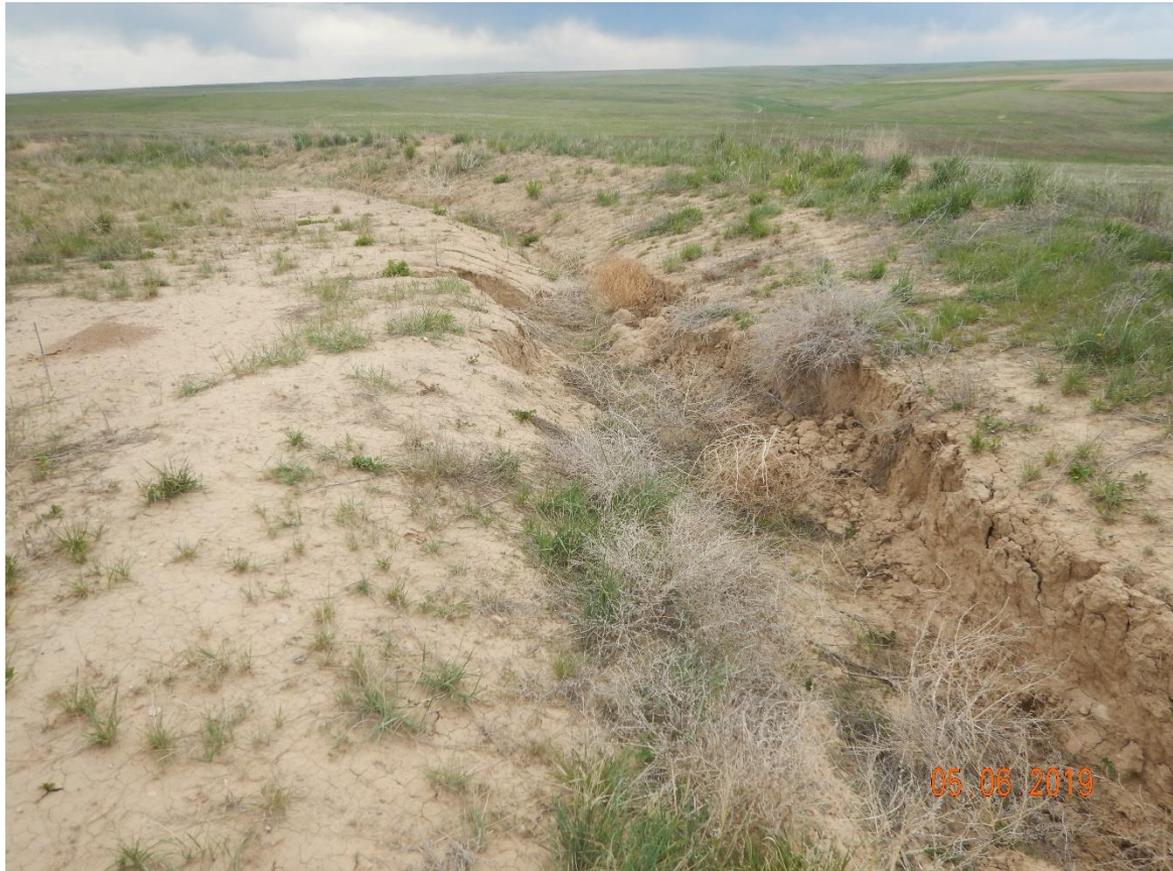
**Photo 33:** Photo taken from the north end of the location, facing southwest. Photo shows gully erosion due to stormwater runoff from the ditch has not been repaired or stabilized.

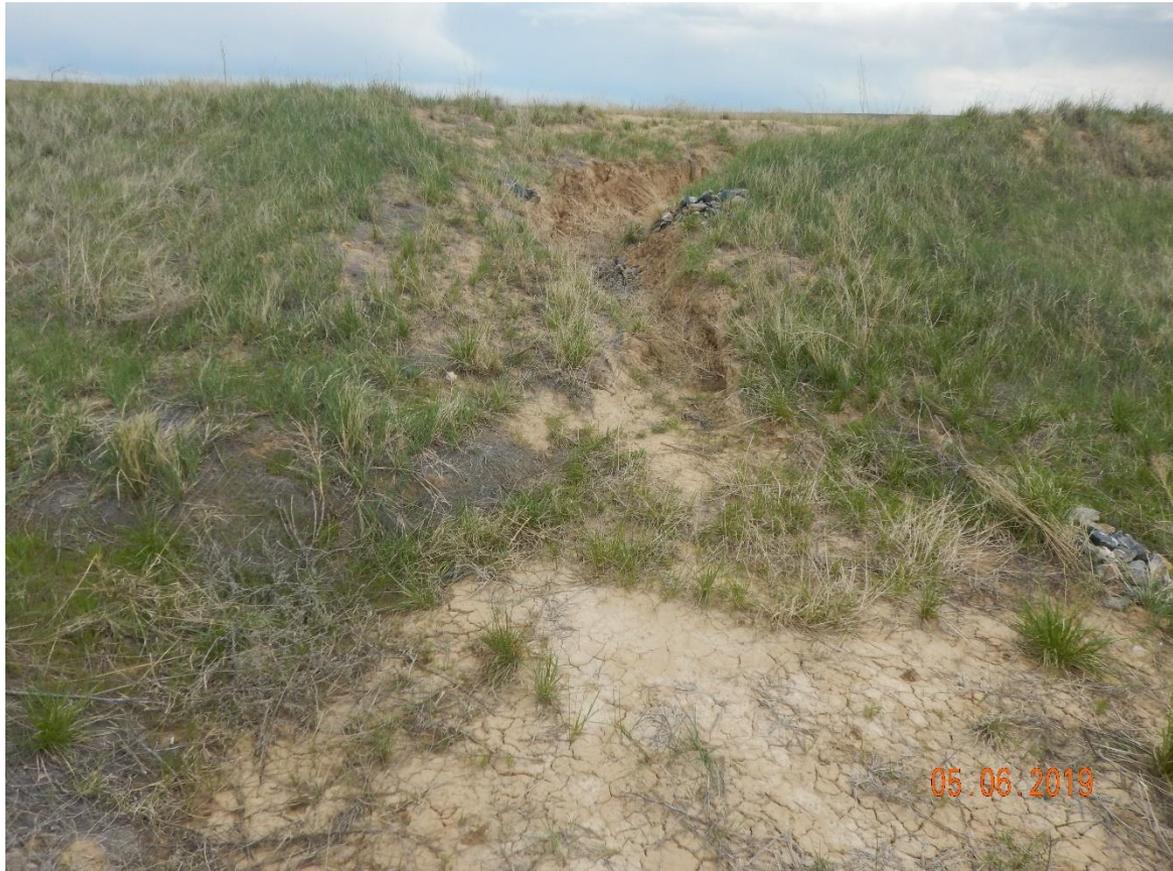
**Photo 34:** Photo taken from the north end of the location, facing south. Photo shows gully erosion due to stormwater runoff from the ditch has not been repaired or stabilized.

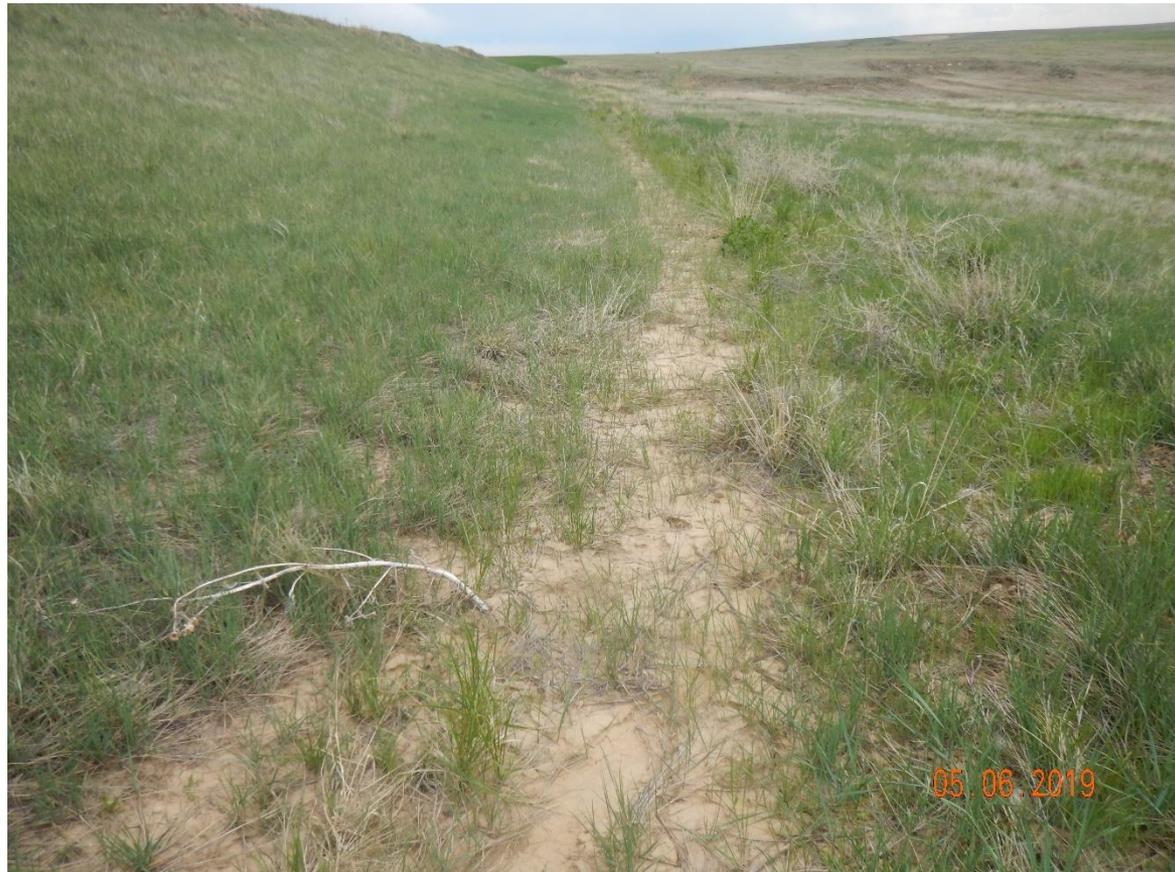
**Photo 35:** Photo taken from the stormwater ditch along the perimeter of the west end of the location. Previous inspections documented that the ditch BMP has filled with sediment and is no longer in proper functioning condition. Additionally, BMP should have been reclaimed during interim reclamation. Photo shows BMP remains filled with sediment. Photo also shows interim reclamation to reduce the area of disturbance has not been conducted.
