Inspection Photos

5/07/2019

Operator: VERDAD RESOURCES LLC # 10651

Location ID: 456563

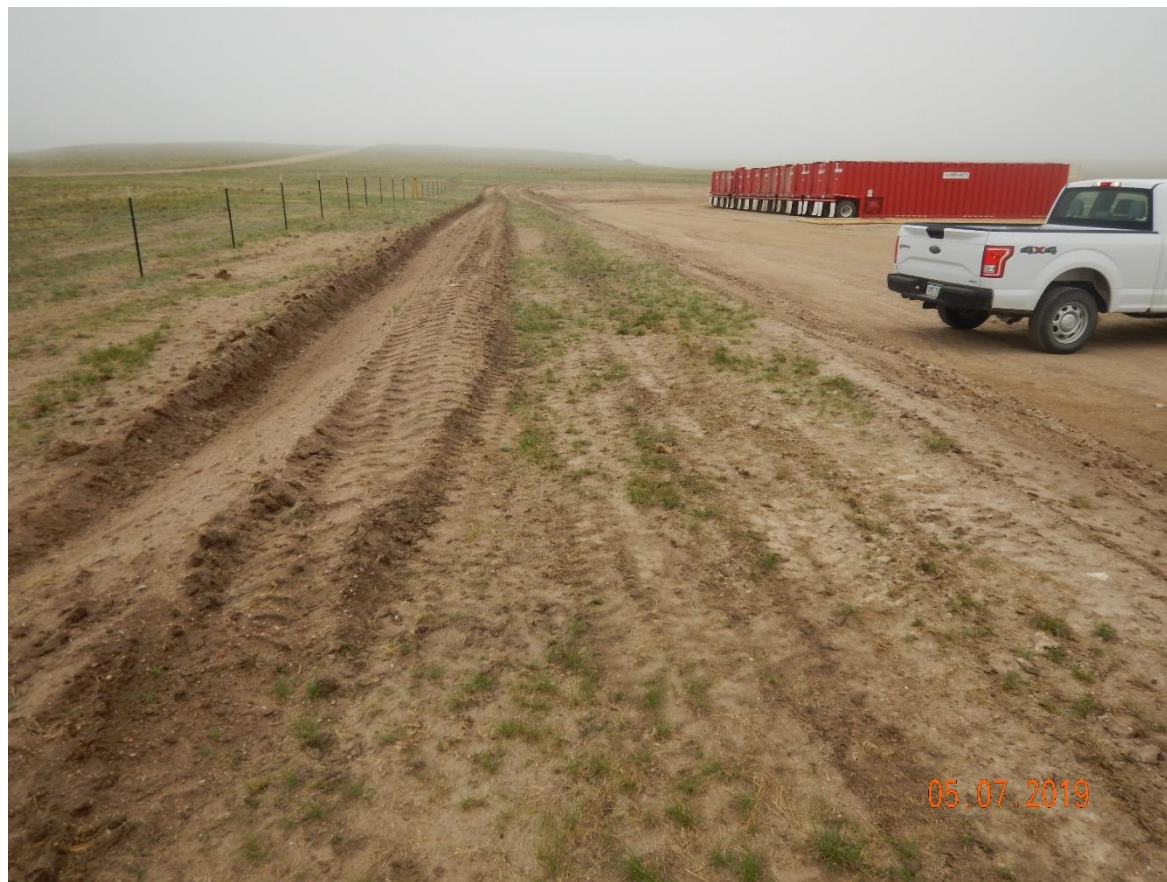
Photo 1: Photo taken from the west end of the location, facing north. Photos 1-4 provide and overview of the location from north, northeast, southeast to south.

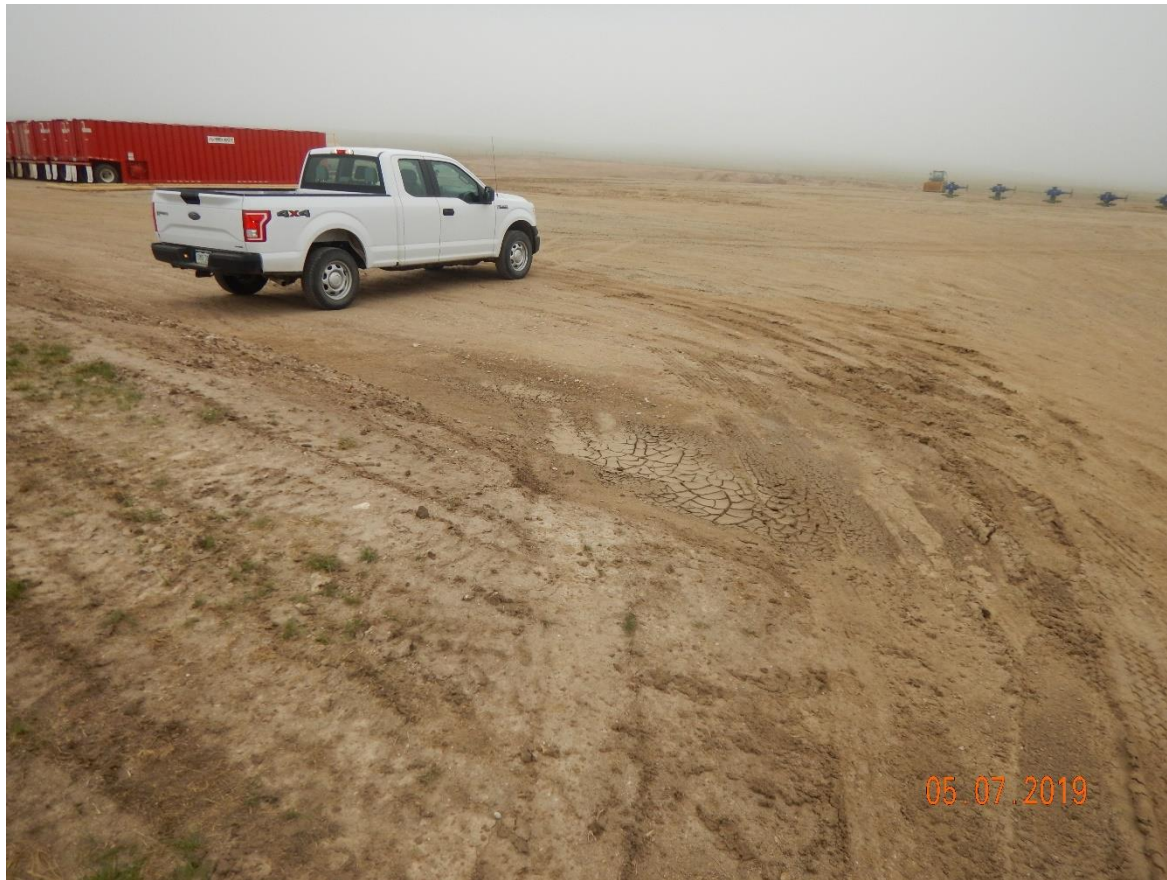
Photo 2: See comments under photo 1.

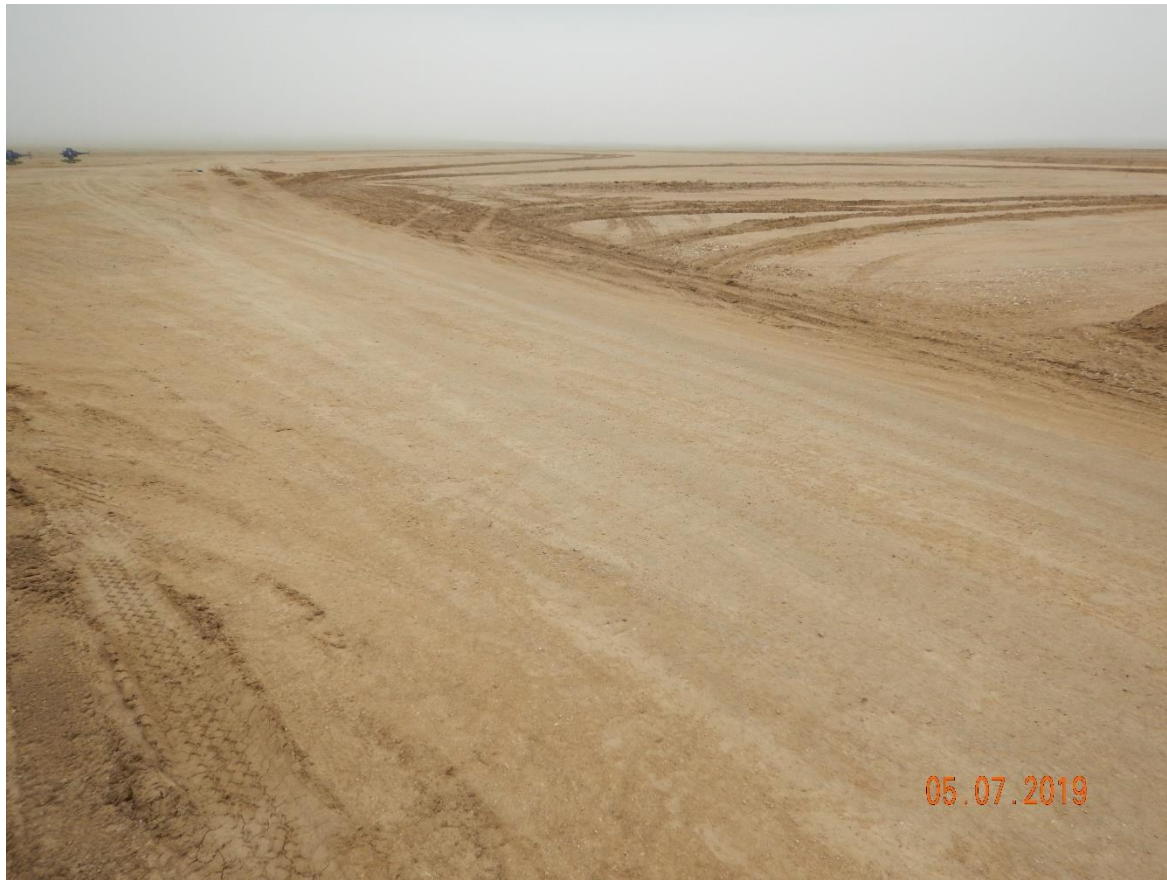
Photo 3: See comments under photo 1.

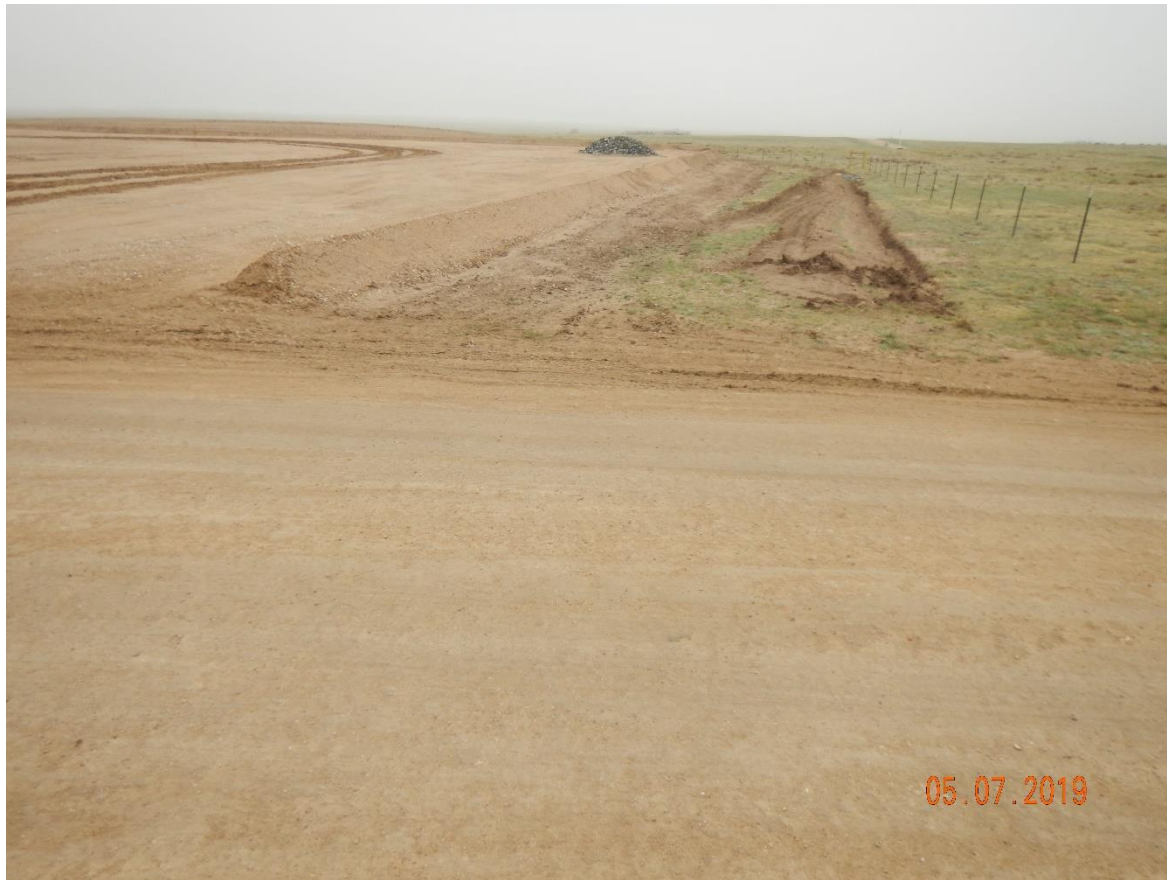
Photo 4: See comments under photo 1.

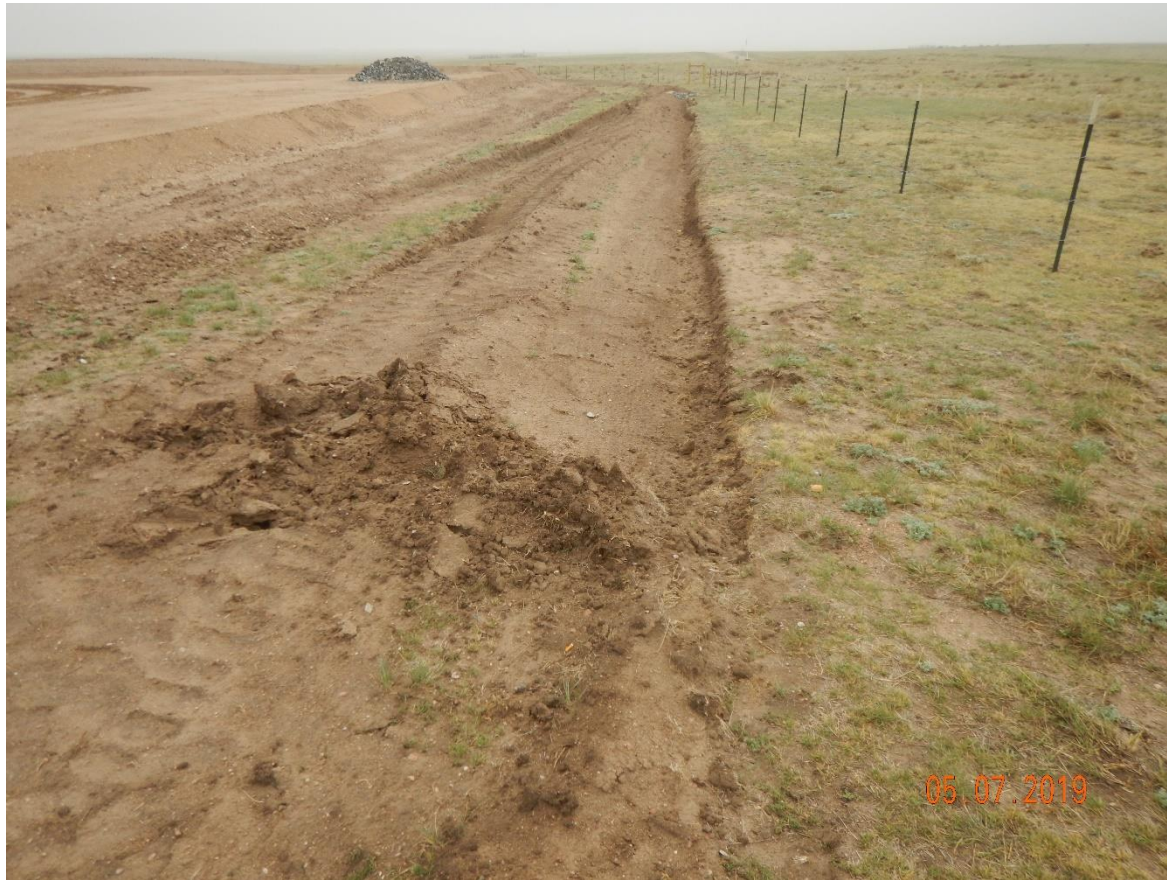
Photo 5: Photo taken from the wet end of the location, facing south. Photo shows stormwater ditch along perimeter of location. BMP appears to have been constructed with a blade leaving a vertical grade of unconsolidated material. Ditch has not been constructed in accordance with good engineering practices.

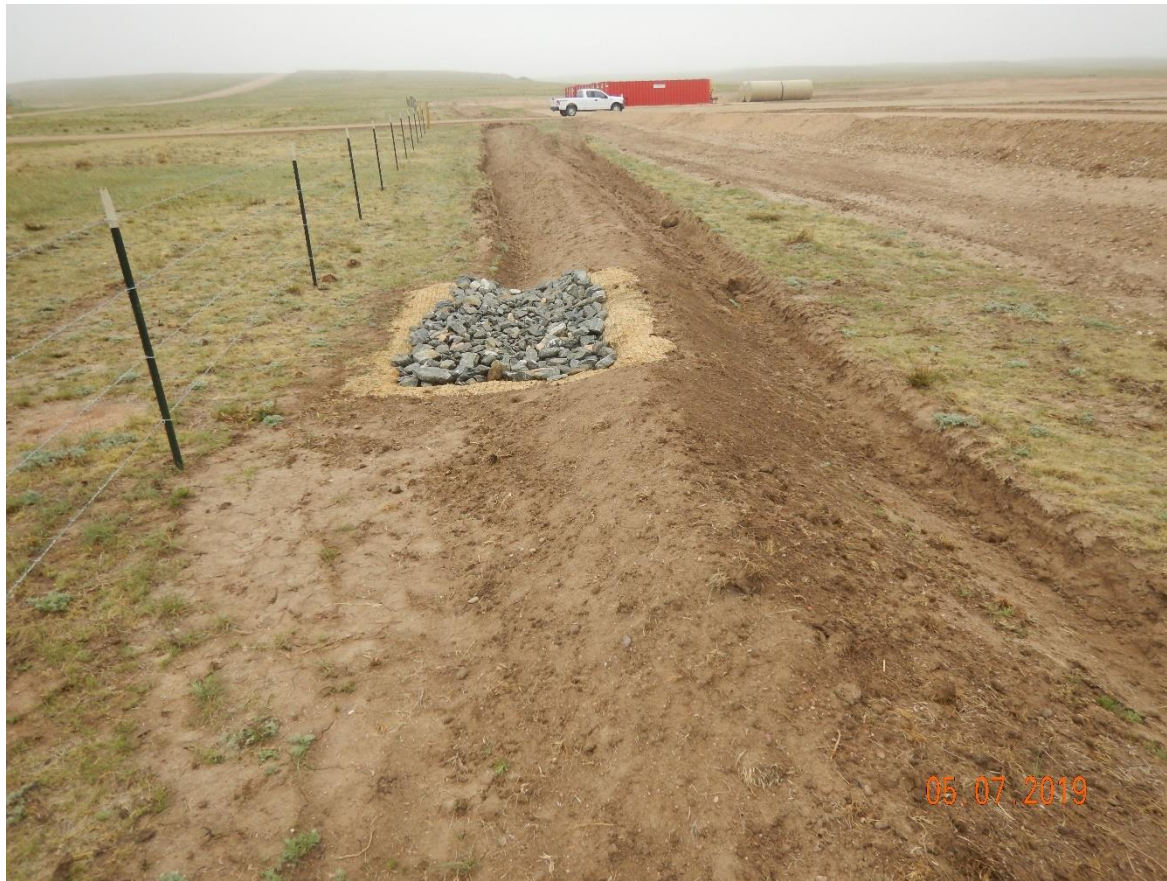
Photo 6: Photo taken from the southwest end o the location, facing north. Photo shows outlet armoring at the stormwater ditch.

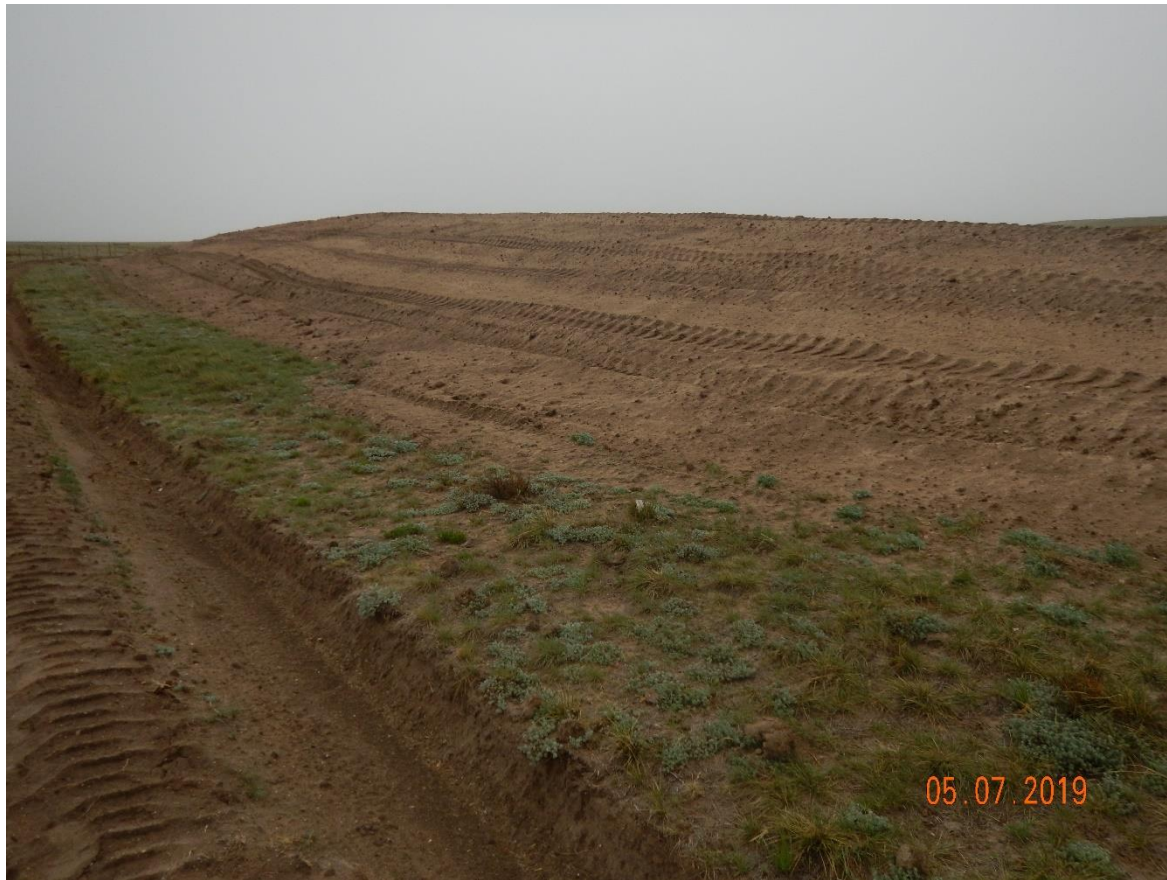
Photo 7: Photo of soil stockpile on the south end of the location.

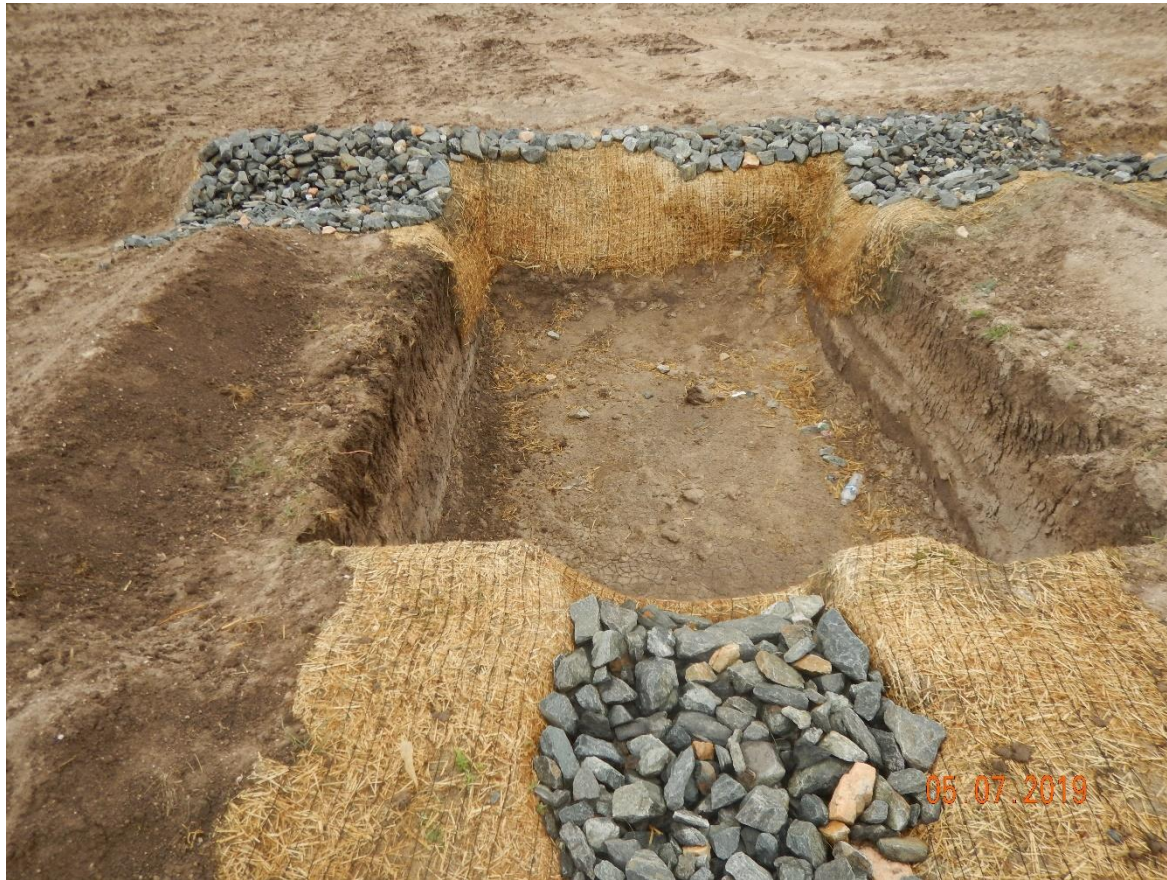
Photo 8: Photo taken from the southeast corner of the location. Photo of sediment trap. Operator has installed one (1) sediment trap on the southeast end of the location. Sediment trap does not appear to be sufficient in size to manage stormwater runoff from the 8.26 acre pad. Additionally, sediment has been constructed with vertical slopes rather than a grade, that will likely promote erosion degradation within the BMP. Sediment trap does not appear to have been constructed in accordance with good engineering practices

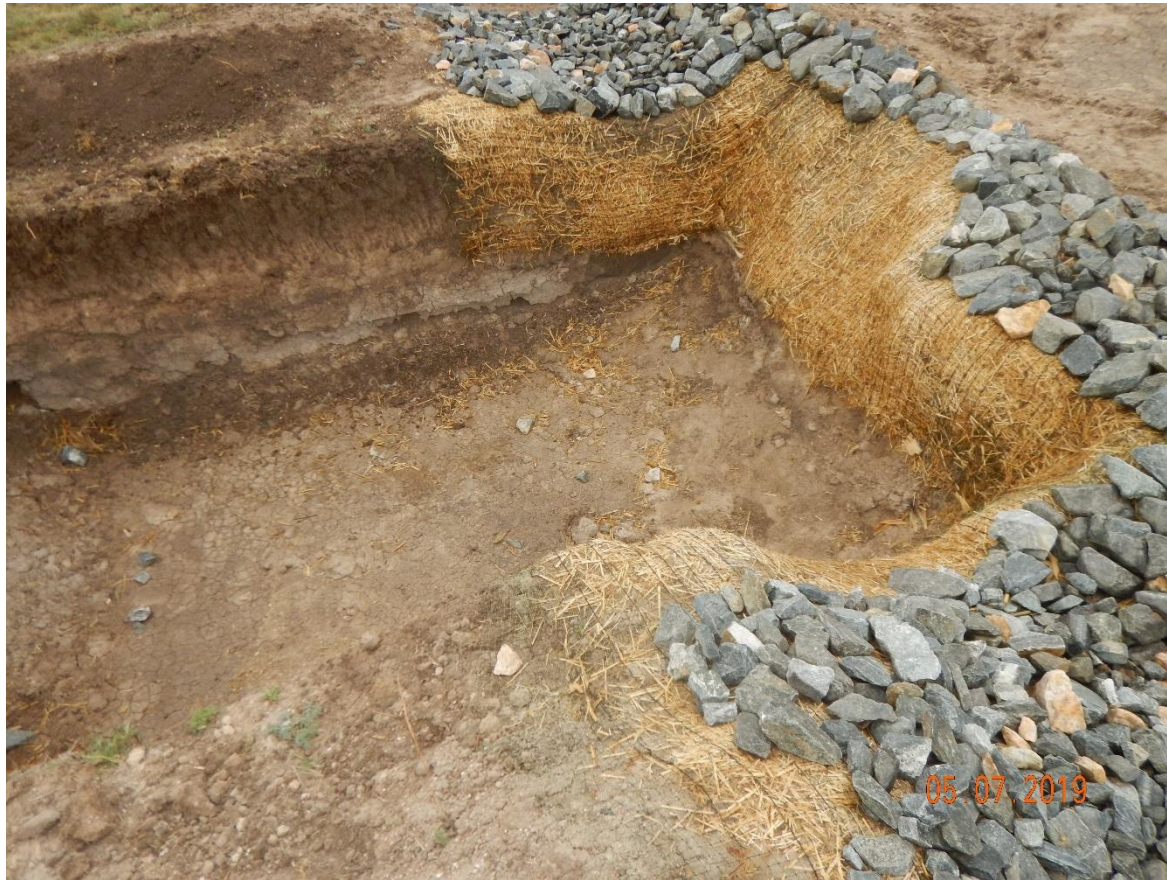
Photo 9: See comments under photo 8.

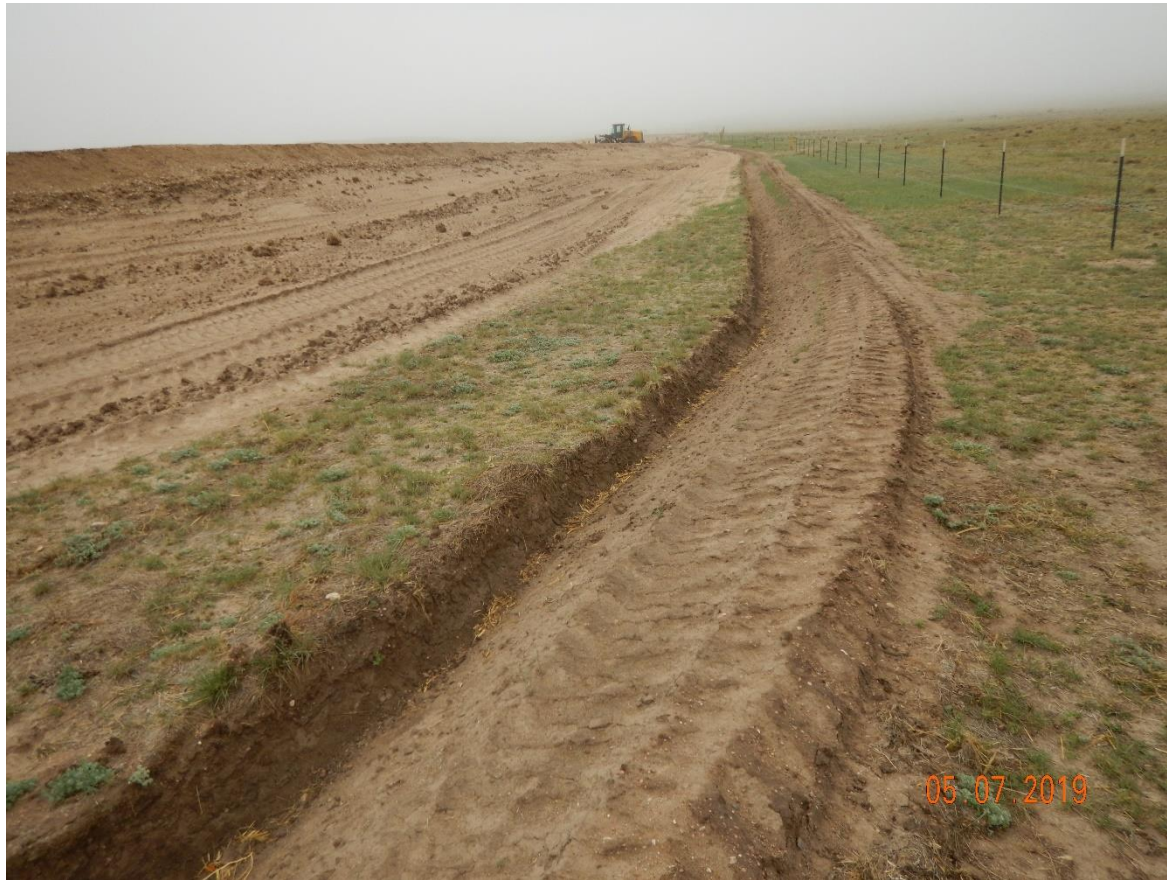
Photo 10: Photo taken from the southeast corner of the location, facing north. Photo shows stormwater ditch along perimeter of location. BMP appears to have been constructed with a blade leaving a vertical grade of unconsolidated material. Ditch has not been constructed in accordance with good engineering practices.

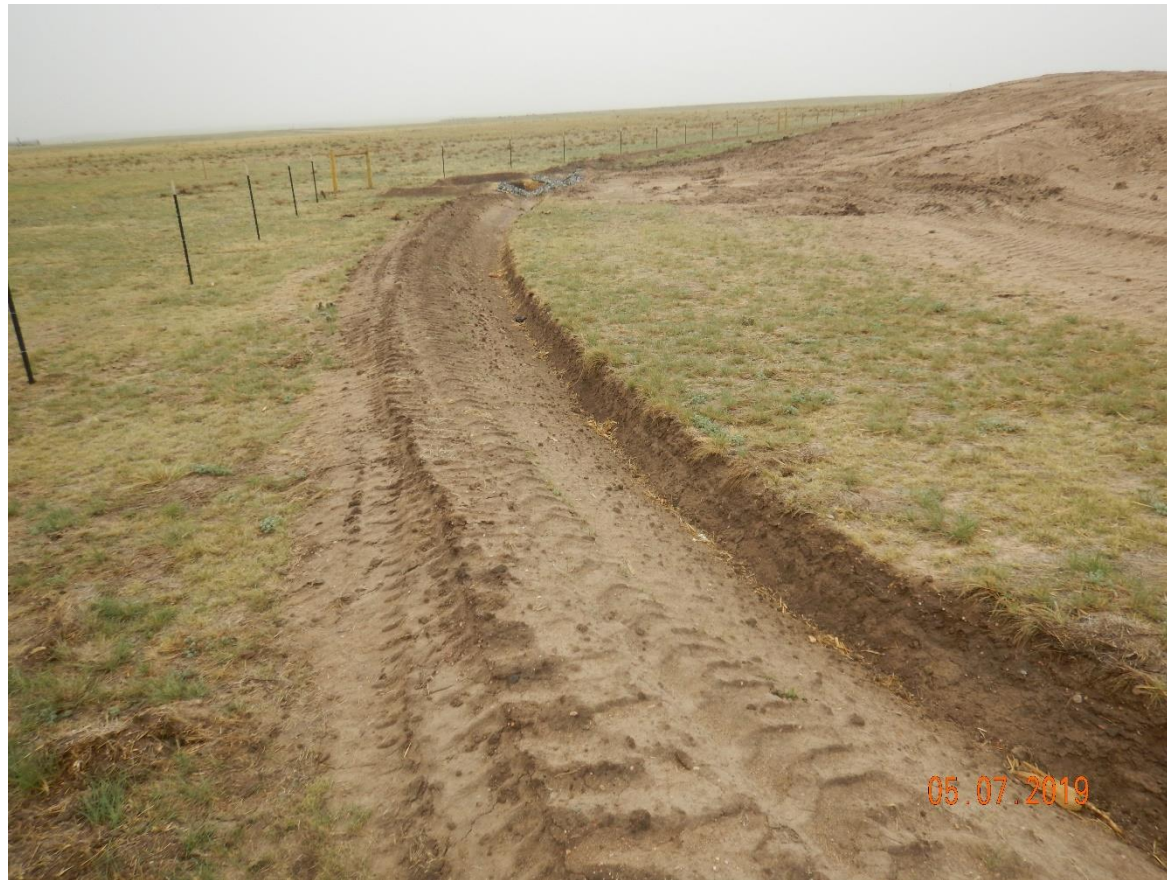
Photo 11: Photo taken from the southeast corner of the location, facing southwest. Photo shows stormwater ditch along perimeter of location. See comments under photo 10

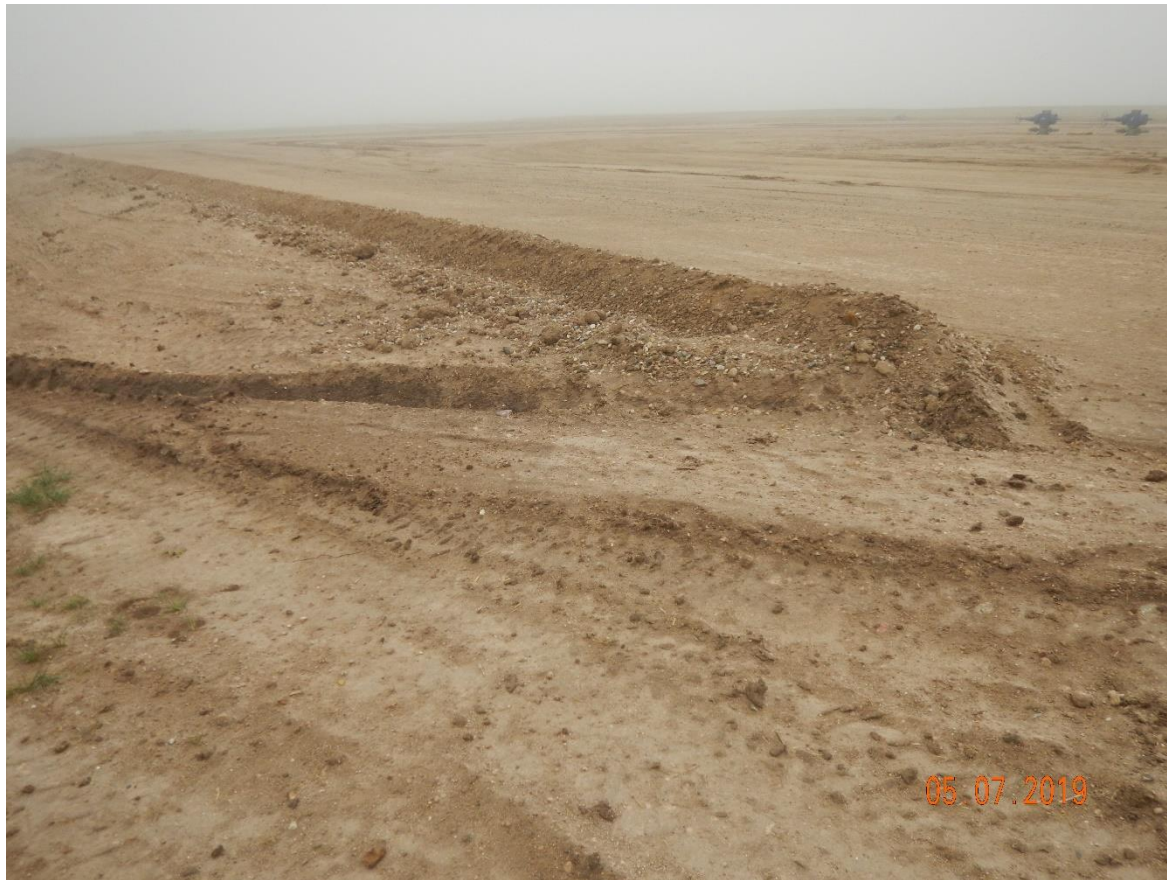
Photo 12: Photo taken from the east end of the location, facing southwest. Photo of stormwater ditch on west end of the location

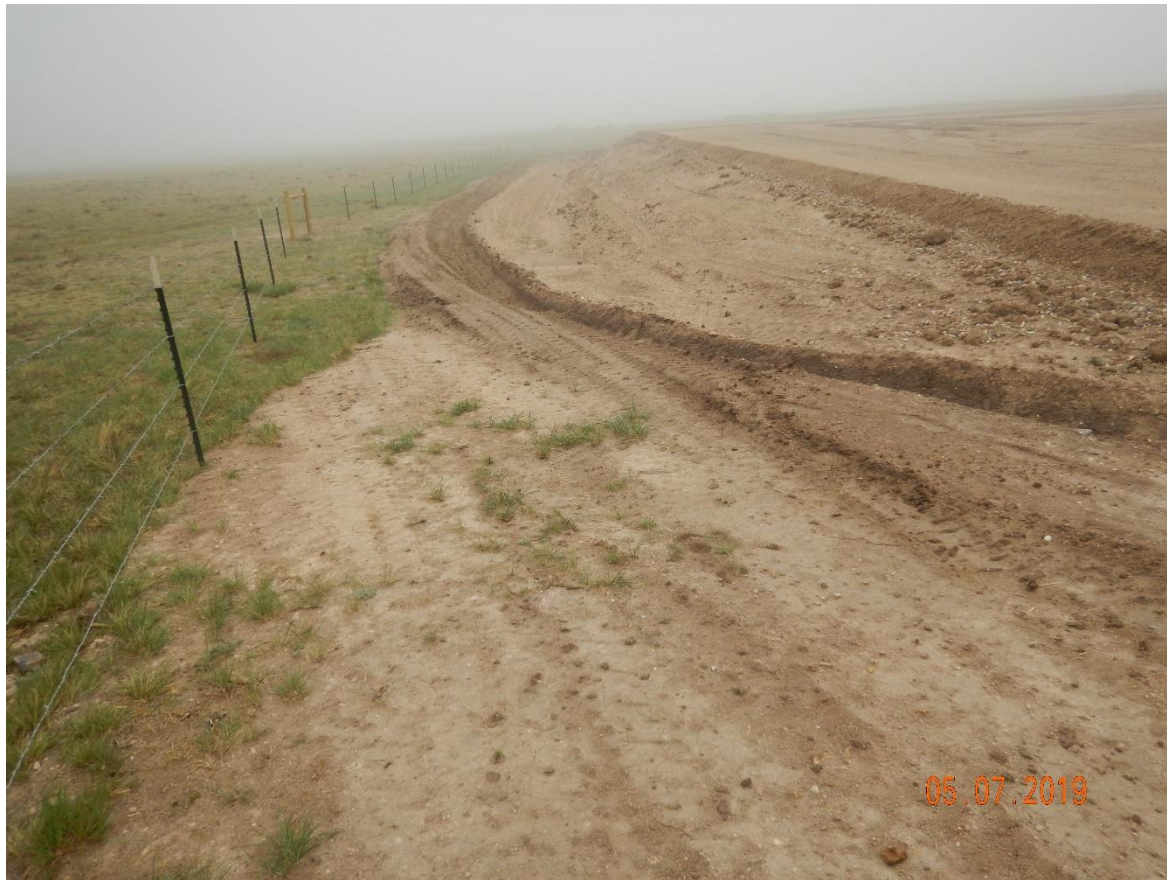
Photo 13: Photo of stormwater ditch on west end of the location. See comments under photo 10.

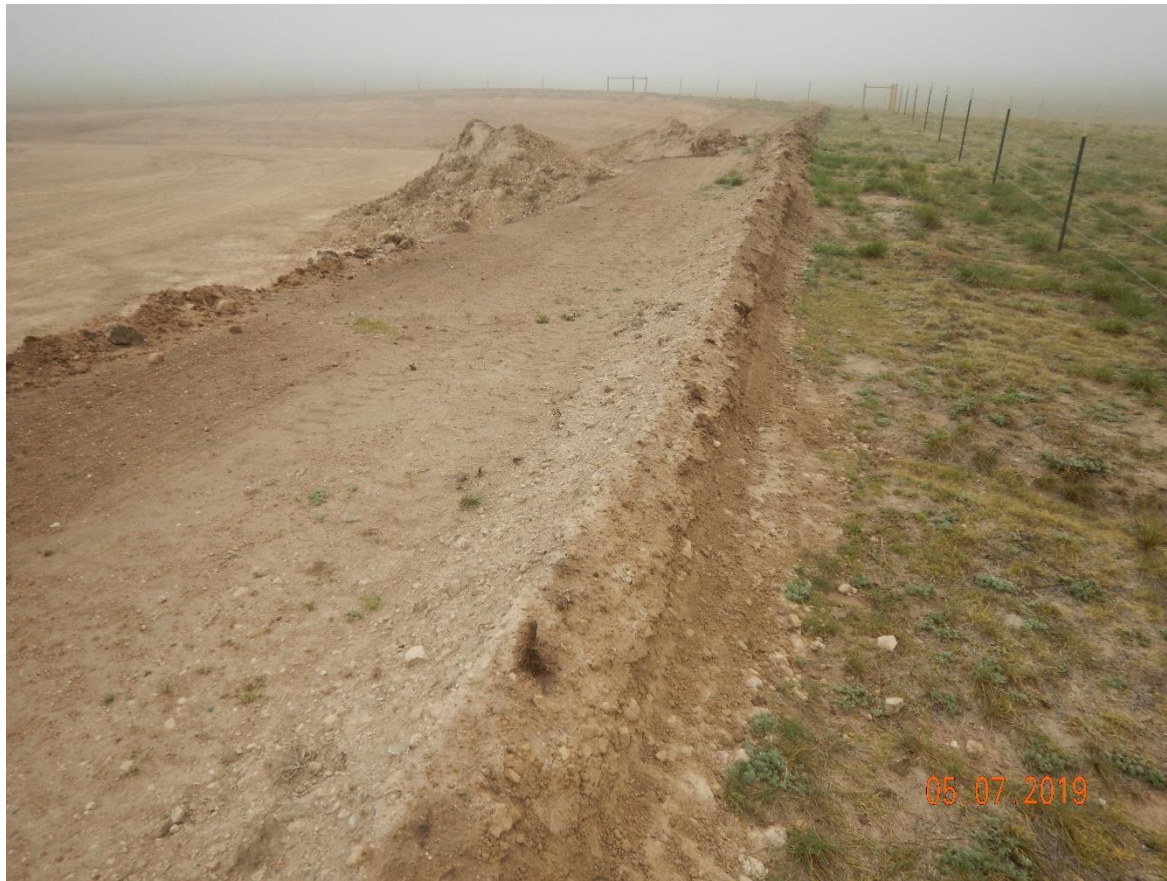
Photo 14: Photo taken from the northeast end of the location, facing north. Photo shows areas where operator installed a berm along perimeter of the location. Berms have not been consolidated in accordance with good engineering practices. Berms remain loose material and a potential pollutant source.

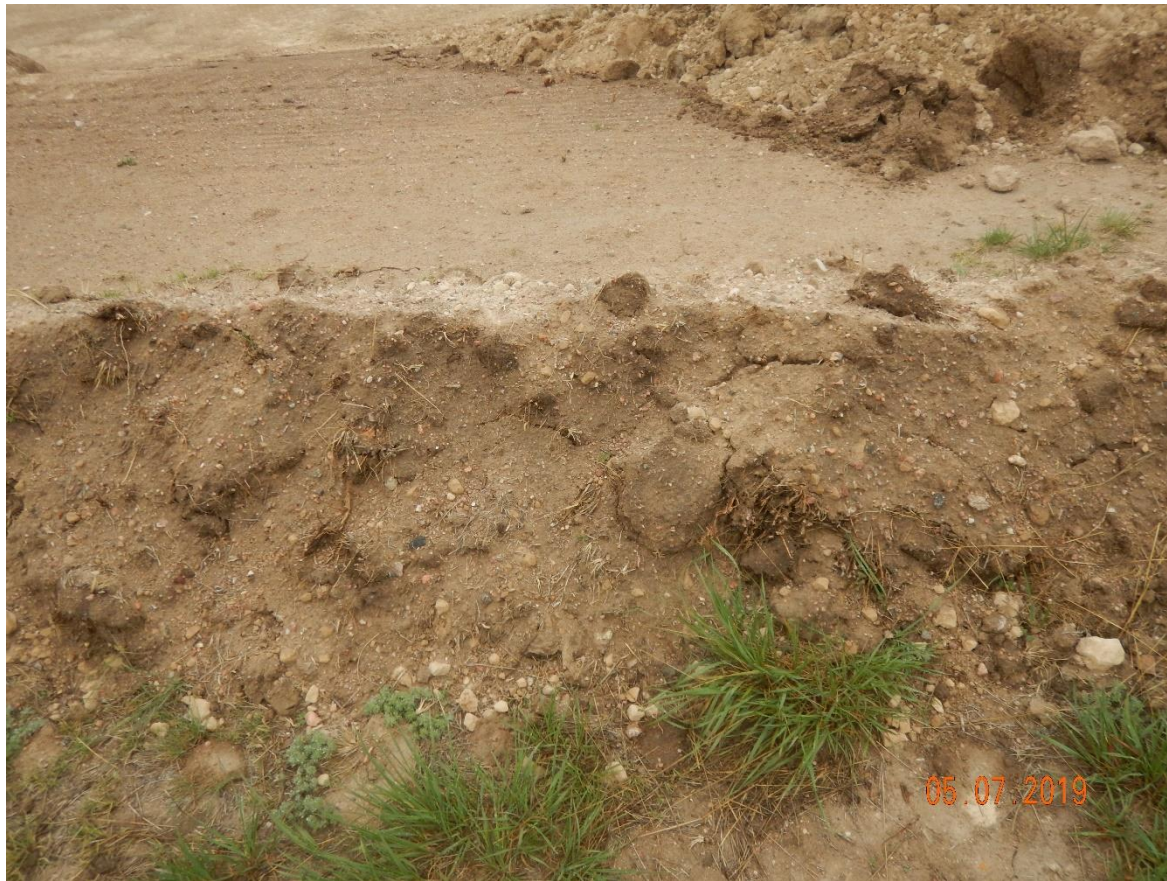
Photo 15: Photo of berm on the northeast end of the location. See comments under photo 14.

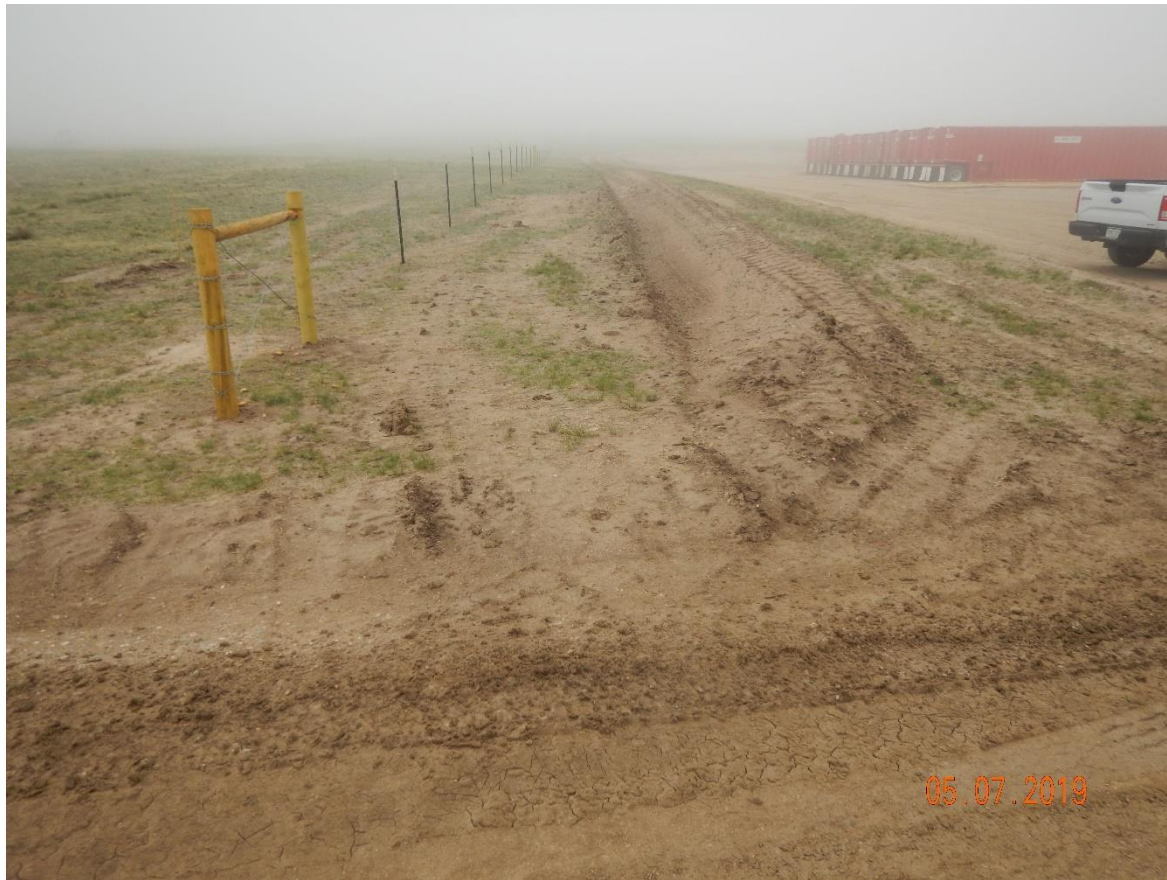
Photo 16: Photo taken from the west end of the location. Photo shows area where the ditch abruptly ends without sufficient outlet protection to allow for sediment laden free stormwater discharge; ditch has not been constructed in accordance with good engineering practices.

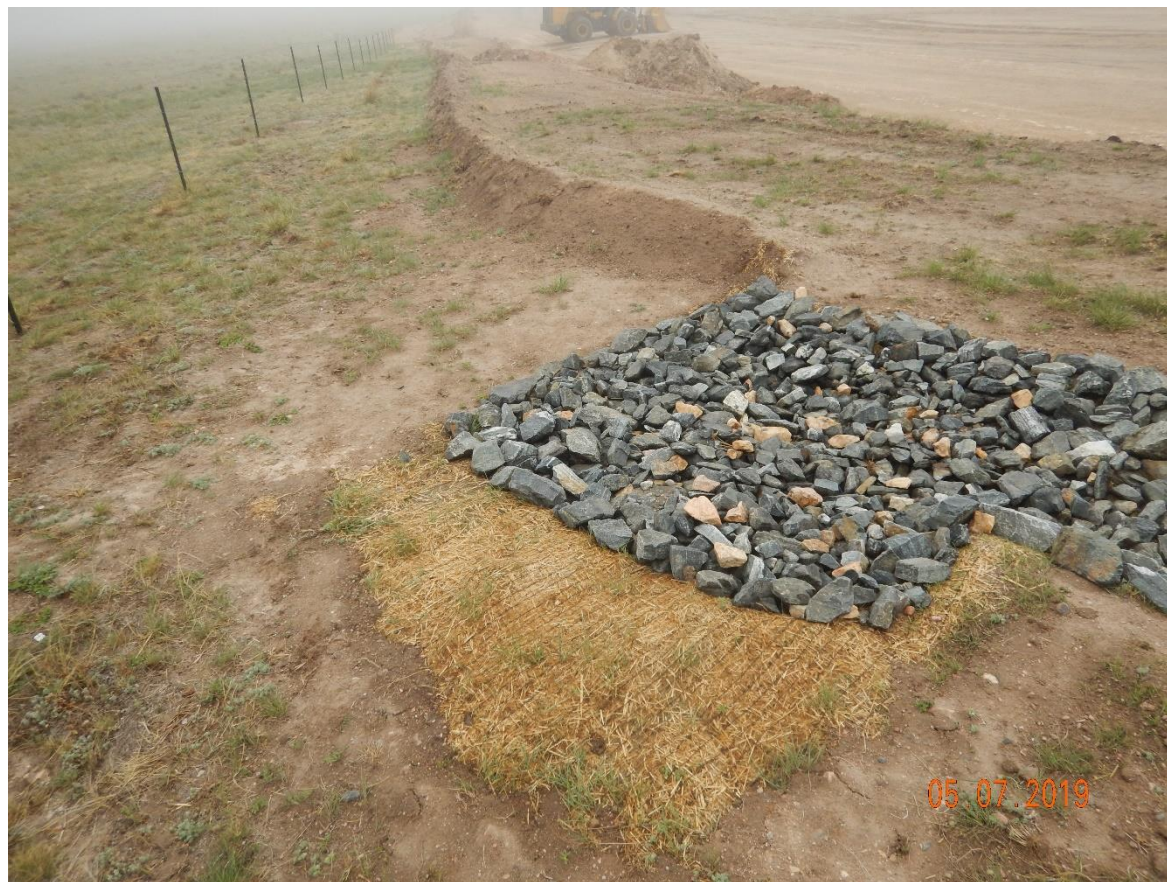
Photo 17: Photo taken from the northeast corner of the location. Photo shows outlet that appears to be sufficiently armored to allow for sediment laden free stormwater discharge from the northeast end of the location.

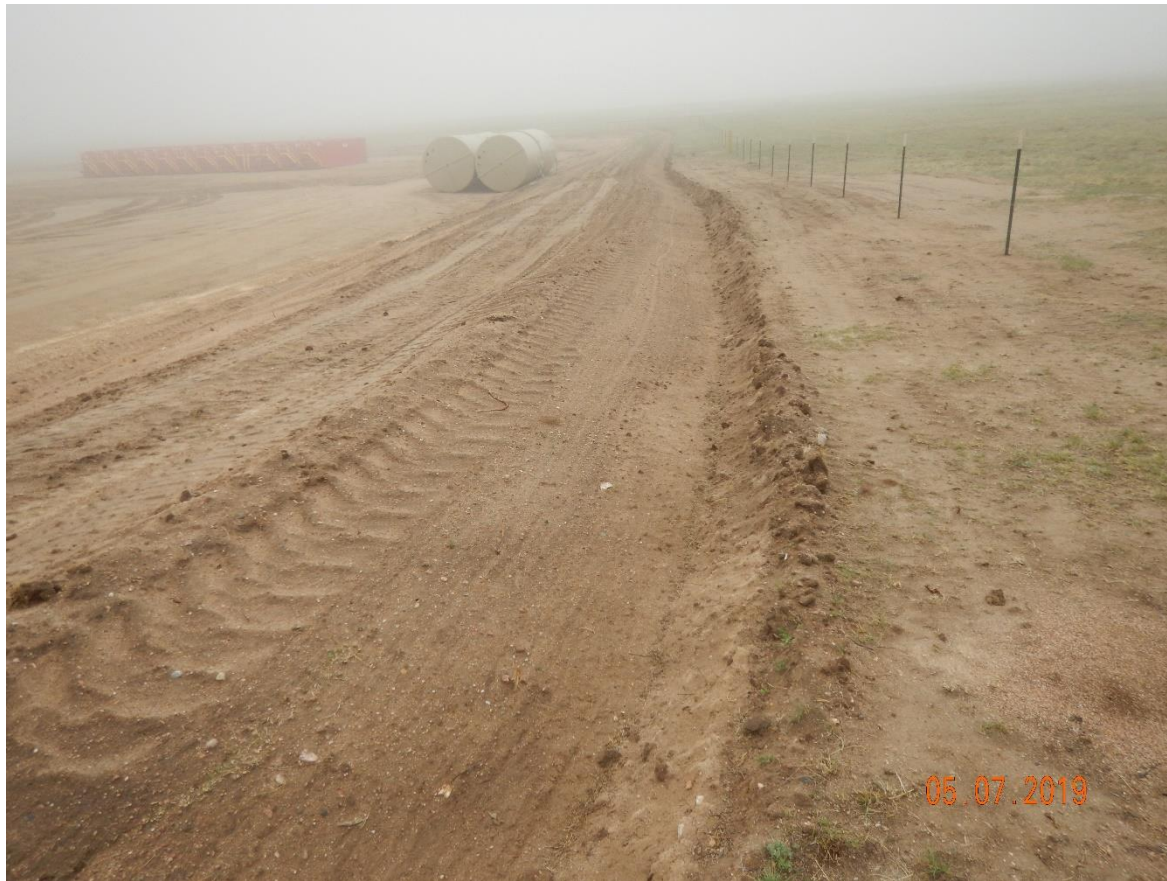
Photo 18: Photo taken from the northeast corner of the location, facing west. Photo shows ditch and berm along perimeter. Ditch to have been constructed with a blade leaving a vertical grade of unconsolidated material. Ditch has not been constructed in accordance with good engineering practices.

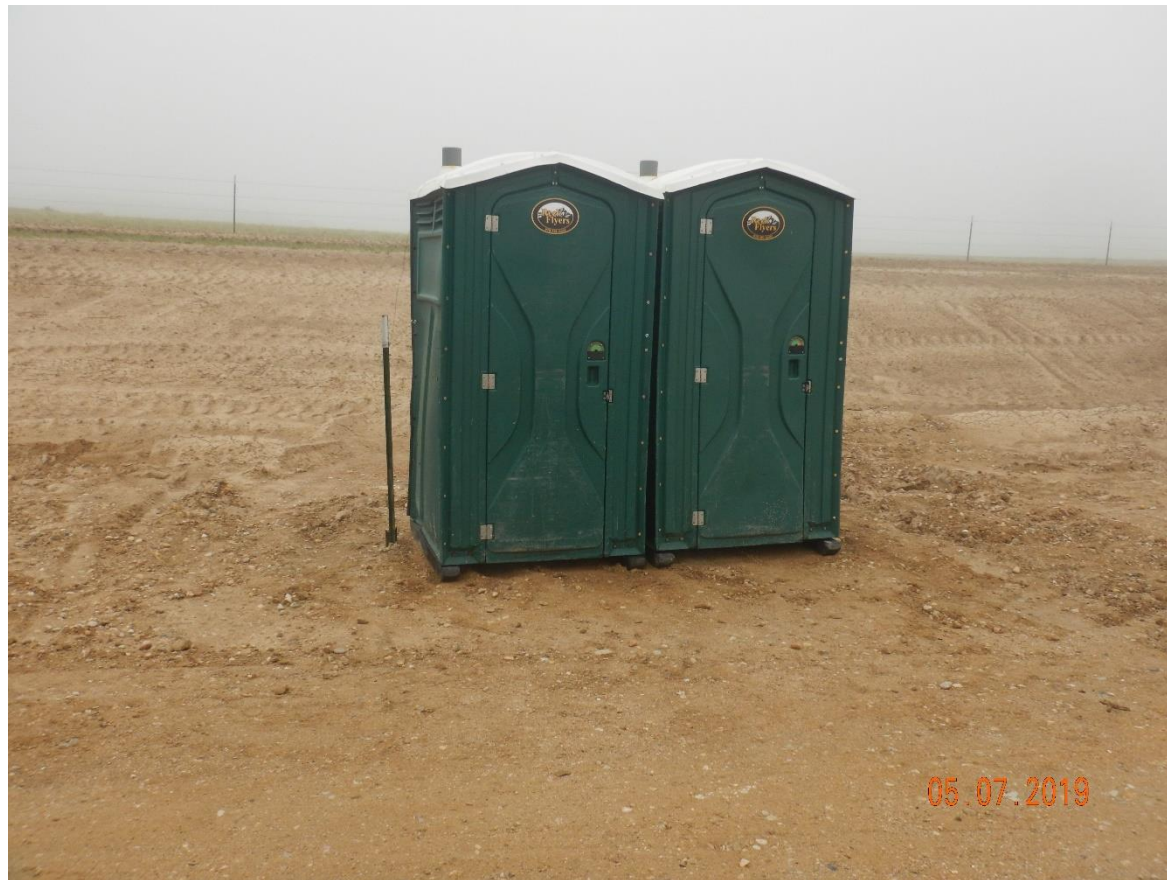
Photo 19: Photo taken from the north end of the pad. Photo shows porta-john appear to be sufficiently secured.

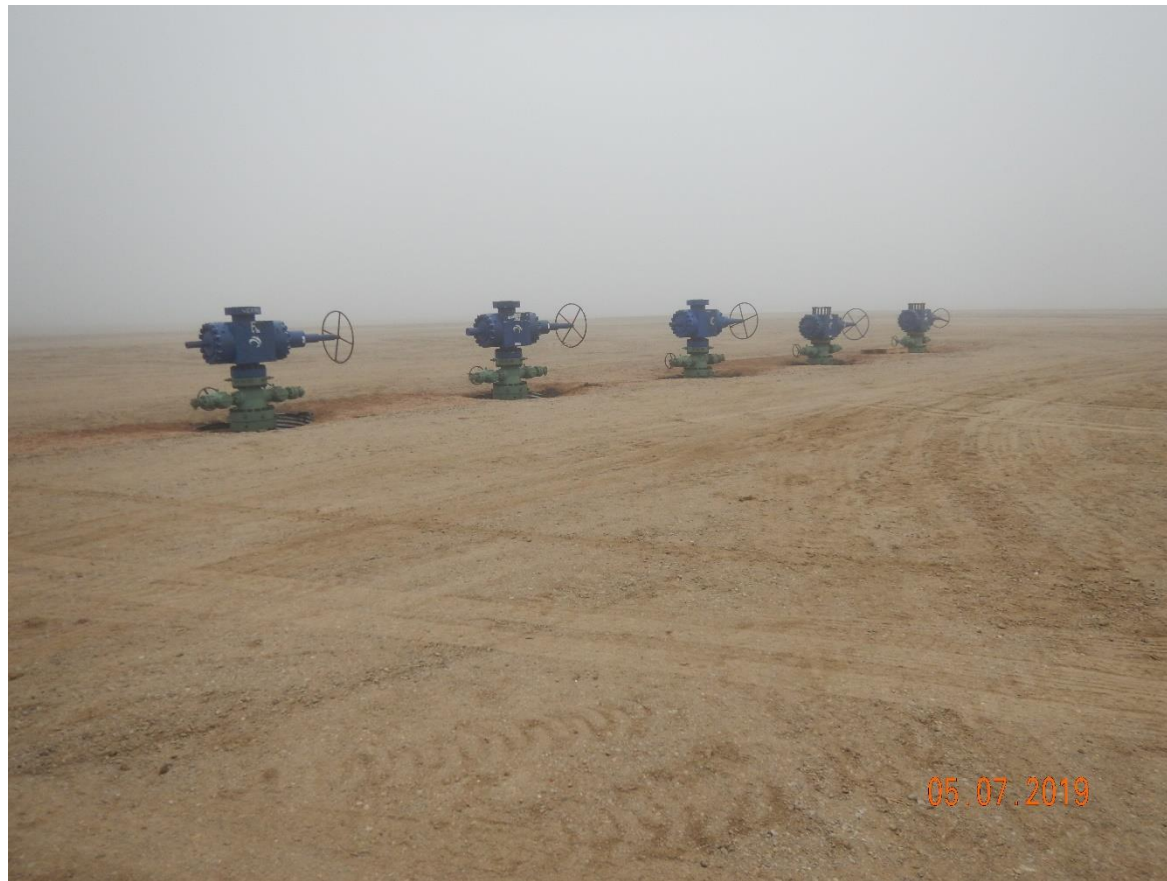
Photo 20: Photo of the 5 drilled wells.
