Inspection Photos

Operator: PCR OPERATING LLC - 10657

Location ID: 454154

Inspection Doc. Number: 696200038

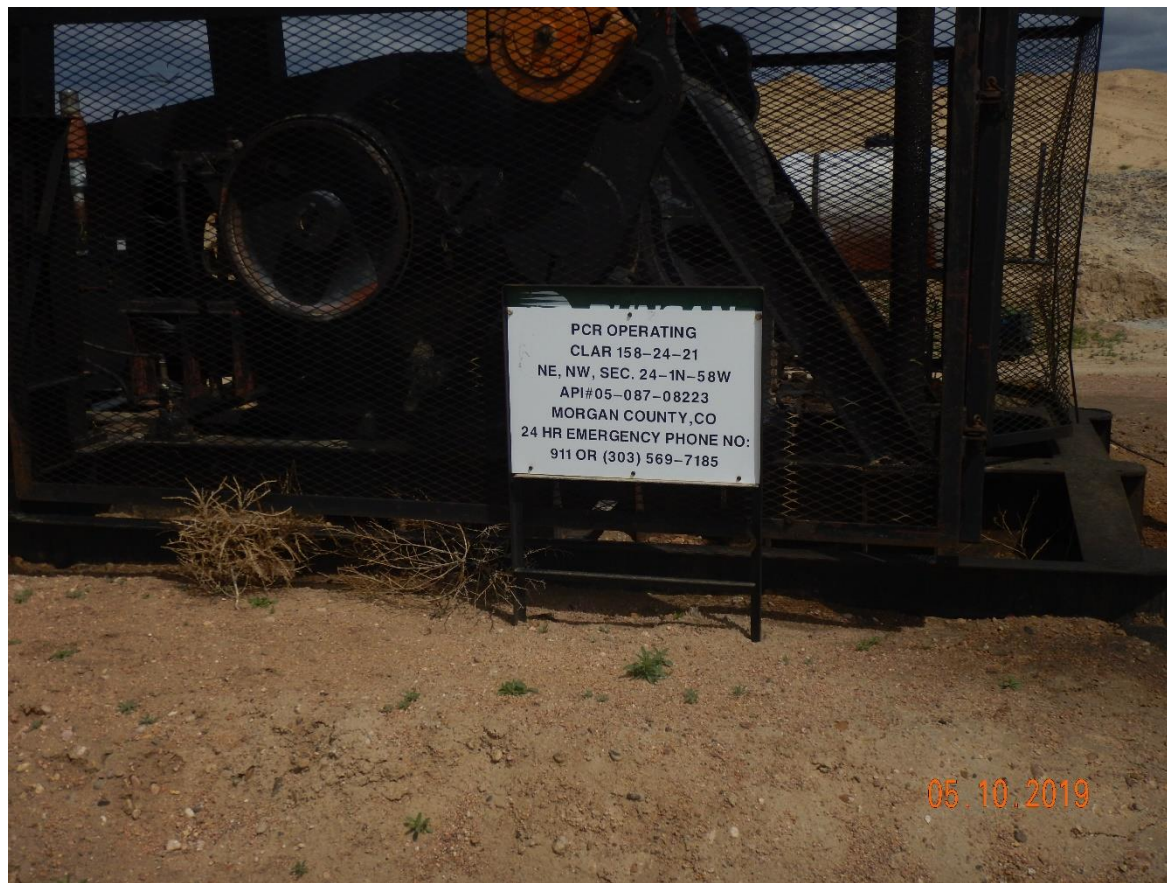
Photo 1: Photo of sign at well.

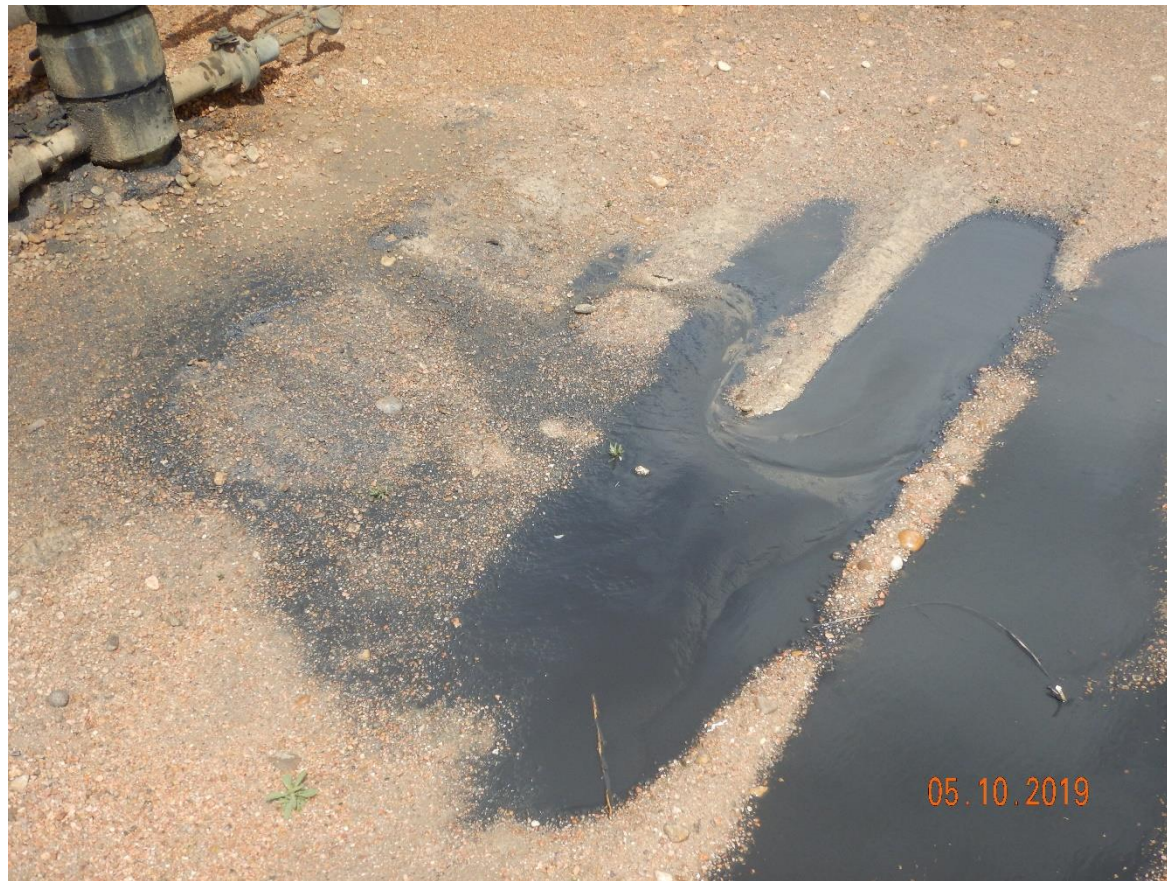
Photo 2: Photo taken at well head. Photo shows a fluid spill and stained soils (approximately 15 ft. by 20 ft) observed at the well.

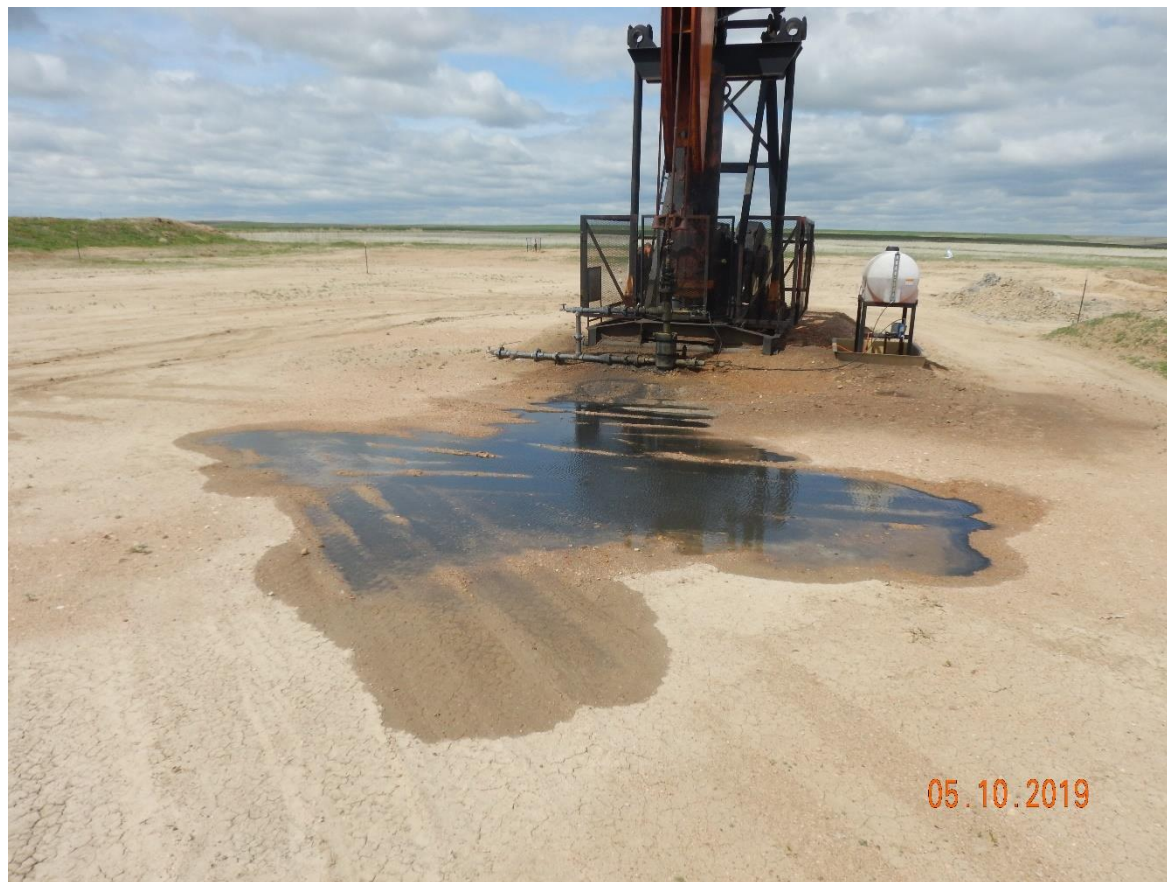
Photo 3: Photo taken from the east end of the well, facing west. Photo shows a fluid spill and stained soils (approximately 15 ft. by 20 ft.) observed at the well.

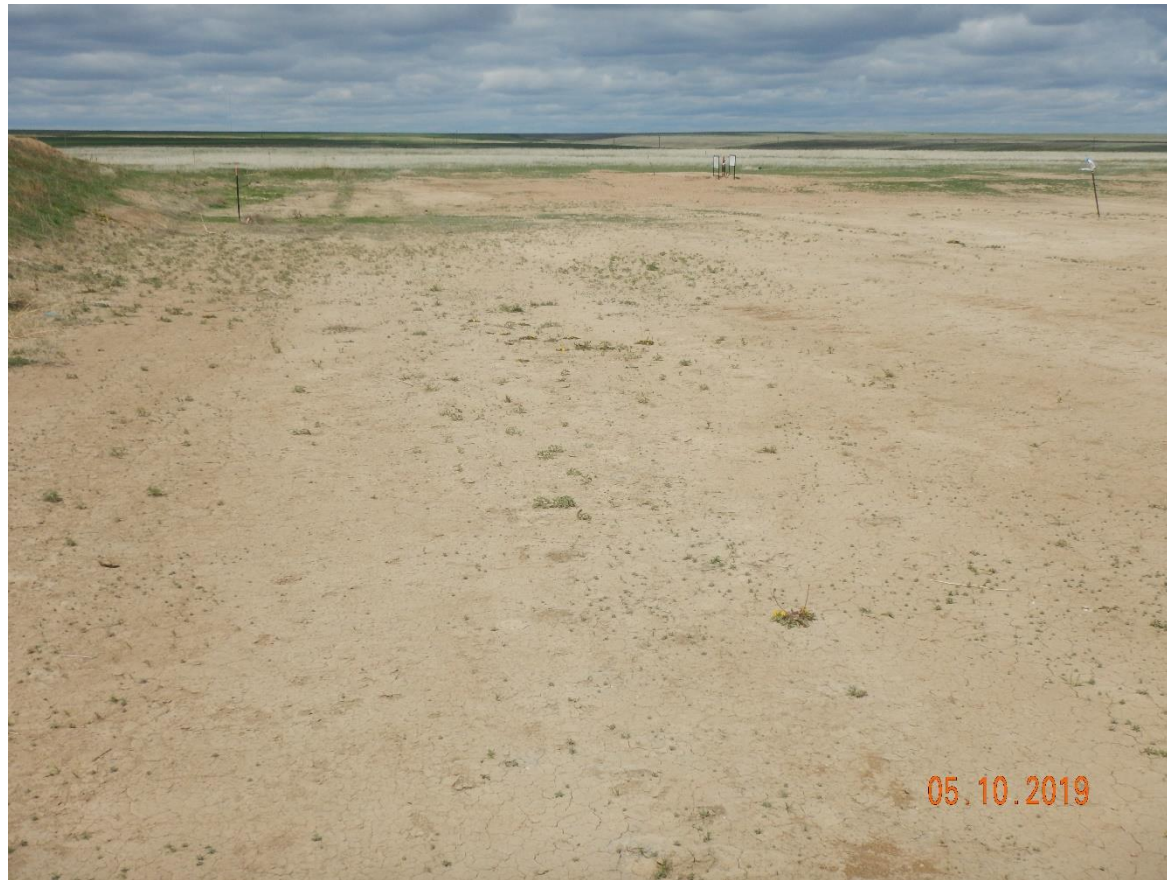
Photo 4: Photo taken from the south end of the location (north side of the topsoil stockpile). Photos 4-7 provide an overview of the location from west, northwest, northeast to east. Photo also shows interim reclamation on areas of the location not needed for production has not been conducted.

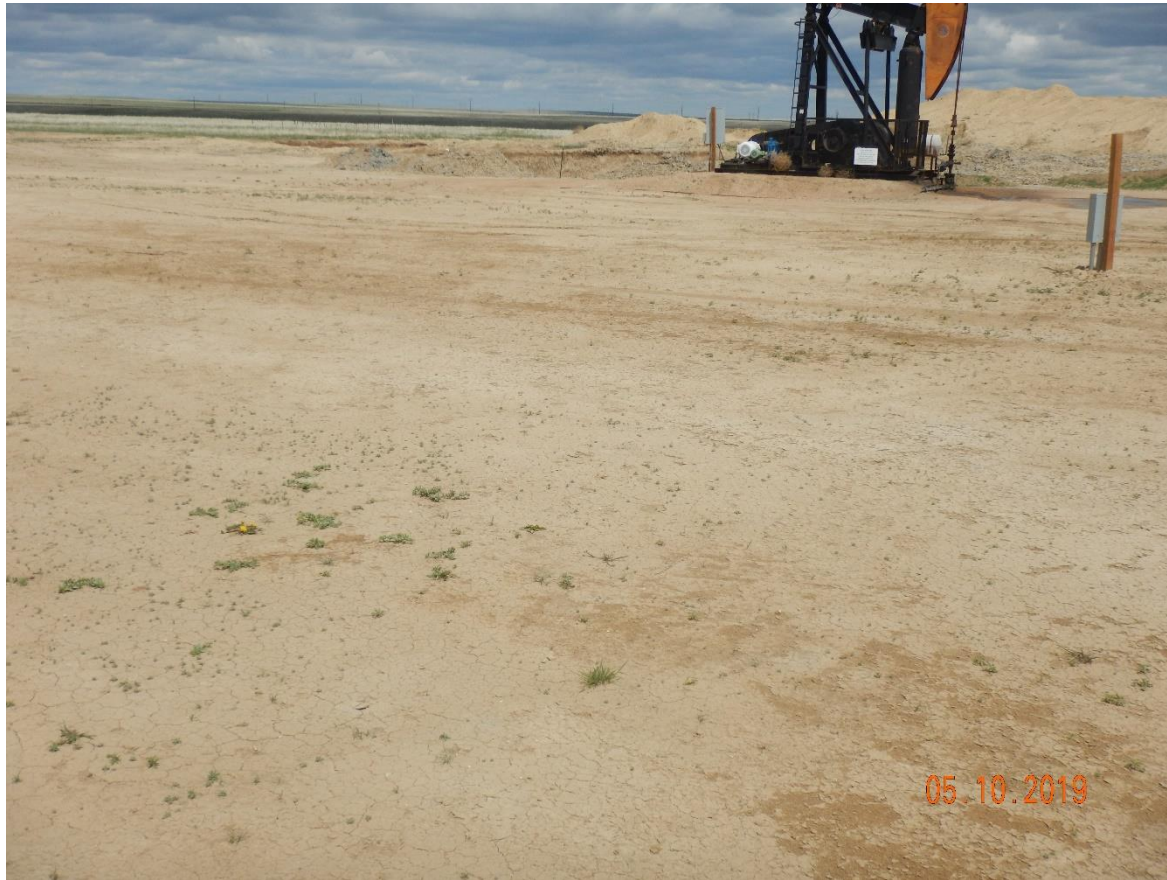
Photo 5: See comments under photo 4.

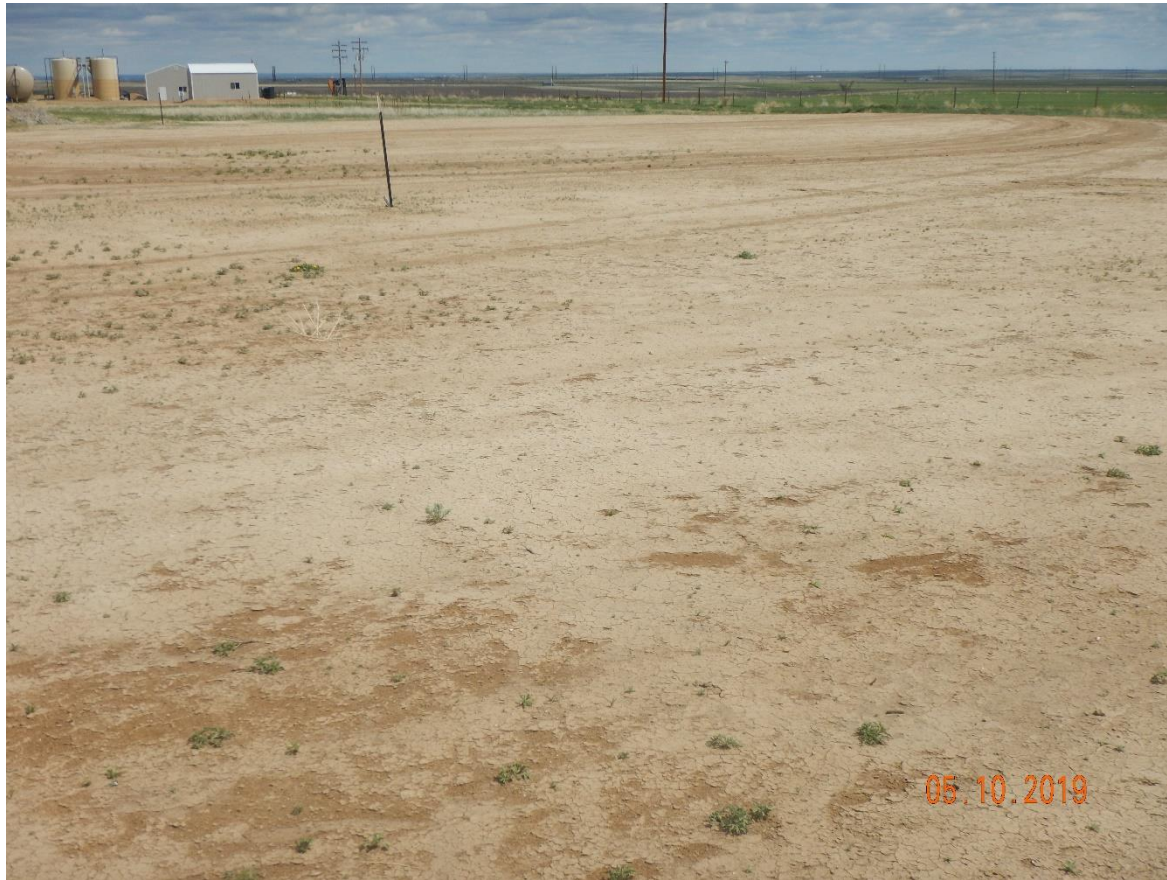
Photo 6: See comments under photo 4.

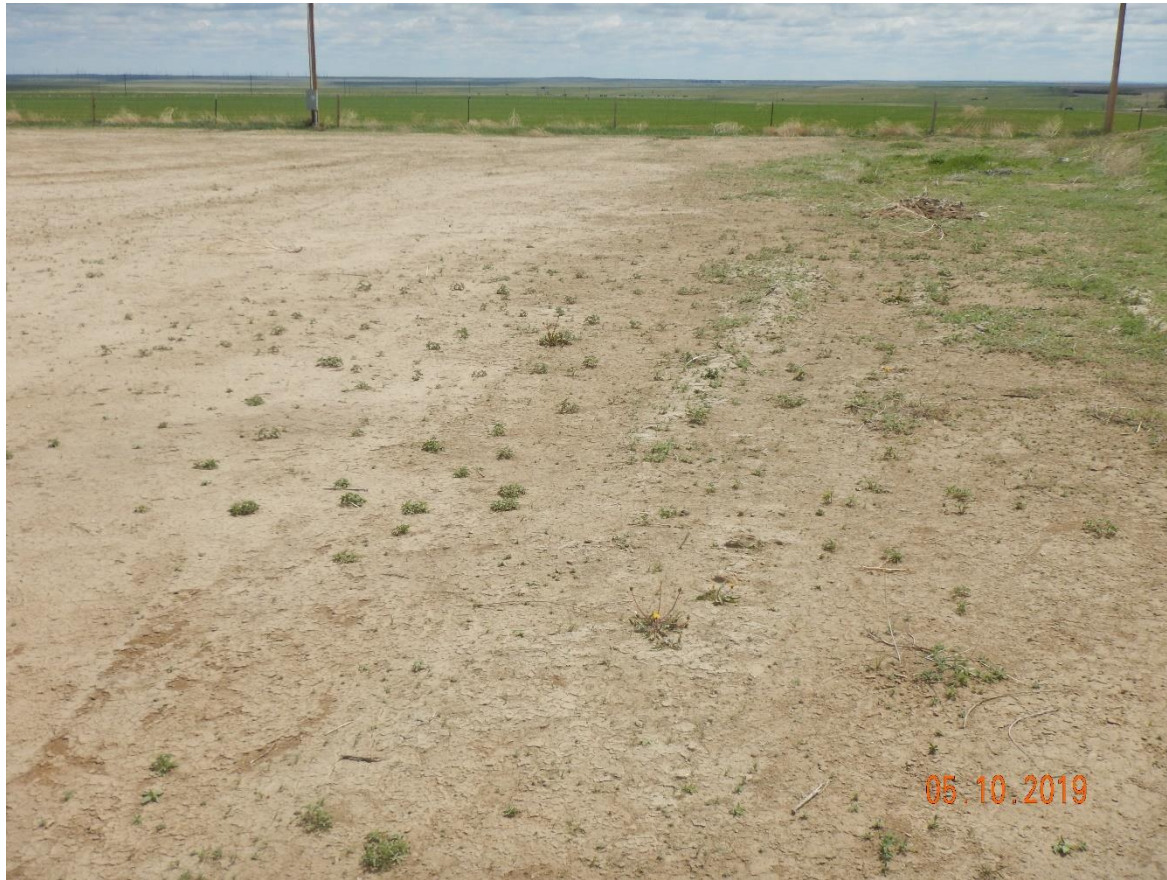
Photo 7: See comments under photo 4.

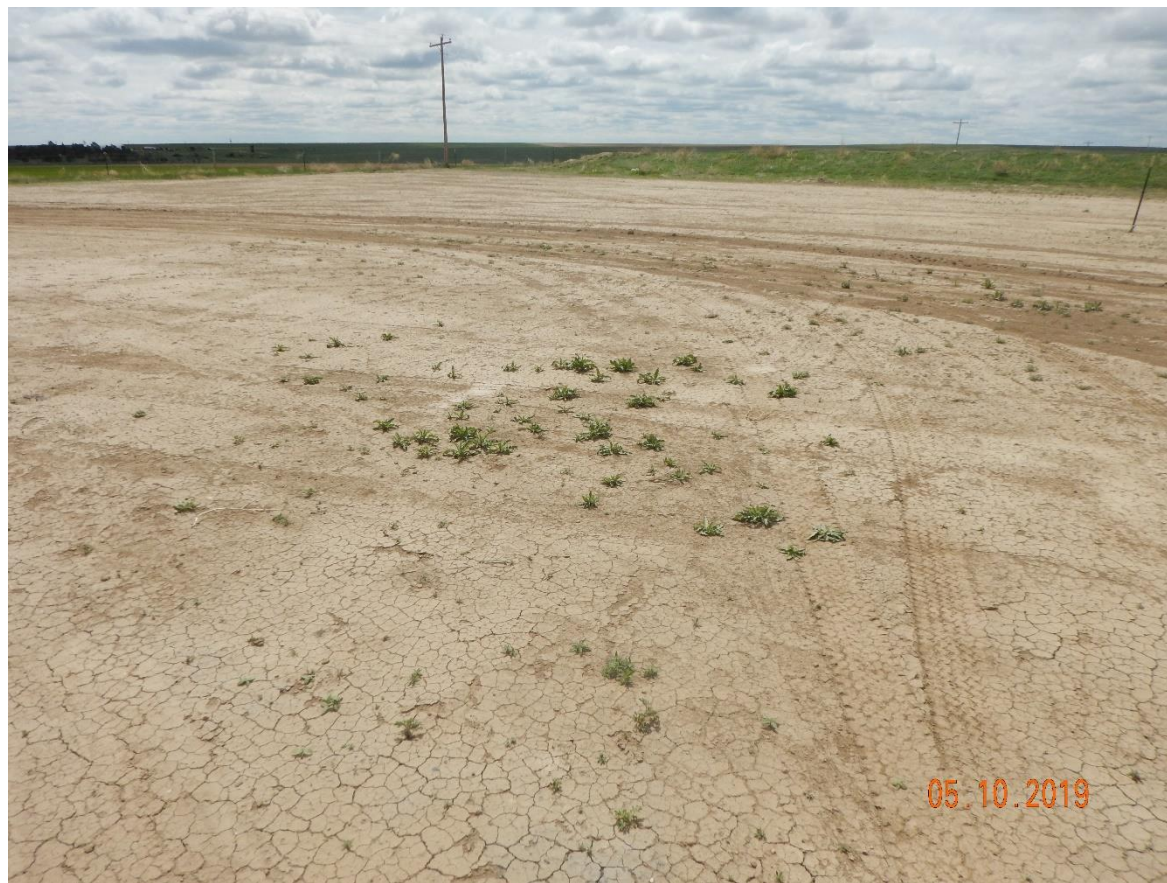
Photo 8: Photo taken from the central area of the location, facing east. Photo shows Canada Thistle (*Cirsium arvense*) establishing on the location. This is a Colorado State listed noxious weed and needs to be managed.

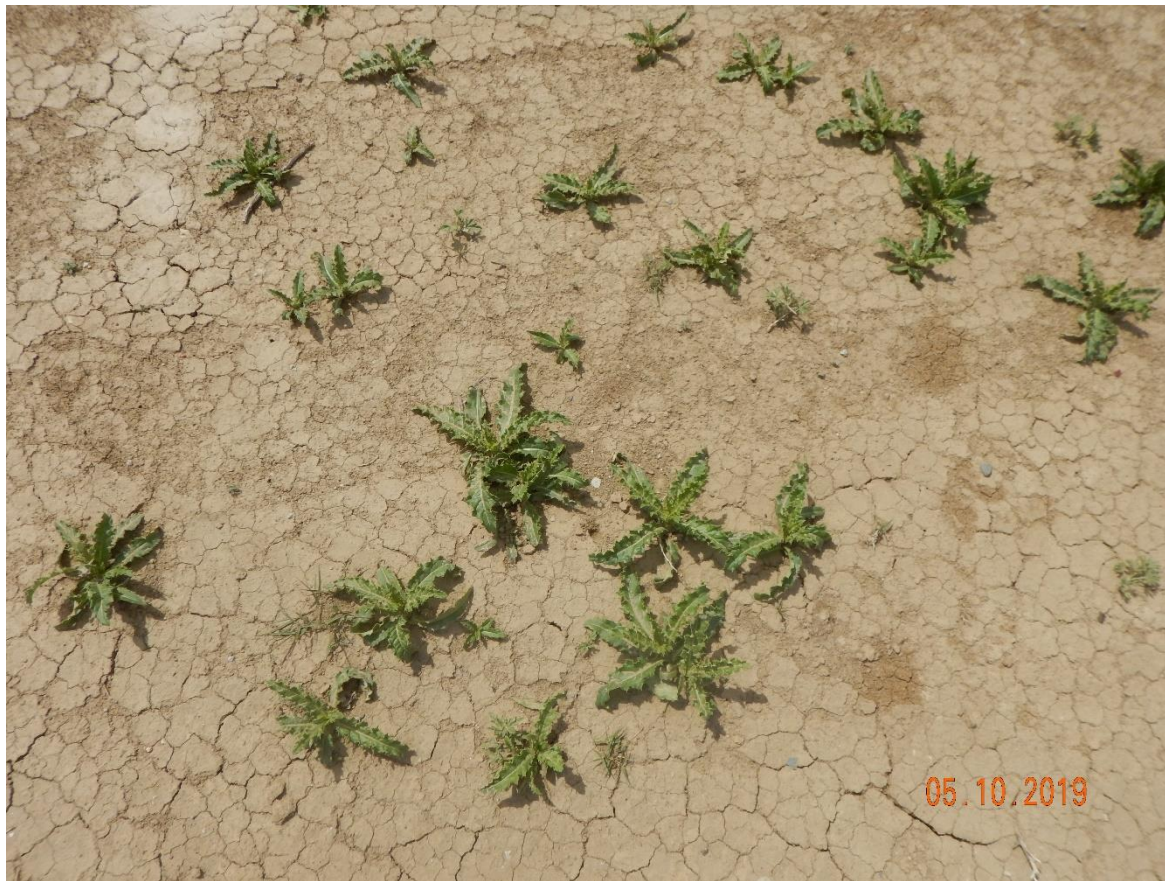
Photo 9: Continued from photo 8.

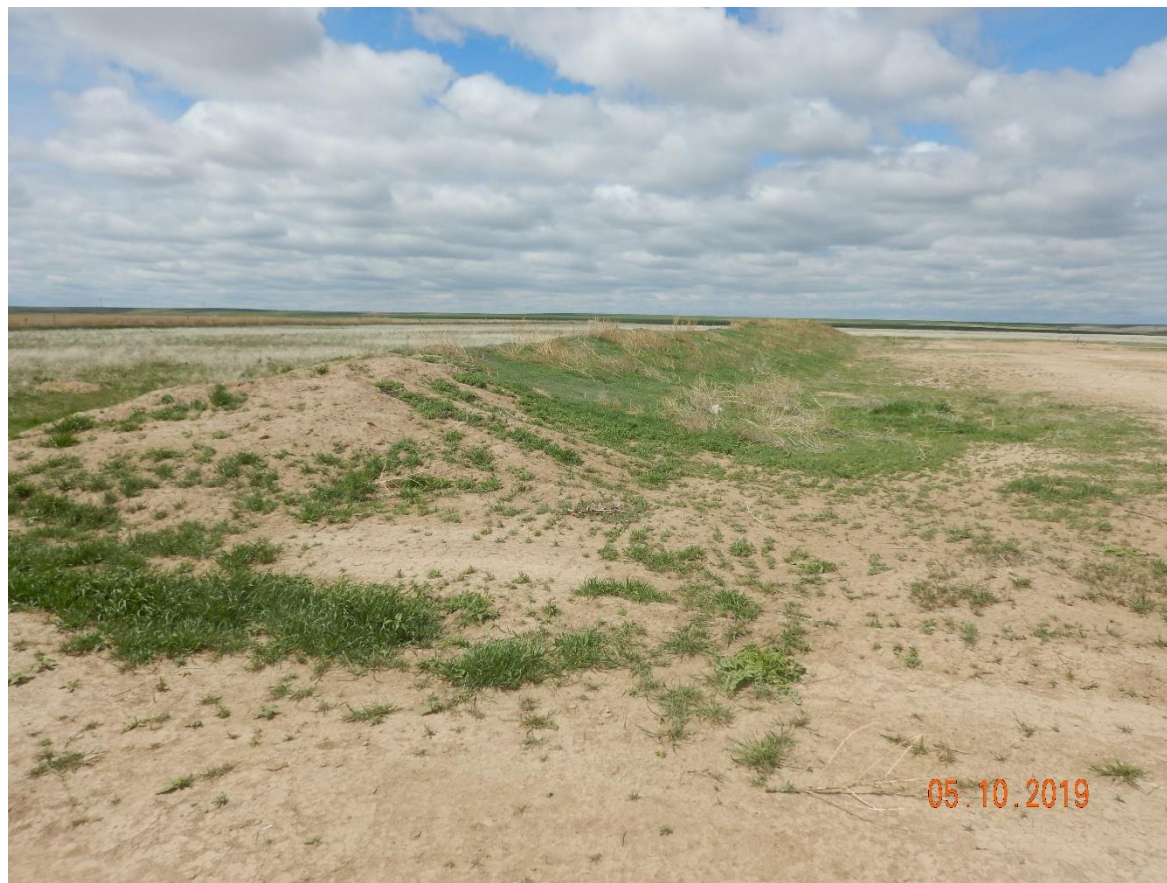
Photo 9: Photo taken from the southeast end of the location, facing west. Photo shows topsoil stockpile. Vegetation observed on stockpile is predominantly undesirable weedy plant species. Noxious weeds also observed at soil stockpile. This does not comply with 603.f, 1002.c and 1003.f

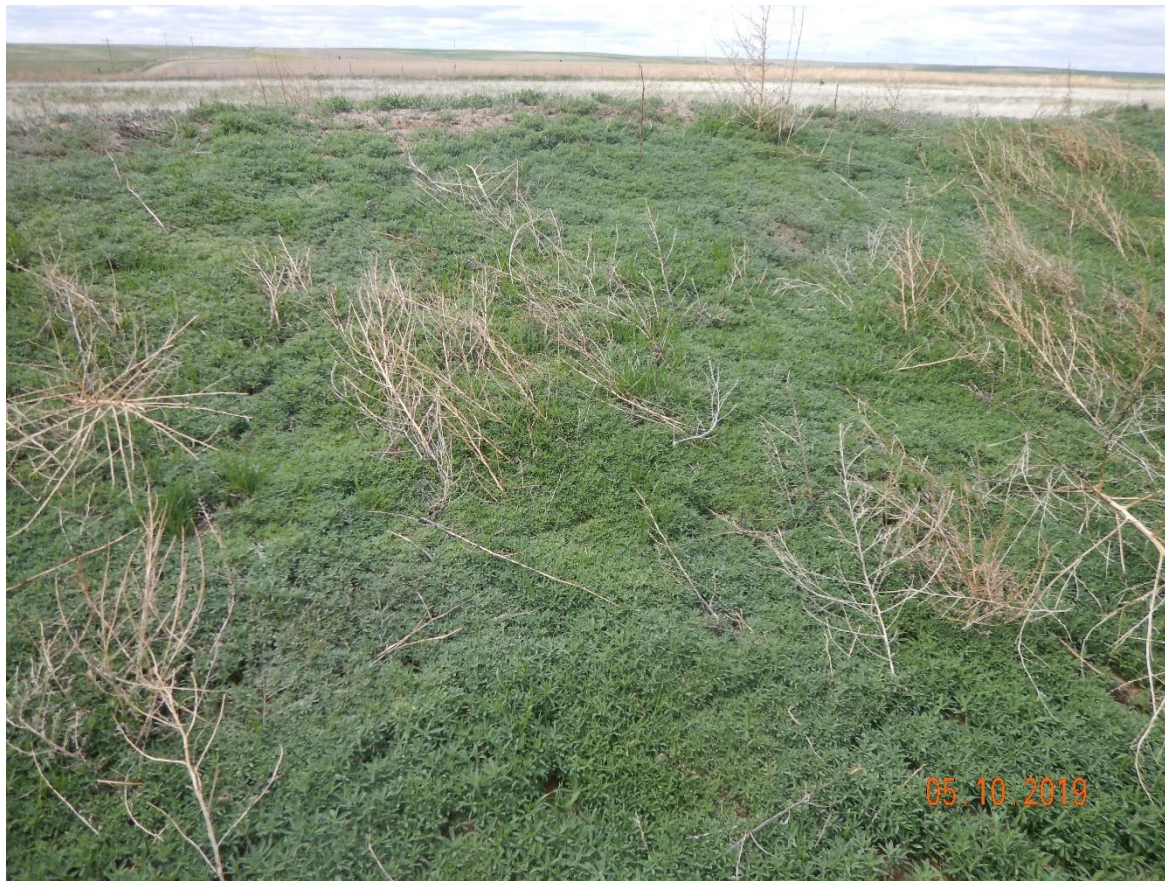
Photo 11: Photo taken from the topsoil stockpile on the south end of the location, facing south. See comments under photo 10. Photo shows undesirable weedy plant establishment on stockpile.

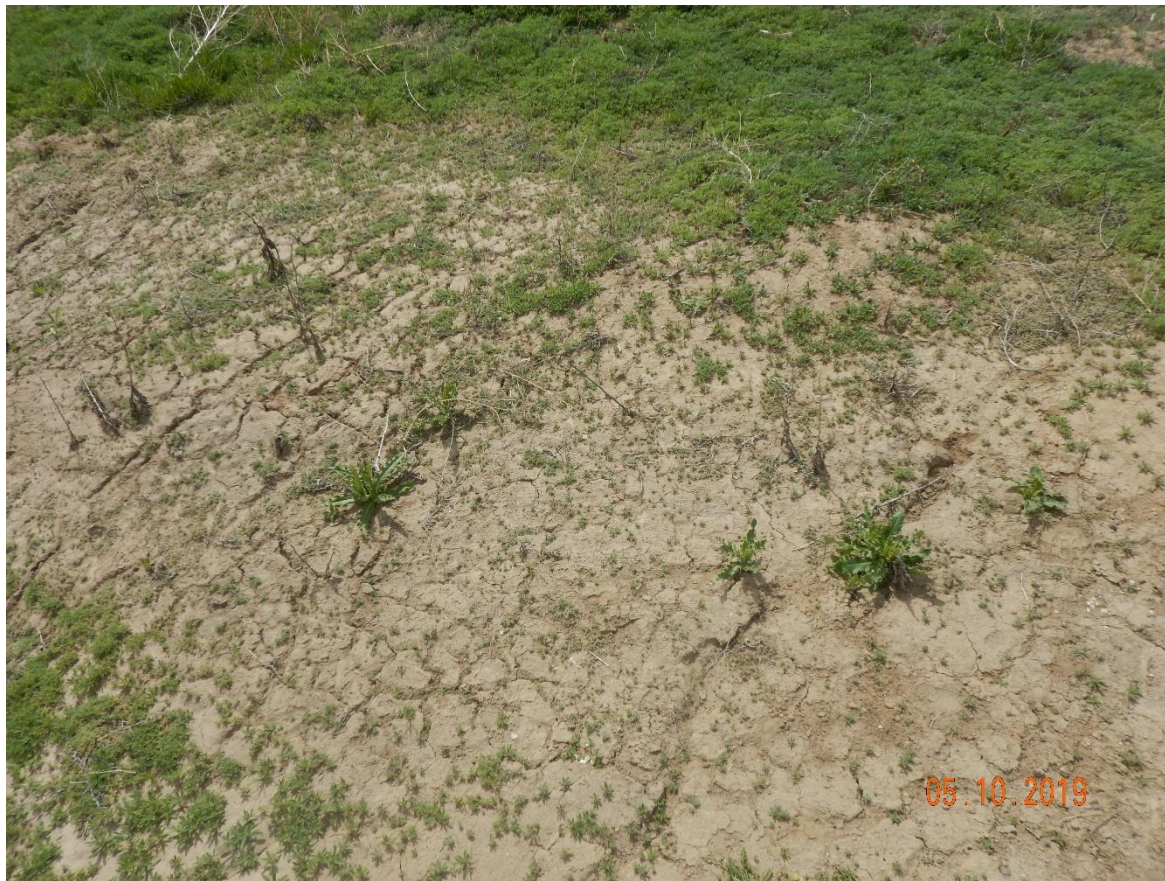
Photo 12: Photo taken from the topsoil stockpile on the south end of the location. See comments under photo 10. Photo shows Canada thistle rosettes.

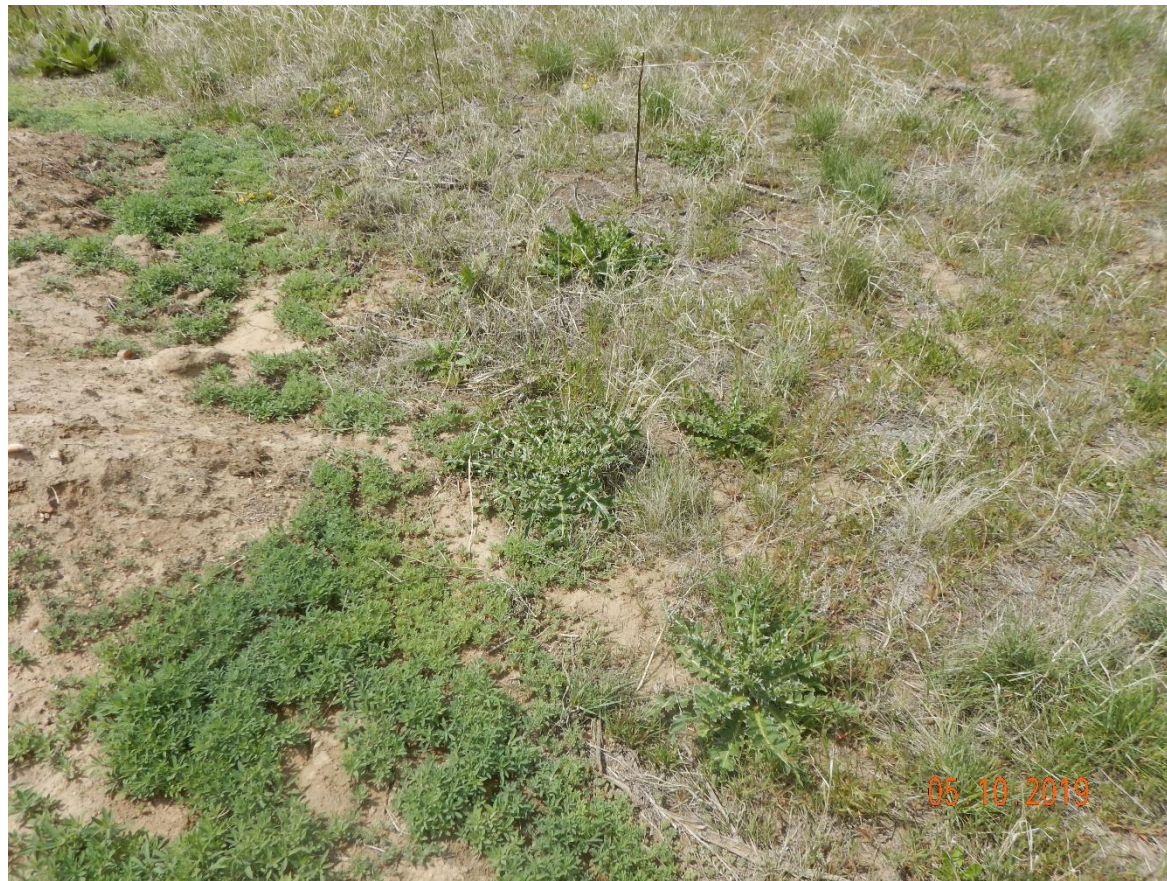
Photo 13: Photo taken from the topsoil stockpile on the south end of the location, facing south. See comments under photo 10. Photo shows Scotch thistle rosettes.

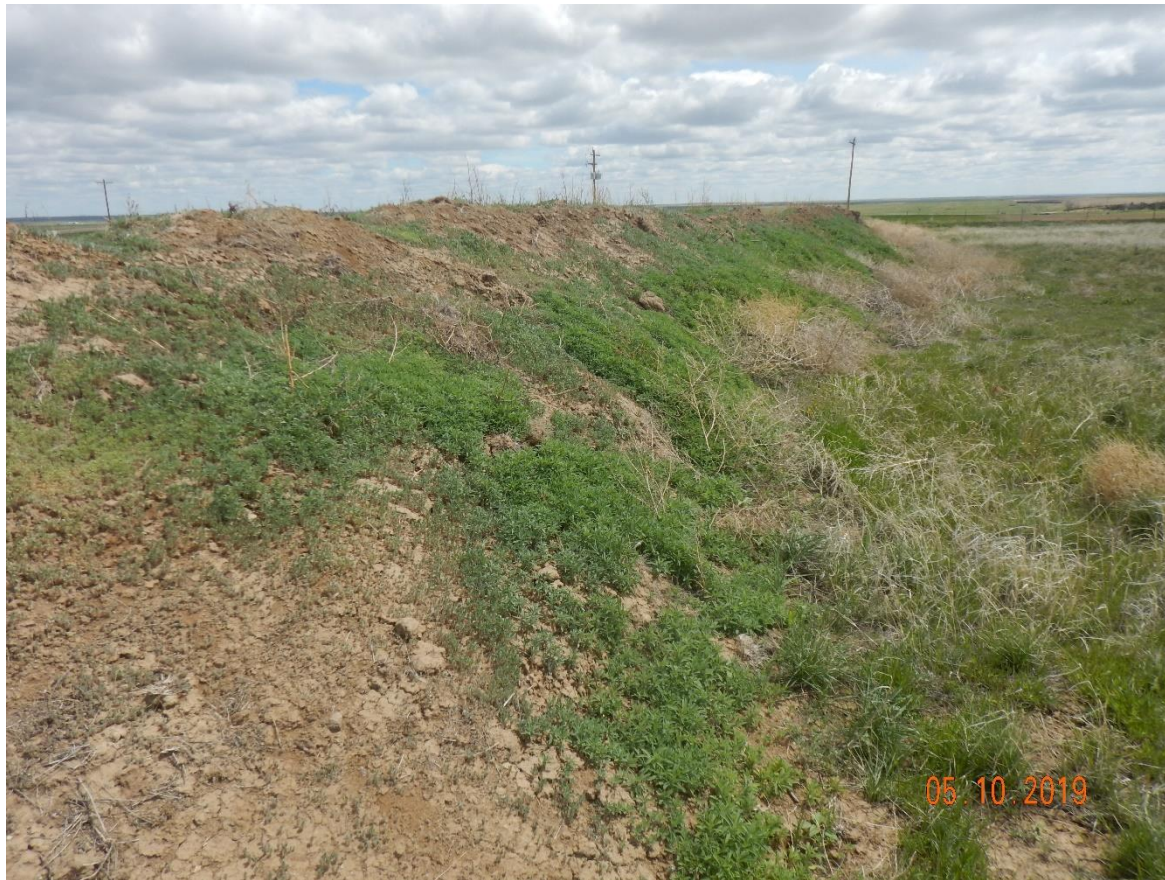
Photo 14: Photo taken from the southwest end of the location, facing east. See comments under photo 10. Photo also shows insufficient stormwater and erosion control BMPs have been installed to stabilize soil stockpile, or mitigate sediment transport from the stockpile and location in accordance with 1002.f and 1002.c.

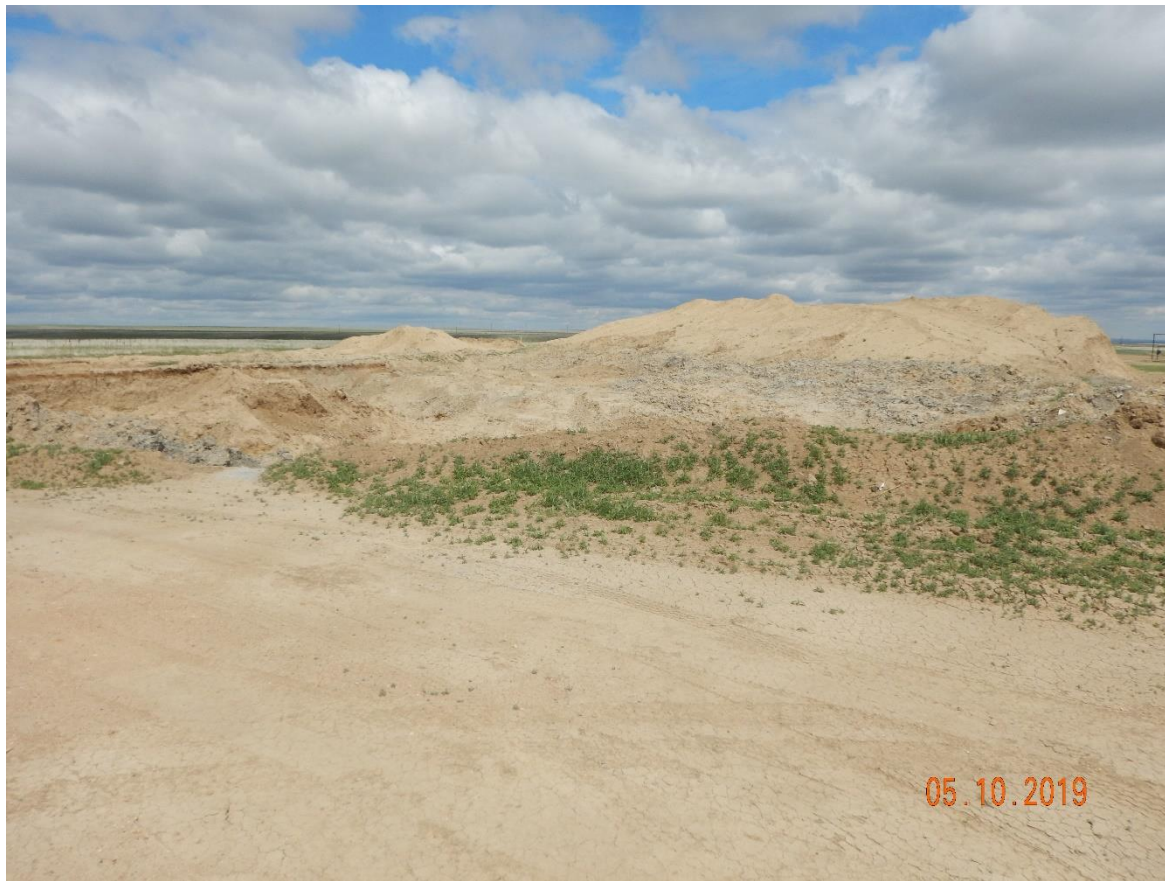
Photo 15: Photo taken from the southeast end of the drill pit, facing northwest. Photo shows drill pit has not been closed in accordance with 2A COAs and per 1003 rules.

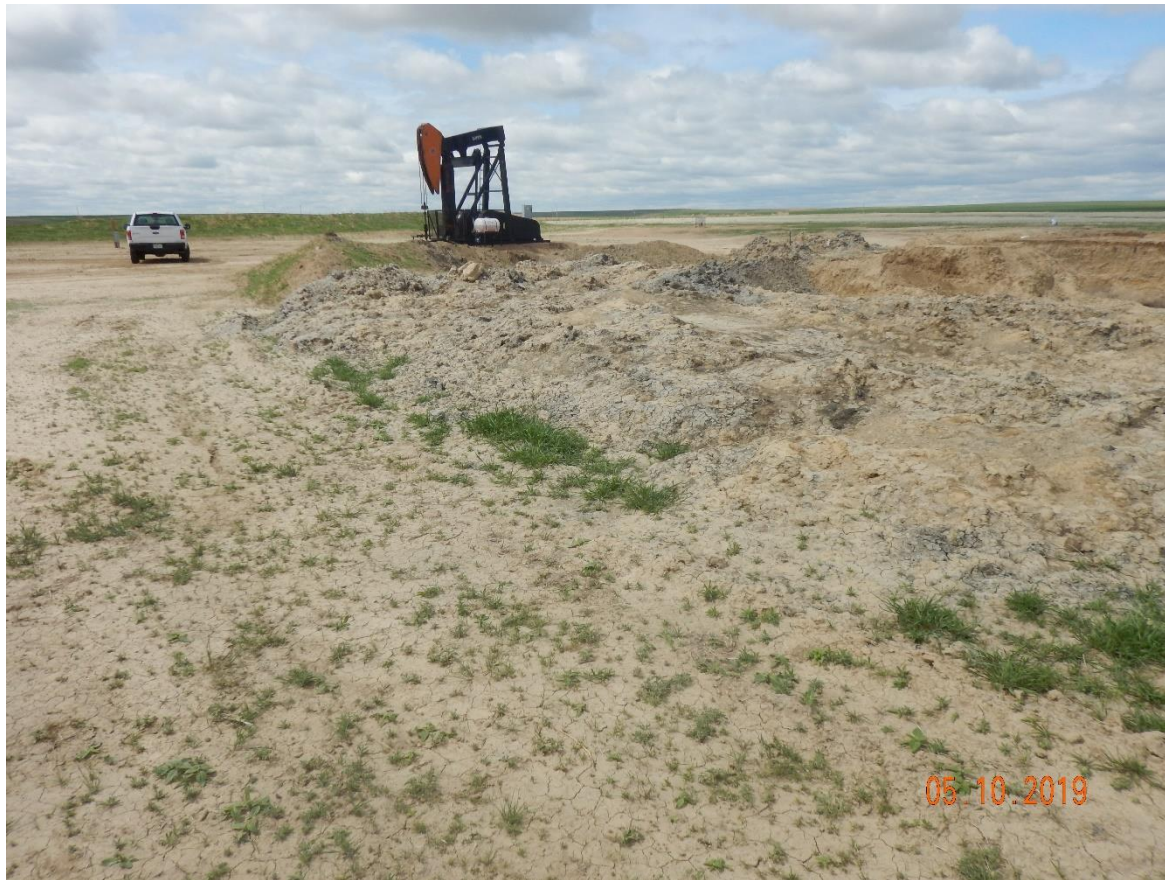
Photo 16: Photo taken from the east end of the drill pit, facing southwest. Photo shows drill pit has not been closed in accordance with 2A COAs and per 1003 rules.

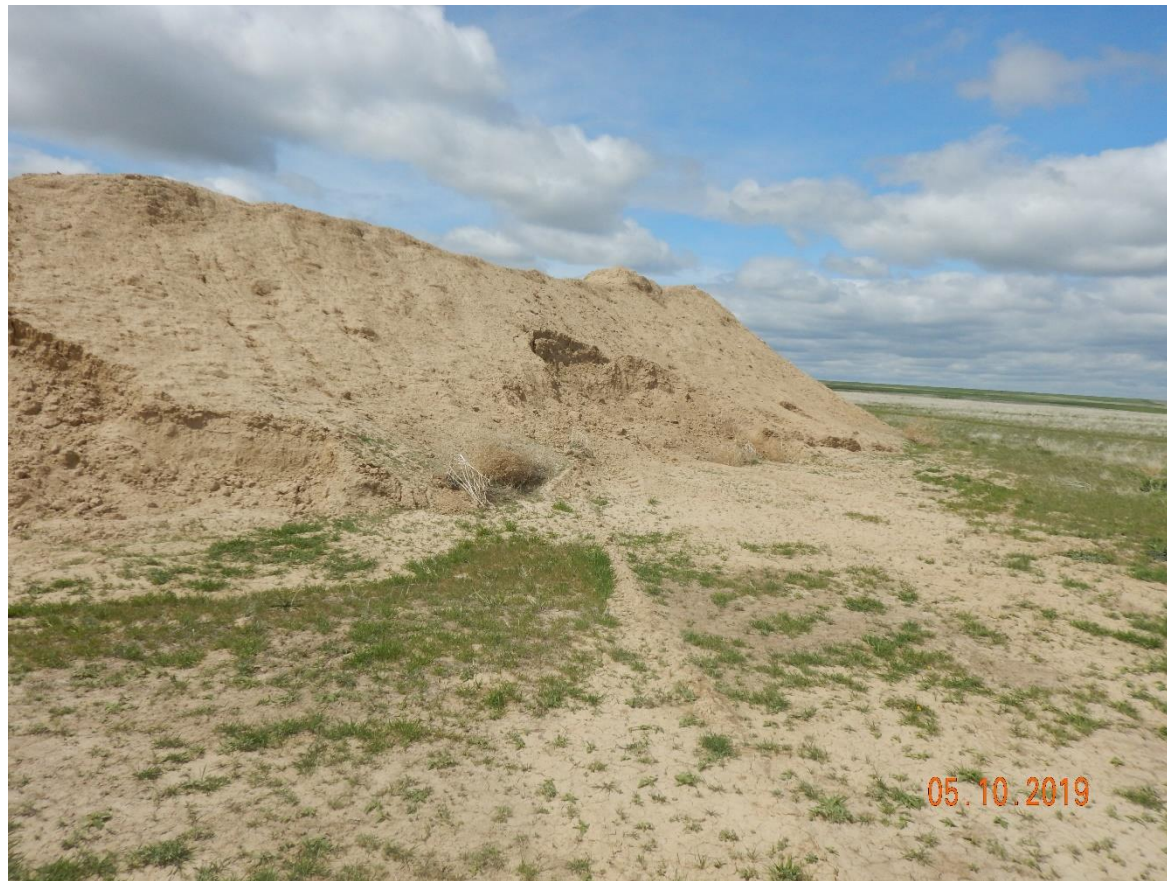
Photo 17: Photo taken from the northeast corner of the location, facing west. Photo shows insufficient stormwater and erosion control BMPs have been installed to stabilize soil stockpile, or mitigate sediment transport from the stockpile and location; erosion degradation and sediment transport/deposition evident.

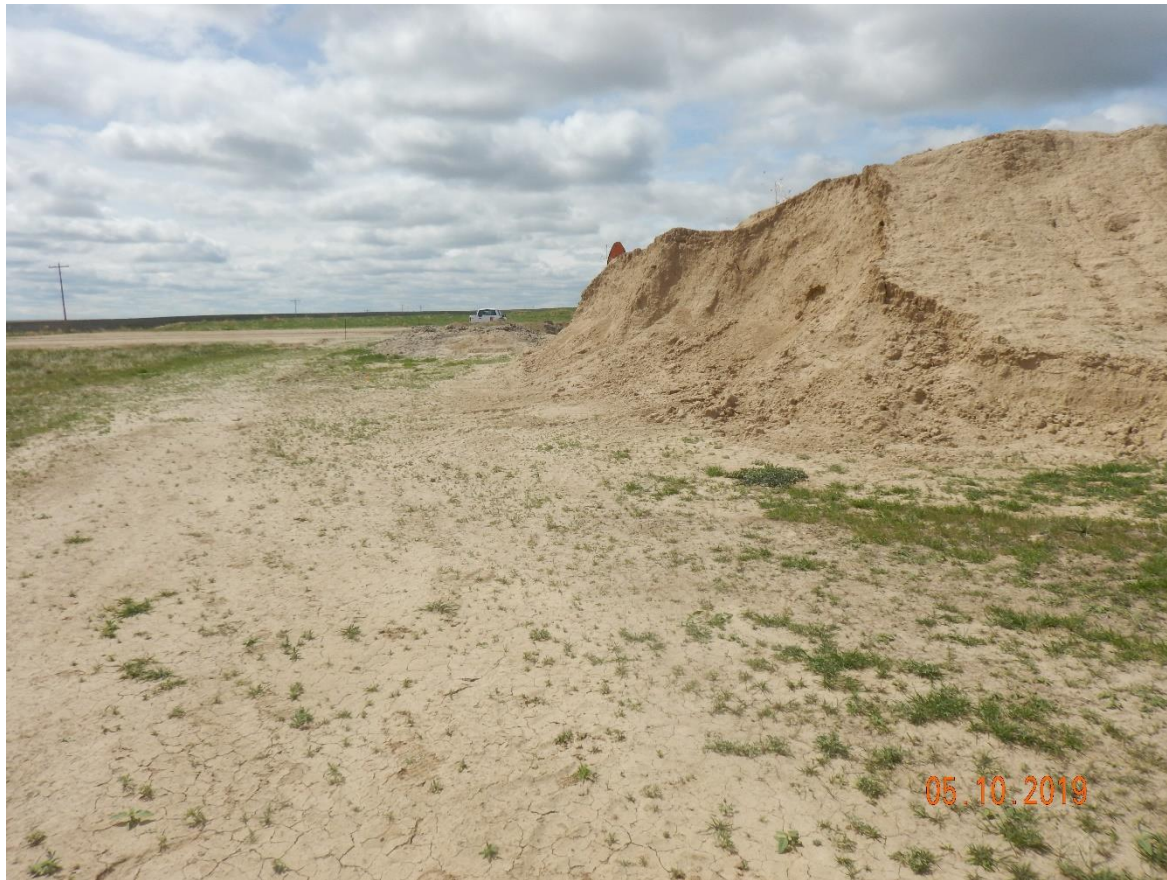
Photo 18: Photo taken from the northeast corner of the location, facing south. See comments under photo 17

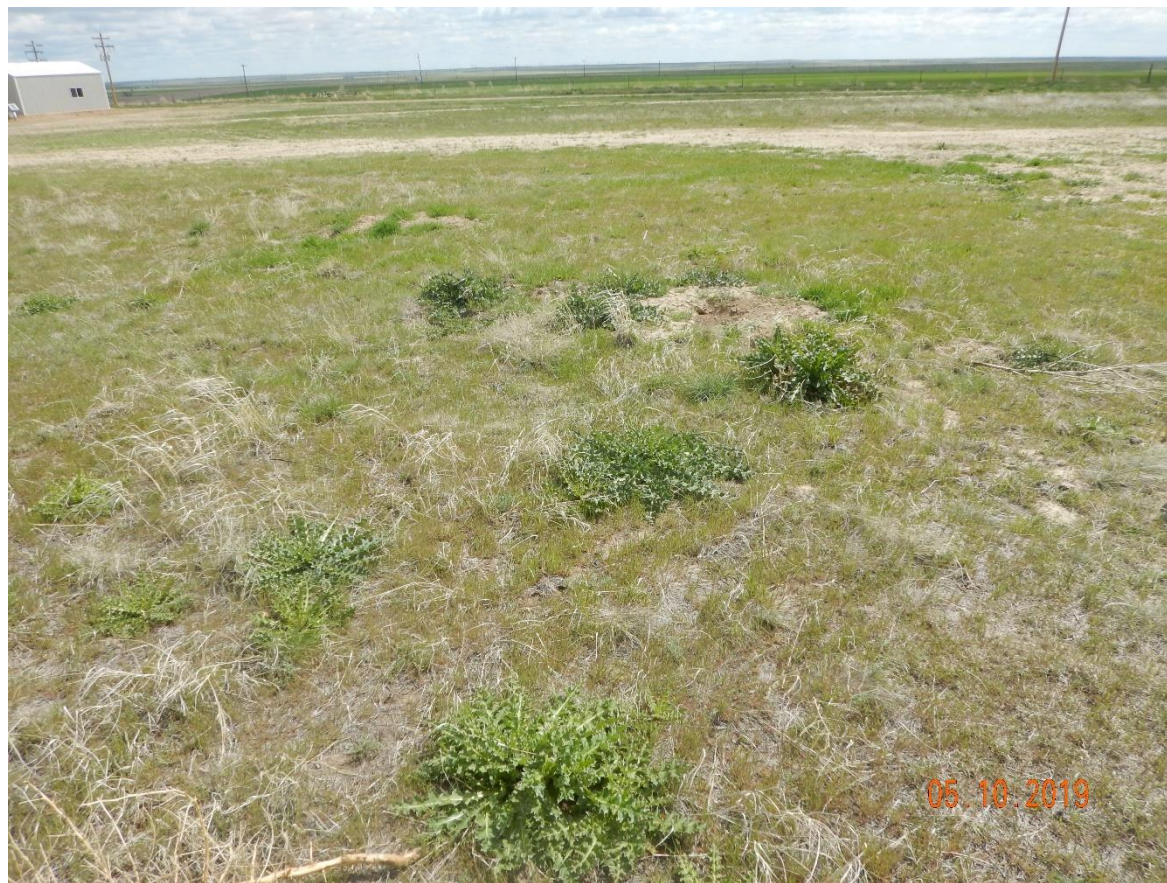
Photo 19: Photo taken from soil stockpile on the north end of the location. Photo shows Scotch thistle on location.

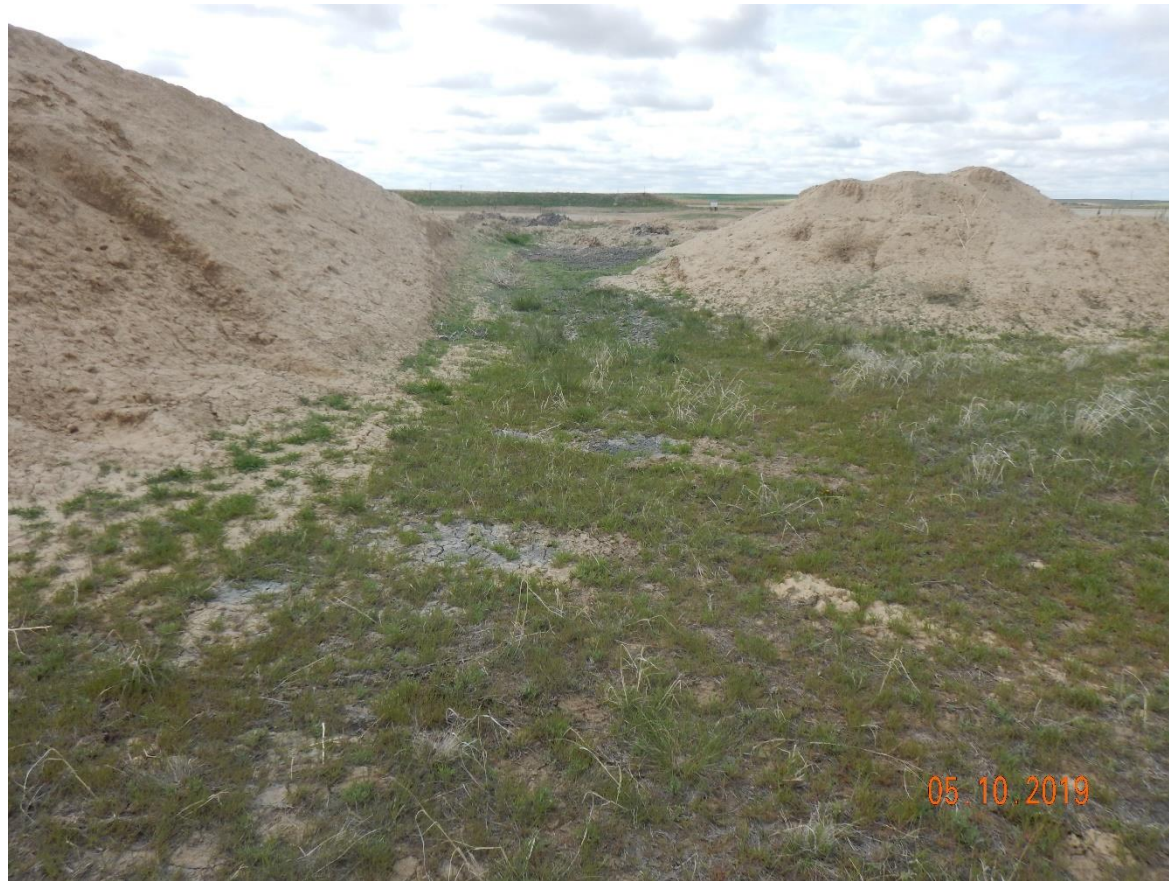
Photo 20: Photo taken from the northwest corner of the location, facing south. See comments under photo 17

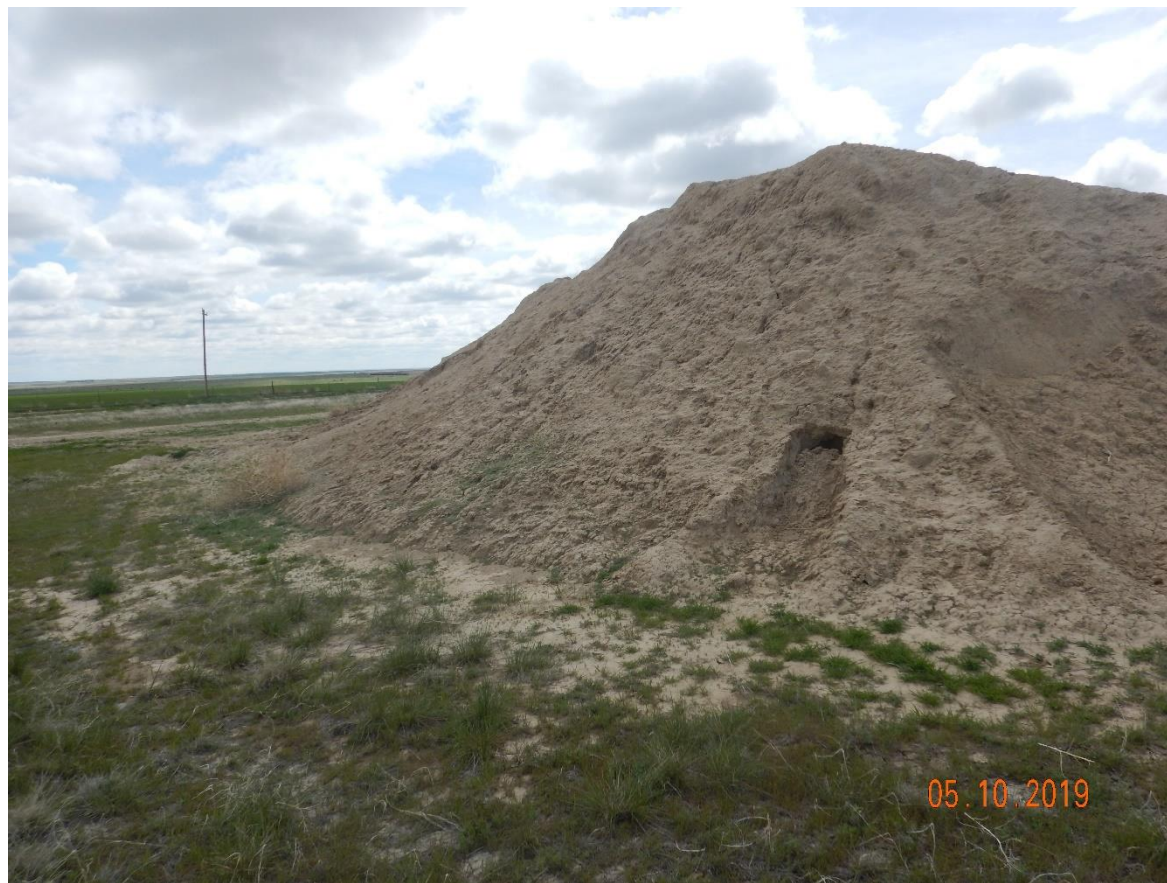
Photo 21: Photo taken from the northwest corner of the location, facing east. See comments under photo 17
