Inspection Photos

Operator: PCR OPERATING LLC - 10657

Location ID: 454154

Inspection Doc. Number: 696200038

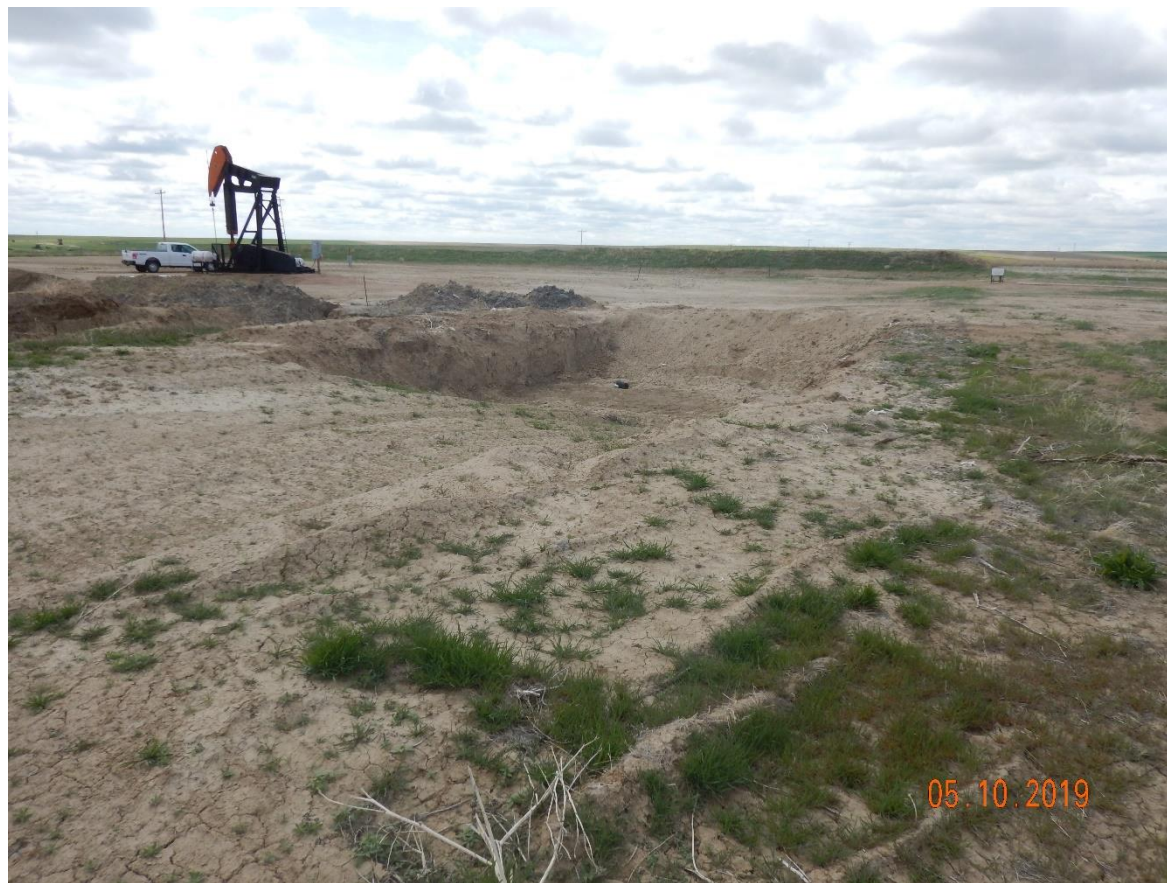
Photo 22: Photo taken from the west end of the drill pits, facing southeast. Photo shows drill pit has not been closed in accordance with 2A COAs and per 1003 rules.

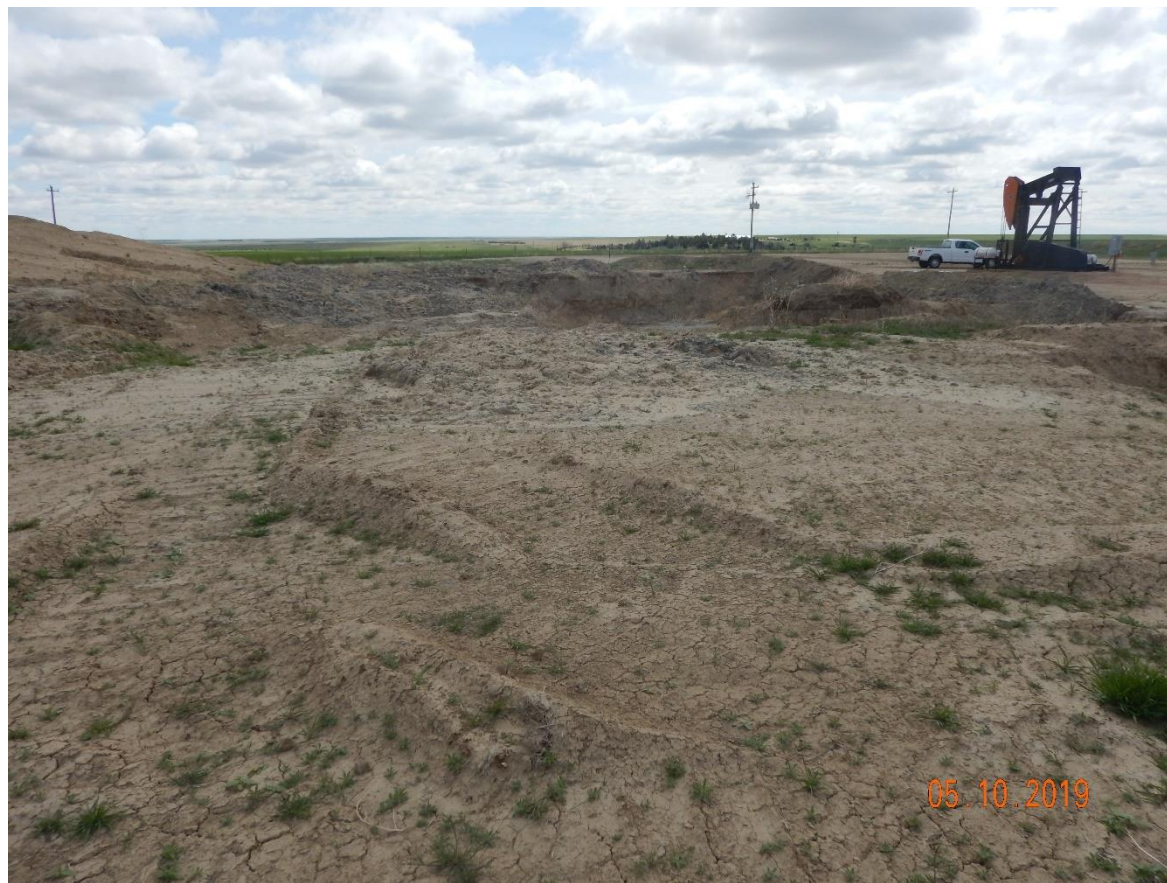
Photo 23: Photo taken from the west end of the drill pits, facing east. Photo shows drill pit has not been closed in accordance with 2A COAs and per 1003 rules.

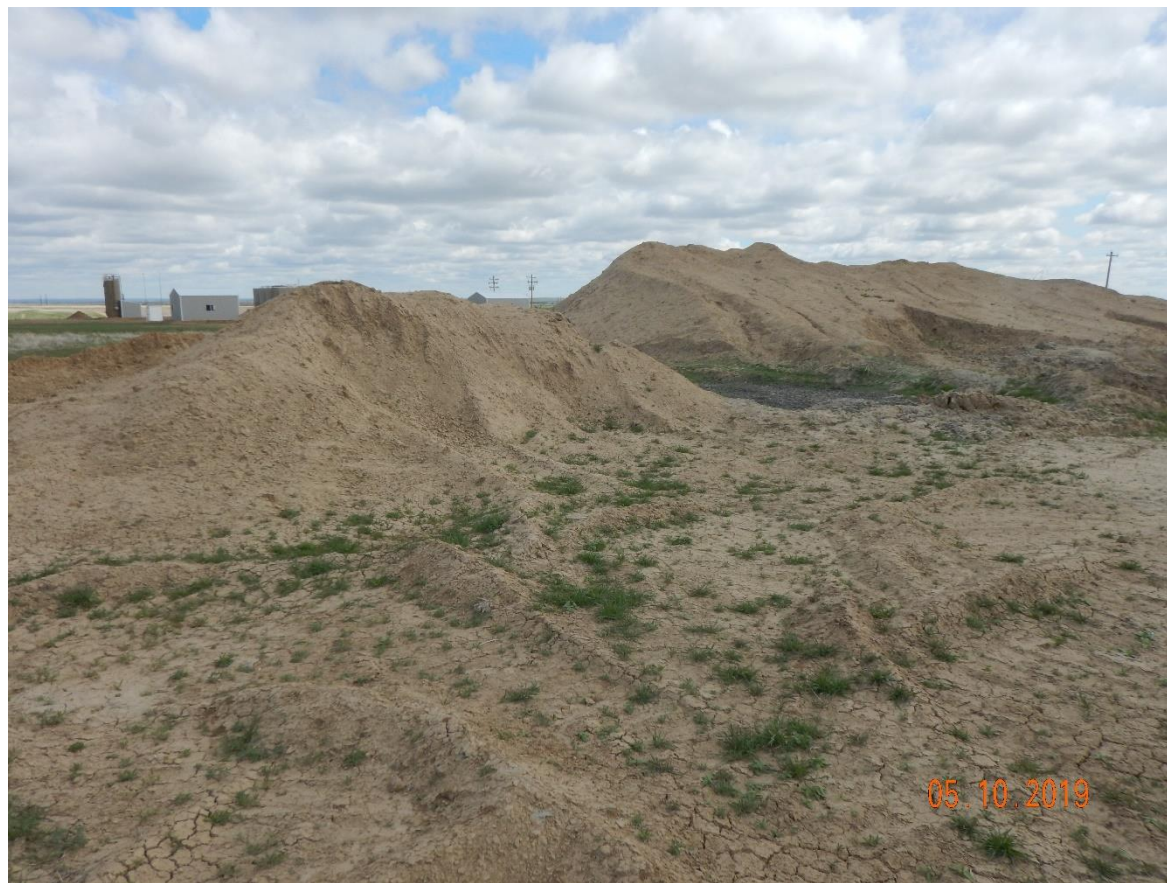
Photo 24: Photo taken from the west end of the drill pits, facing northeast. Photo shows drill pit has not been closed in accordance with 2A COAs and per 1003 rules. Photo also shows insufficient stormwater and erosion control BMPs have been installed to stabilize soil stockpile, or mitigate sediment transport from the stockpile and location; erosion degradation and sediment transport/deposition evident.

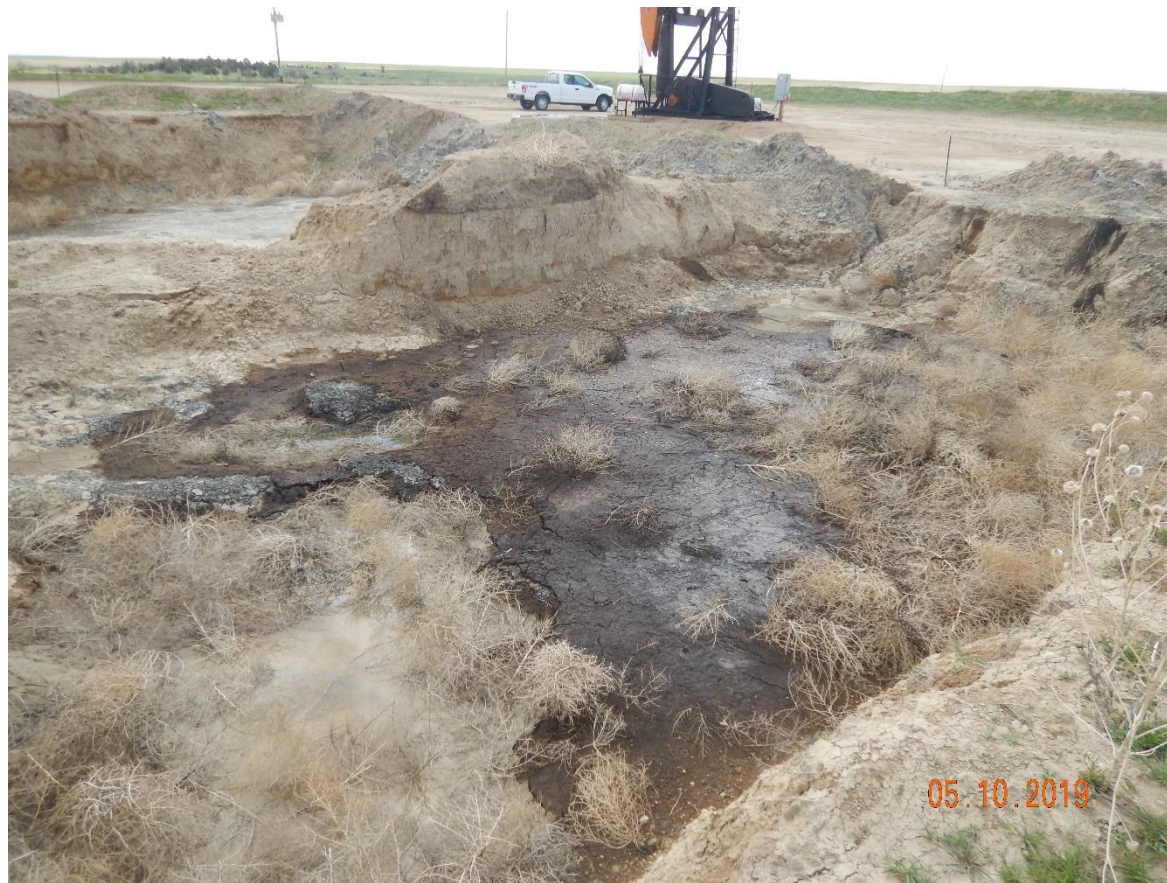
Photo 25: Photo taken from the west end of the drill pit, facing southeast. Photo shows oily material observed within the drill pit.

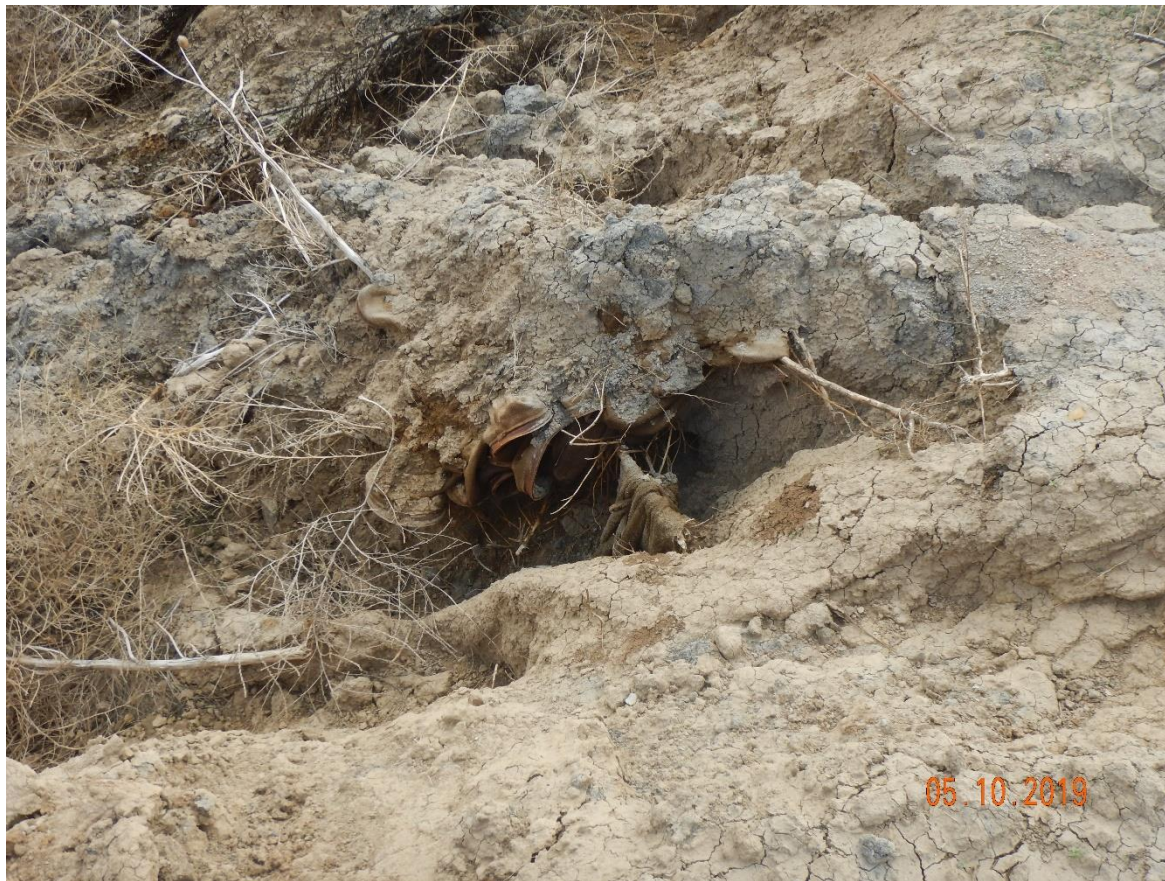
Photo 26: Photo taken from the southwest end of the drill pit. Photo shows various trash debris (partially covered with drill cuttings) observed within the drill pit.
