**Inspection Photos**  
**Location Name: B-Farm LD 18-392HN**  
**Location ID: 452914**

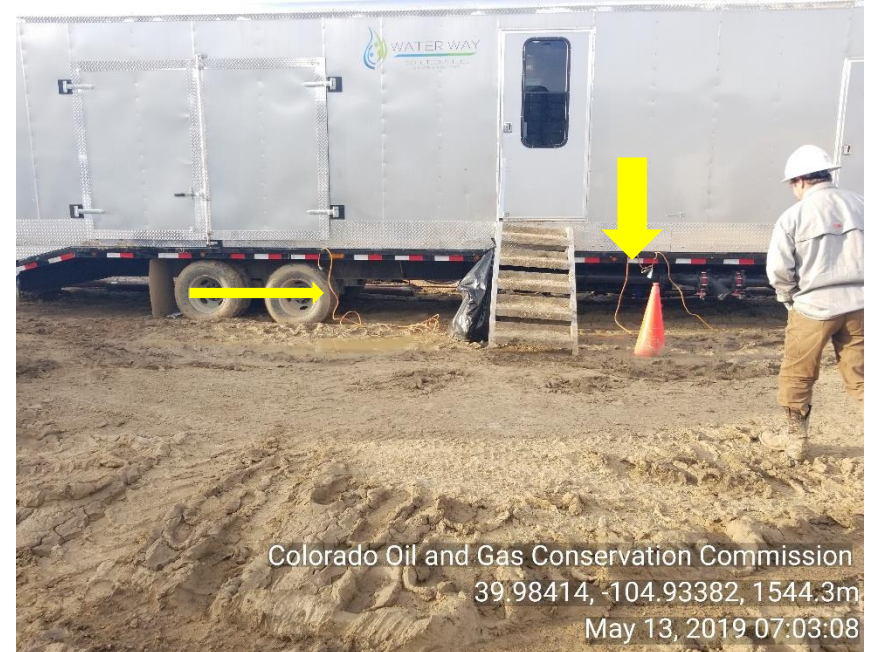
**Photo 2 electric cords laying in mud and water.**

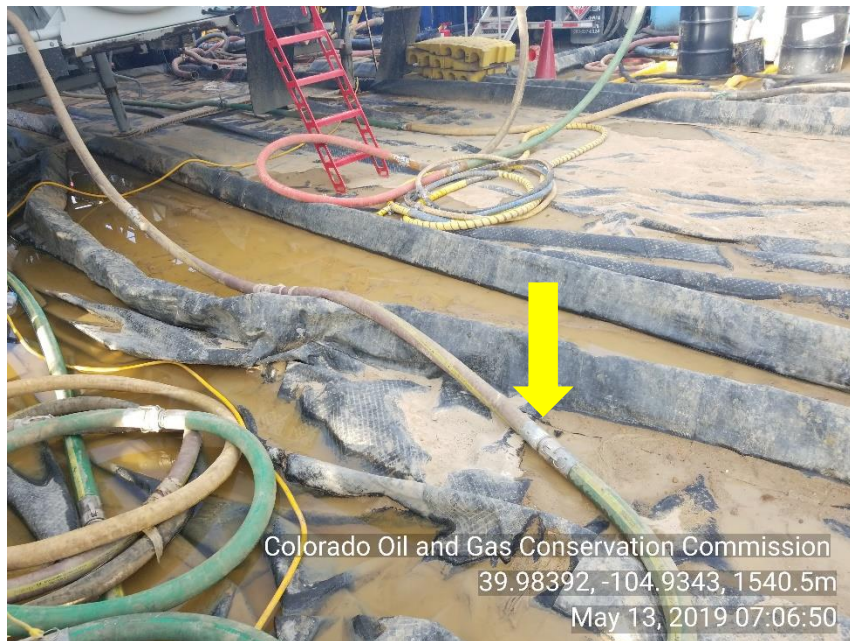
**Photo 3 Chemical hose cam lock not properly taped or double lock cam lock**

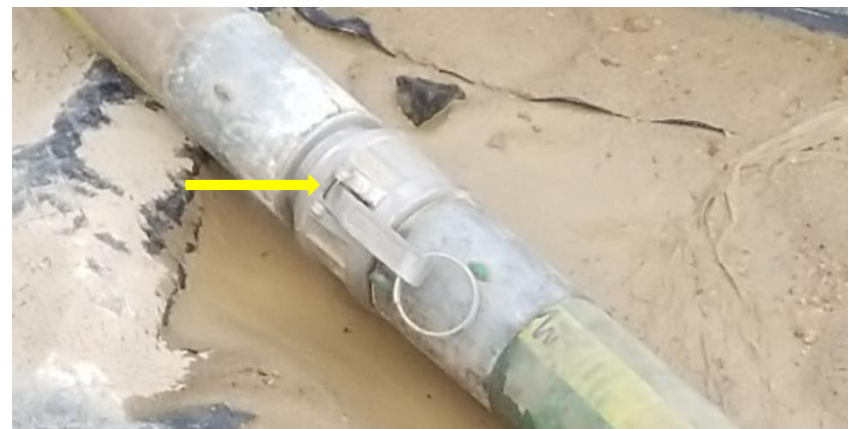
**Photo 4 Chemical hose cam lock not properly taped or double lock cam lock. Possible spill or storm water issue.**

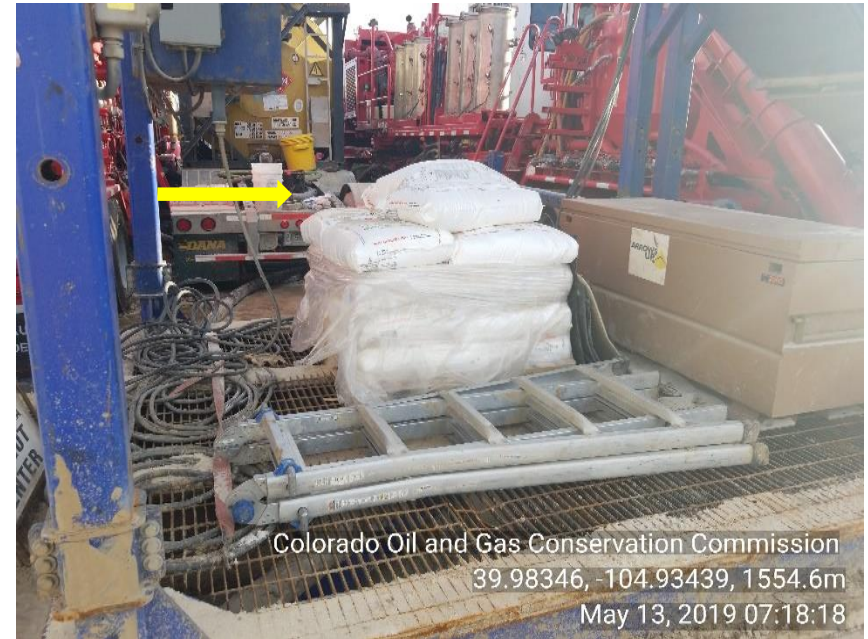
**Photo 6 Improper chemical storage: Chemical's not covered.**

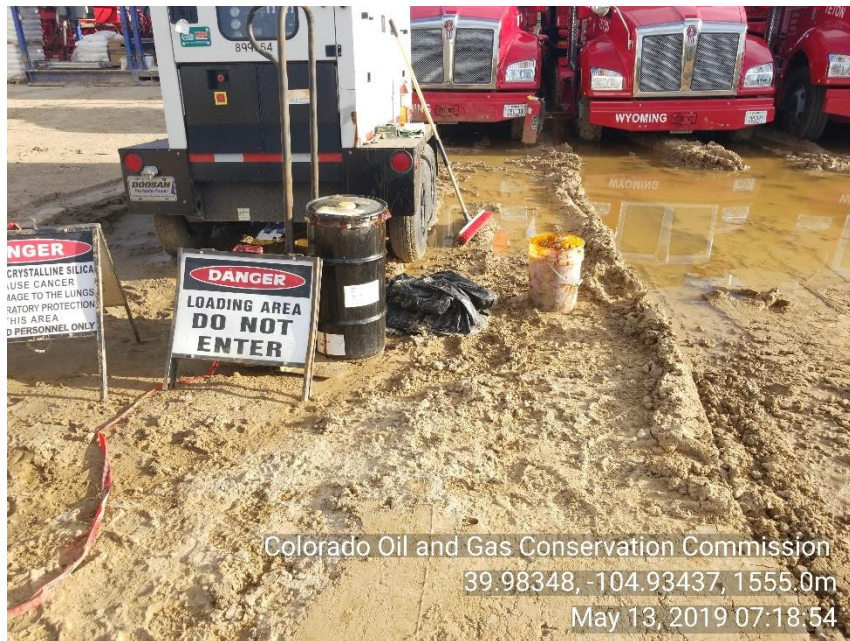
**Photo 7 Improper storage of grease. No secondary containment.**

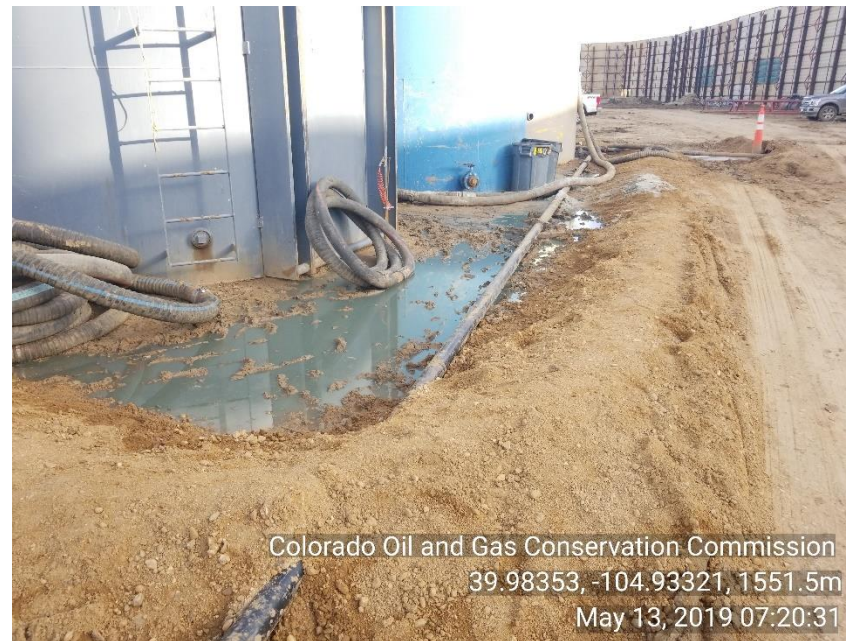
**Photo 8 Spill release: unknown fluid in drill out tank containment.**

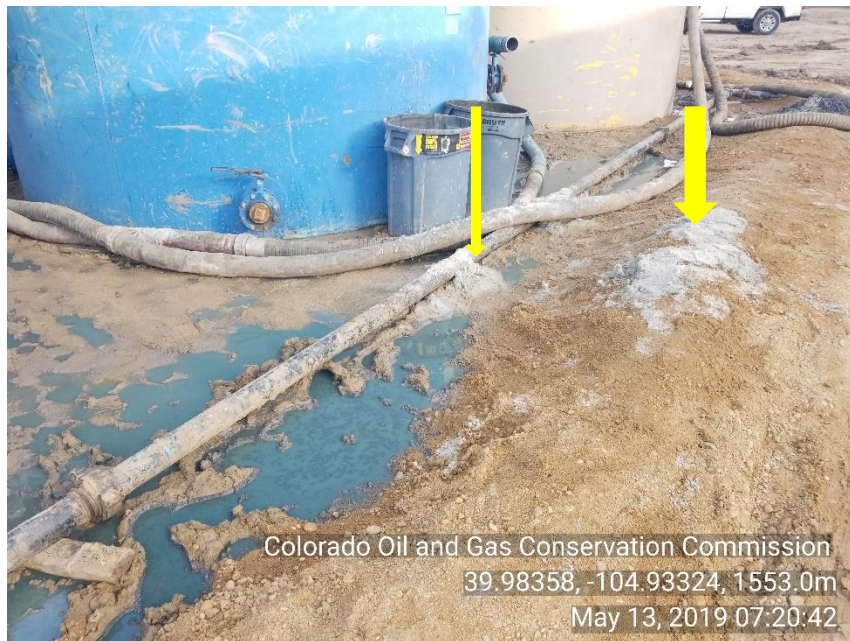
**Photo 9 Spill release: unknown fluid in drill out tank containment.  
Frac sand in and on berm. Inadequate containment.**

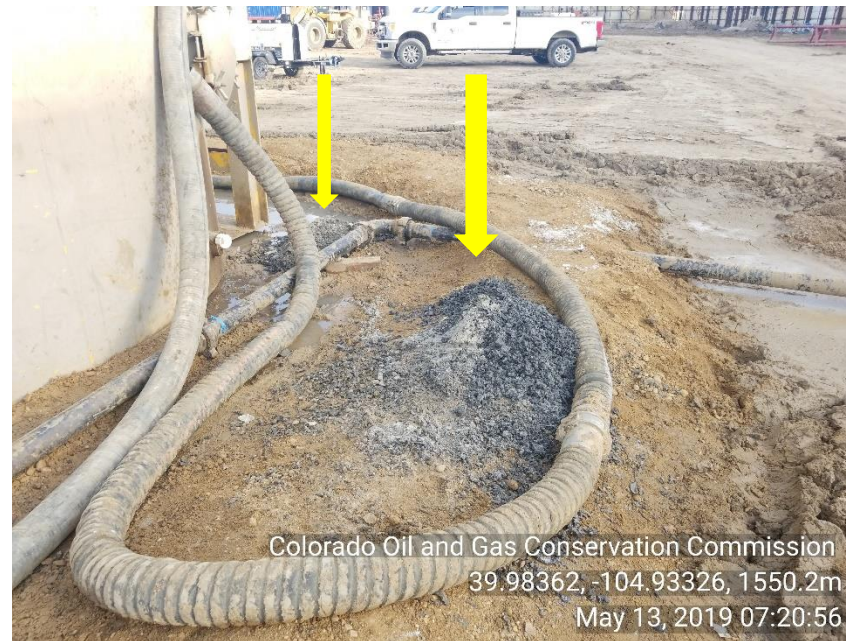
**Photo 10 Stained soil in and on berm.**

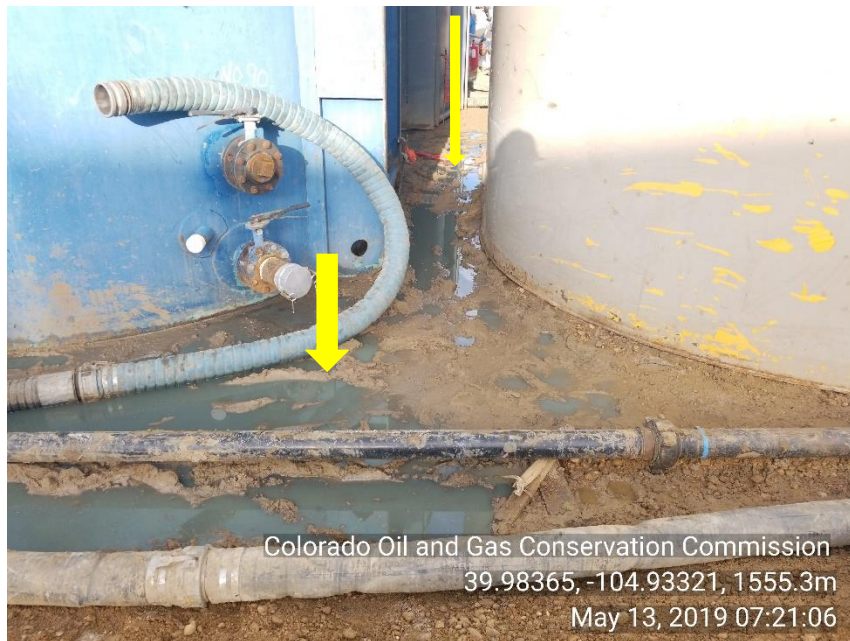
**Photo 11 Spill release: unknown fluid in drill out tank containment.**

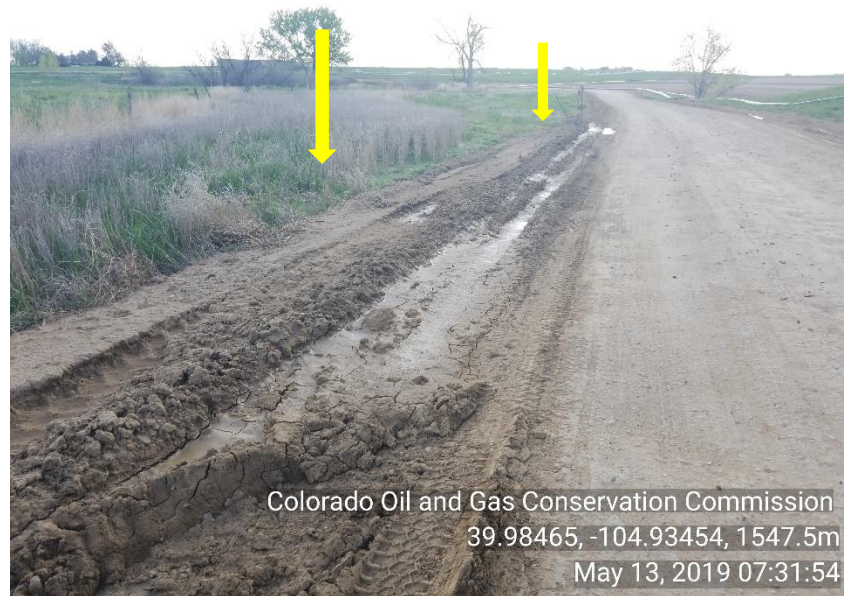
**Photo 12 Build up of mud and water improper drainage and no BMP's in place to control sediment from leaving access road to location.**

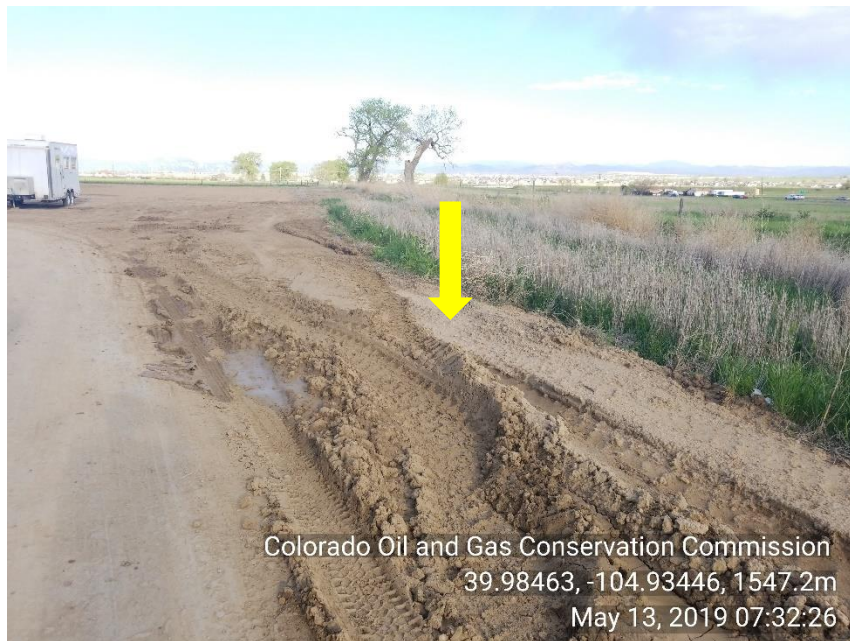
**Photo 13 Build up of mud and water improper drainage and no BMP's in place to control sediment from leaving access road to location.**

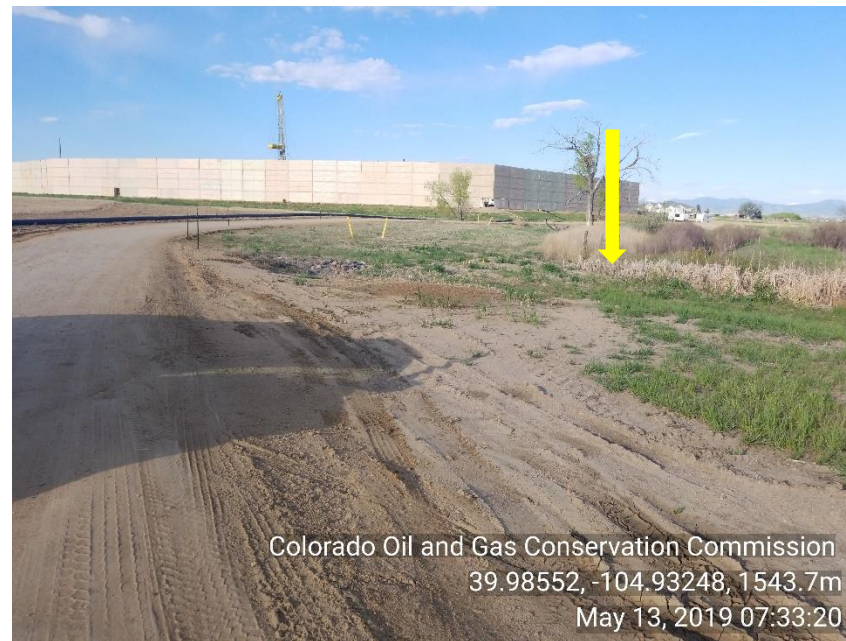
**Photo 14 Storm water: no BMP's in place to control sediment from leaving access road to location. Sediment is running off and covering vegetation.**

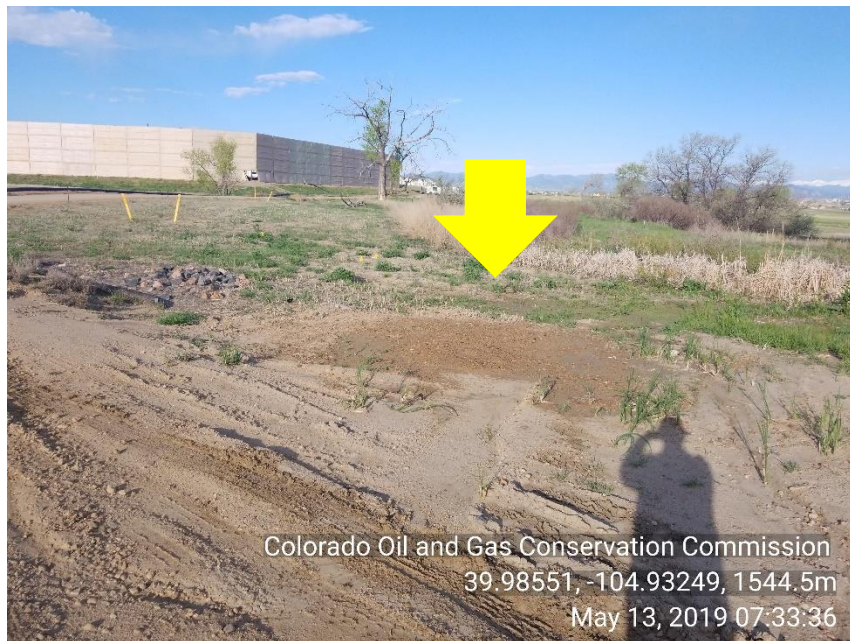
**Photo 15 Storm water: no BMP's in place to control sediment from leaving access road to location. Sediment is running off and covering vegetation.**

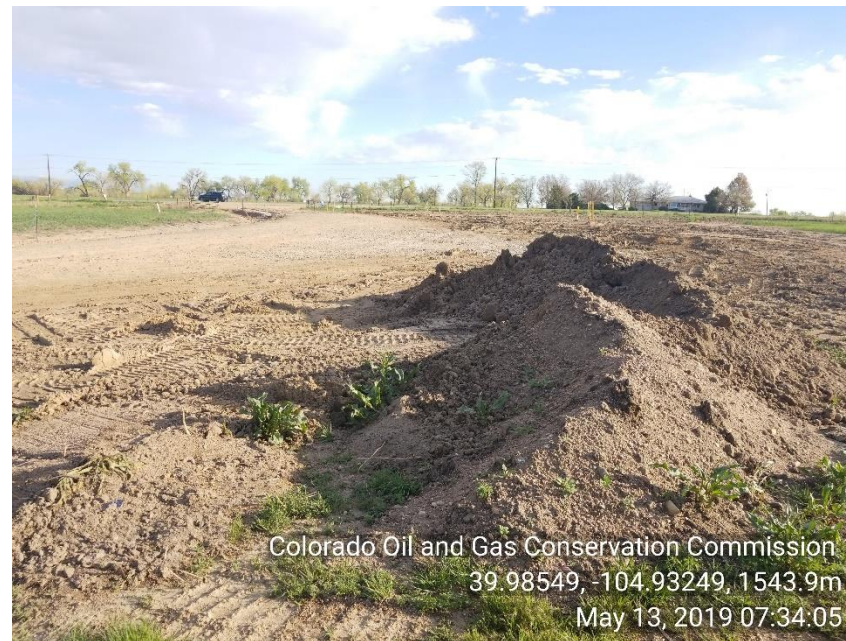
**Photo 16 Storm water: no BMP's in place to control sediment from leaving access road to location.**

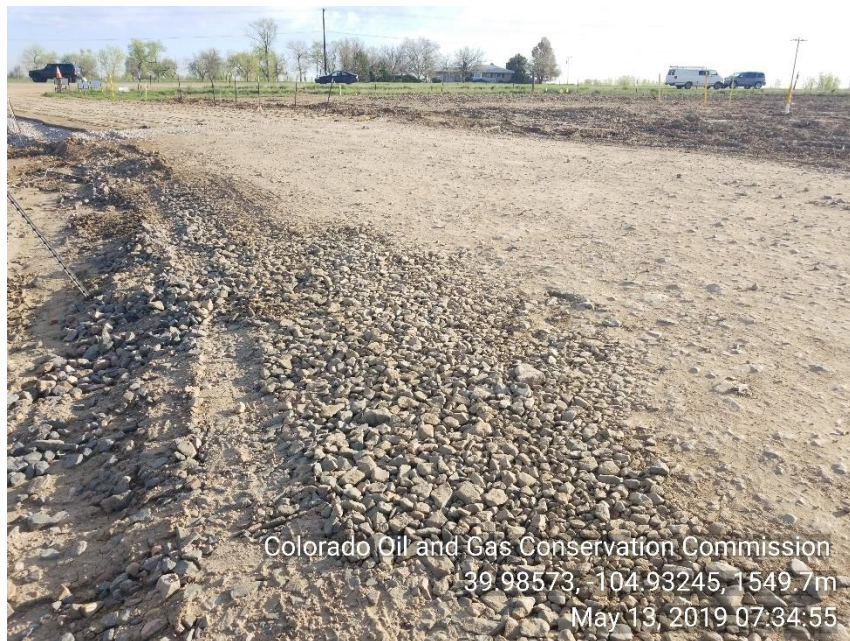
**Photo 15 Tracking pad: Rock tracking pad impacted with sediment not properly maintained.**

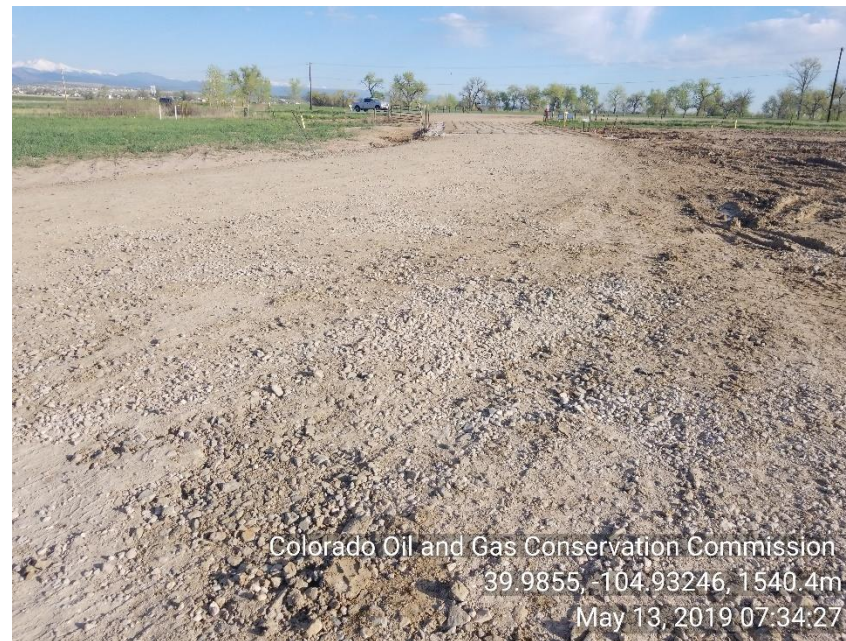
**Photo 16 Tracking pad: Rock tracking pad impacted with sediment not properly maintained.**

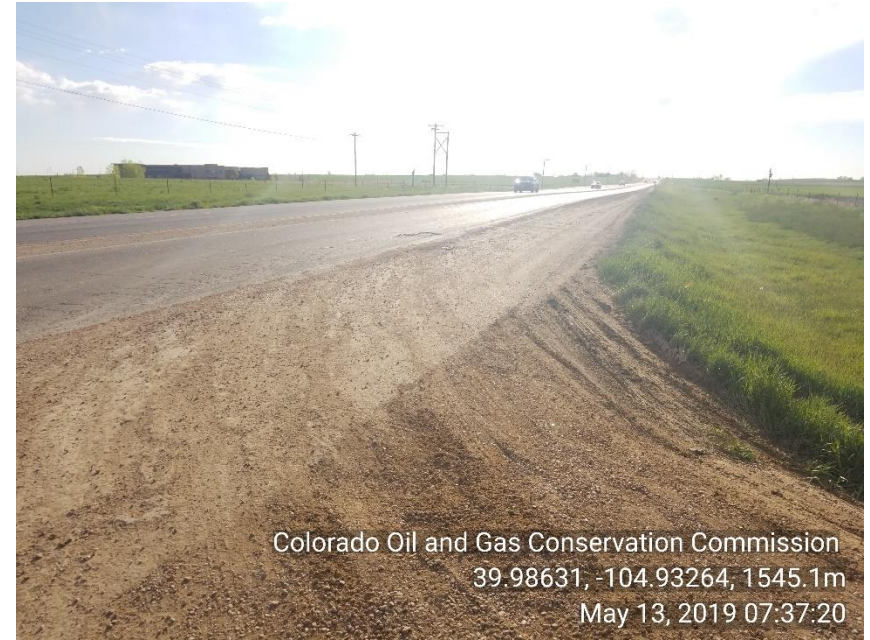
**Photo 18 Vehicle tracking: Sediment from access road being carried onto HWY 7 .**

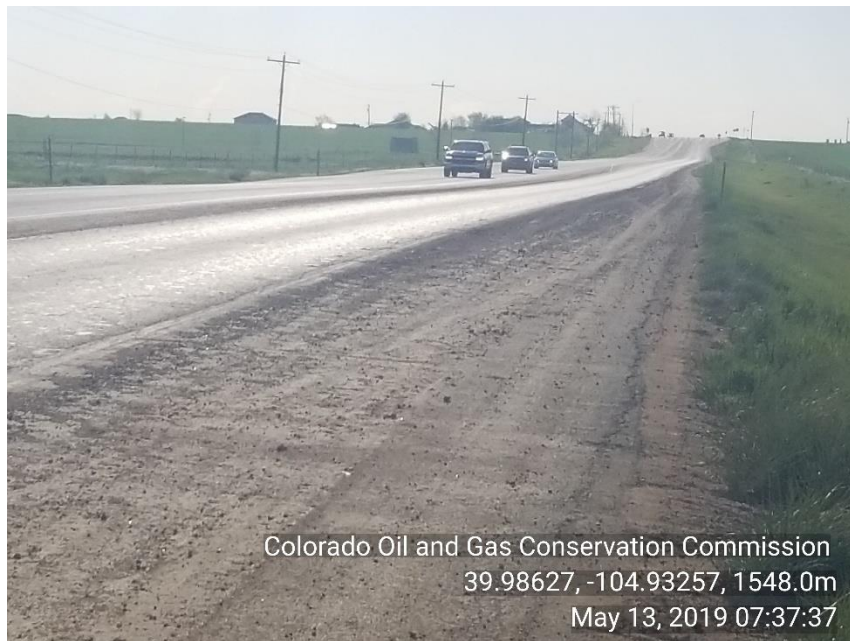
**Photo 19 Vehicle tracking: Sediment from access road being carried onto HWY 7 .**

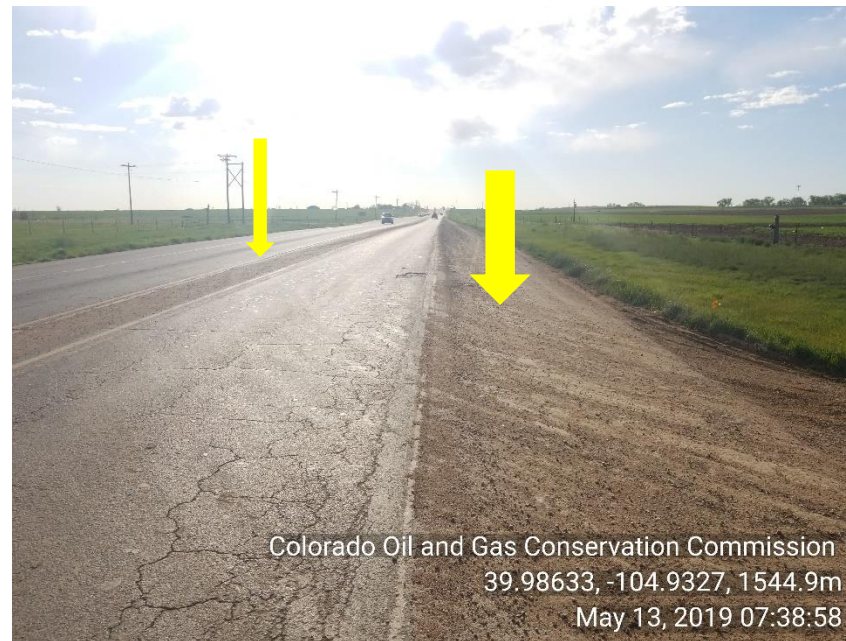
**Photo 20 Vehicle tracking: Sediment from access road being carried onto HWY 7 .**

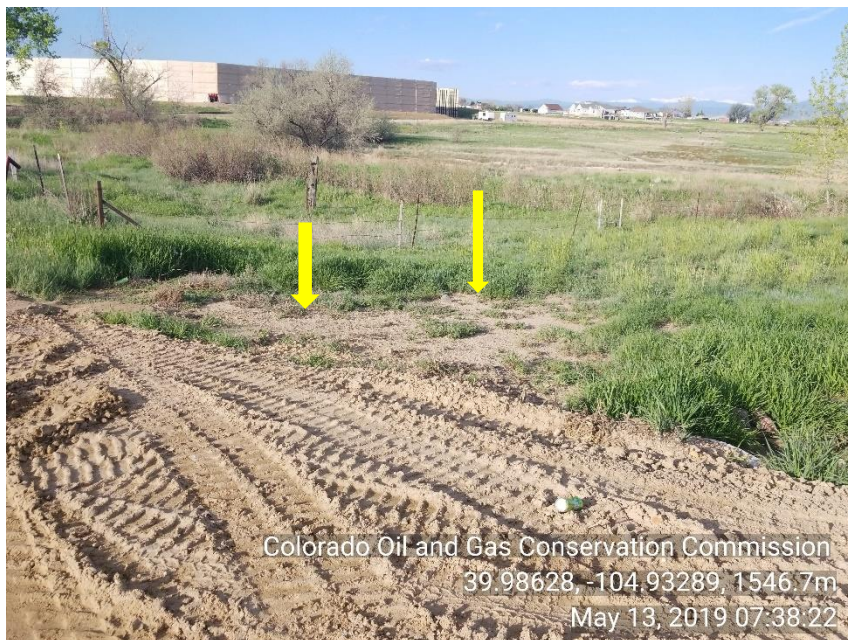
**Photo 21 Storm water Improper BMP's sediment being carried off access road into vegetation.**

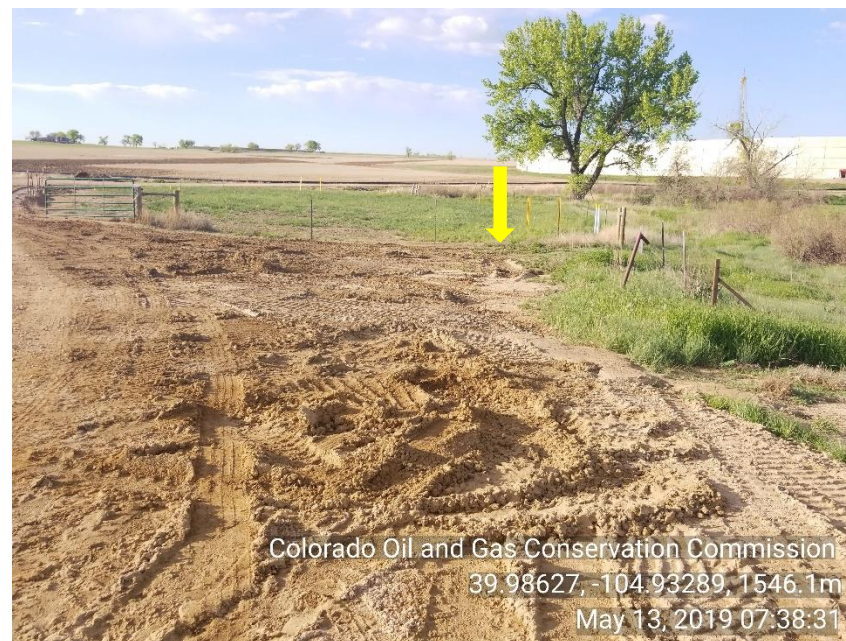
**Photo 22 Storm water Improper BMP's sediment being carried off access road into vegetation.**
