Inspection Photos
Operator: Catamount Energy
Location/API #: 067-08284
Date: 5-9-2019

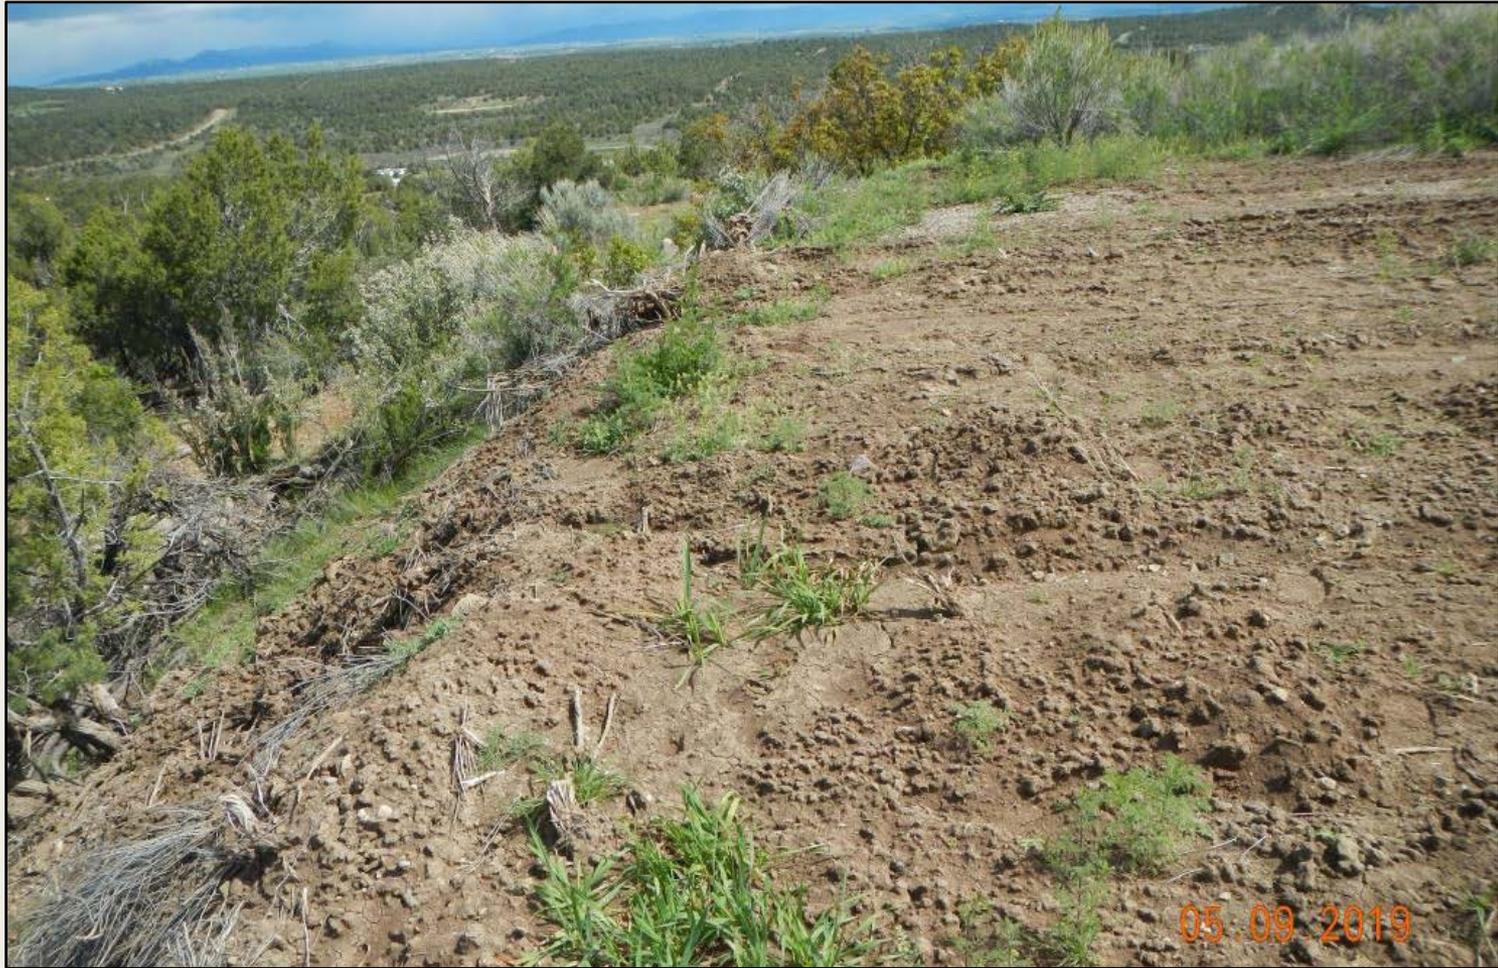
Photo 1. View of disturbance area in the western project area, needing stormwater controls and reclamation.

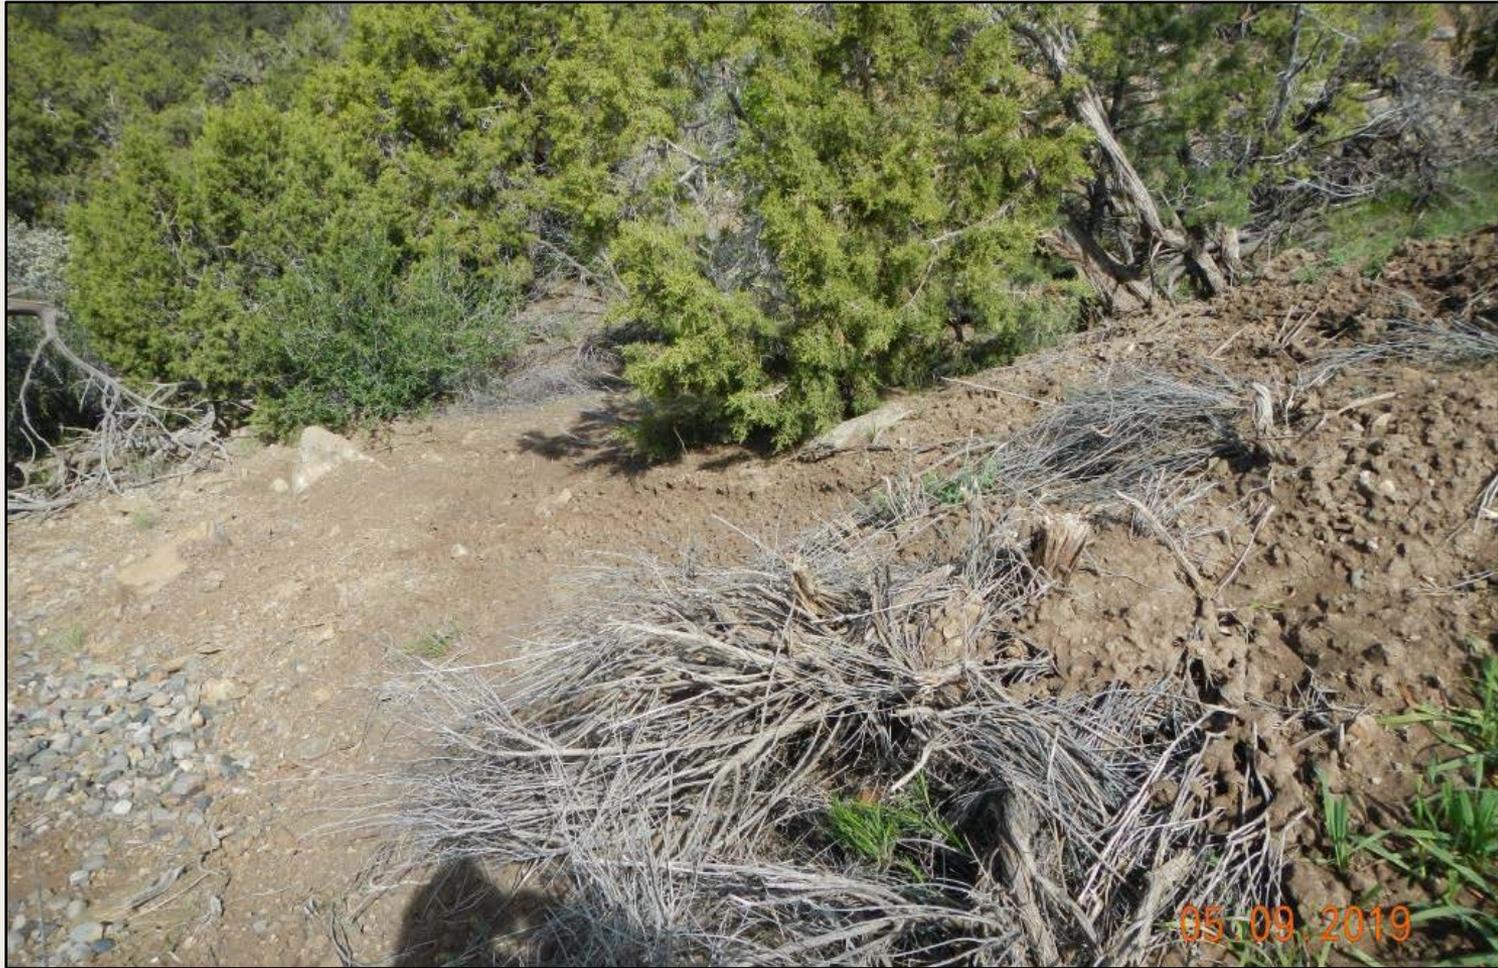
Photo 2. Downslope of disturbance area in the western project area where soil was pushed down-slope. Sediment controls are needed here.

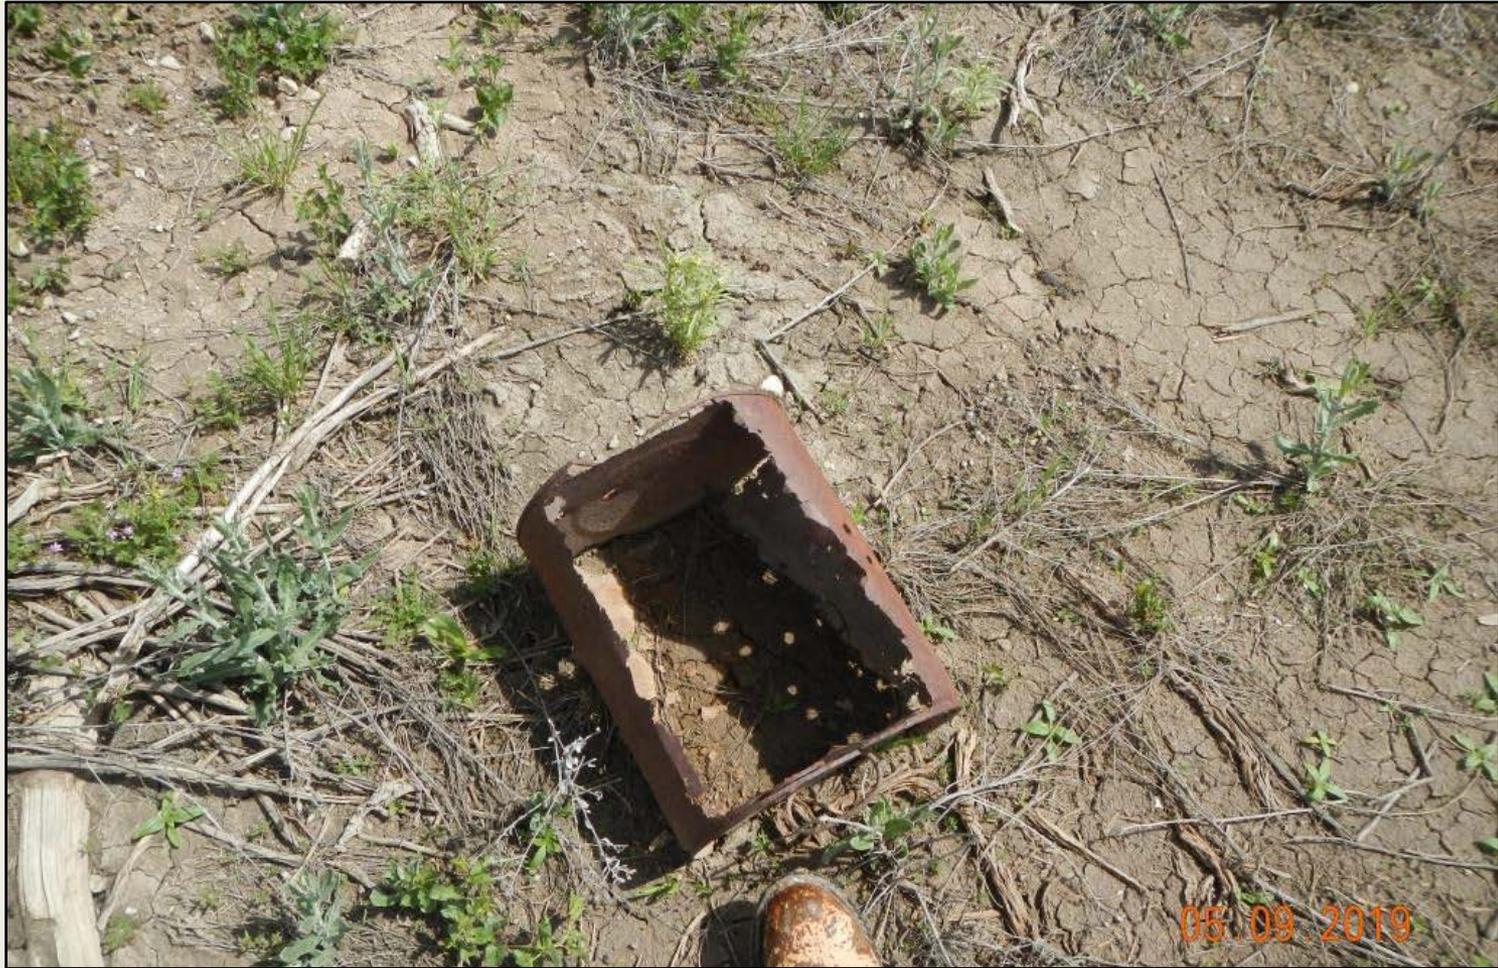
Photo 3. View of metal debris within the project area.

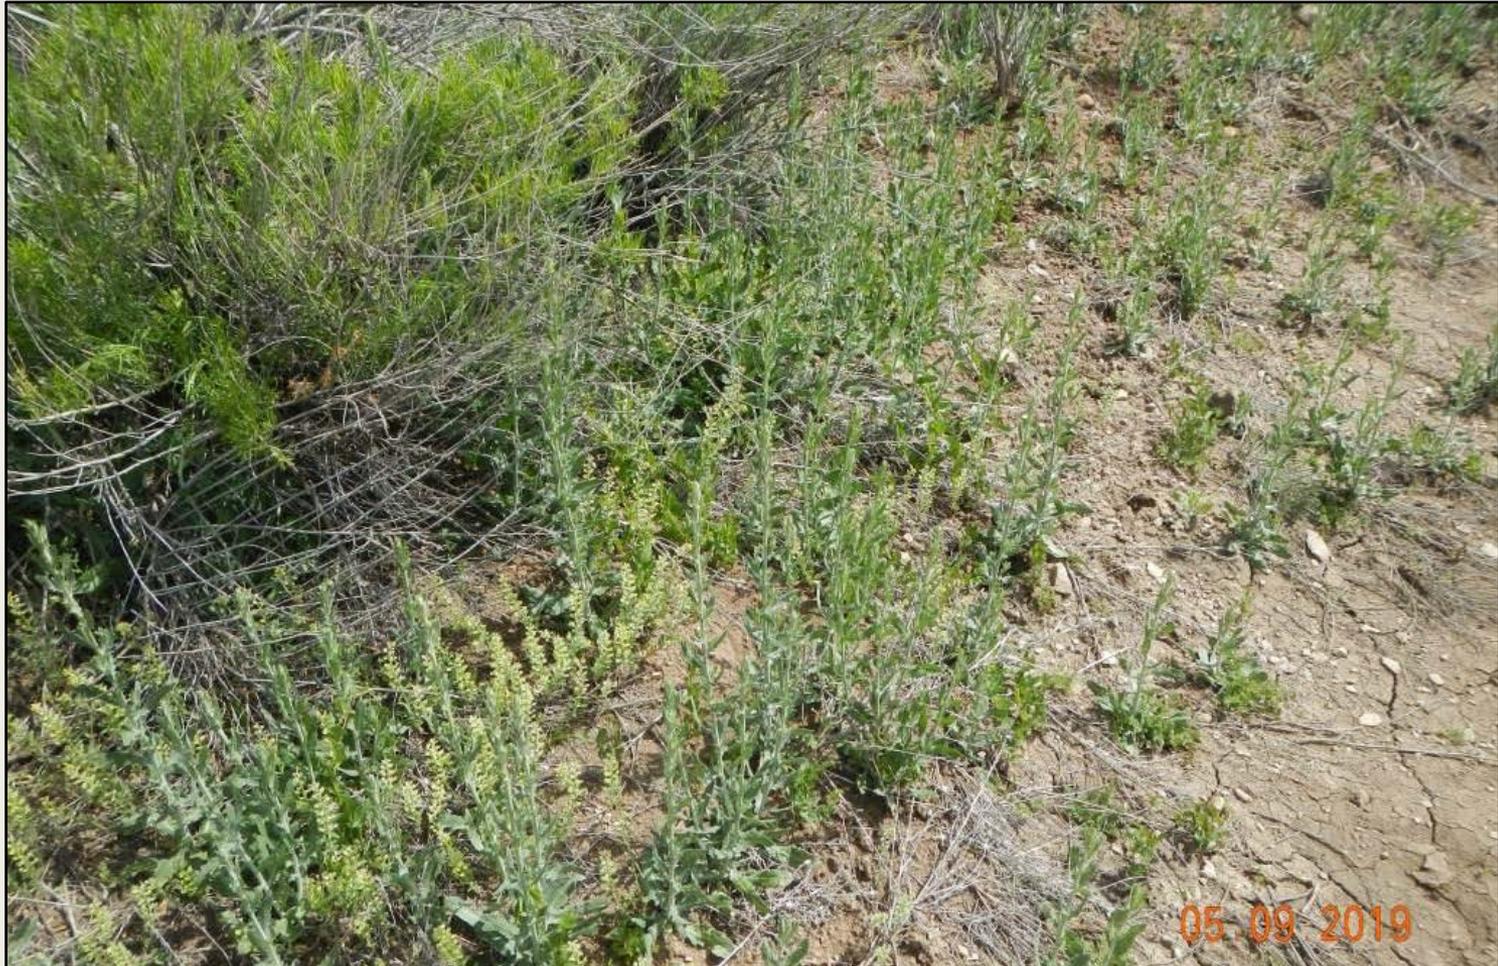
Photo 4. View of Russian knapweeds (*Rhaponticum repens*) within the northern project area.

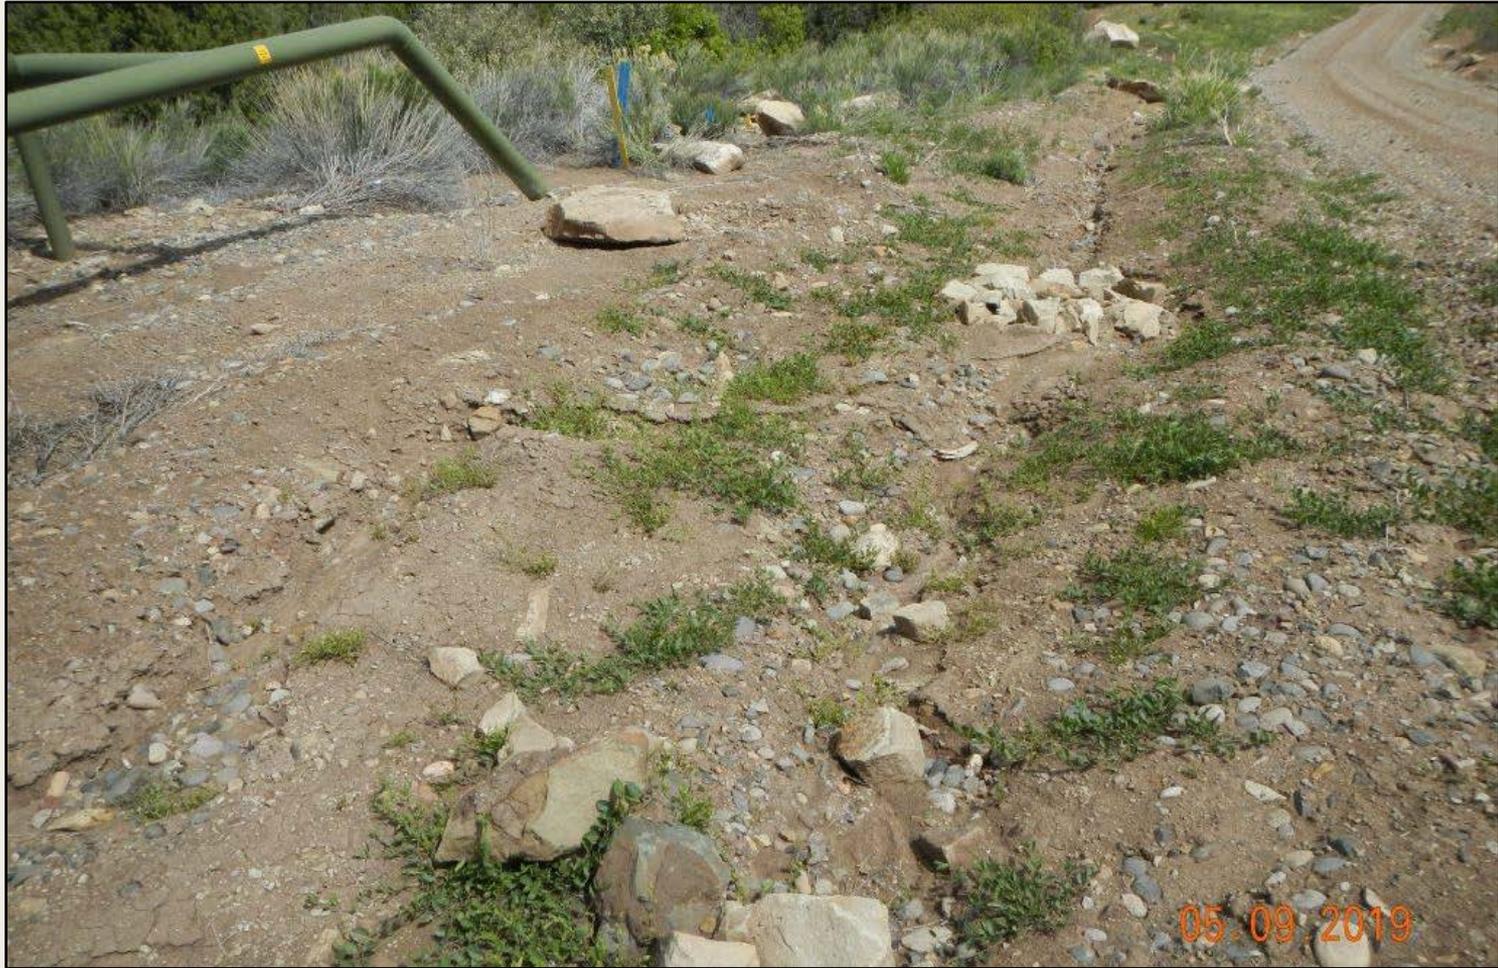
Photo 5. View of erosional channeling at the well pad entrance, and along the access road. BMPs are not sufficient in this area. Road was recently improved, appears to have been crowned, graveled, and ditched.
