Inspection Photos
Location Name: Titanium 26-10-7HI & 2
API: 05-057-06094

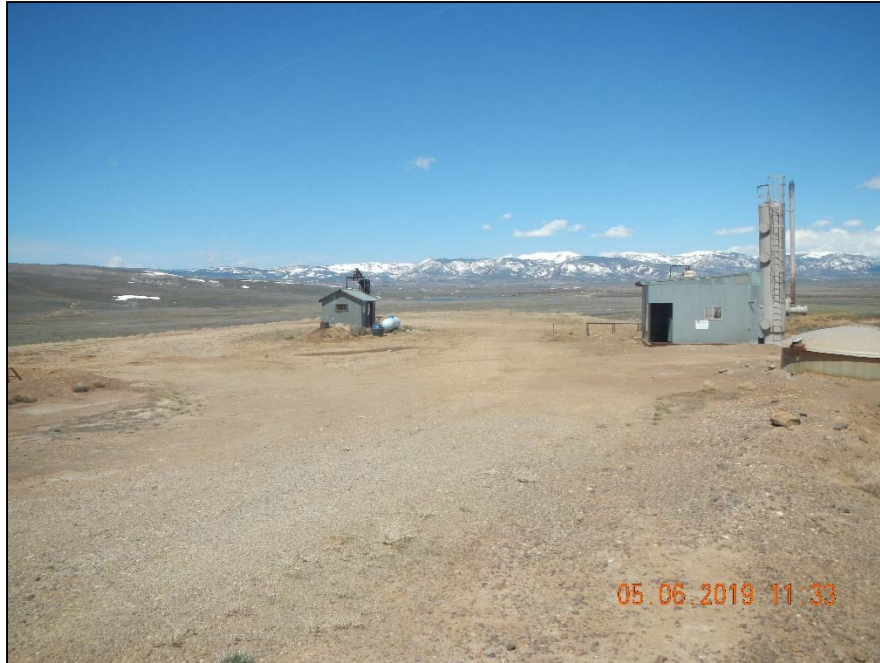
Photo 1. Overview of location taken at entrance facing west.

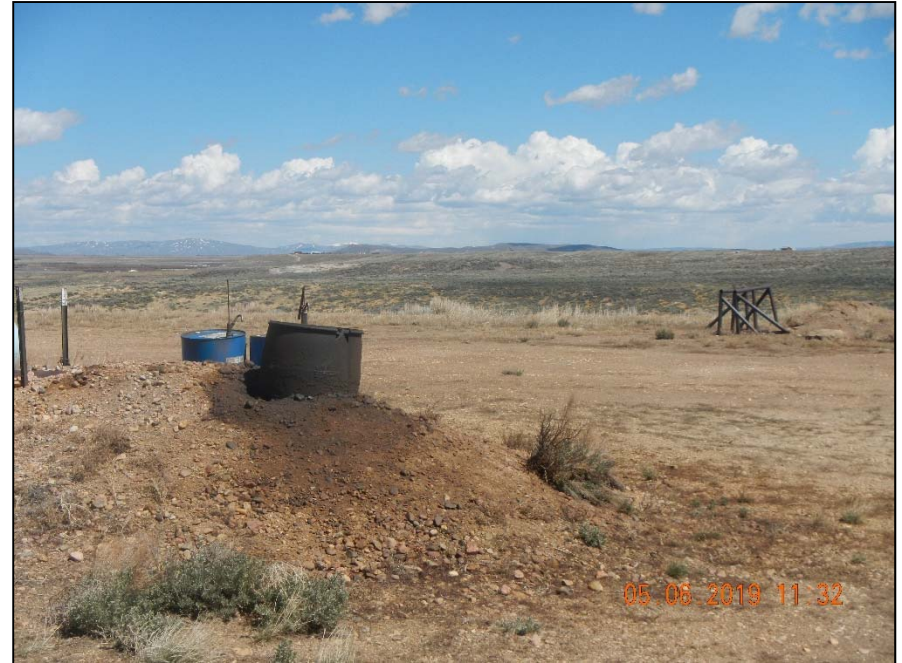
Photo 2. Stained soil at pump jack motor exhaust.
