**FRAM OPERATING LLC – 10310**  
**API # 05-077-08864 JENSEN #12-1**  
**Inspection Date : 05/13/2019**

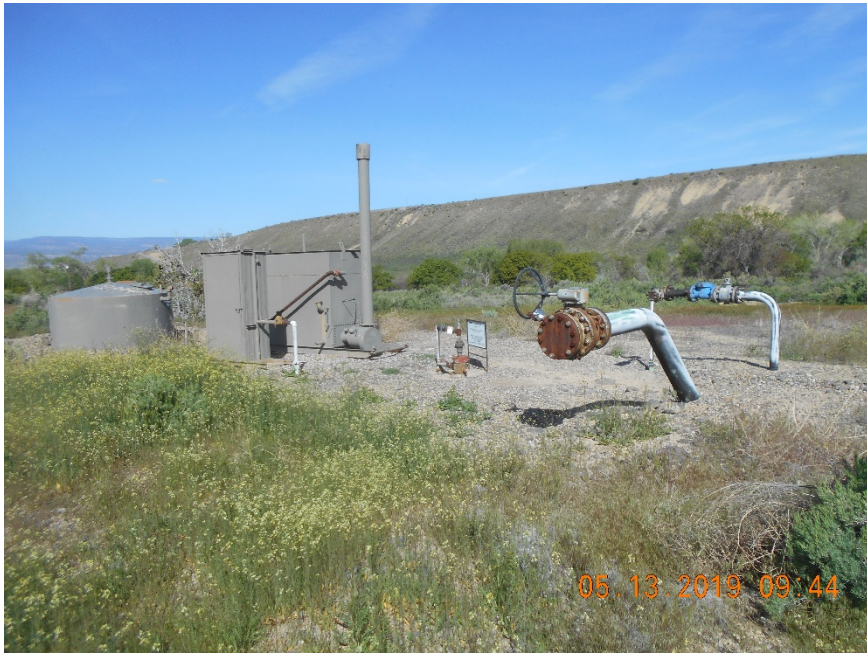
**Overview of location from SE corner of pad  
looking W**

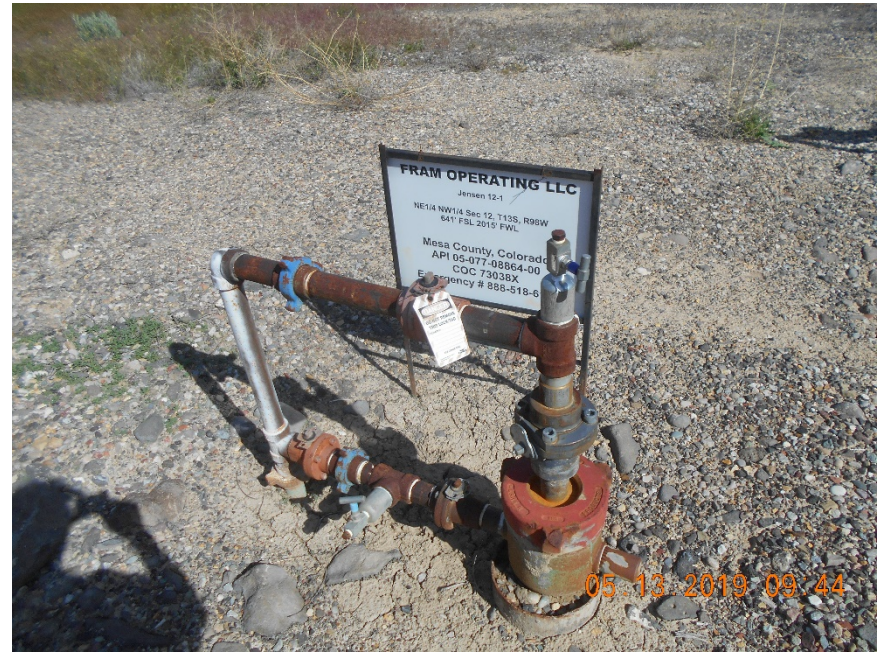
**Shut in wellhead with sign. Locked out/Tagged out.**

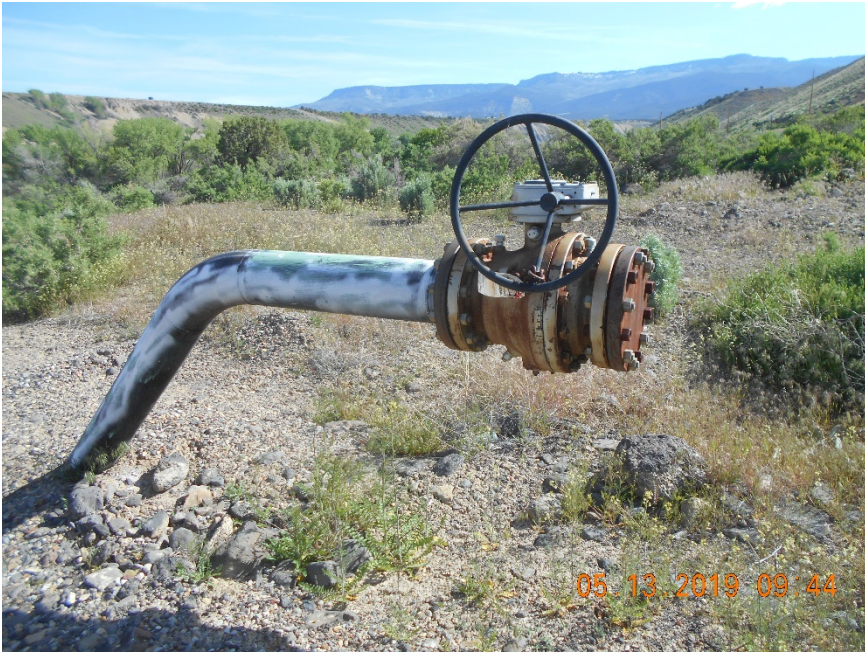
**8' Gathering line riser. Blind flanged and  
Locked out/Tagged out**

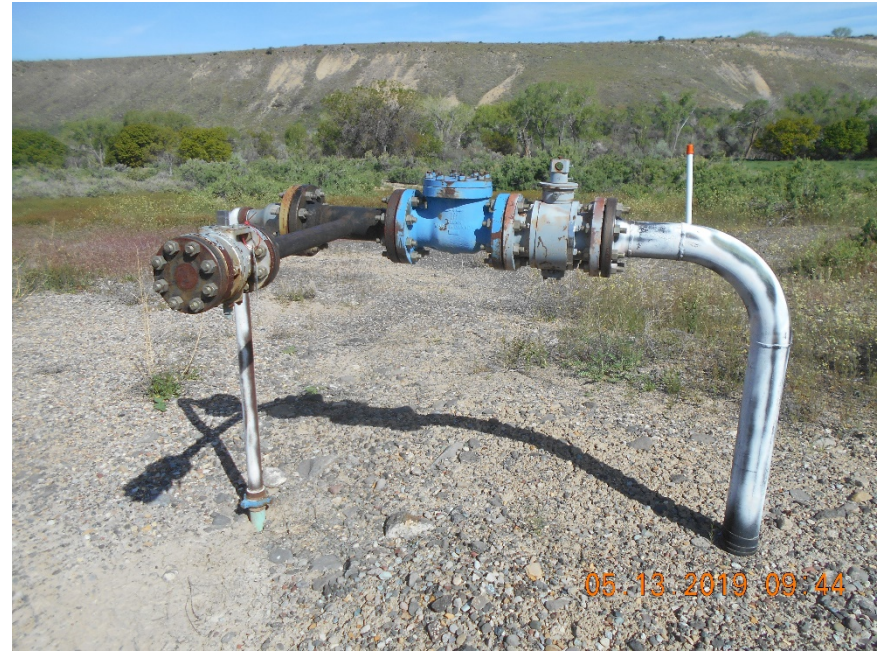
**4" & 2" Production line riser. Blind flanged and  
Locked out/Tagged out.**

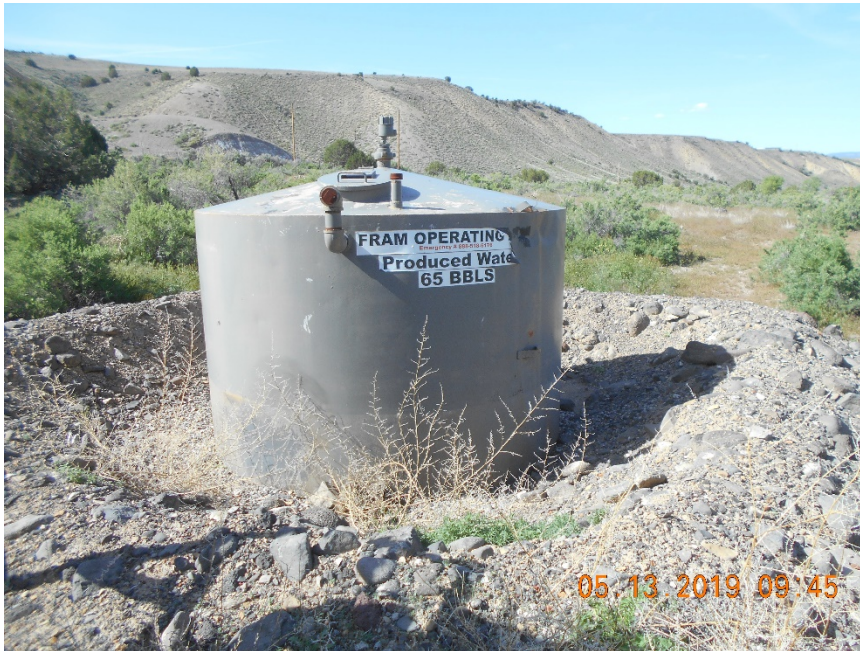
**65 BBL Produced water tank with earth berms. No connections, Not in service.**

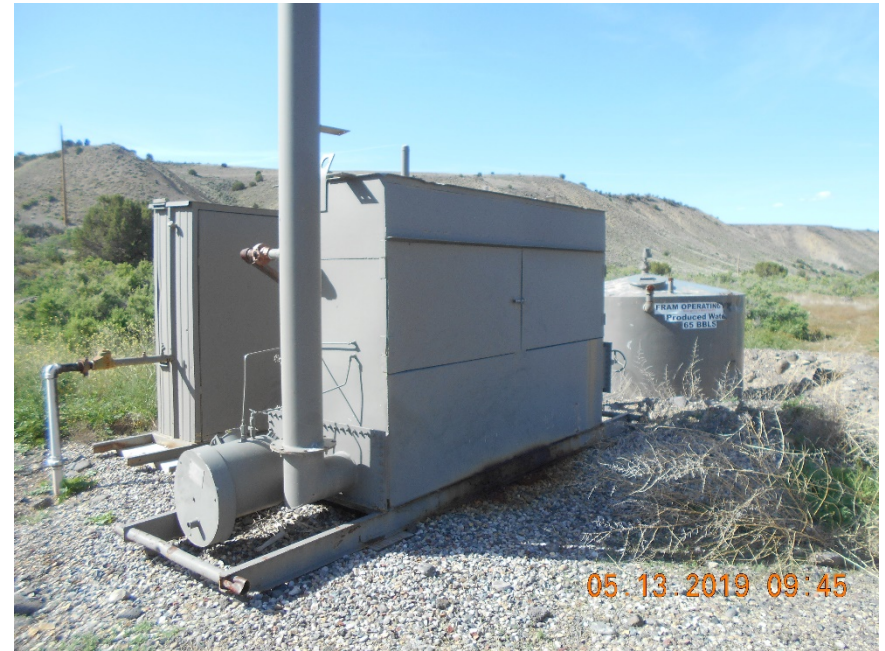
**Separator and Meter housing.**

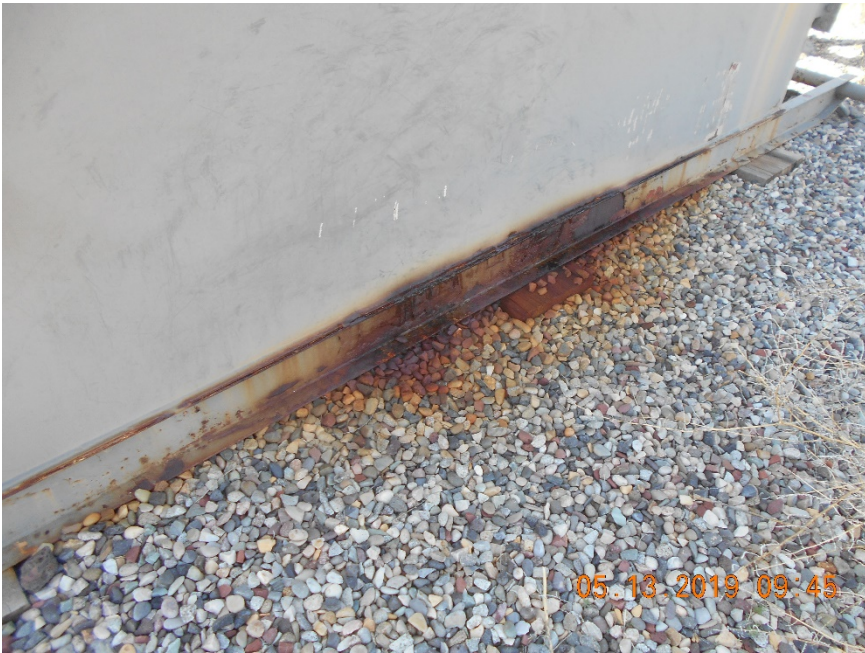
**Staining of soil at base of Separator from  
previously repaired leak.**

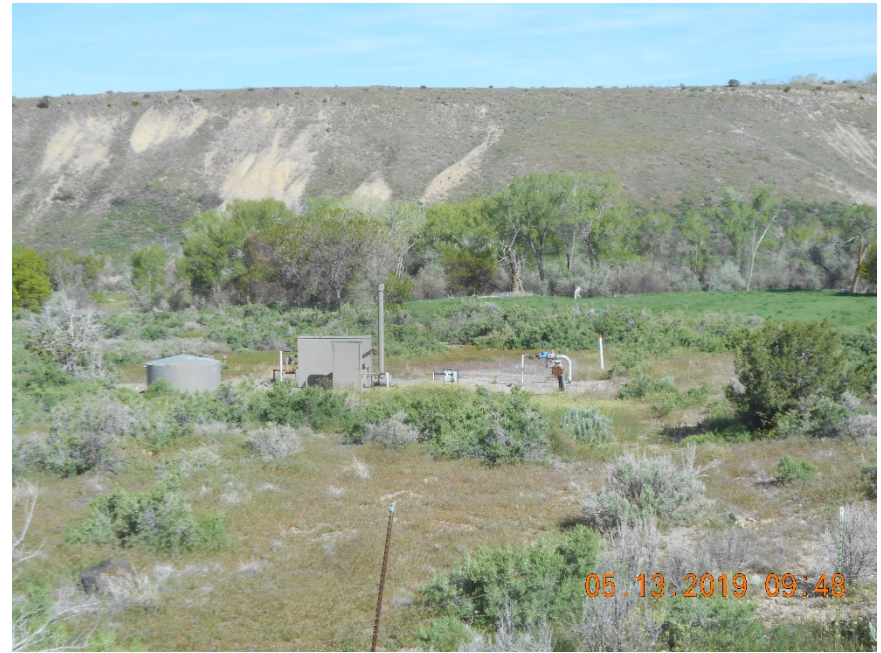
**Overview of location from Kannah Creek Rd.  
looking NW**
