Inspection Photos

Operator: Catamount Energy
Location/API #: 067-09578
Date: 5-9-2019

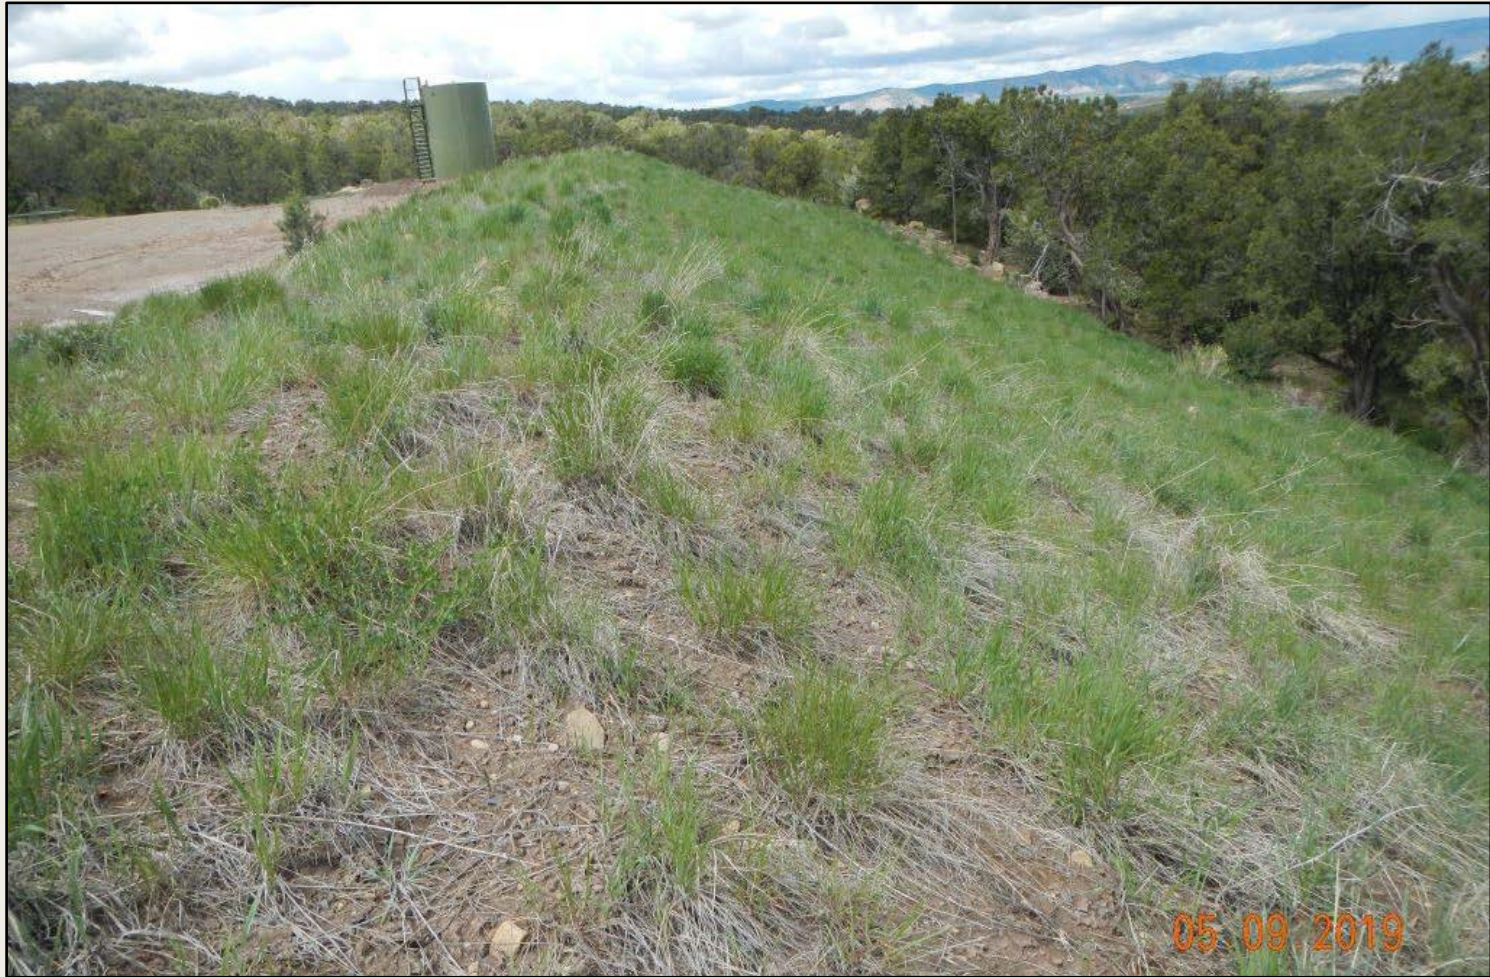
Photo 1. View of revegetation within the northern project area.

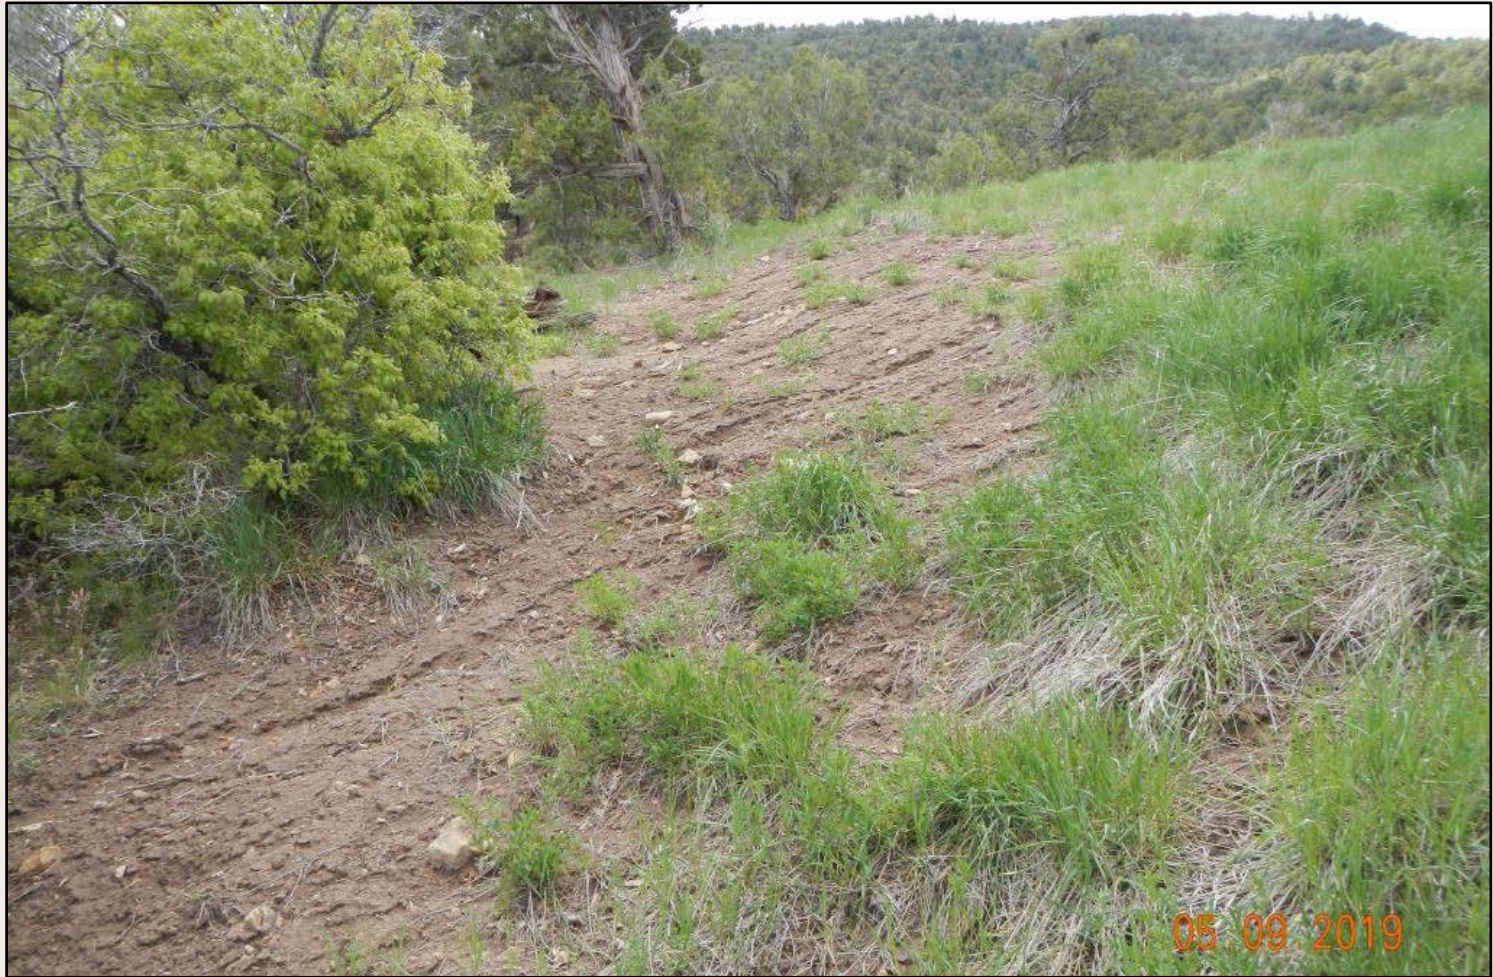
Photo 2. Downslope of rilling along the southeastern edge of the project area.

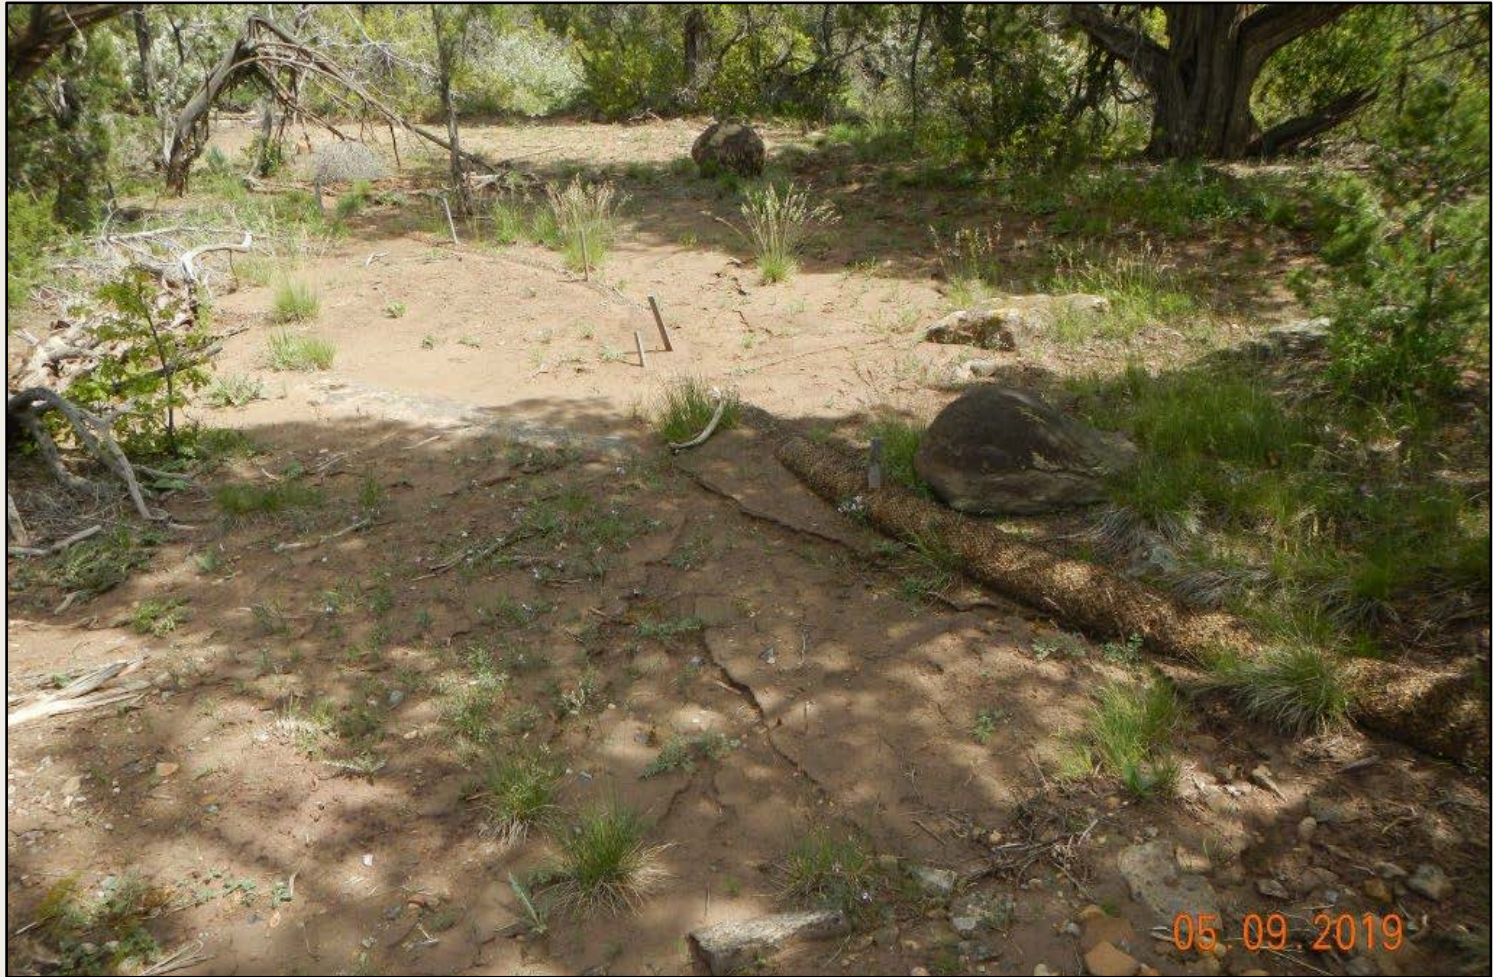
Photo 3. View sediment discharge from the eastern edge of the project area , and wattles filled with sediment.

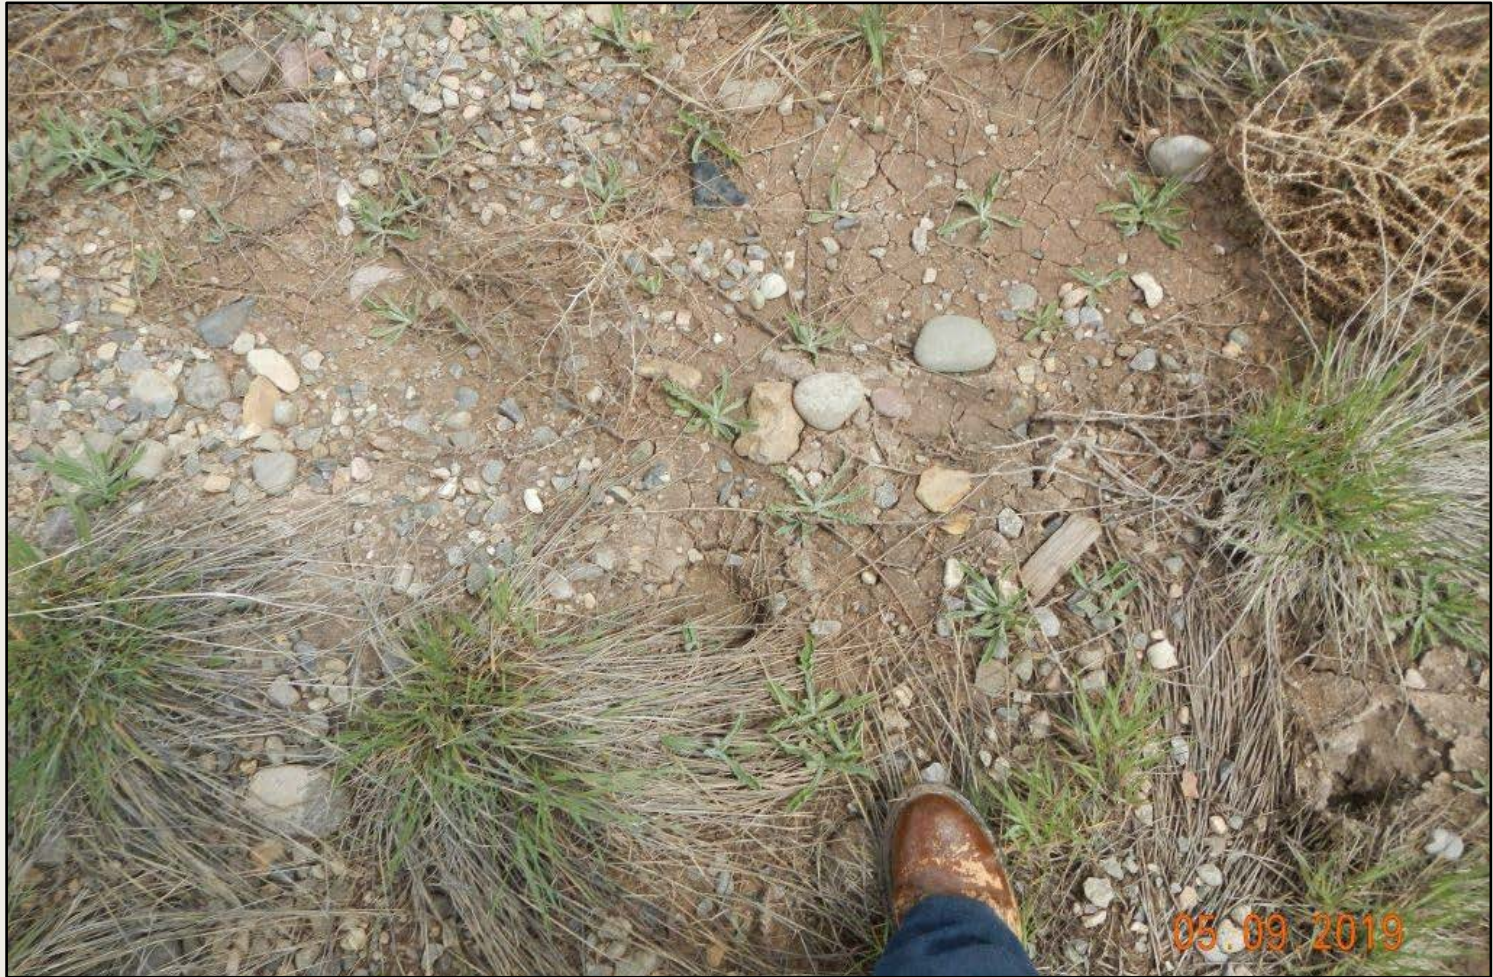
Photo 4. View of Russian knapweeds (*Rhaponticum repens*) along the eastern edge of the working area.

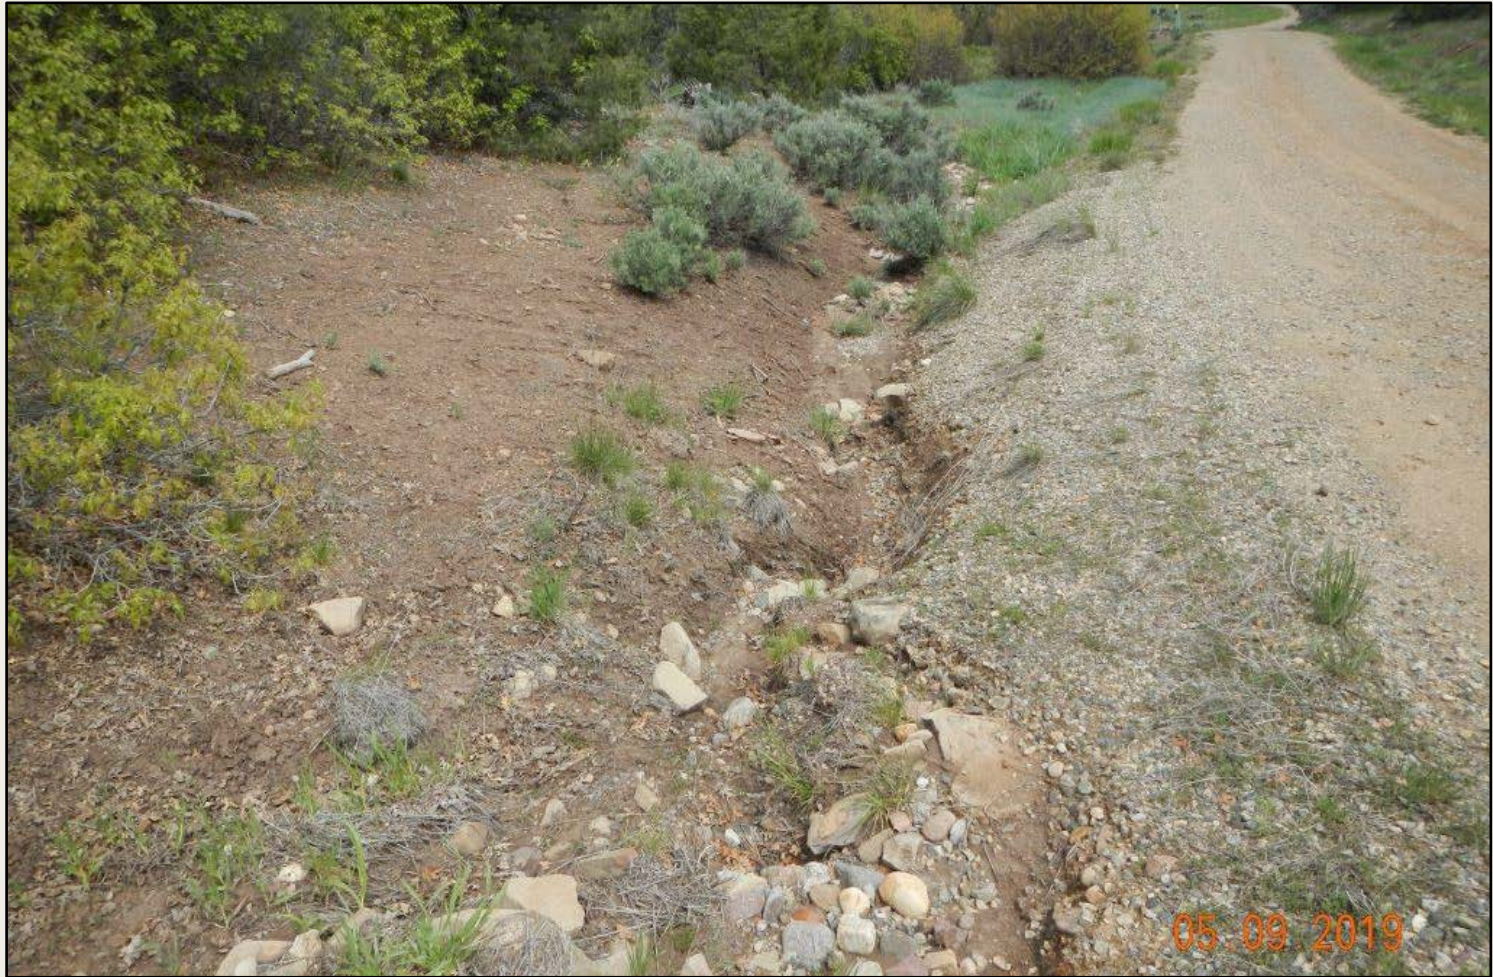
Photo 5. View of erosional channeling along the access road.

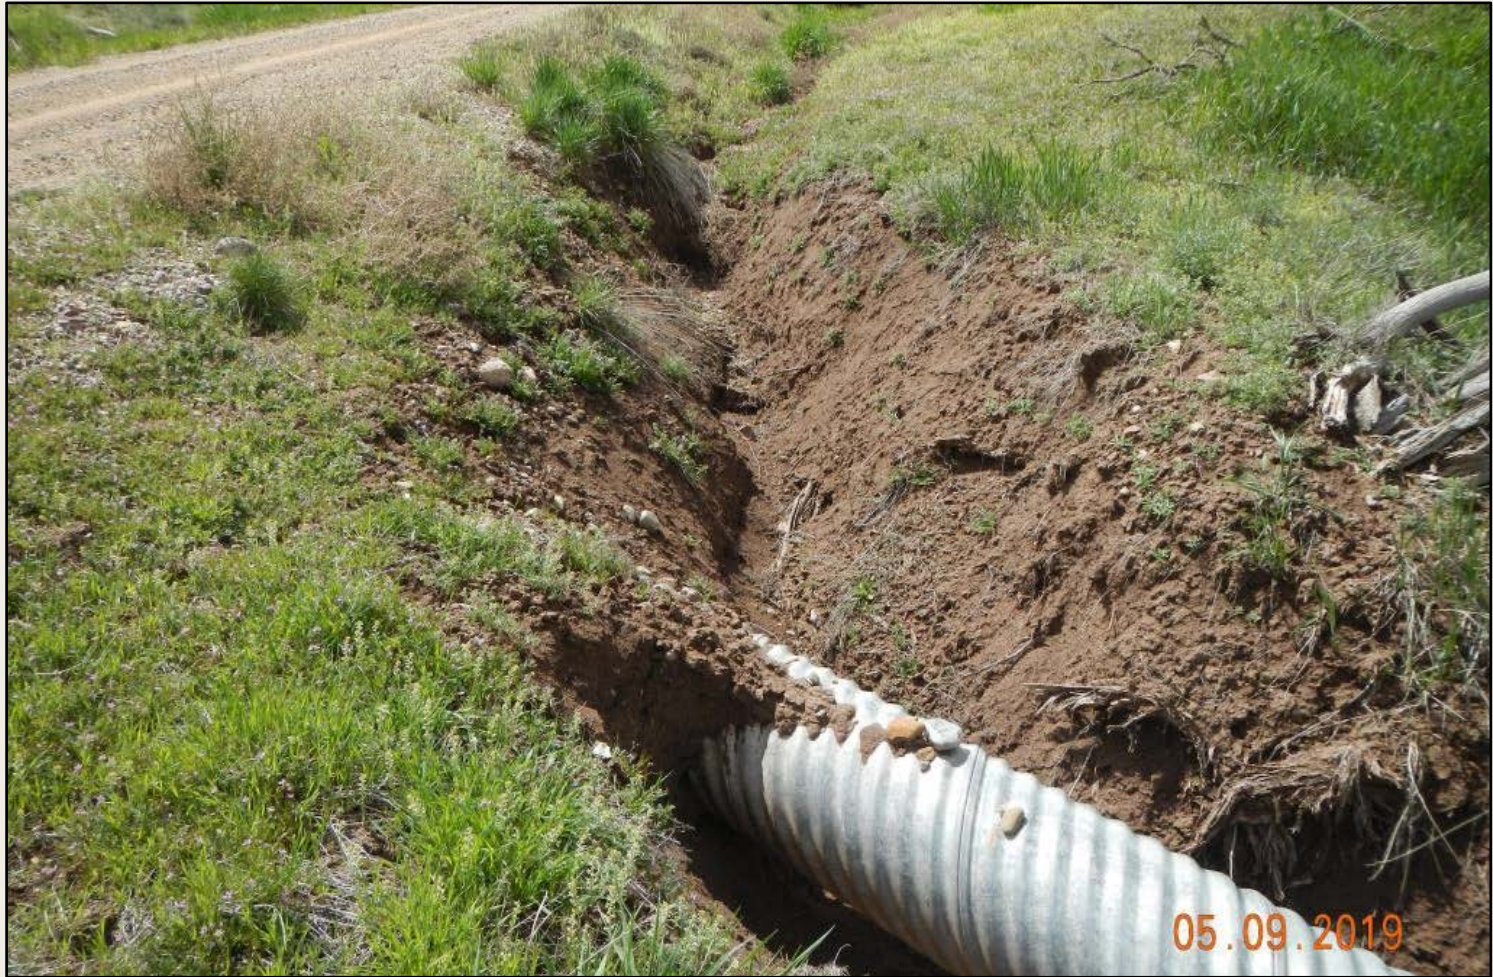
Photo 6. View of erosion where stormwater flows from the access road bisect the culvert outlet.
