Inspection Photos

API: 05-061-06296

Operator: STRACHAN EXPLORATION INC

Inspection Date: 5/15/2019

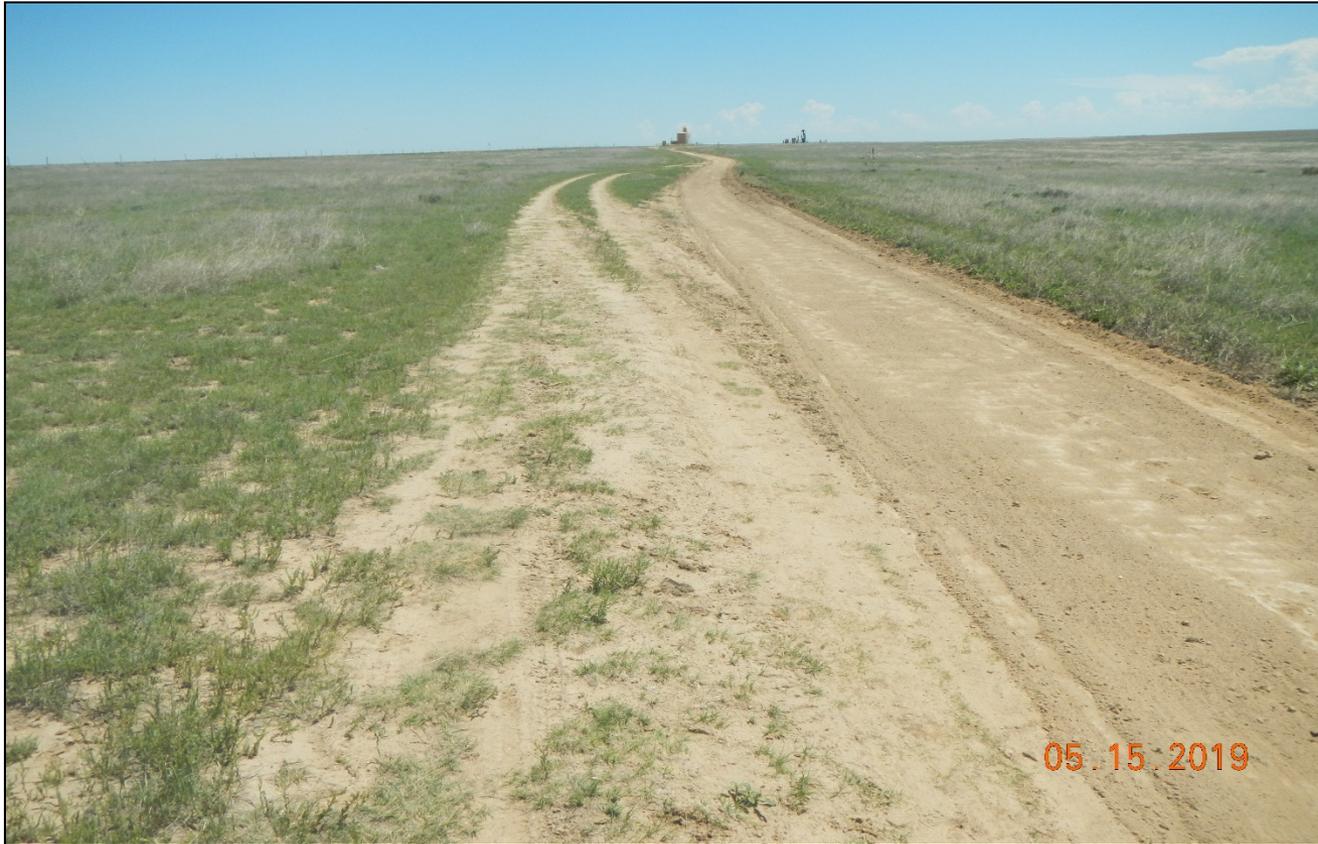
Photo 1. It appears water pools onto the access road. A new road has been made by vehicles avoiding this area when wet causing additional disturbance that needs to be reclaimed.

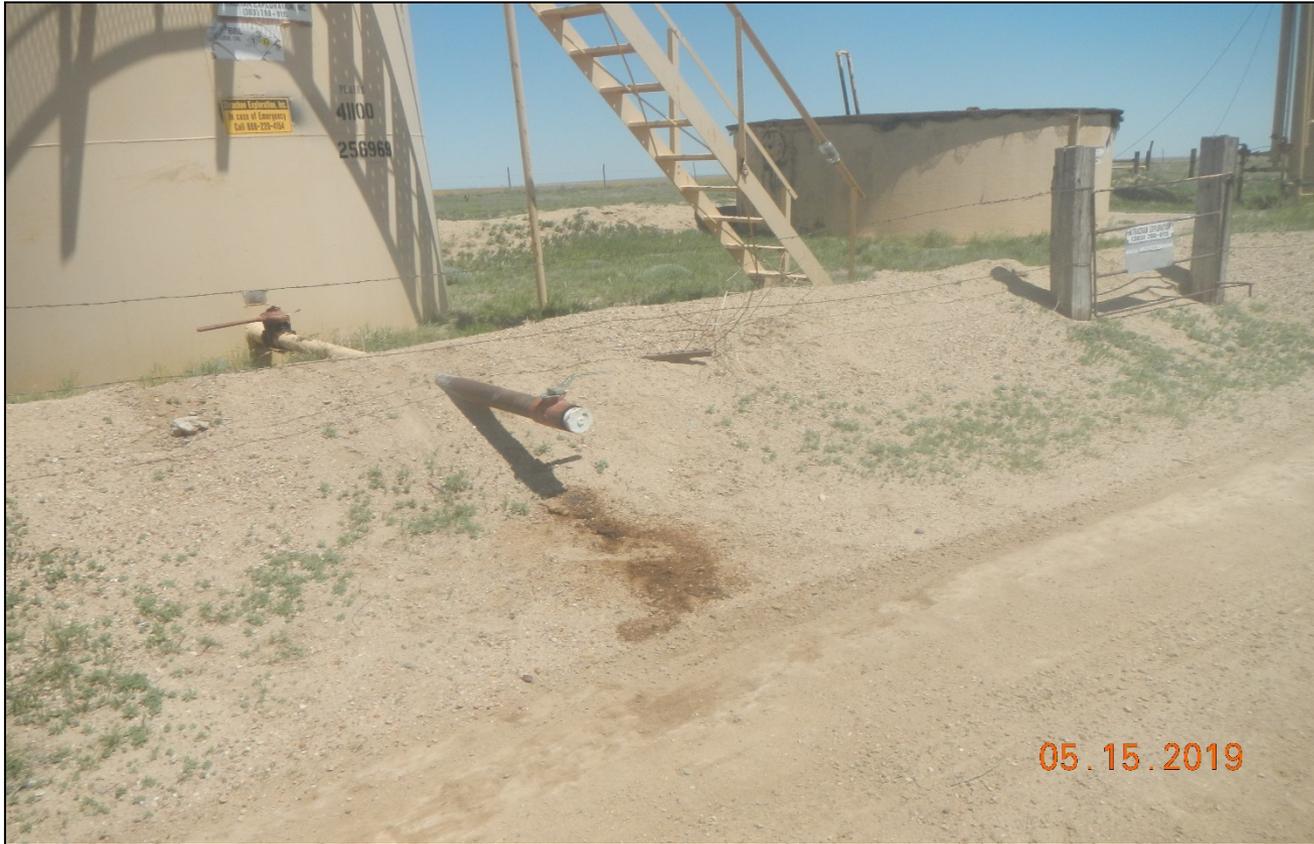
Photo 2. There is oil stained soil near the outlet of the tank shown in the photo. No containment present.

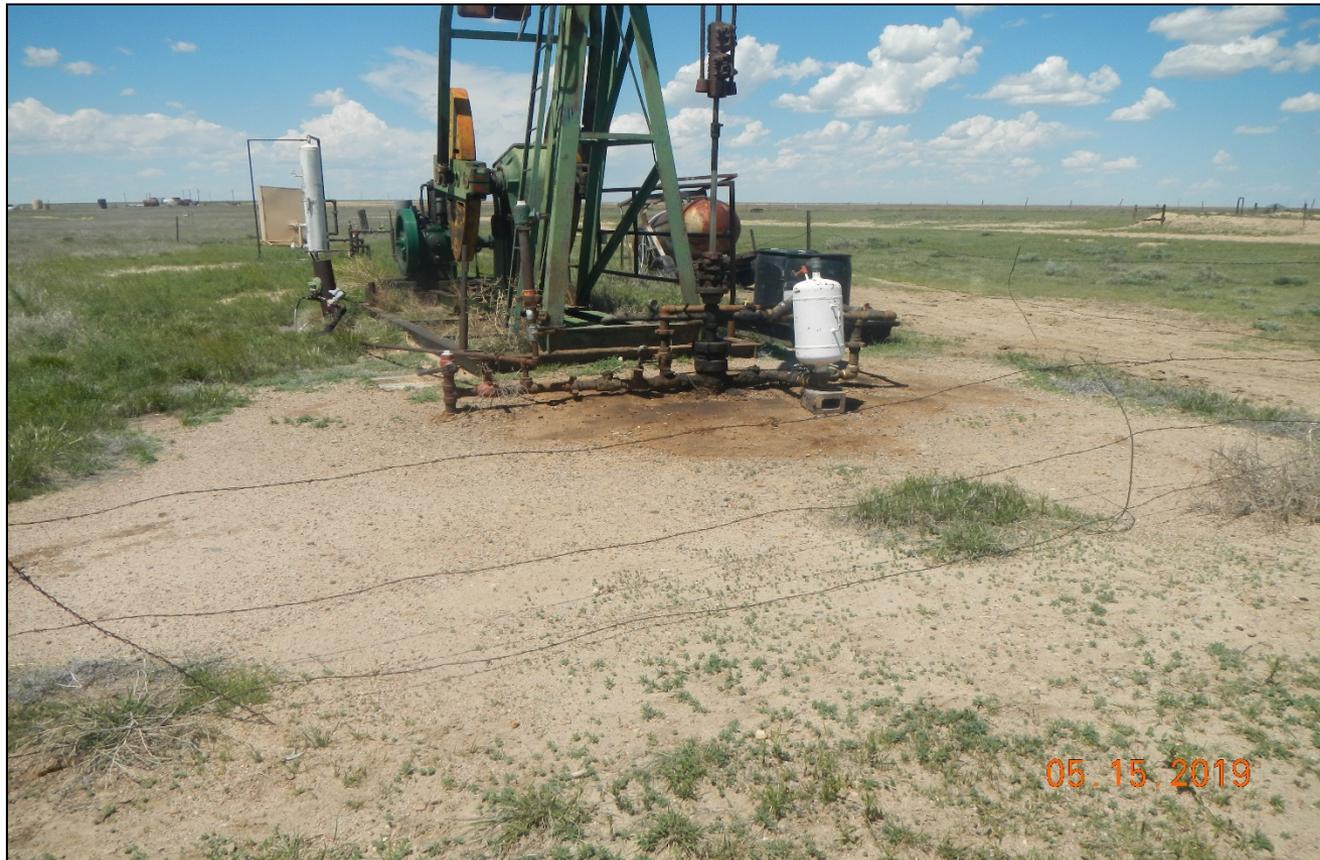
Photo 3. There is oil stain soil around the wellhead.

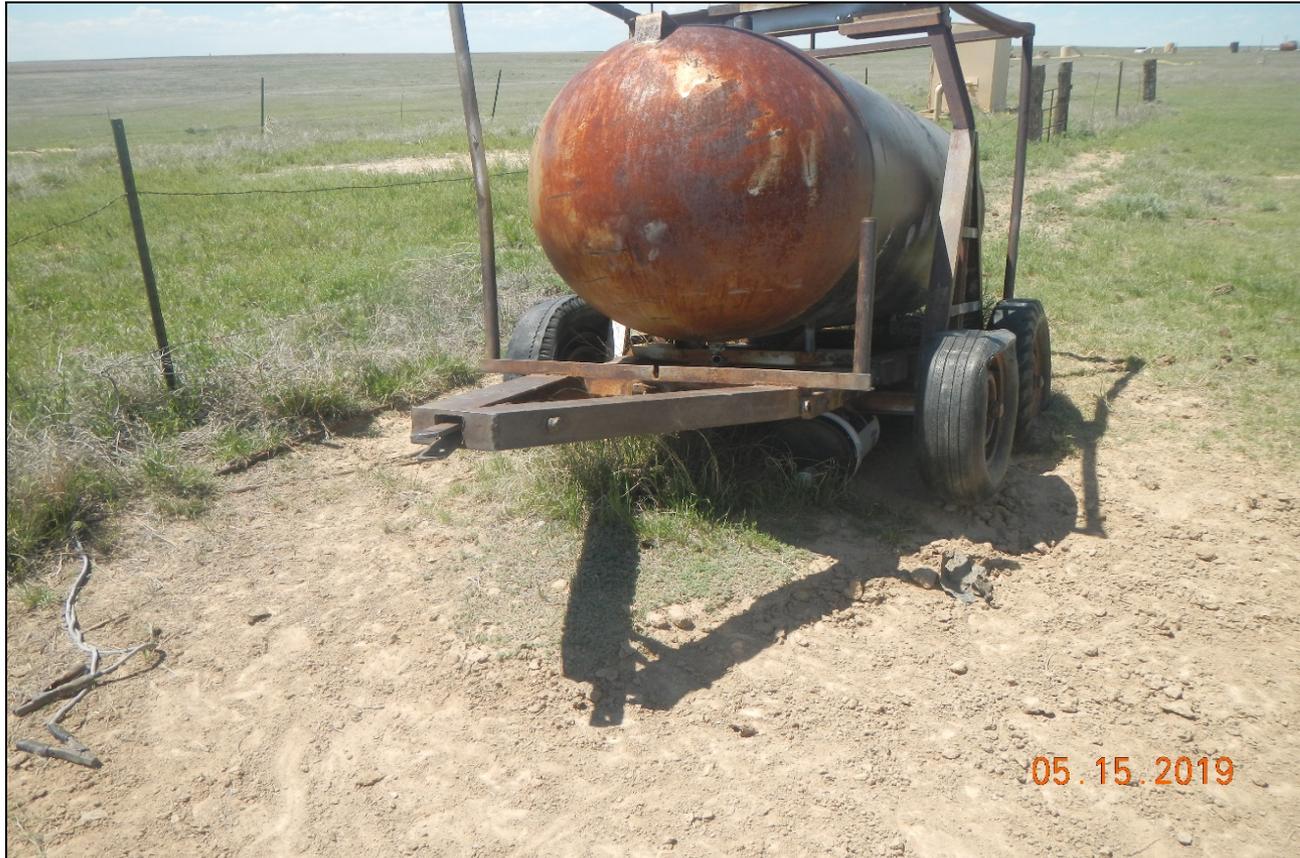
Photo 4. This appears to be unused equipment stored at the site. A 5 gallon bucket is underneath equipment.

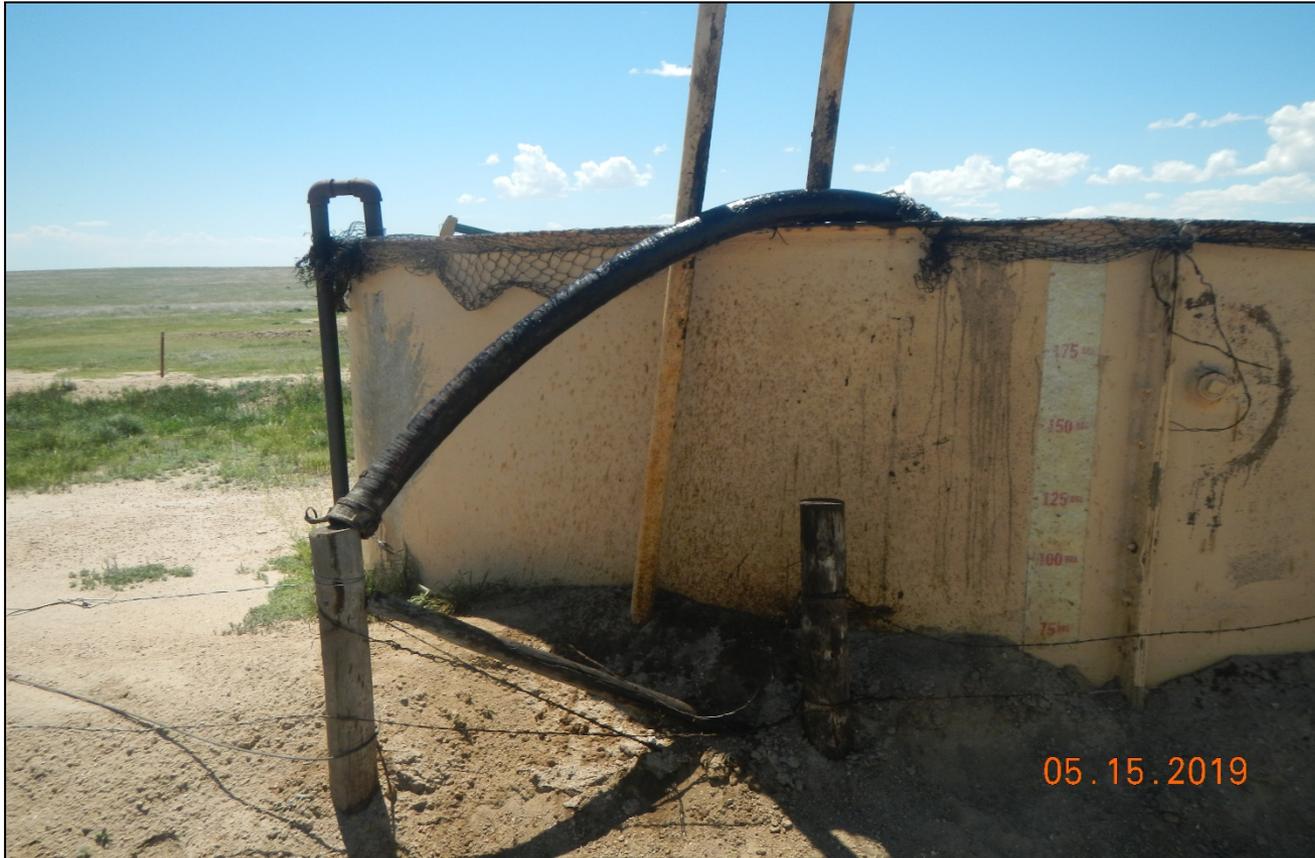
Photo 5. There is oil dripping off the hose that goes into the tank. No secondary containment.

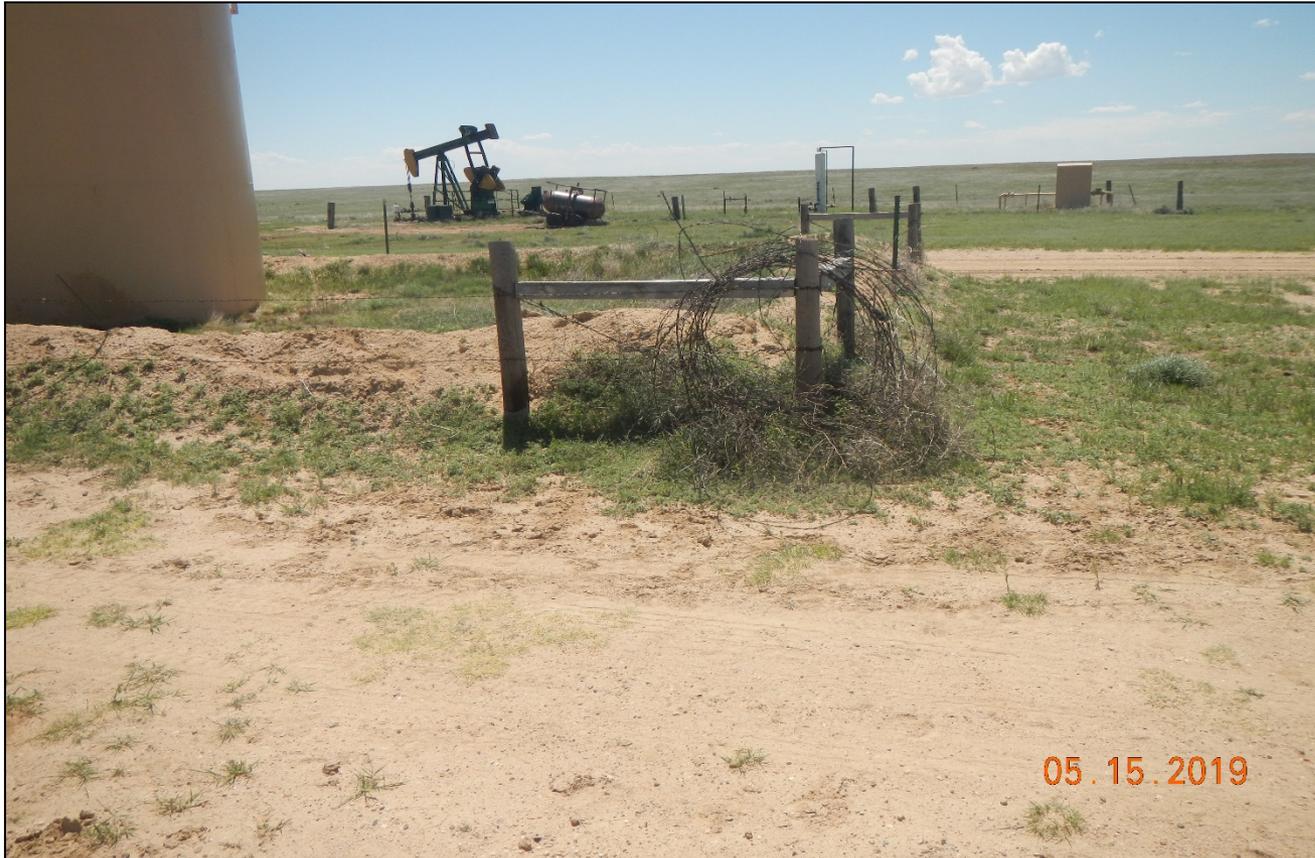
Photo 6. The fence around the equipment is insufficient to prevent livestock entry. There is a roll of barbed wire left on the H brace.
