Inspection Photos

API: 05-061-06397

Operator: BERRY ENERGY INC

Inspection Date: 5/15/2019

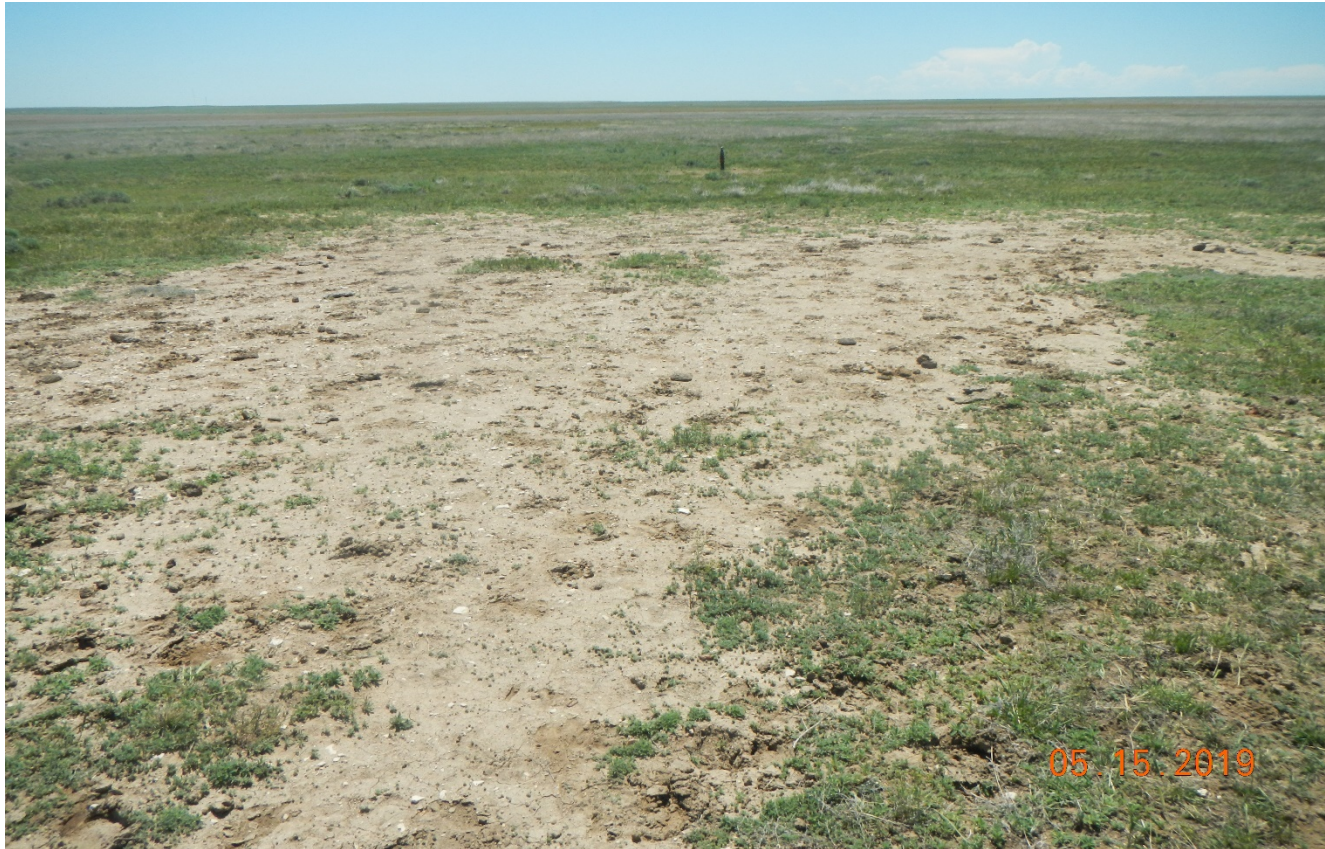
Photo 1. Facing south toward the location. There is a bare area with no vegetation growth approximately 100 ft. x 60 ft.

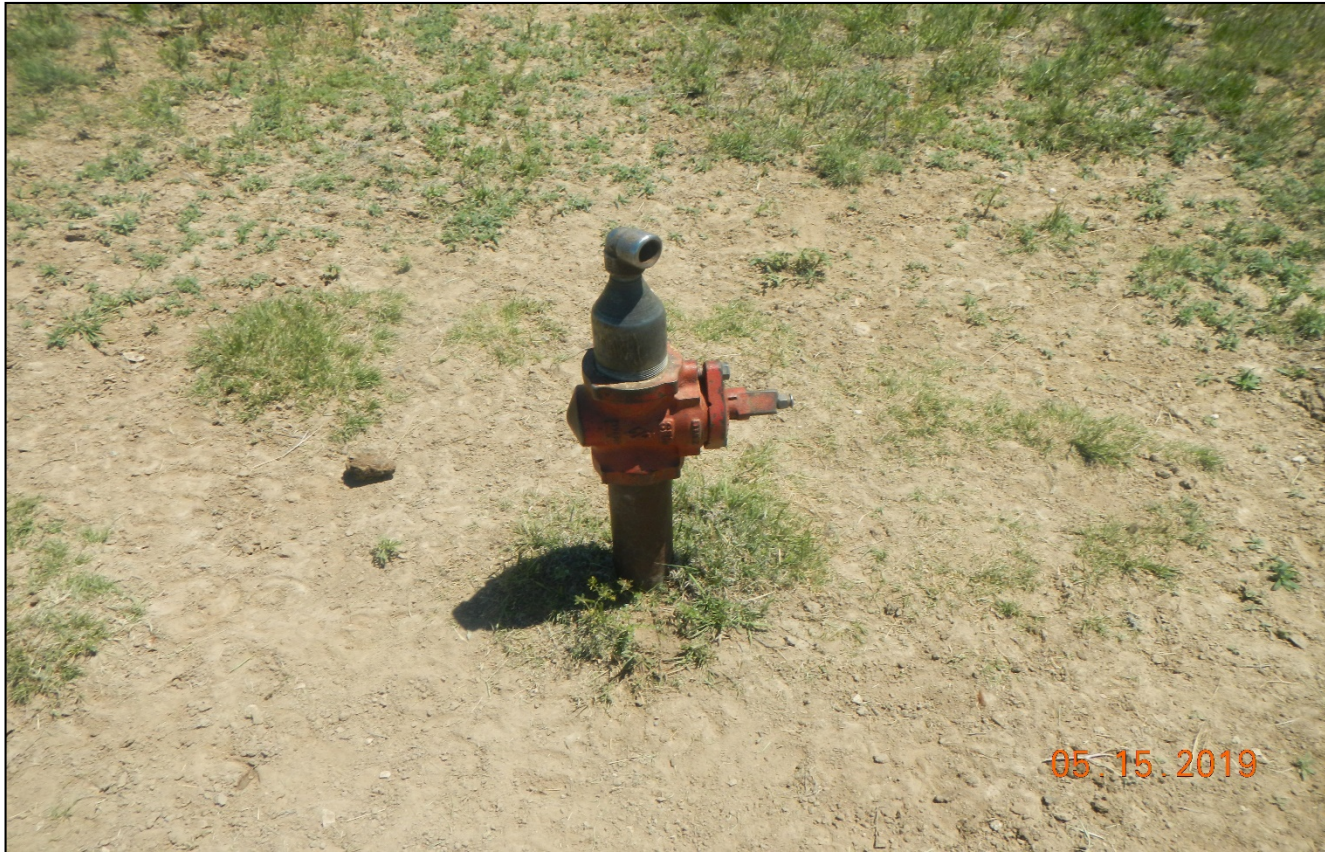
Photo 2. There is a pipe riser that remains at the location.

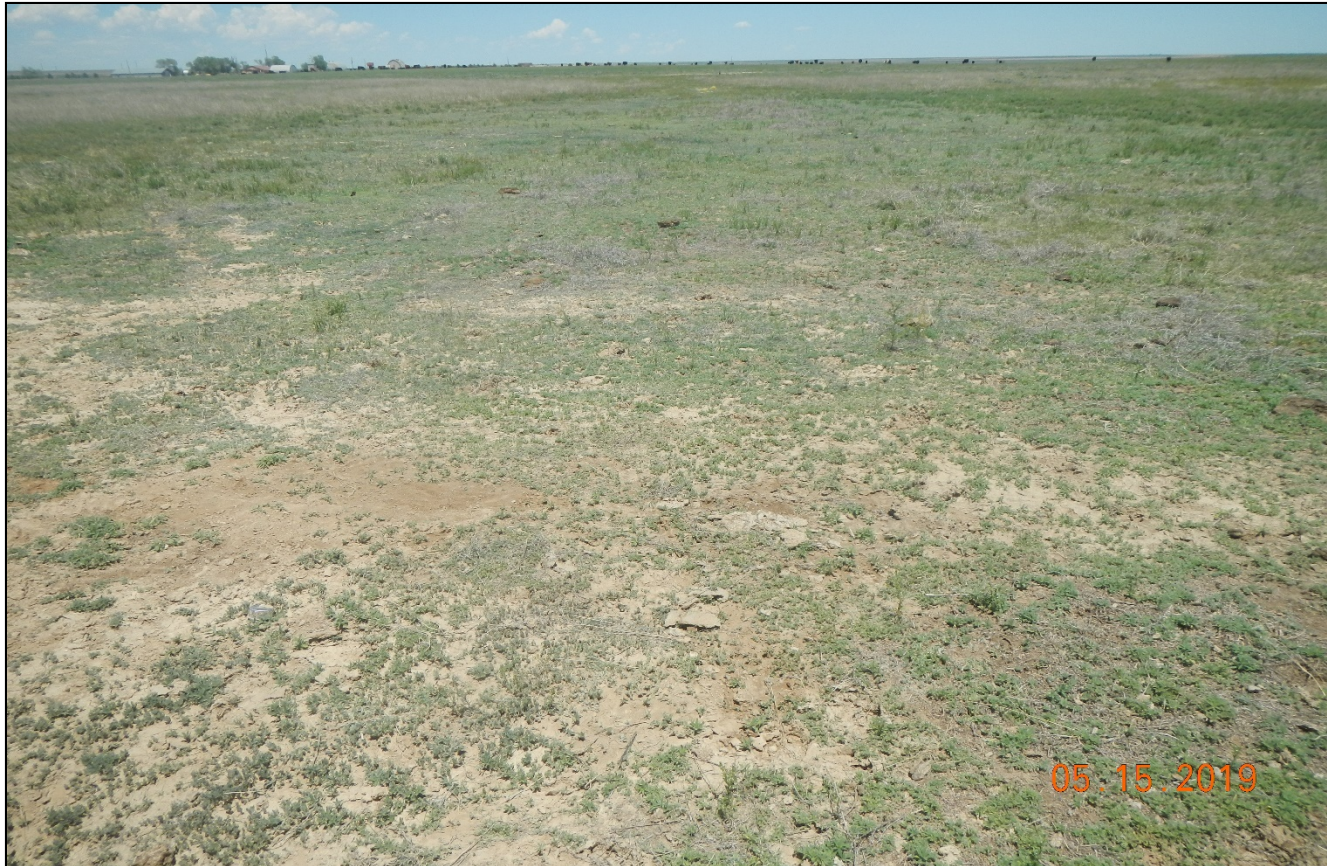
Photo 3. Facing south toward the location. There is predominately undesirable weeds (Kochia) in this area.

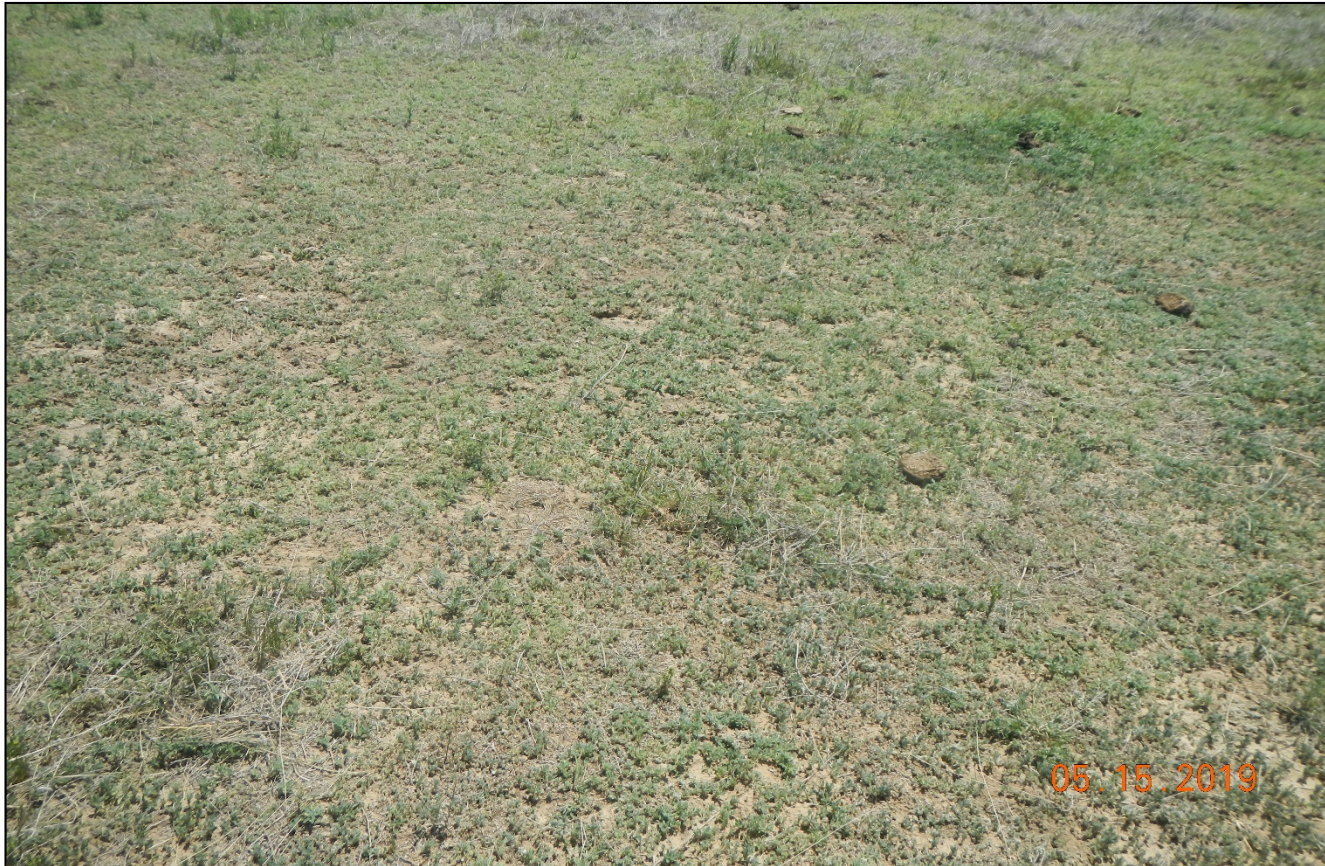
Photo 4. View of undesirable weeds growing at the south side of the location.

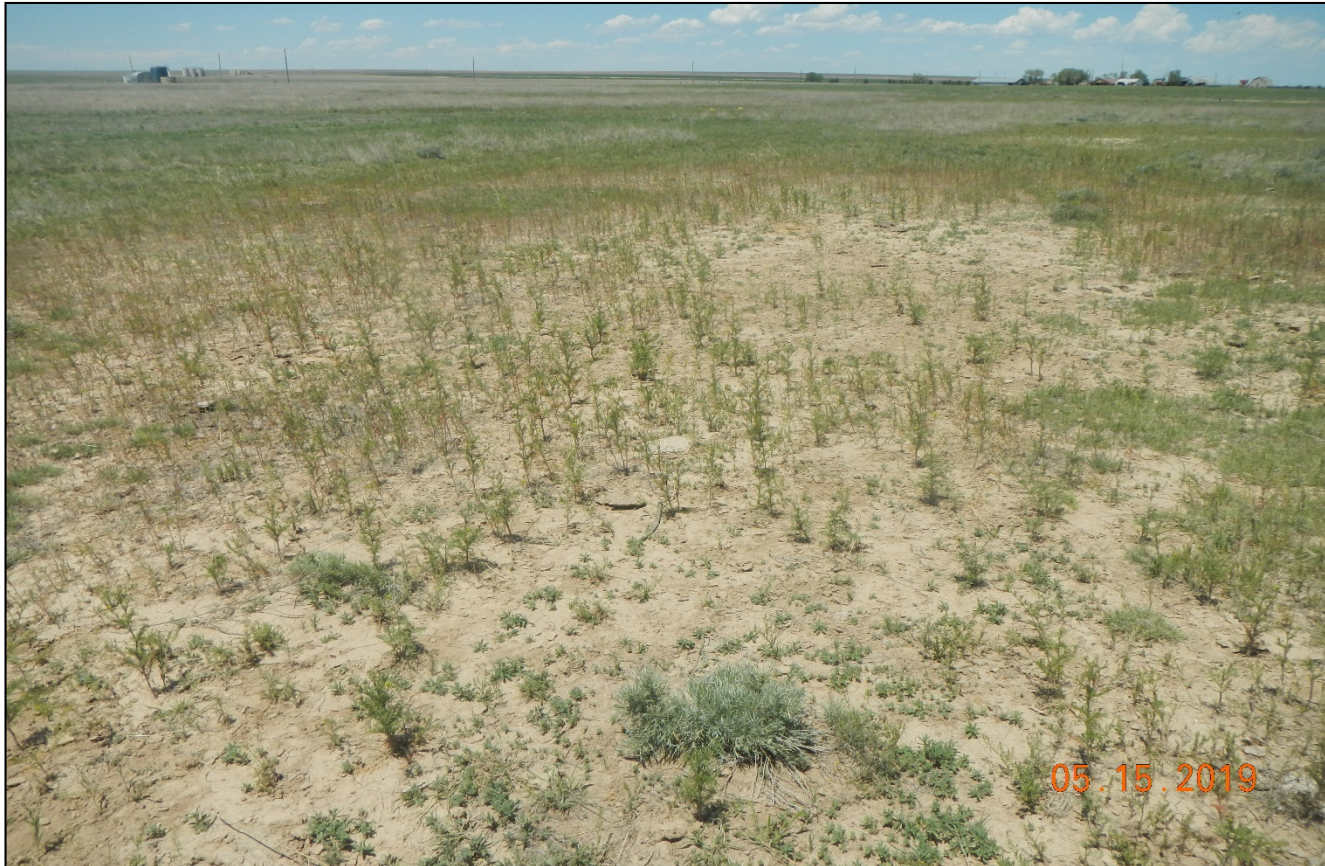
Photo 5. Facing east at the south side of location. Vegetation has not established in this area.

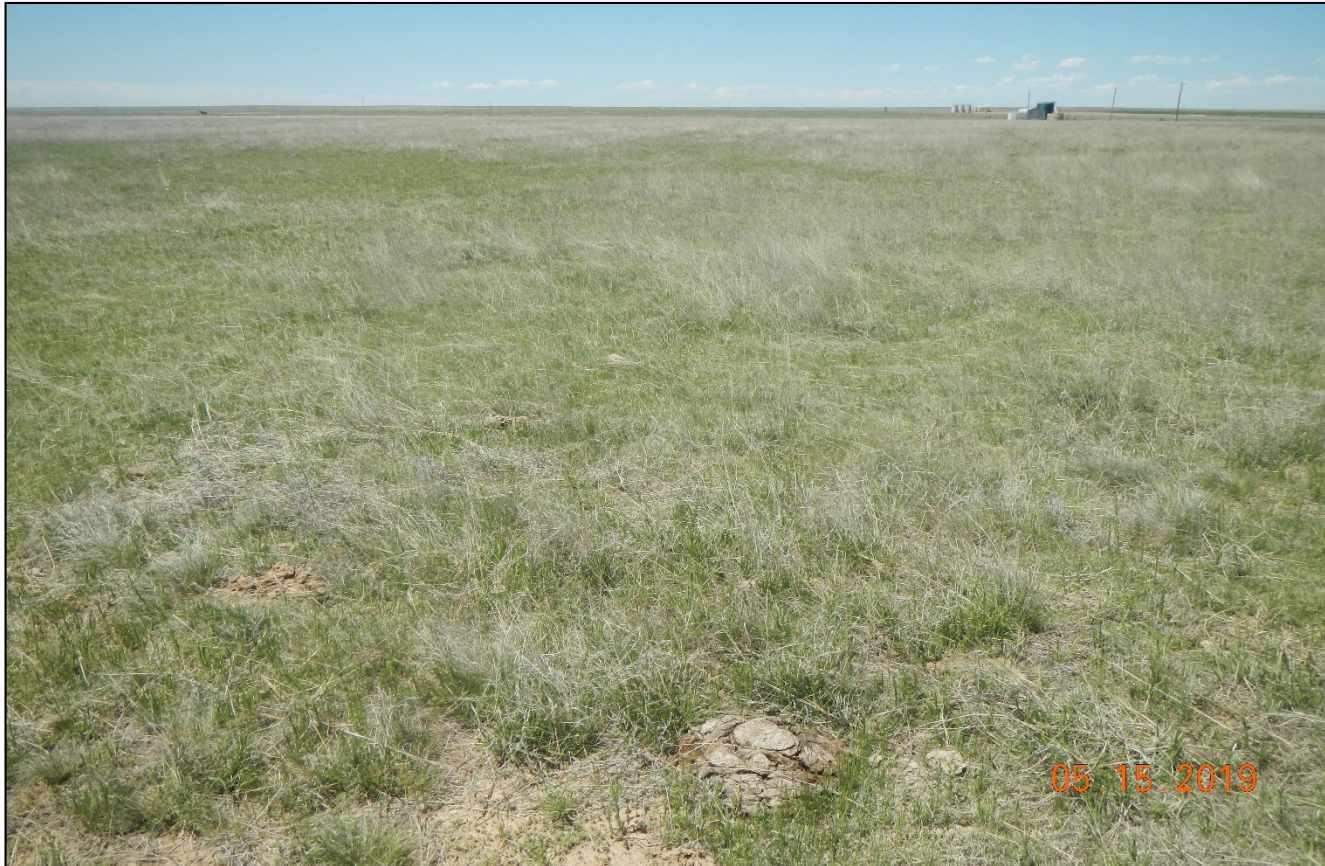
Photo 6. Facing toward the surrounding undisturbed pasture which contains Bou gra, Spo cry, Oli ari, Pas smi, among other native plants.
