Inspection Photos  
Location Name: CC 604-12-13 Annex  
Location ID 424970

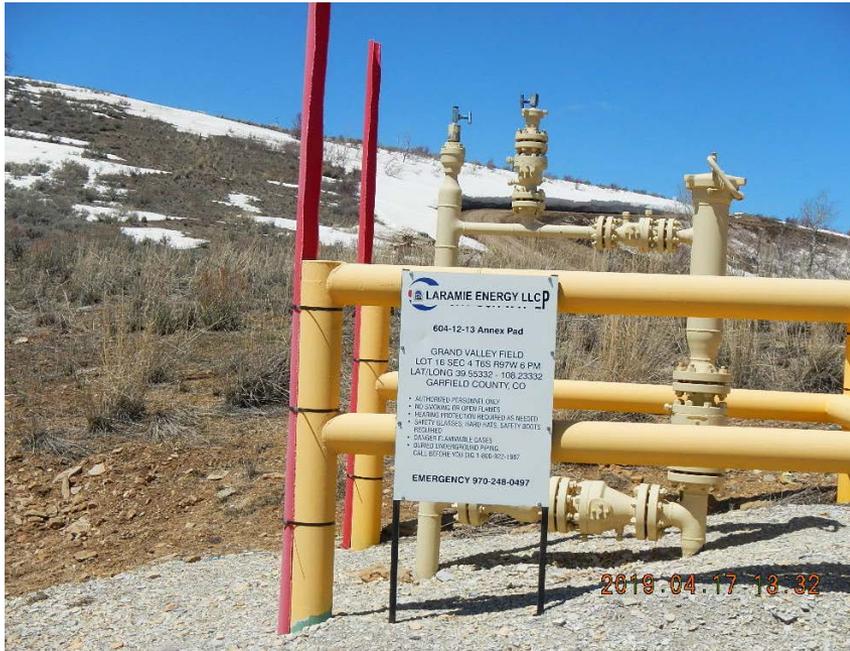
Location ID 424970 Entrance sign.

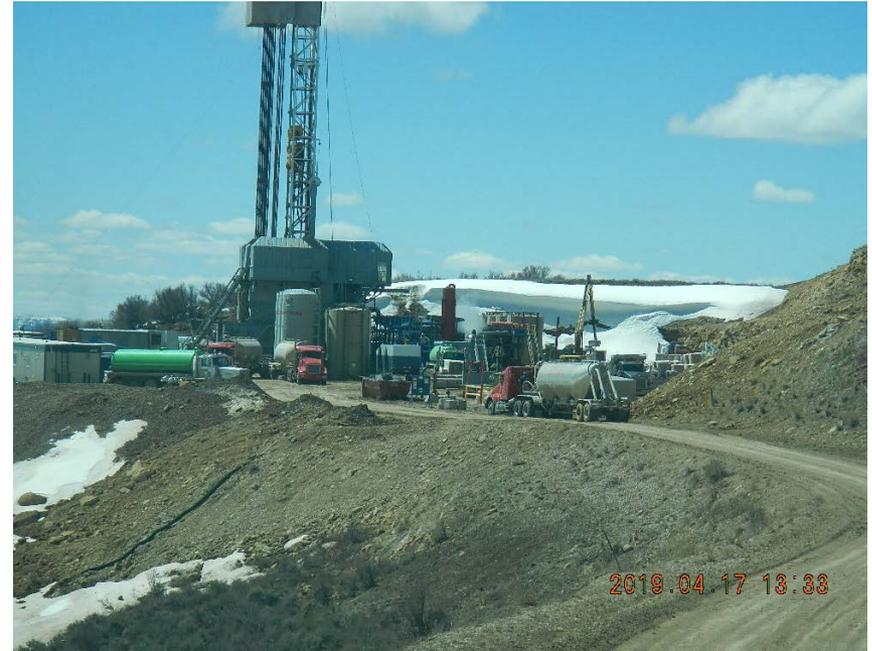
Location ID 424970 Active drilling location.

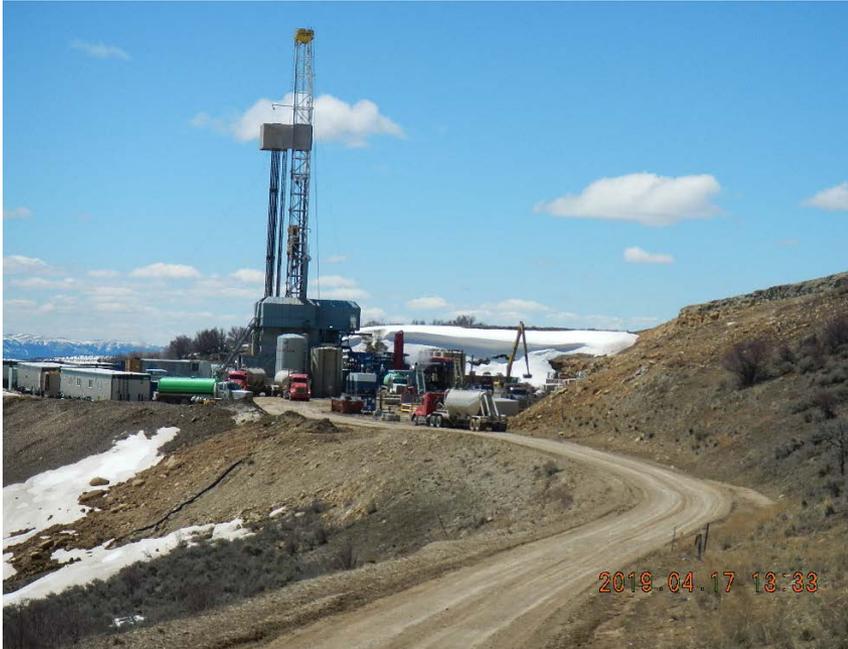
Location ID 424970 Track-hoe spreading material over what appeared to be drill cuttings.

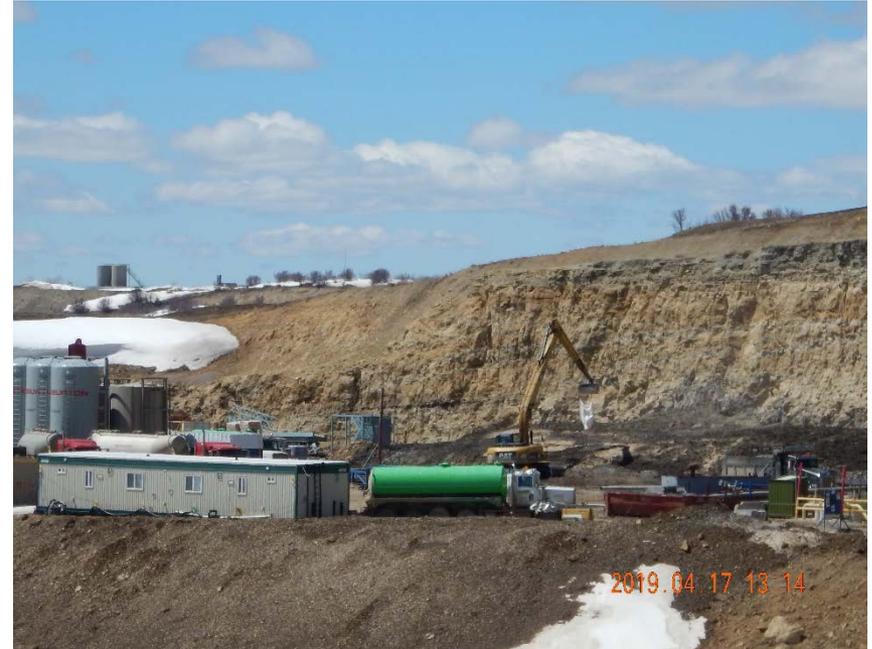
Location ID 424970 Track-hoe spreading material over what appeared to be drill cuttings.
