**Inspection Photos**  
**Location Name: CC 697-03-07Pad**  
**Location ID 452807**

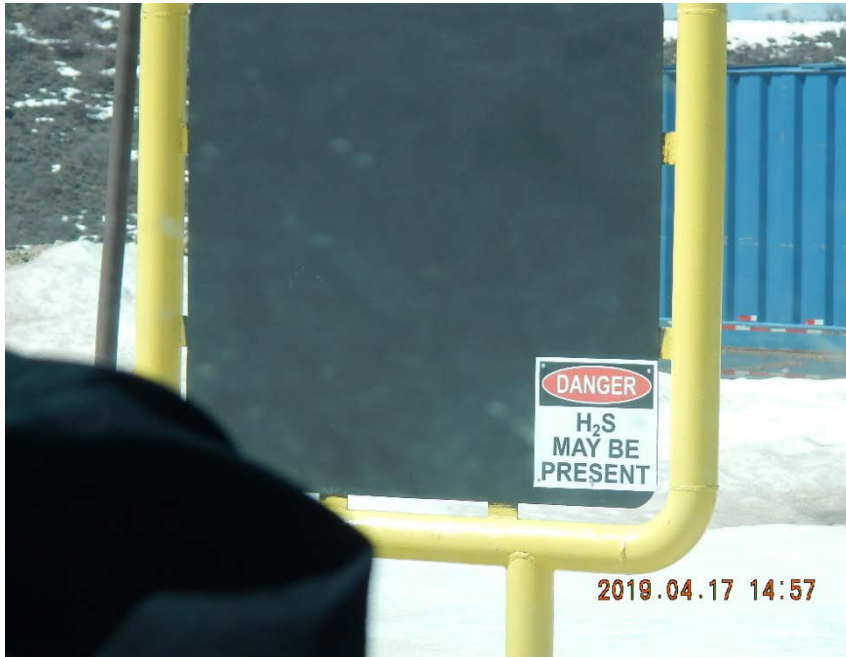
**Location ID 452807 Entrance sign.**

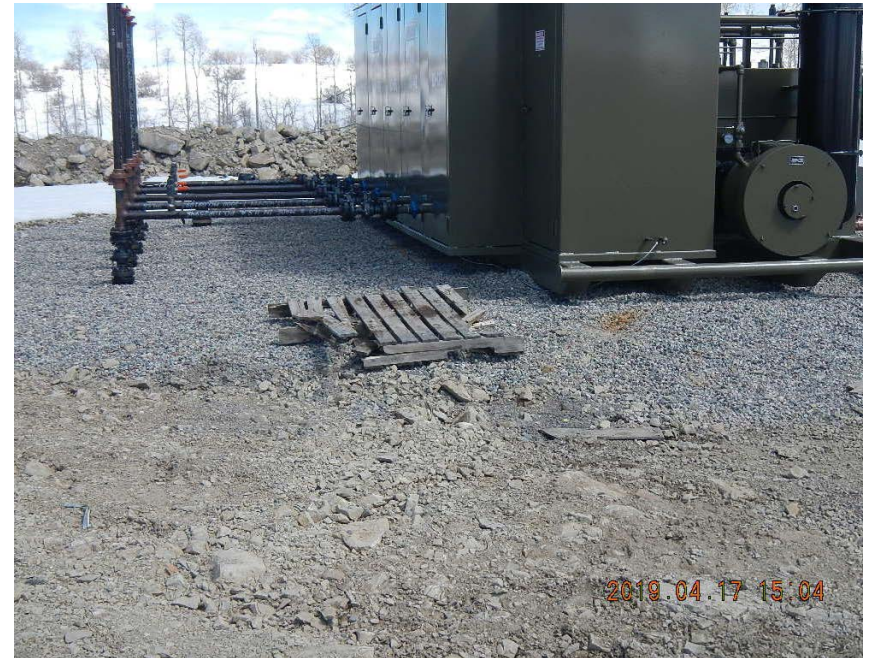
**Wooden pallet debris.**

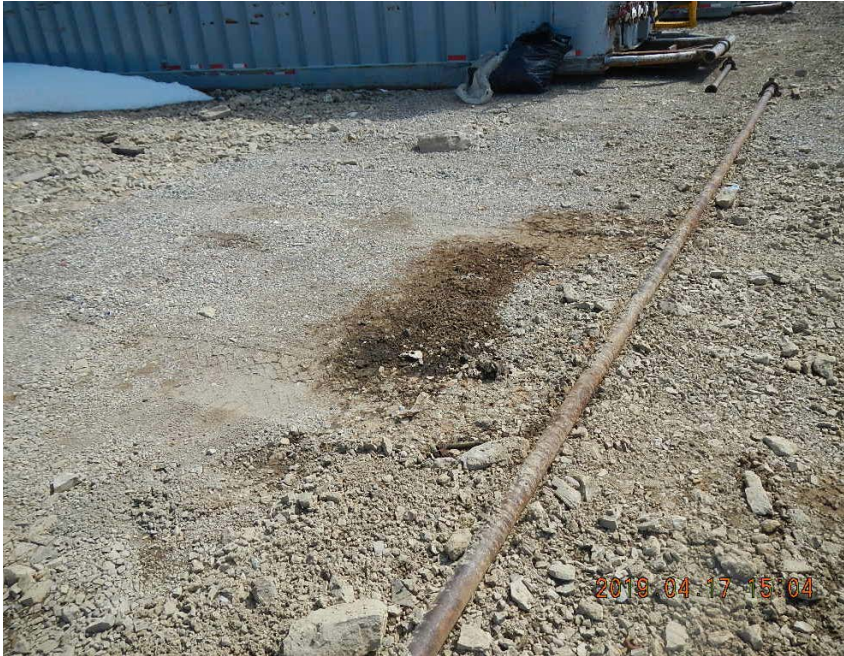
**Oil Stained soil with trash/debris near frac tank.**

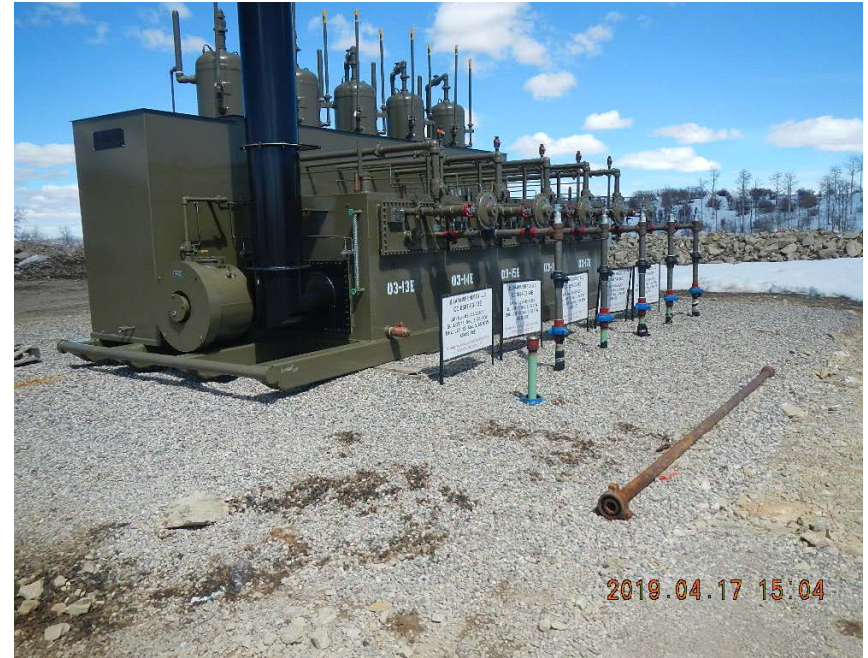
**Oil stained soil, uncapped, unmarked riser.**

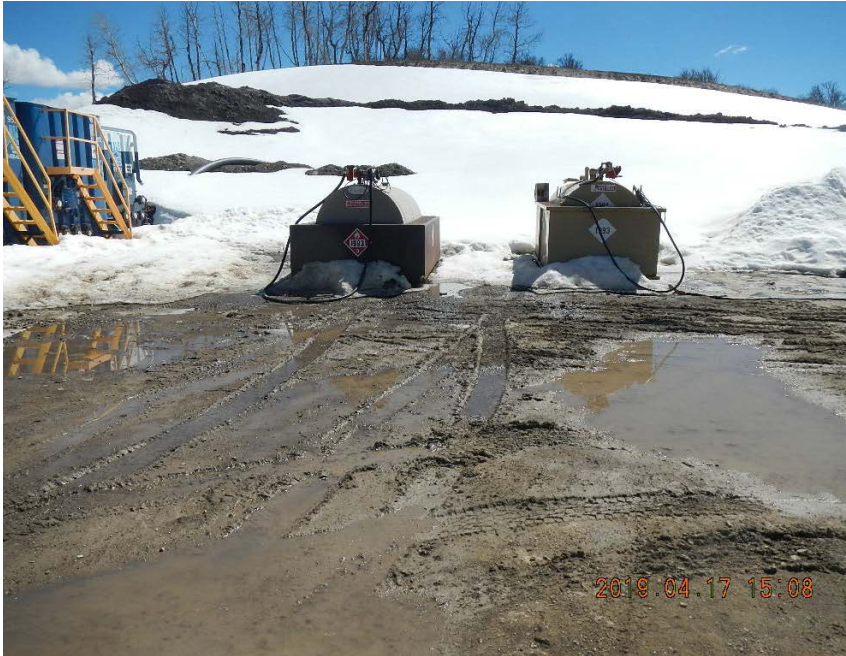
**Diesel ASTs inside of secondary containment. Note drill cutting stock pile on hill behind ASTs.**

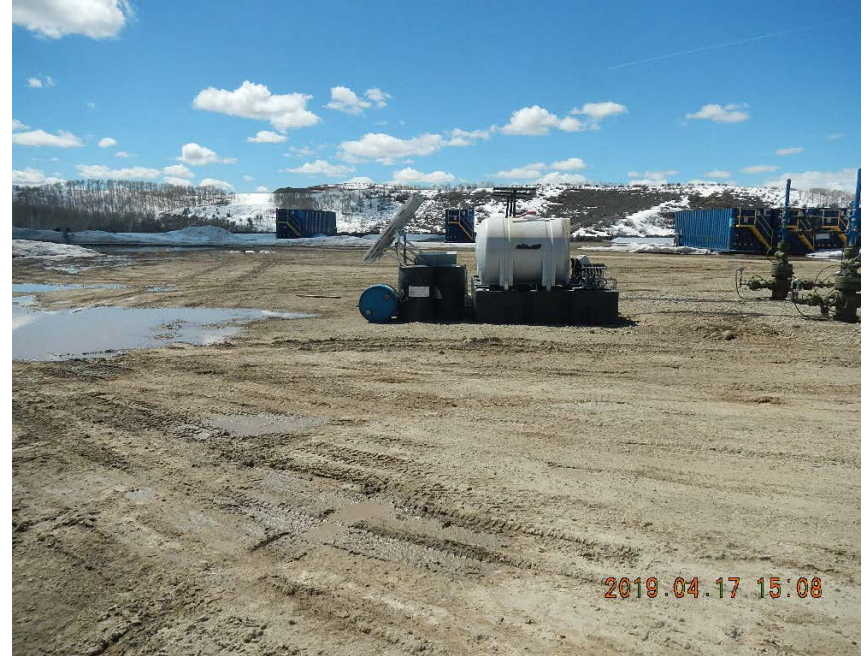
**Three 55-gallon containers, one on its side.**

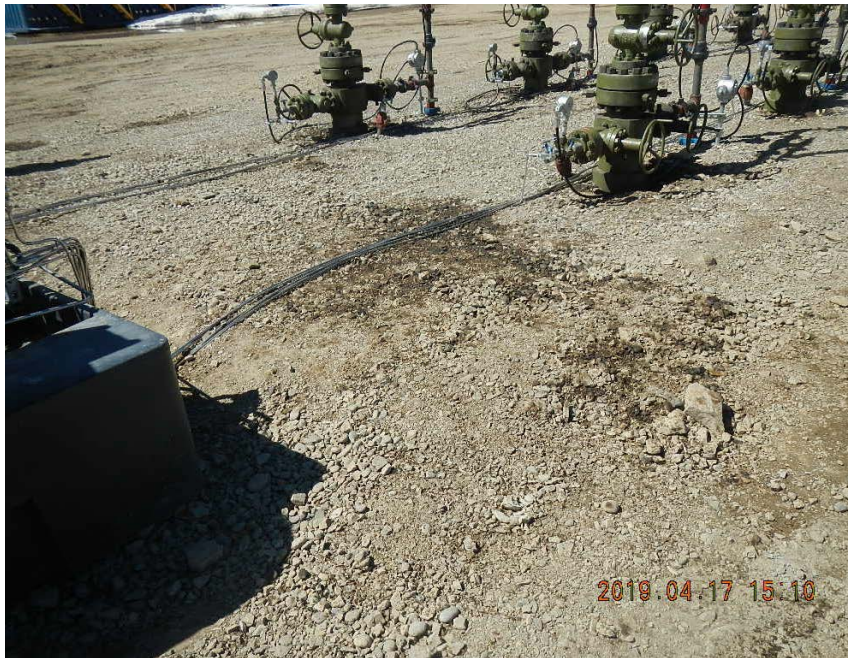
Oil stained soil.

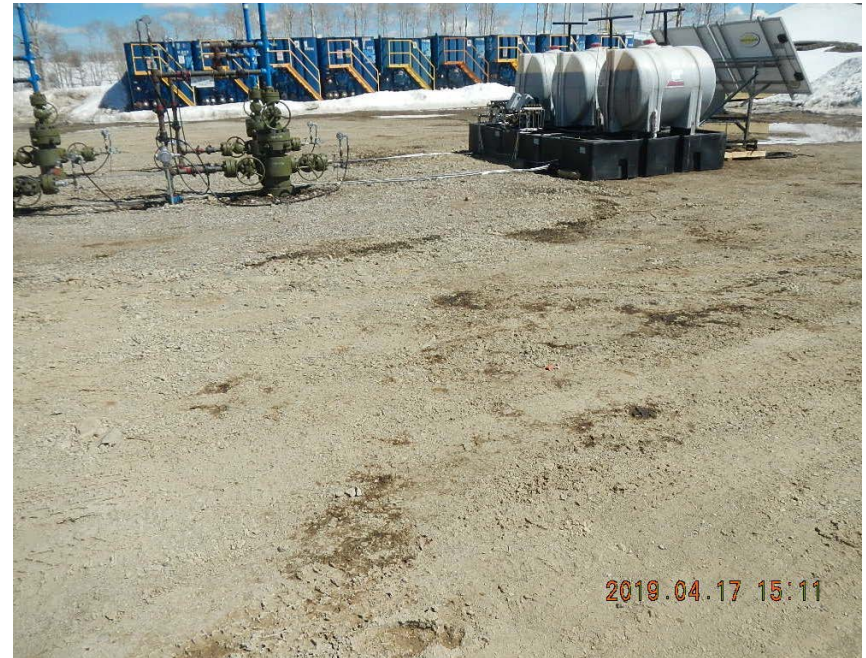
Oil stained soil.

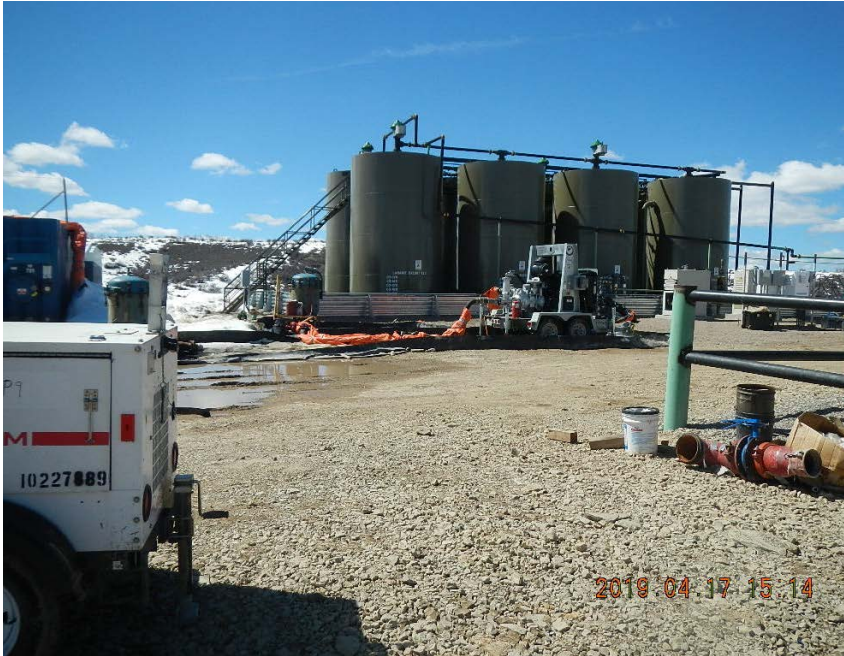
**Pumping operations at tank battery**

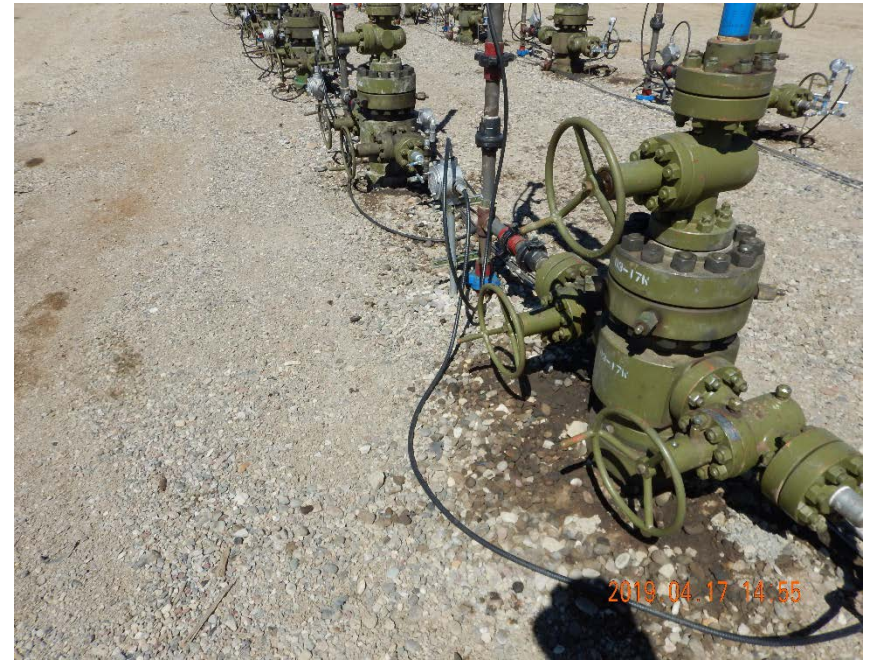
**Oil staining at nearly all well heads.**

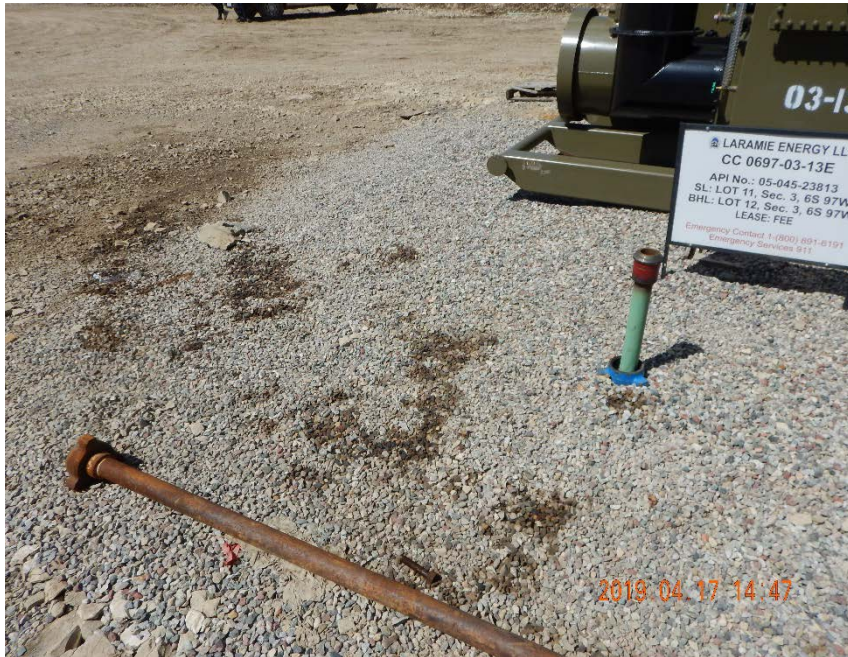
**Unmarked, uncapped riser previously mentioned.**

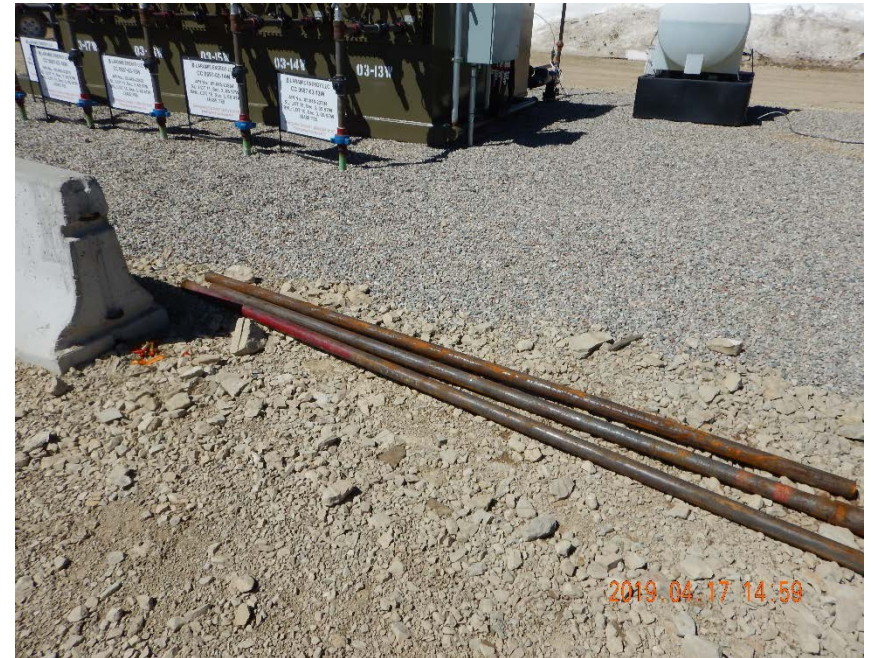
**Food debris at base of concrete jersey barrier.**
