Inspection Photos
Location Name: DNR-Hartman State #11-16
Location ID: 320317

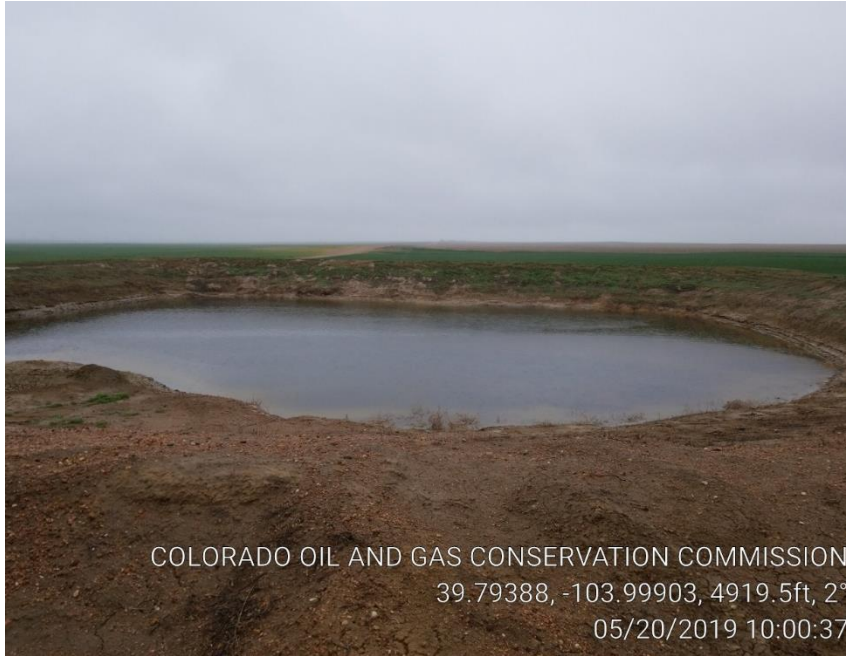
Pic 3 no netting around produced water pit

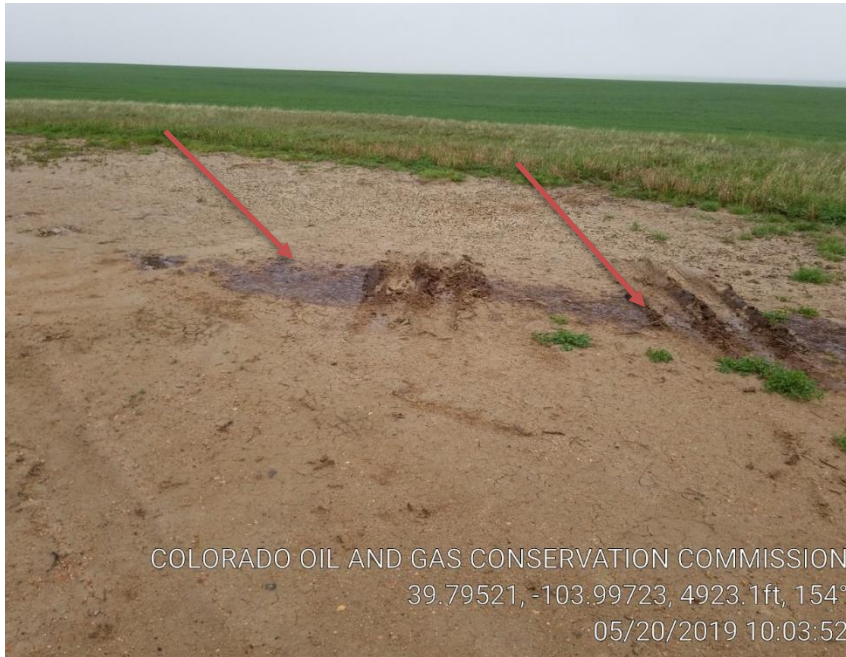
Pic 5 stained soil near wellhead

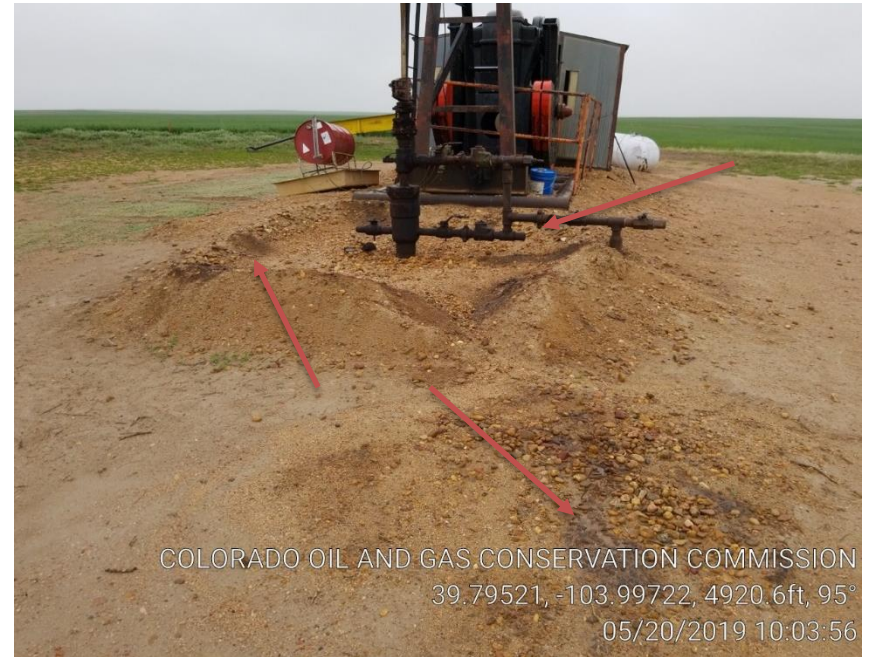
Pic 6 stained soil near wellhead

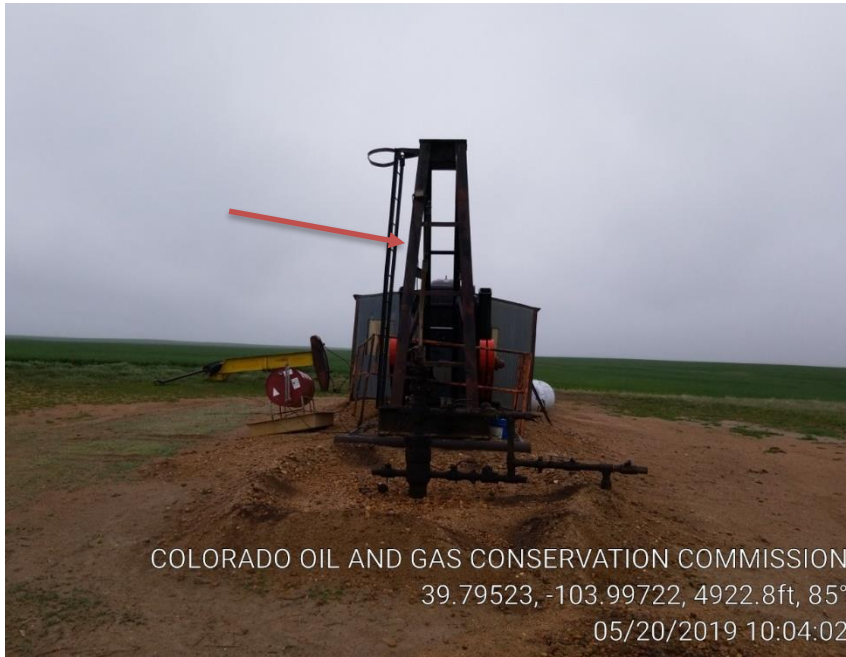
Pic 7 polish rod is bent, no horses head on pumping unit

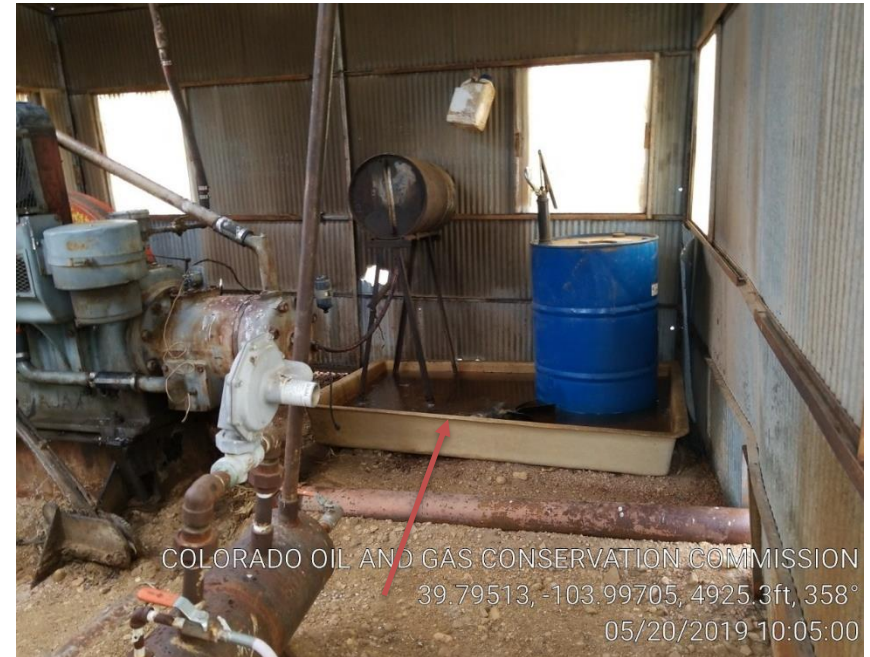
Pic 8 secondary containment in motor house appears to be close to overflowing.
