Inspection Photos

Operator: Maralex Resources
Location/API #: 067-09612
Date: 5-14-2019

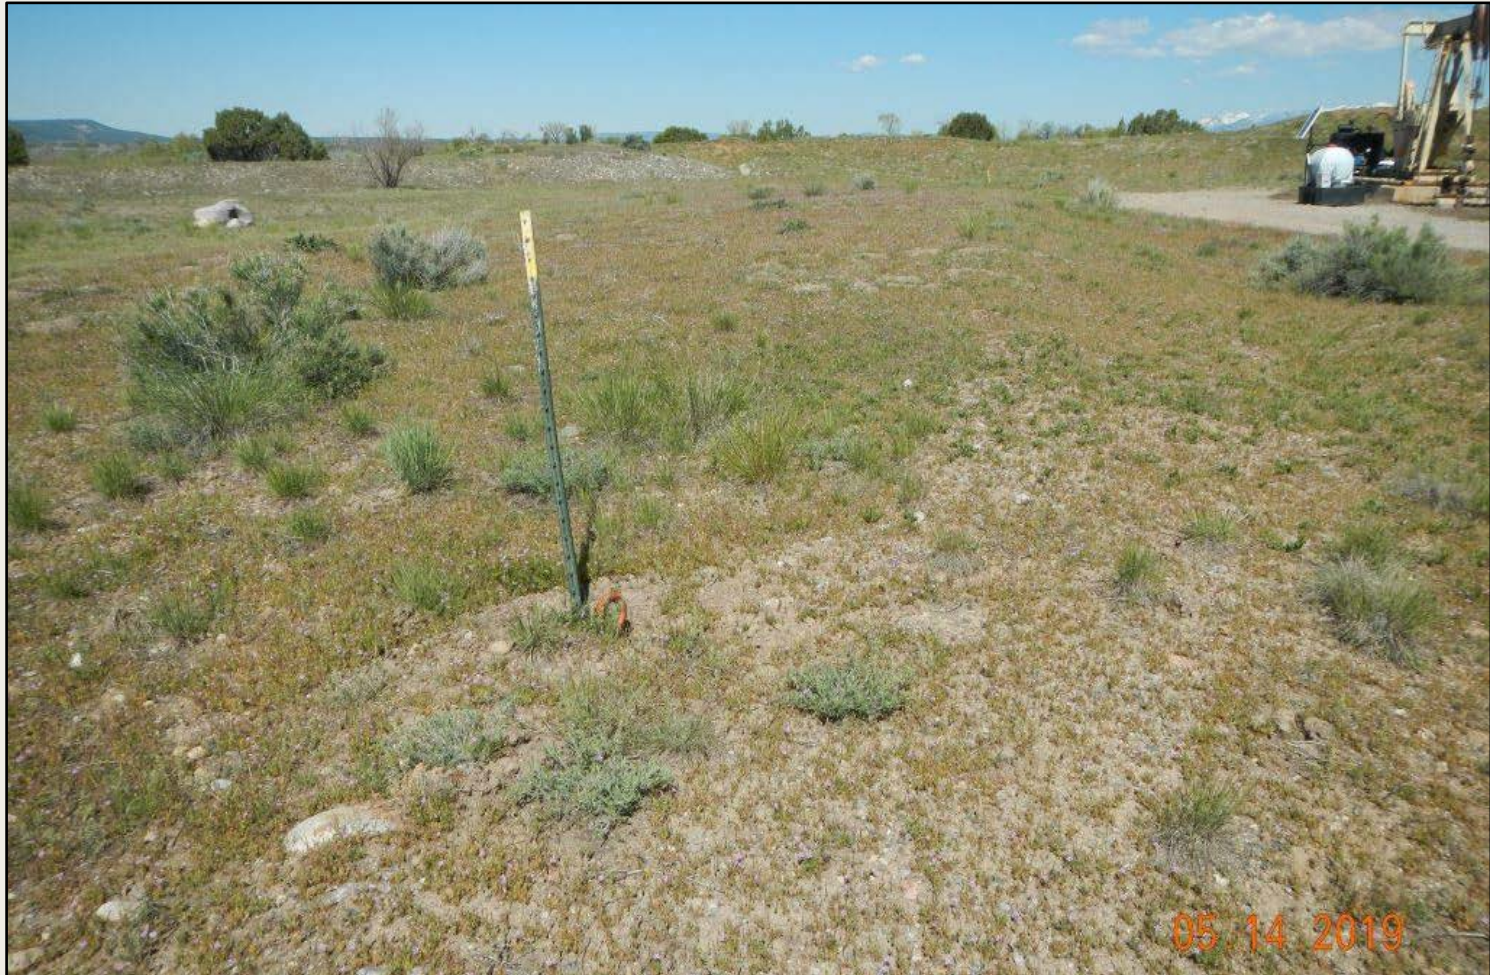
Photo 1. View of the southern project area from the southeastern corner facing westward.

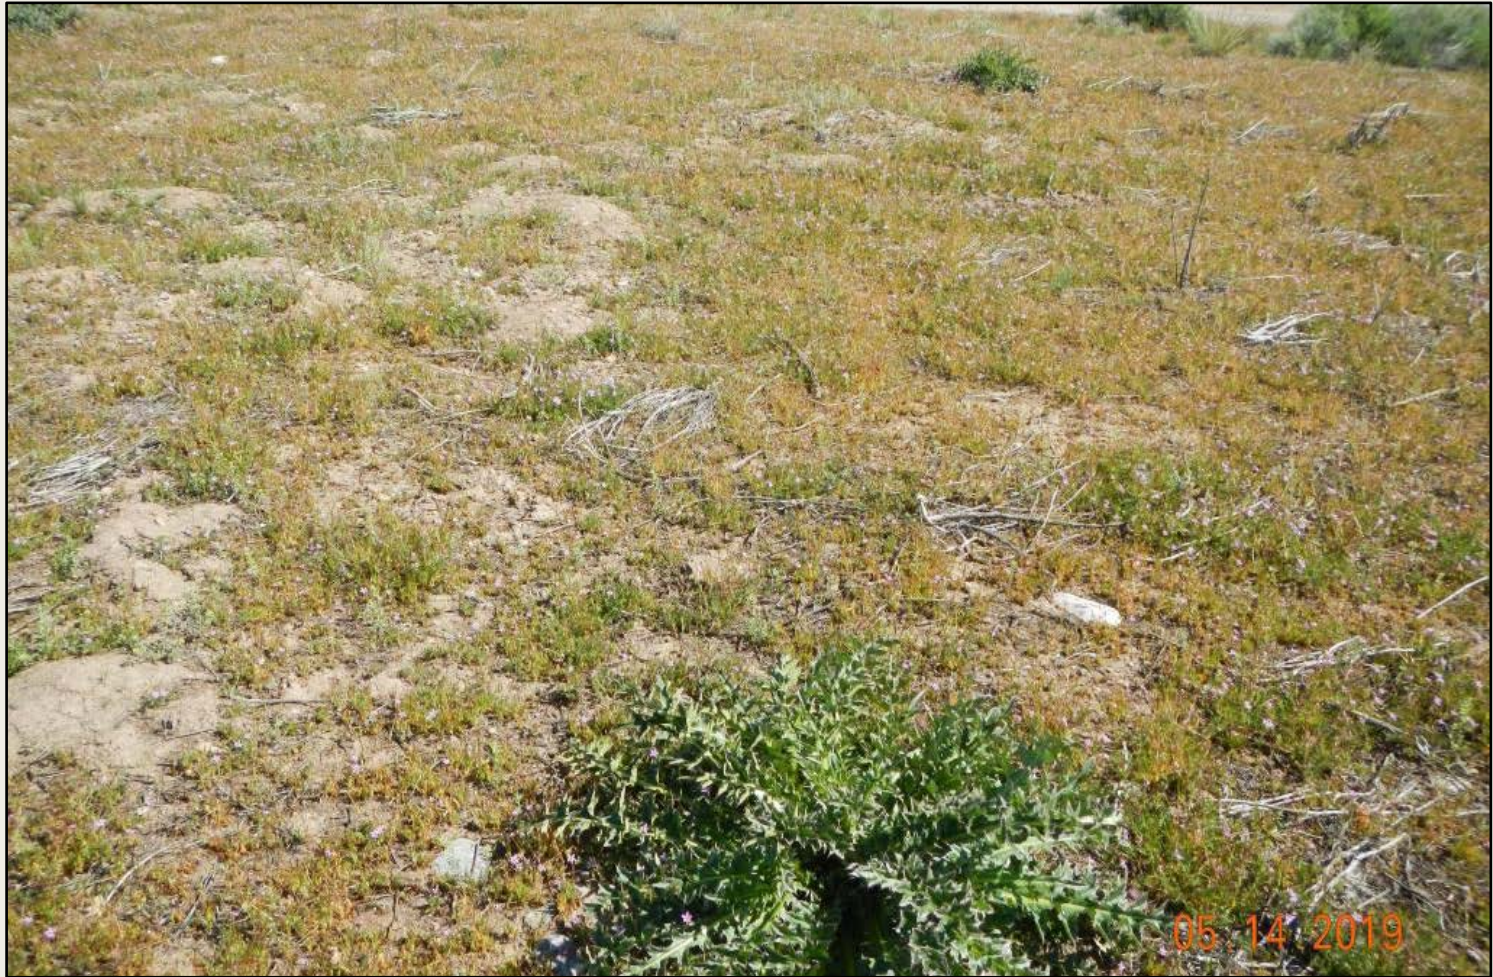
Photo 2. View of musk thistles in foreground and background, within the southern project area.

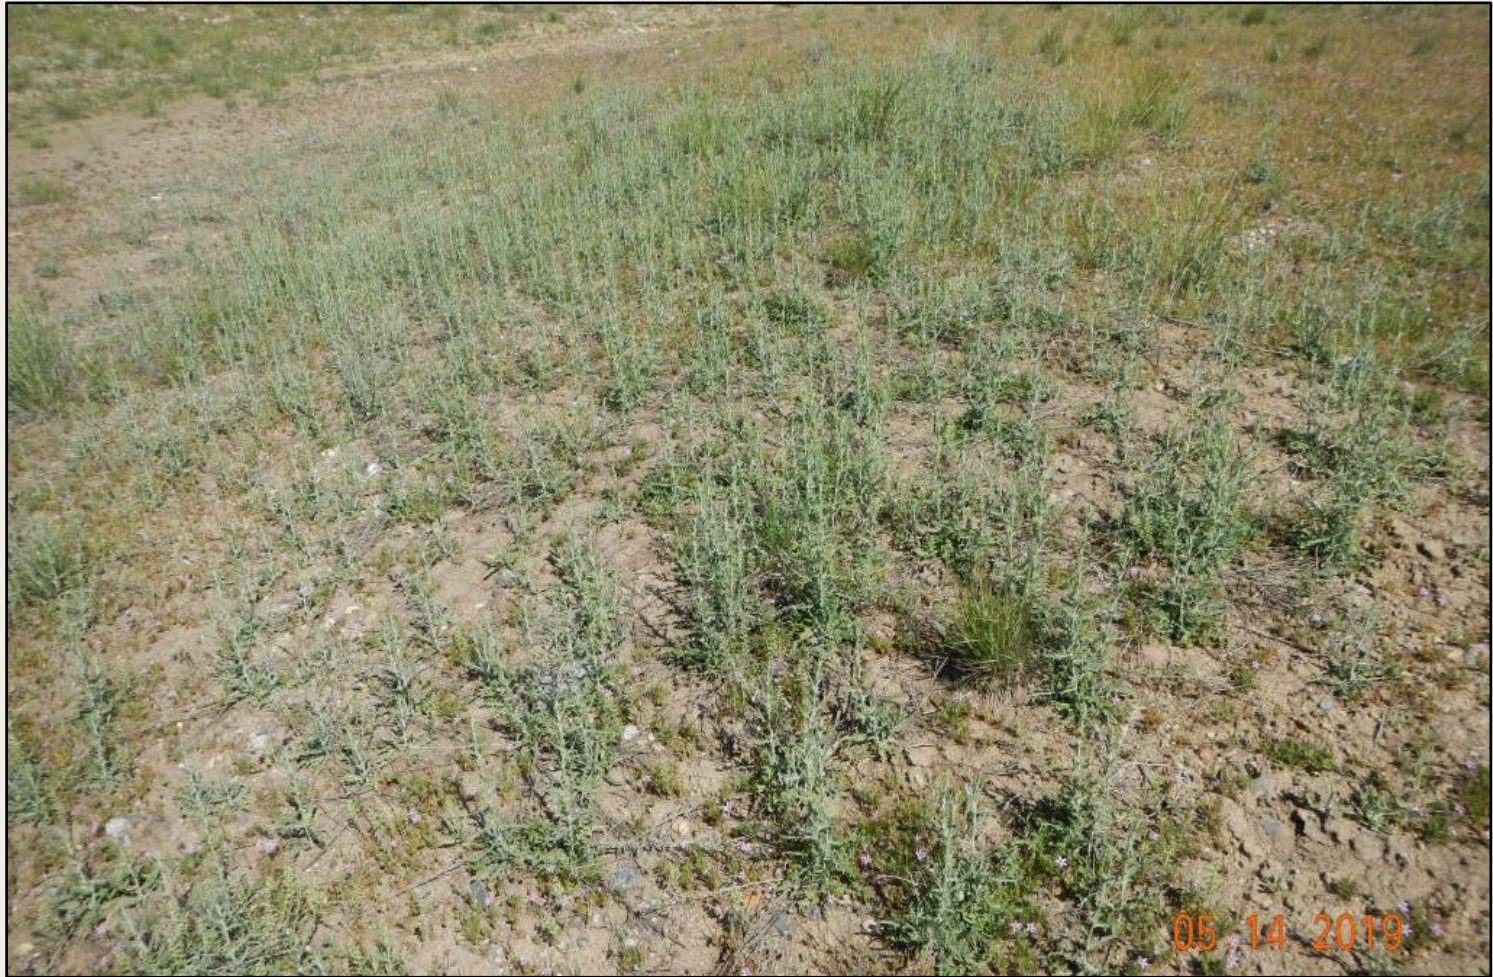
Photo 3. View of Russian knapweed (*Rhaponticum repens*) within the interim reclamation area.

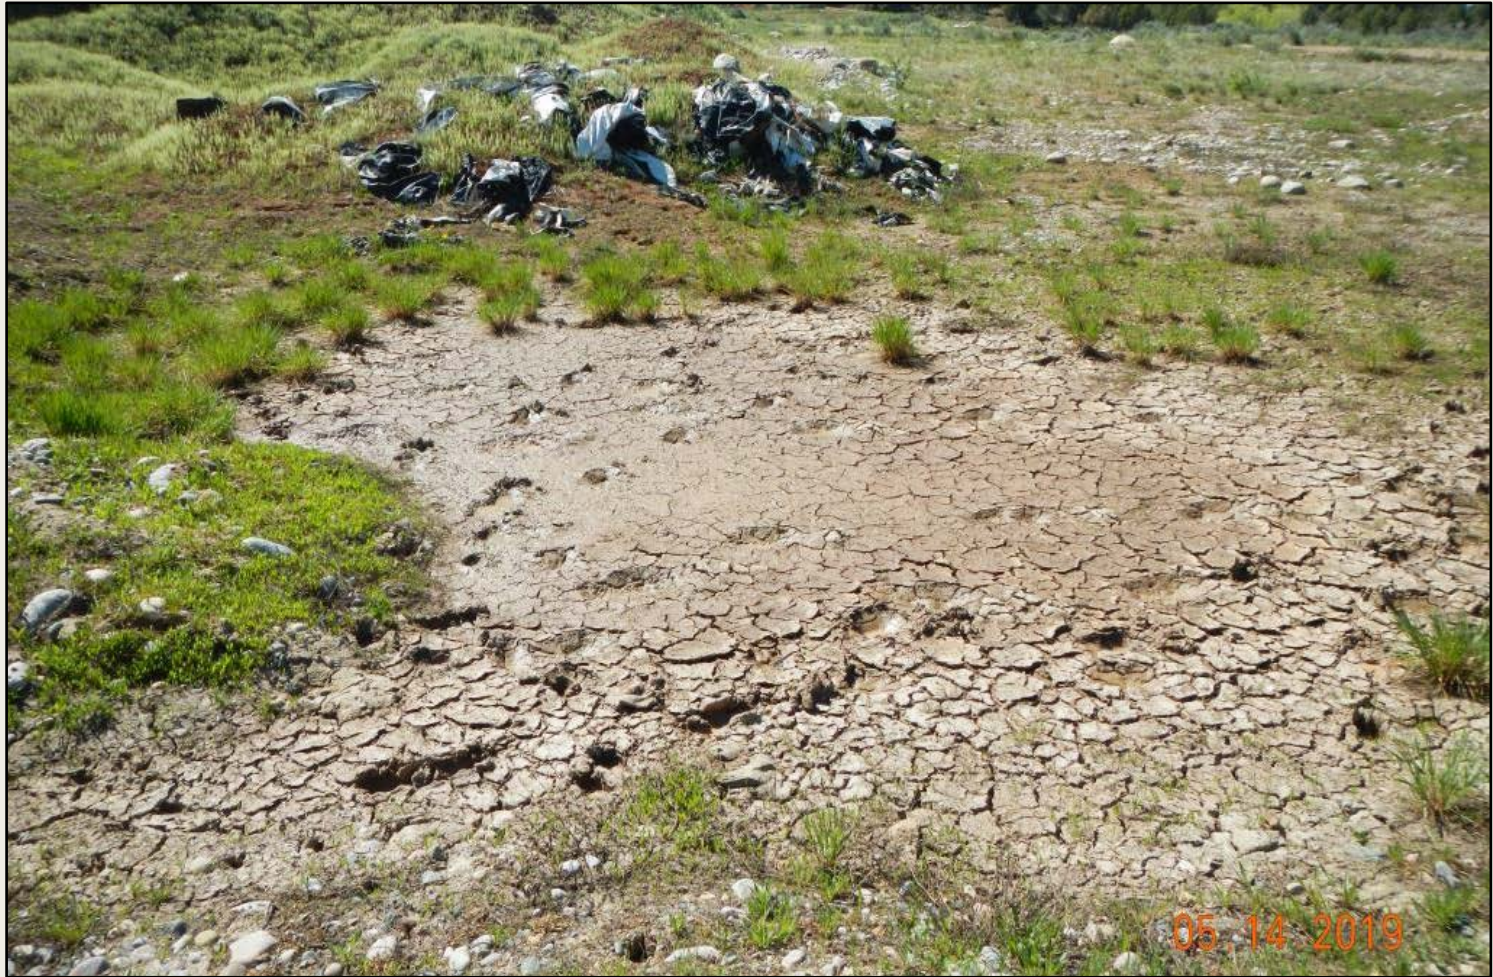
Photo 4. View of pit liner debris and ponding area within the northeastern project area.

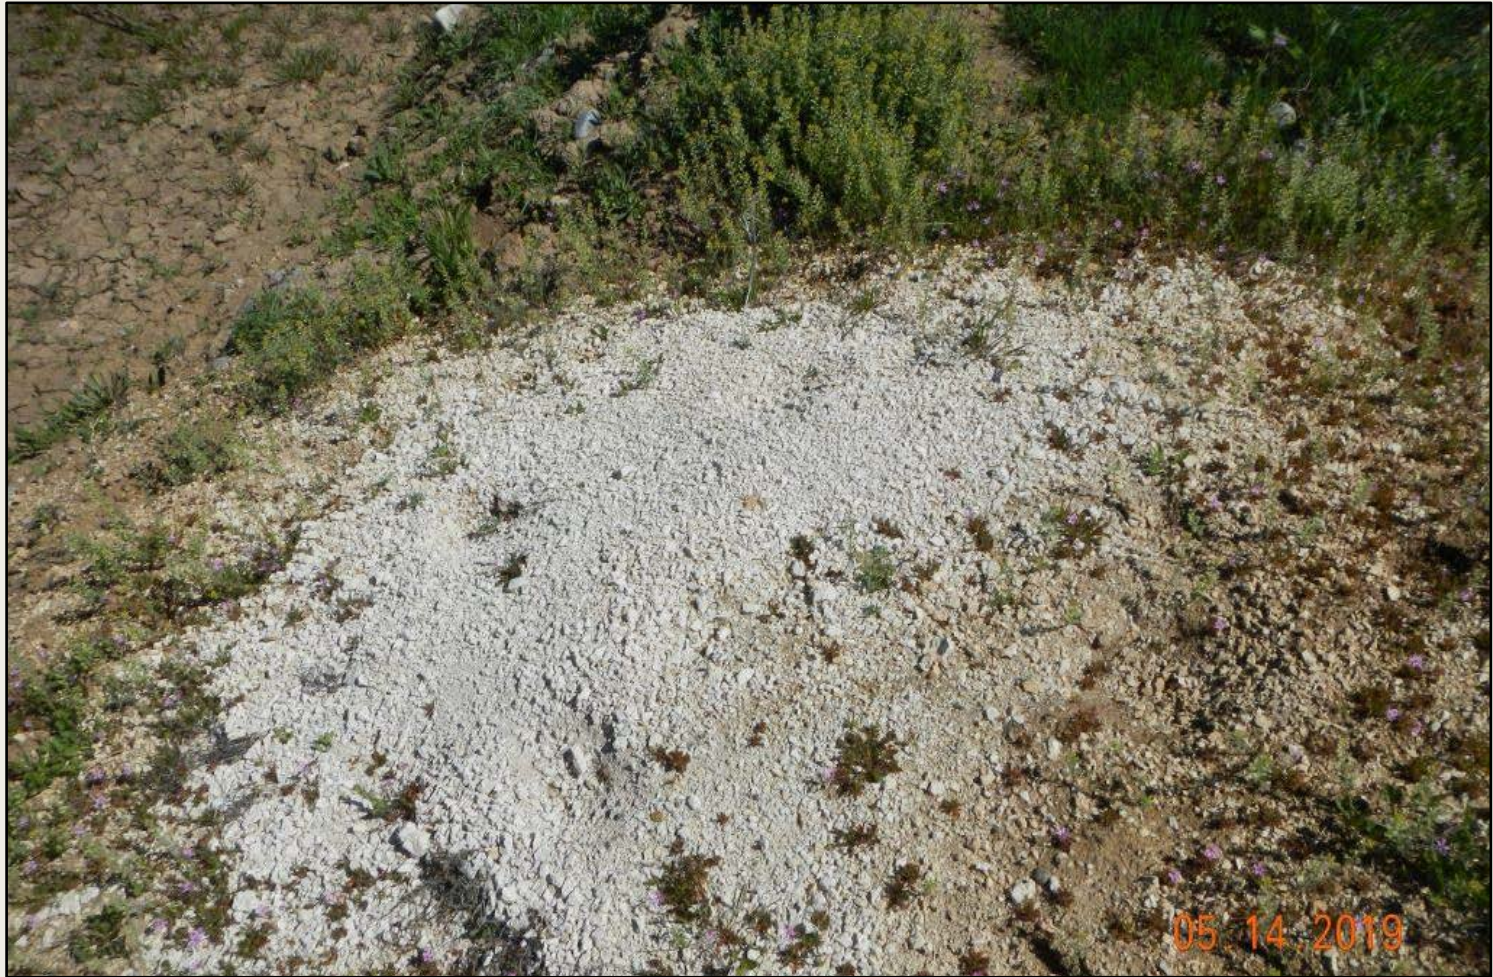
Photo 5. View of concrete debris within piles of liner debris.
