Noble Energy Inspection Photos 05/15/2019
Location: Harper- Kona A21-13 Facility
Spill ID # 464356

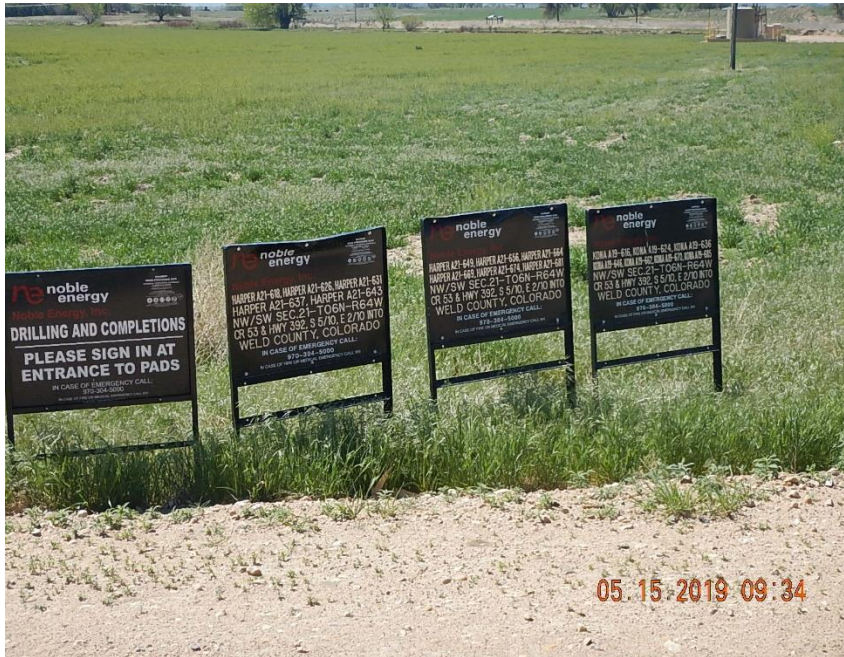
Signage at lease (facility access) road.

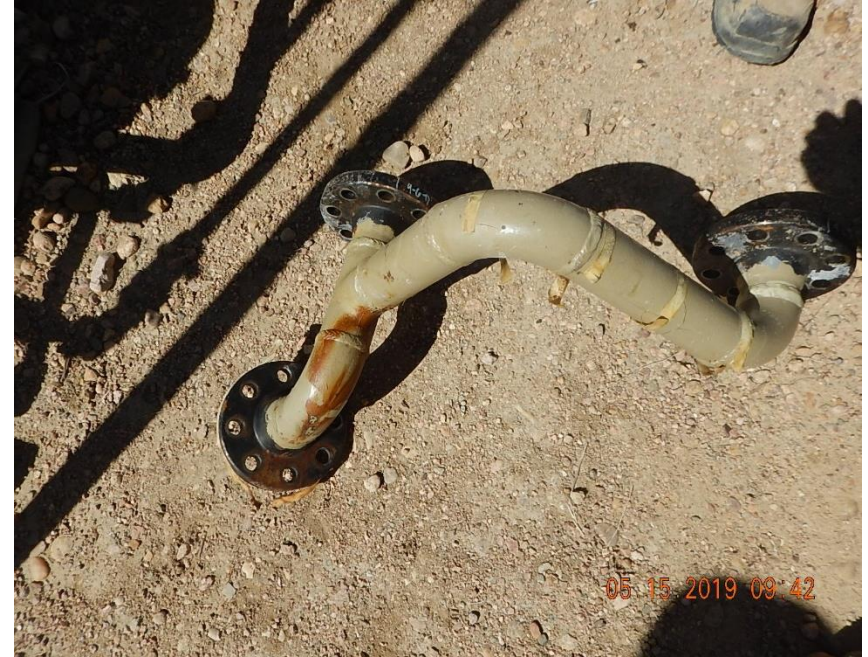
View of process pipe assembly/ equipment failure.

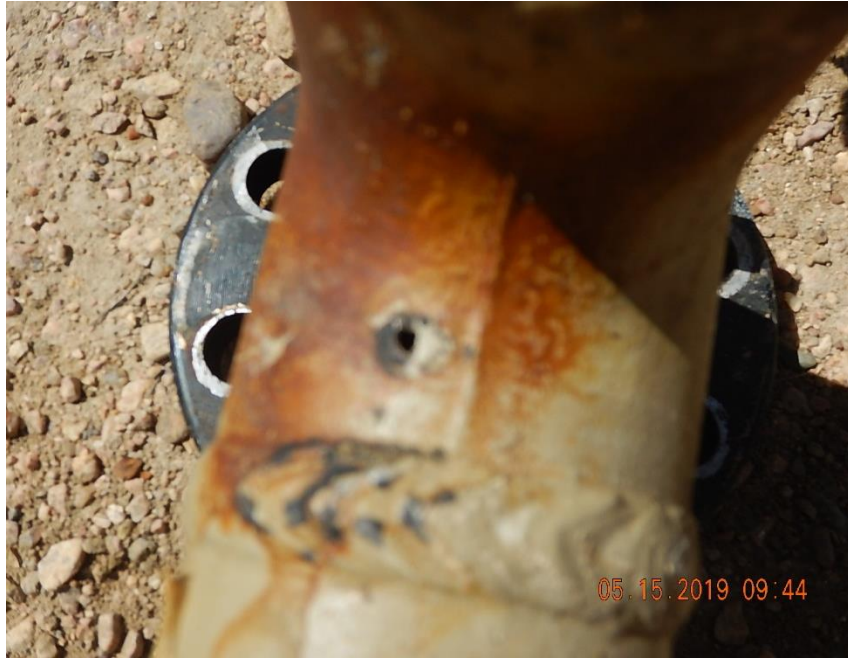
Corrosion pinhole resulting in release.

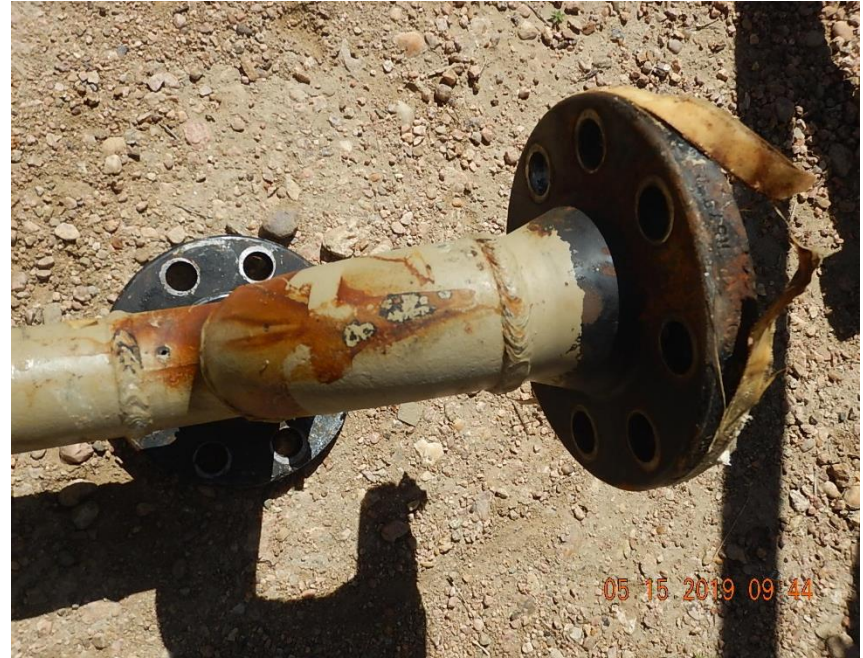
Process pipe assembly and corrosion pinhole.

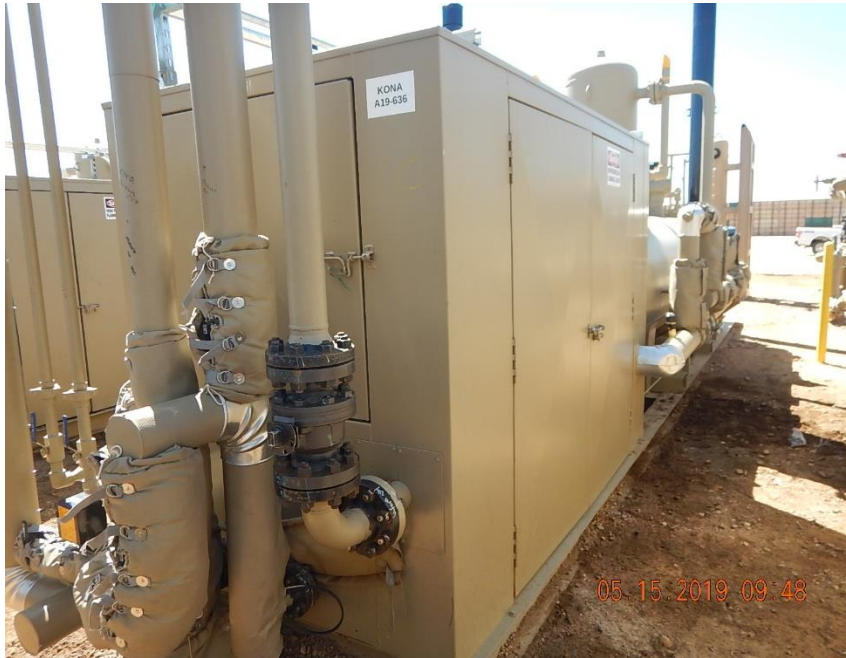
**Kona A19-636 heated horizontal separator and crude oil/
produced water dump flowline outlets (crossover assembly
under insulation).**

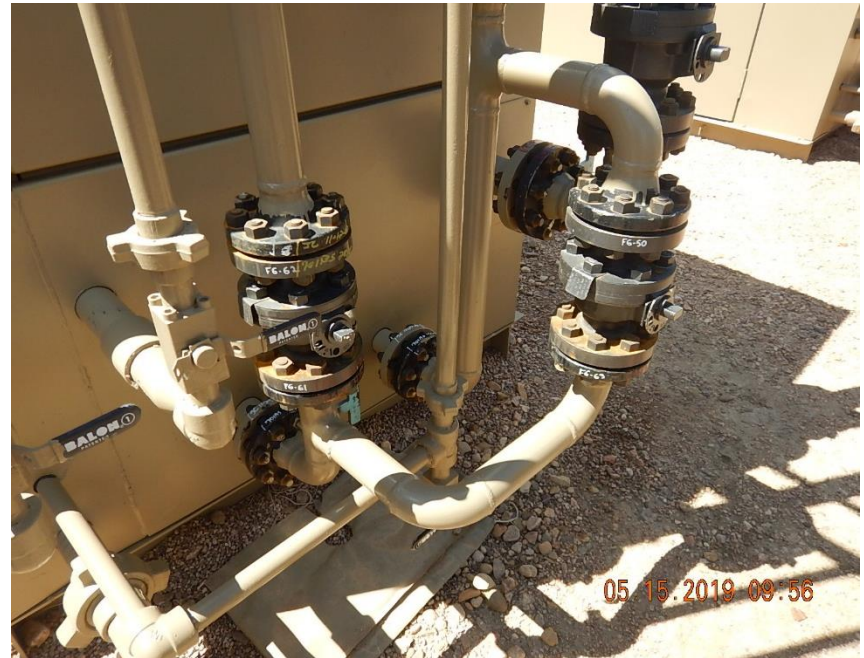
**View of process pipe assembly (no insulation) in place at
outlet of heated horizontal separator.**
