Inspection Photos
Operator: Maralex Resources
Location/API #: 067-09474
Date: 5-14-2019

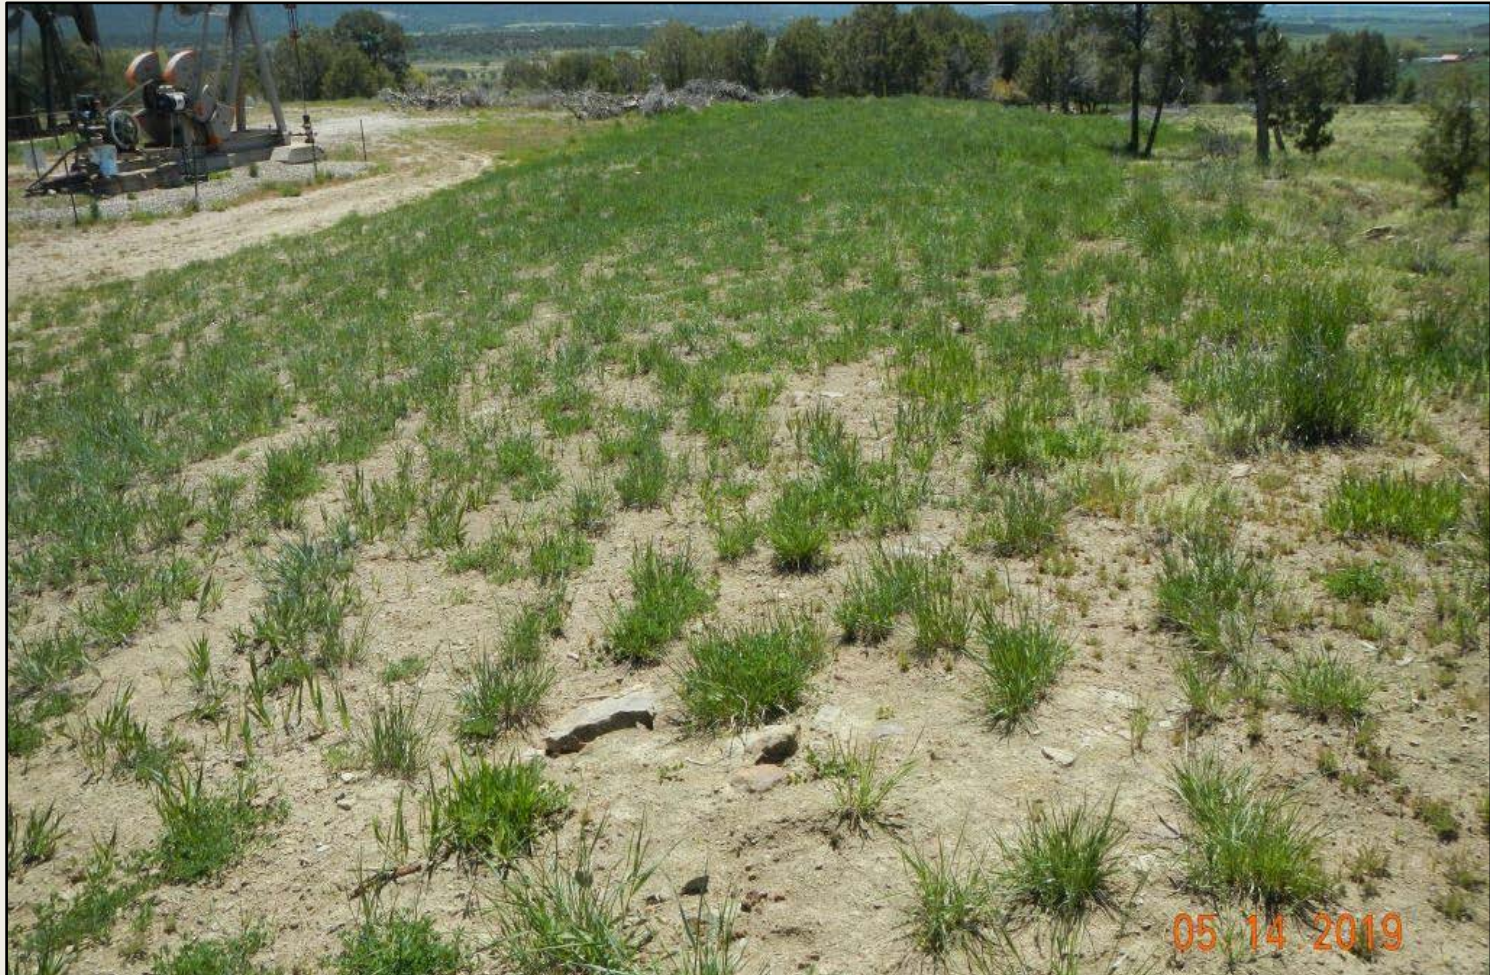
Photo 1. View of the southwestern project area from the northwestern corner facing southeastward. Revegetation is progressing within the interim reclamation area.

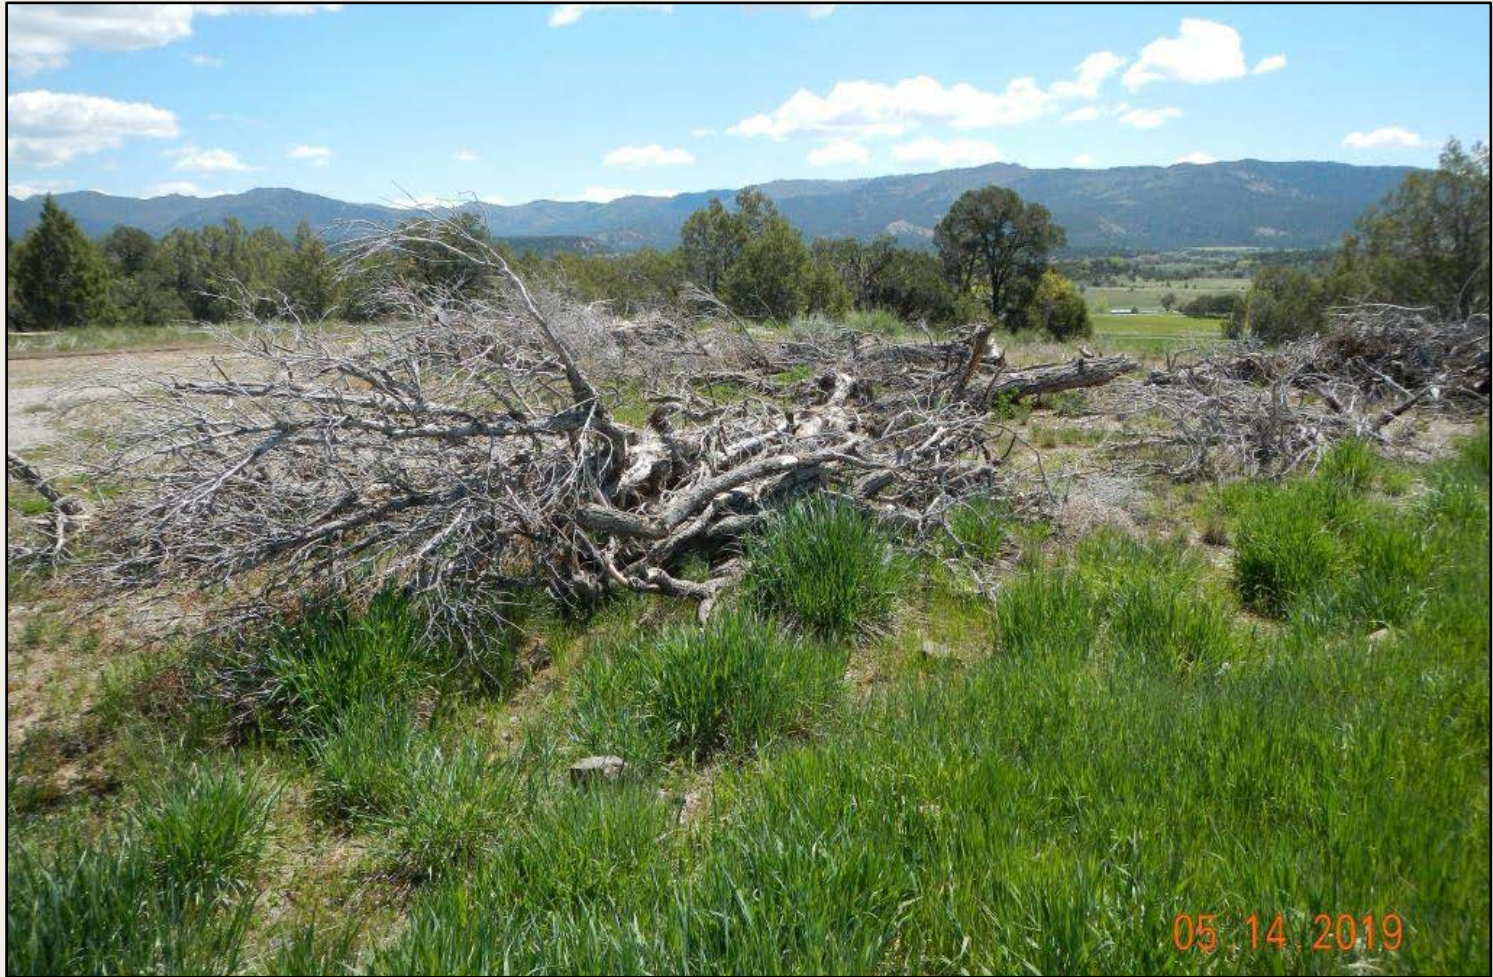
Photo 2. View of wood debris piles within the southern corner of the project area.

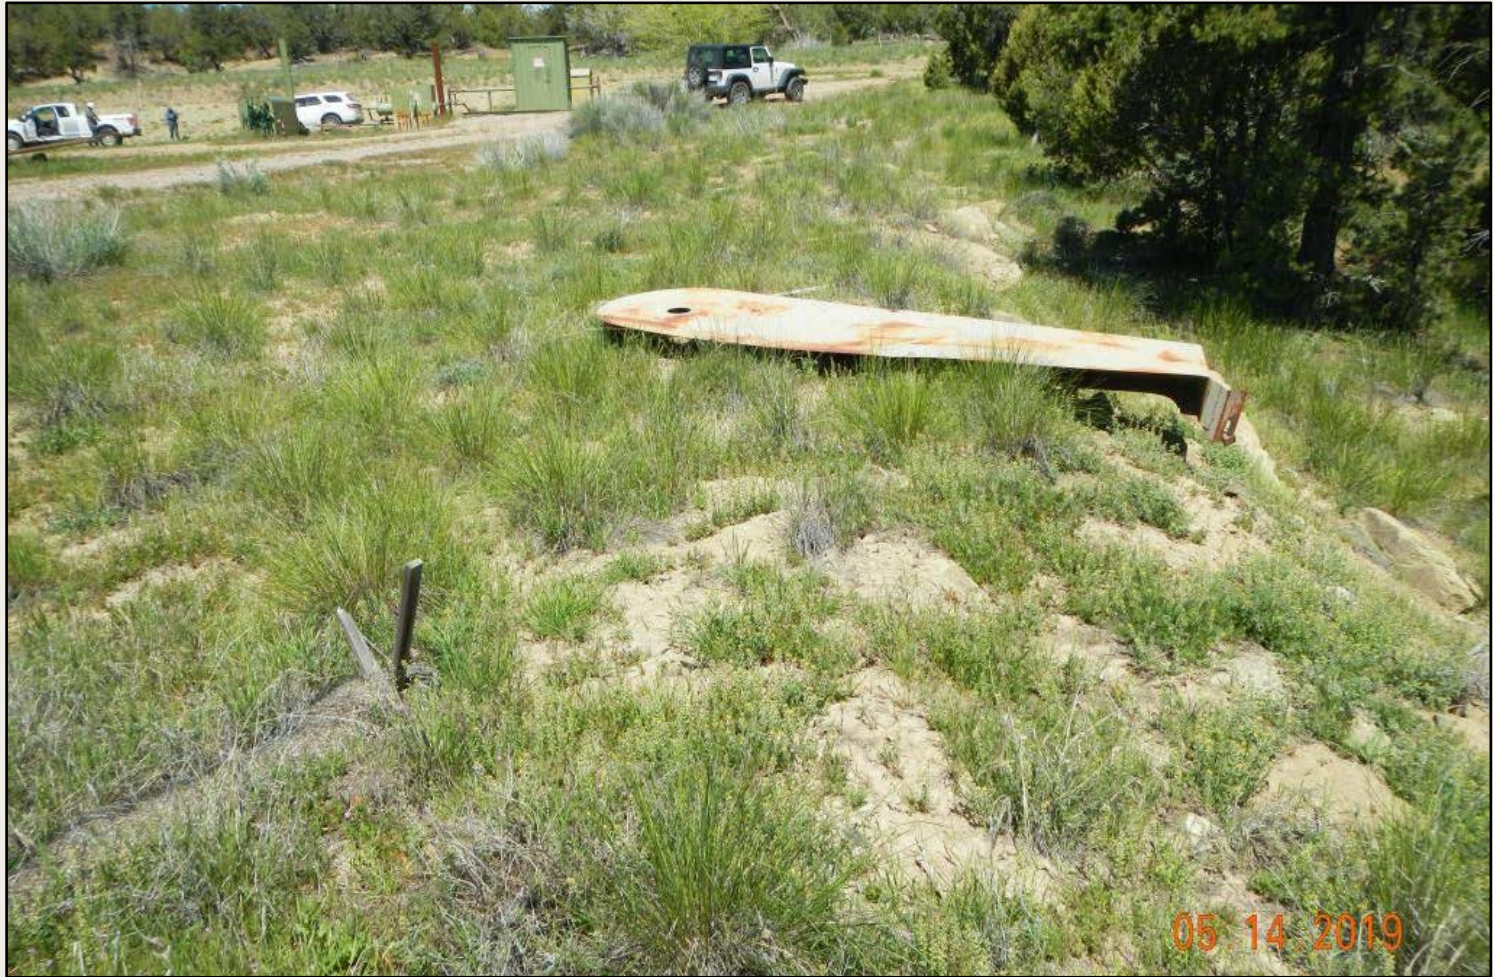
Photo 3. View of unused equipment within the eastern project area.

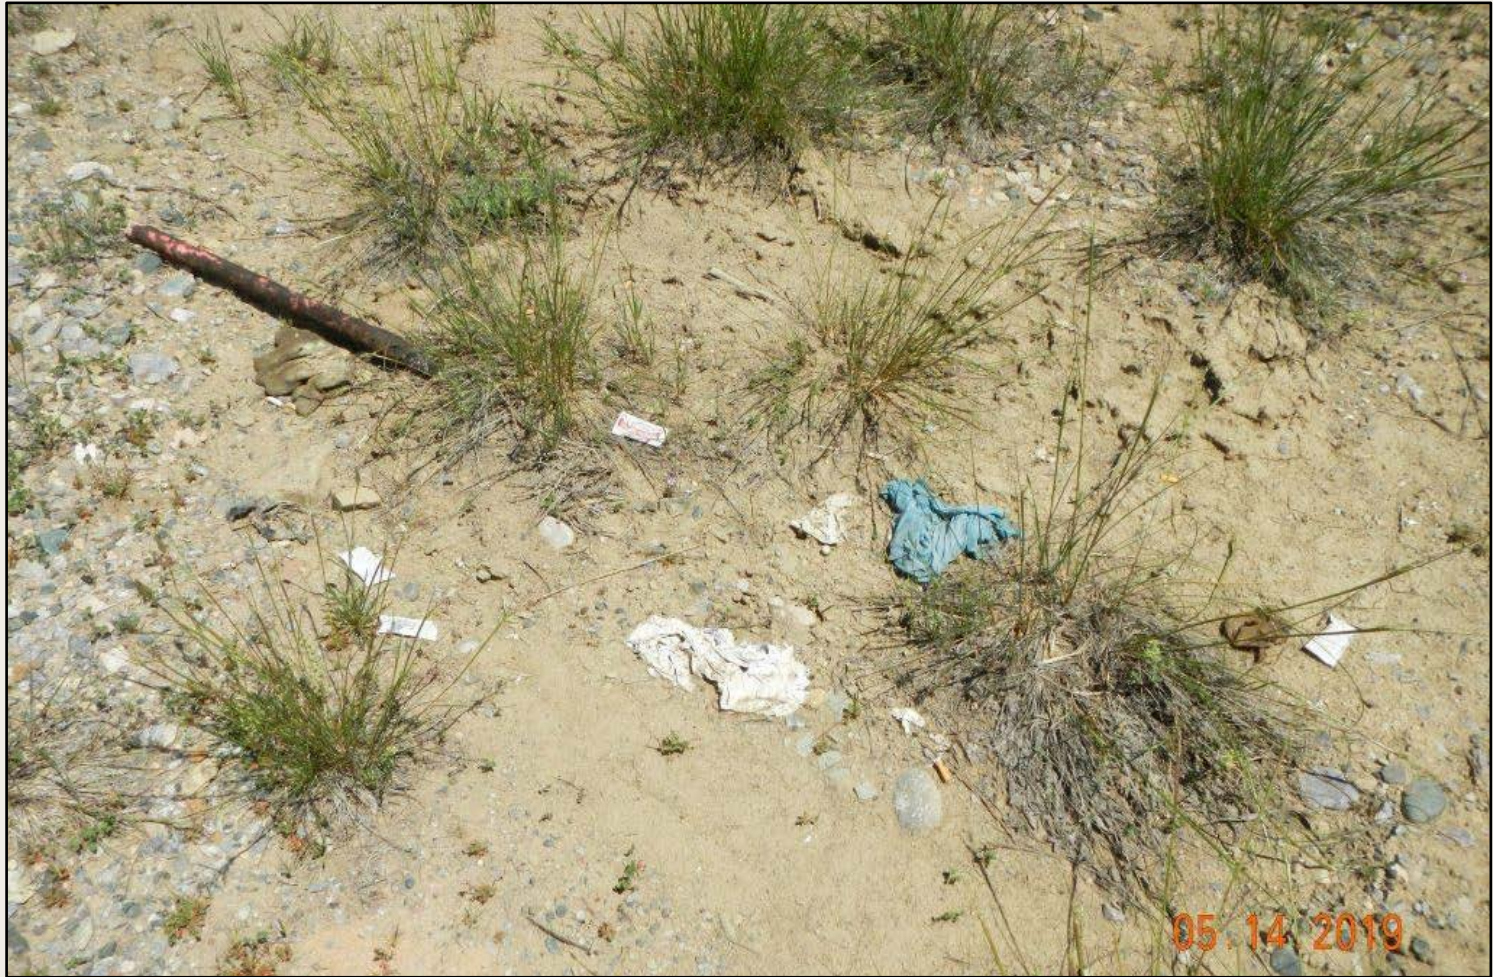
Photo 4. View of waste and debris within the interim reclamation area.
