Inspection Photos
Location Name: Amoco-Federal 20-9
API: 05-081-06516

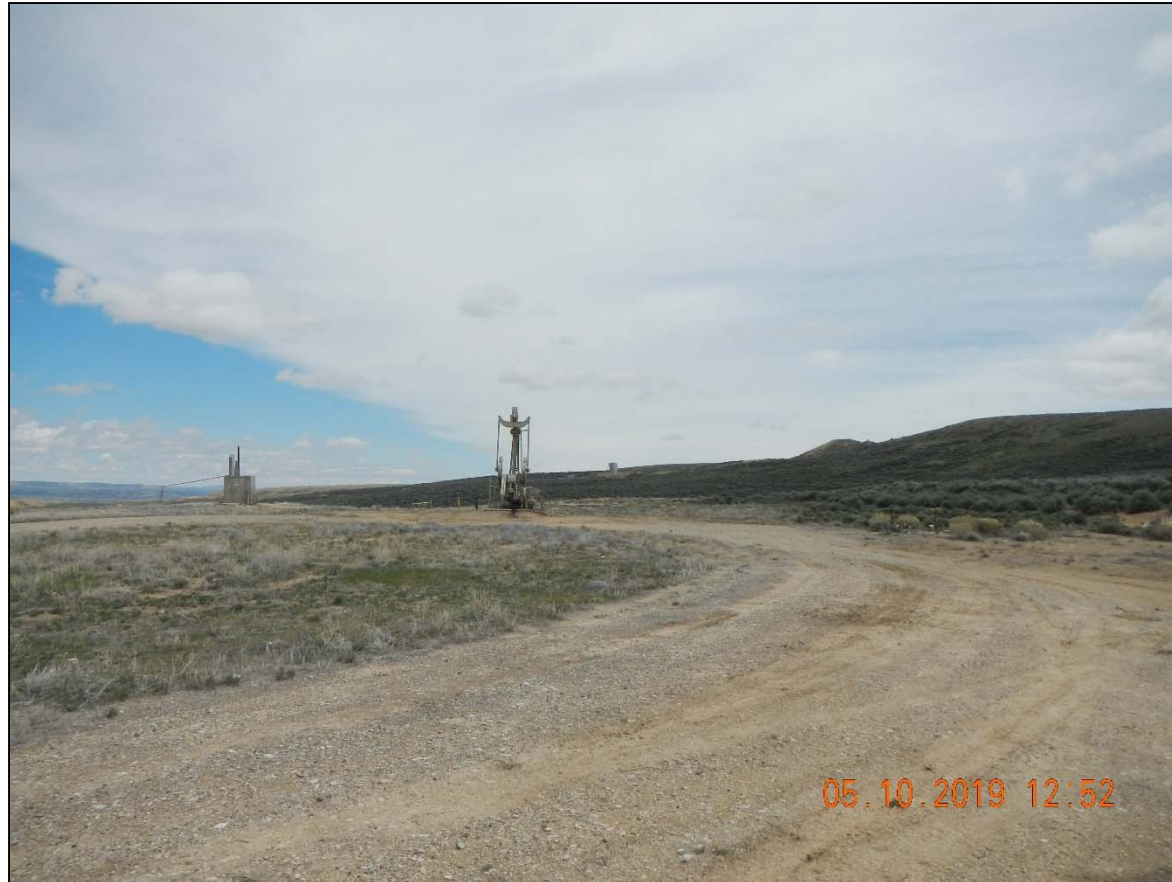
Photo 1. Overview of location taken at entrance facing east.

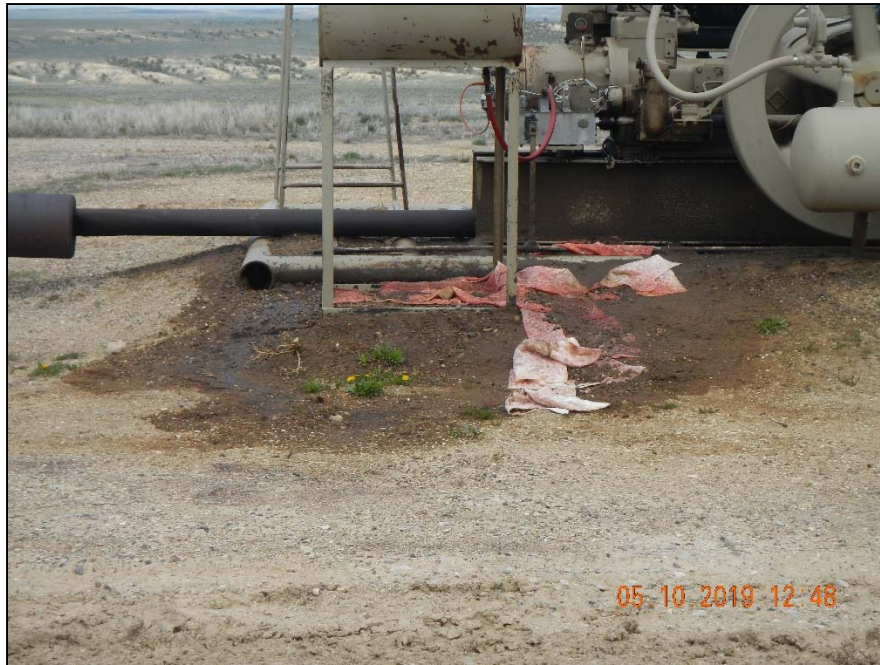
Photo 2. Stained soil at pump jack motor.

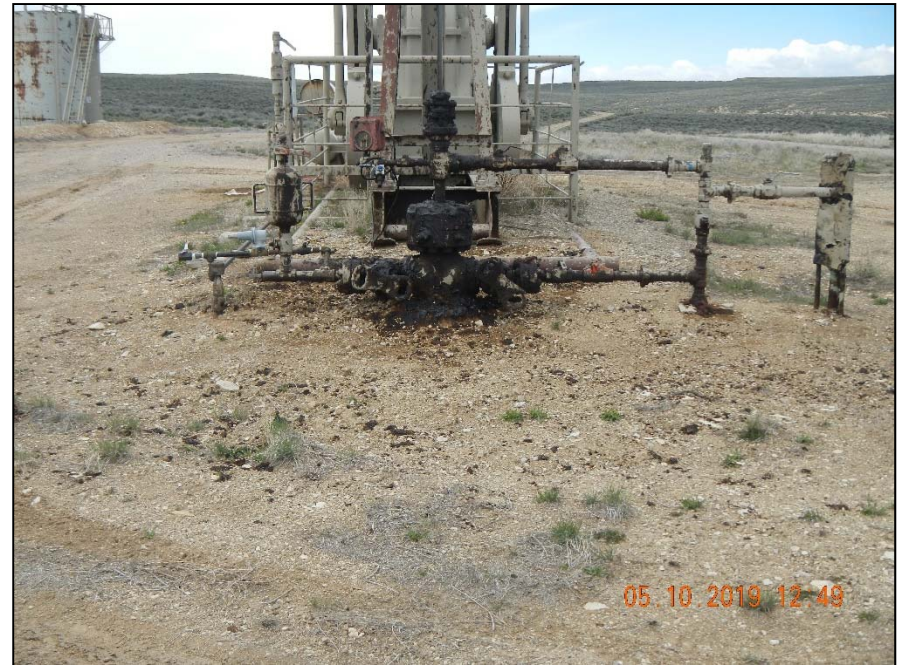
Photo 3. Stained soil at wellhead.

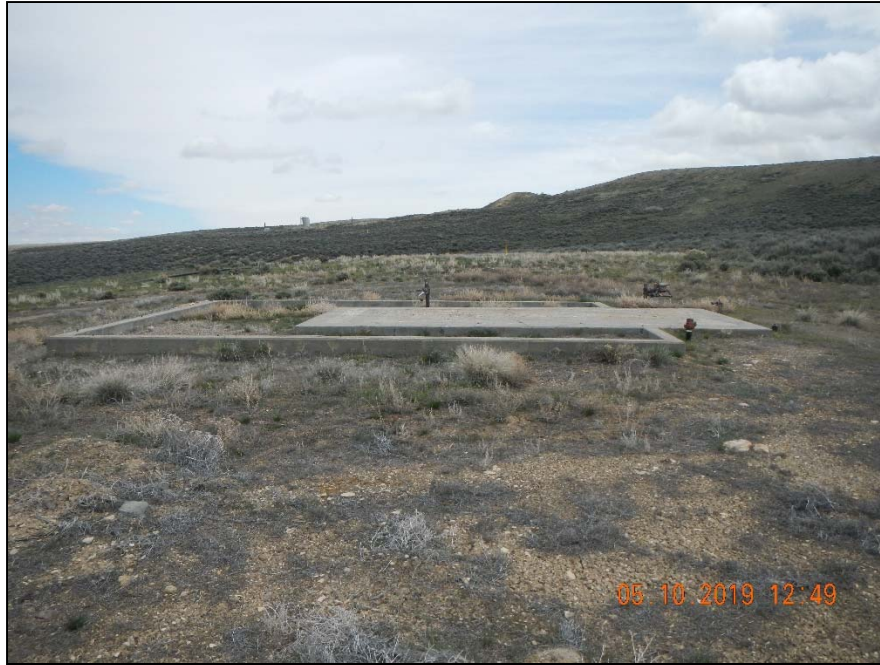
Photo 4. Concrete base stored on location.
