Inspection Photos
Location Name: Elaine #43-28
Location ID: 336320

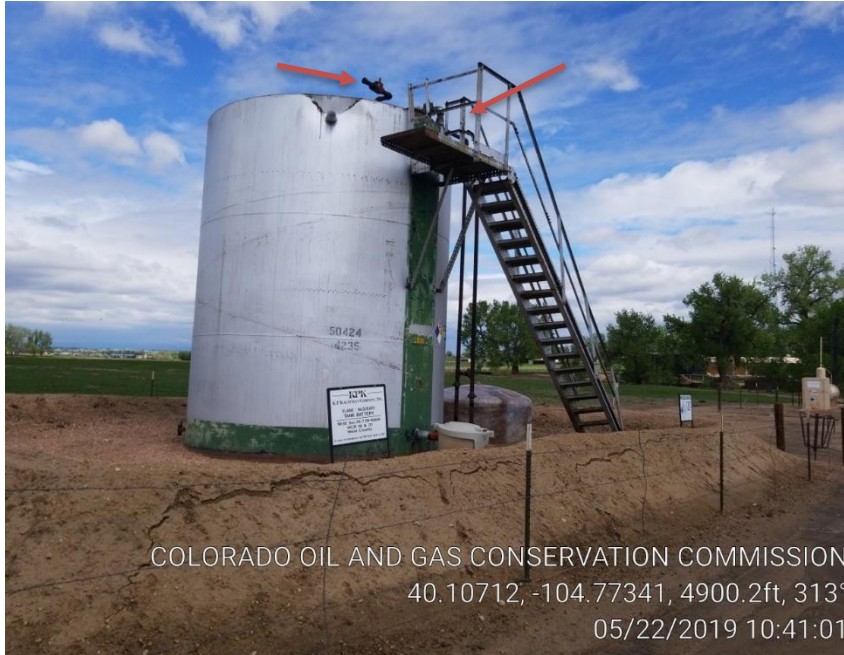
Pic 1 Tank not painted, no placard capacity, open piping not capped

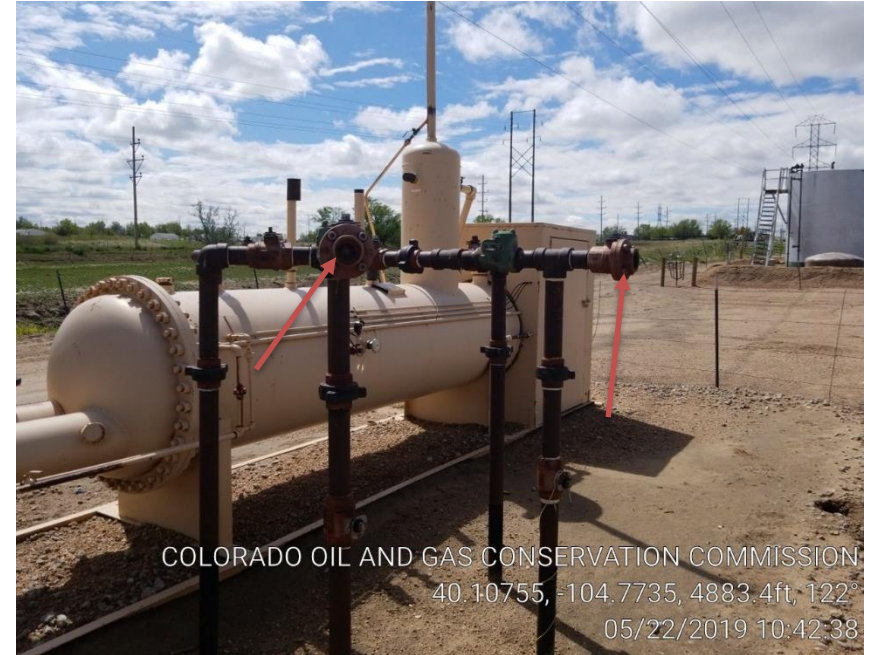
Pic 2 piping not capped on separator

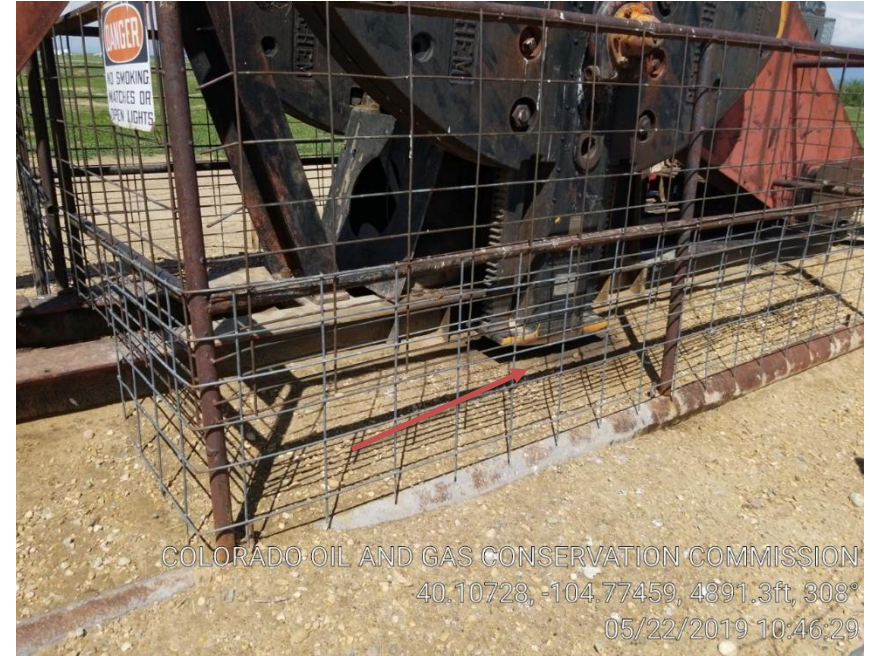
Pic 4 stained soil under counterweight
